The Development of and Lessons from the Fukushima Daiichi **Nuclear Accident**

Greetings and Introduction to This Booklet

The accounts in this booklet about the Fukushima Daiichi and Daini nuclear power stations have been drawn up based on the material contained in TEPCO's Fukushima nuclear accident investigation report.

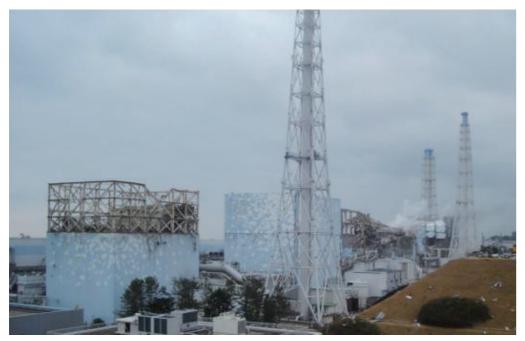
Fukushima Daiichi Nuclear Power Station, after the accident (from left to right, Units 1, 2, 3, and 4; photographed March 16, 2011)

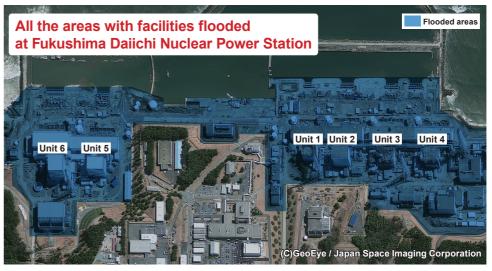
There was damage at Fukushima Daiichi Nuclear Power Station, including damage to outdoor equipment and flooding of important facilities.

Fukushima Daiichi Nuclear Power Station took a direct hit from an enormous tsunami about 50 minutes after the earthquake happened. Pumps and other outdoor equipment installed on the seaside for releasing heat from the reactor to the sea were damaged, and almost the entire site on which the reactors were built was flooded as a result of the tsunami. Also, water flooded into the turbine building and other structures and power-supply facilities became unusable. As a result, various key safety functions, such as the injection of coolant into reactors and the ability to monitor status, were lost. Furthermore, a variety of damage was inflicted, such as the spread of debris by the tsunami that prevented people from moving around the site.

Fukushima Daiichi Nuclear Power Station after having been damaged by the tsunami (overall view); photo taken March 19, 2011

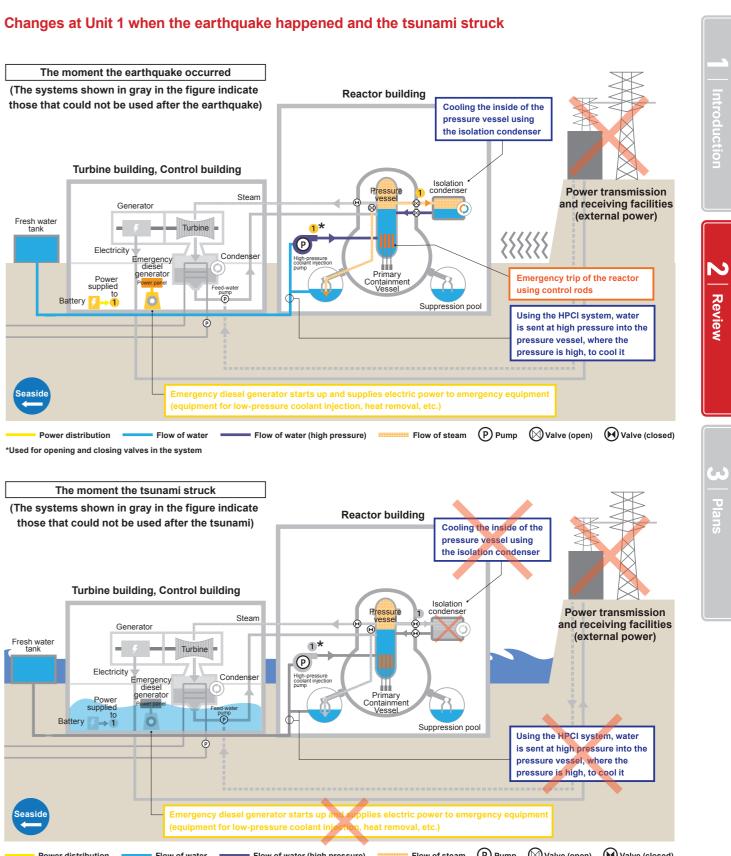
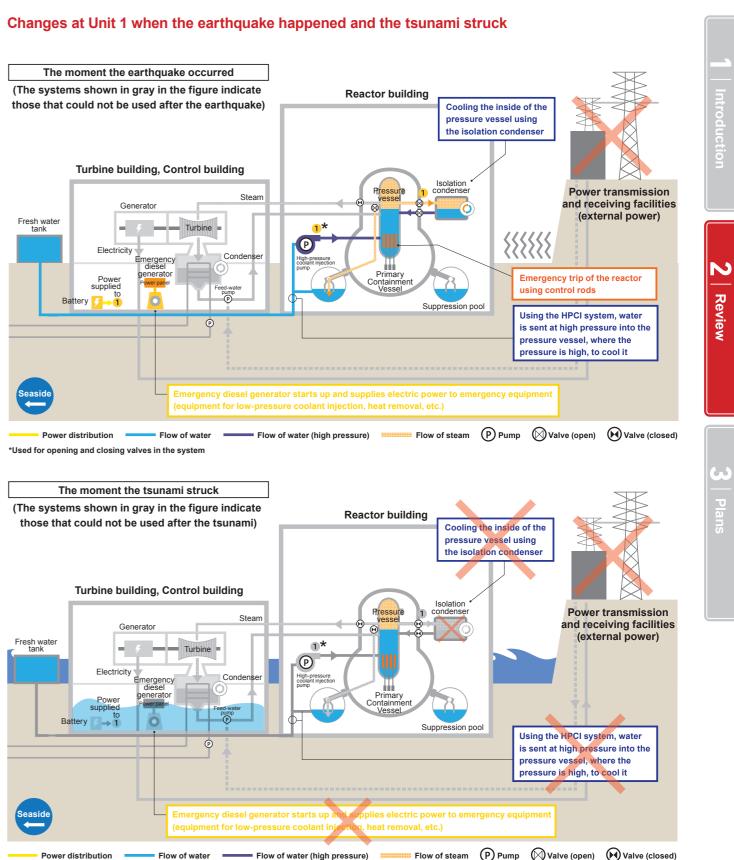
Accident issues of note (Unit 1)

Lessons from the accident	Problem(s) that arose
1: Protection from tsunami	 The buildings and areas outside were flooded due to the tsunami.
2:Guaranteeing power sources/means of injecting coolant	 All coolant injection and heat removal function was lost due to the loss of all AC and DC power. Owing to the inability to inject coolant or remove heat, the water level inside the pressure vessel dropped and, approximately 4 hours after the tsunami, the core was damaged.

3:Impact mitigation after core damage	 The hydrogen generated due to the core damage leaked from the pressure and primary containment vessels to the inside of the reactor building and a hydrogen explosion occurred. The melted reactor core penetrated the pressure vessel and eroded the concrete of the primary containment vessel.

5:Improvements to the recovery work environment	• Due to concerns about major aftershocks and attendant tsunami as well as the scattering of debris, accessibility to the site and the capacity to do work there were reduced.

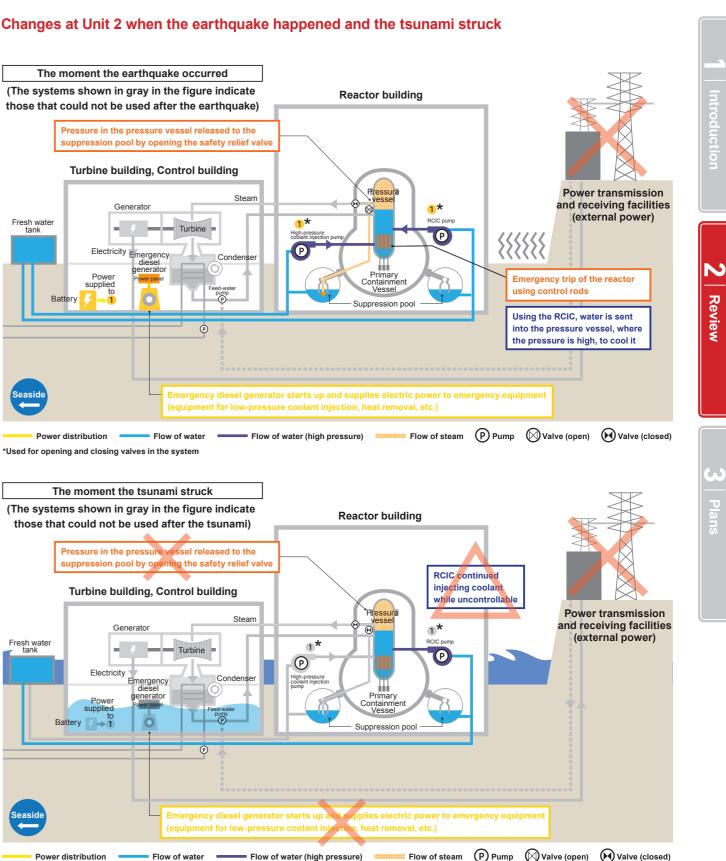
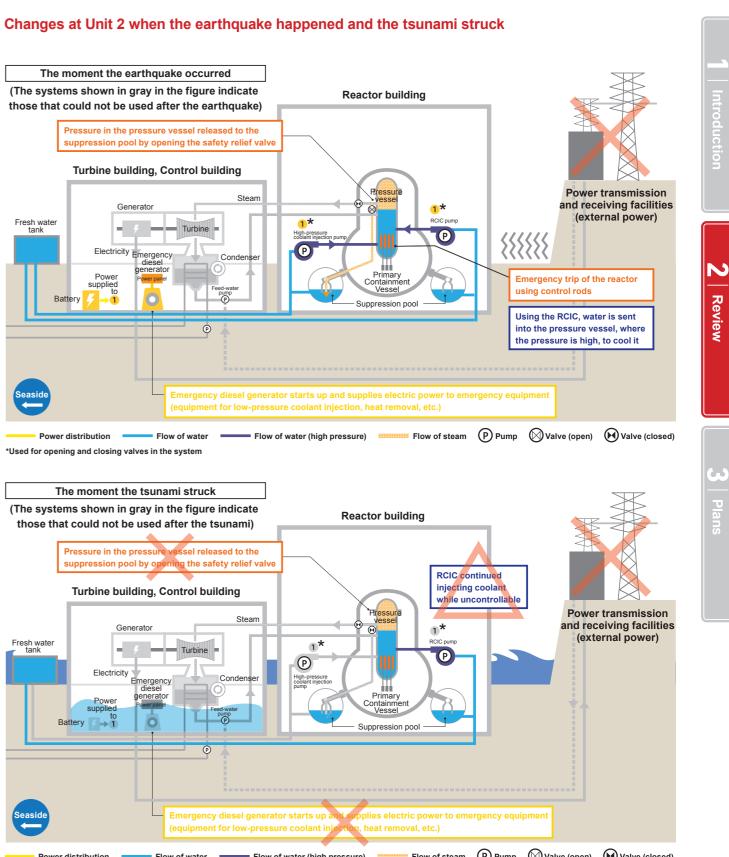
Lessons from the accident	Problem(s) that arose
1: Protection from tsunami	• The buildings and areas outside were flooded due to the tsunami.
2:Guaranteeing power sources/means of injecting coolant	 Due to the loss of all AC and DC power, all coolant injection and heat removal functions were lost except the RCIC. At the same time, the RCIC became uncontrollable. It operated for several days, but subsequently tripped. After the RCIC tripped, time was needed to reduce the pressure of the pressure vessel. The water level fell and core damage eventually occurred.

3:Impact mitigation after core damage	 After the core was damaged, the primary containment vessel was also damaged and both hydrogen and radioactive material were leaked to the outside.

4:Assessing the situation at the plant	 Due to all power having been lost, the means for illumination, communication, monitoring, and measuring were lost. In addition, all units had simultaneously fallen into a crisis situation. This all produced confusion in the initial response and inadequacies in the sharing of information.

5:Improvements to the recovery work environment	 Owing to concerns about major aftershocks and attendant tsunami, as well as the scattering of debris due to the tsunami and the hydrogen explosions at Units 1 and 3, accessibility to the site and the capacity to do work there were reduced. The power-supply car and fire engines that had been prepared were damaged by the hydrogen explosions at Units 1 and 3. The work environment worsened strikingly owing to a lack of resources for dealing with an increase in radiation doses and for managing radiation, as well as the accident response extending to last many days.

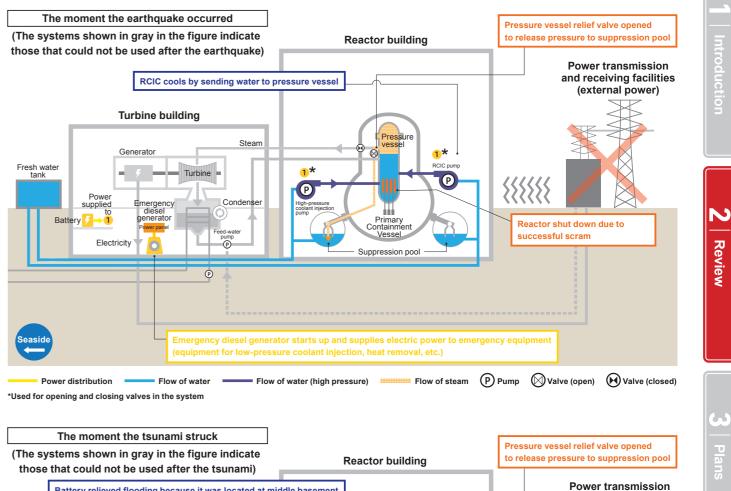
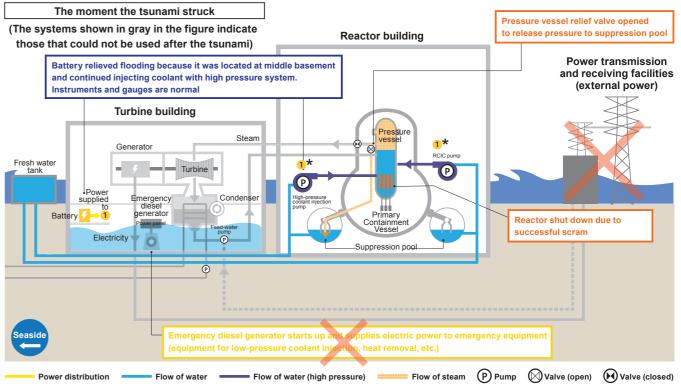
Changes at Unit 3 when the earthquake happened and the tsunami struck

Lessons from the accident	Problem(s) that arose
1: Protection from tsunami	 The buildings and areas outside were flooded due to the tsunami.
2:Guaranteeing power	• The loss of all AC power caused the loss of AC-powered coolant injection and heat removal function.
sources/means of injecting coolant	 Once the HPCI system had tripped, depressurization in the pressure vessel took time, the water level dropped, and the result was core damage.

3:Impact mitigation after core damage	• The hydrogen generated due to the core damage leaked from the pressure and primary containment vessels to the inside of the reactor building and a hydrogen explosion occurred.

5:Improvements to the recovery work	• Due to concerns about major aftershocks and attendant tsunami, as well as the scattering of debris, accessibility to the site and the capacity to do work there were reduced.
environment	 The work environment worsened strikingly owing to a lack of resources for dealing with an increase in radiation doses and for managing radiation, as well as the accident response extending to last many days.

and continued injecting coolant with high pressure system. Instruments and gauges are normal

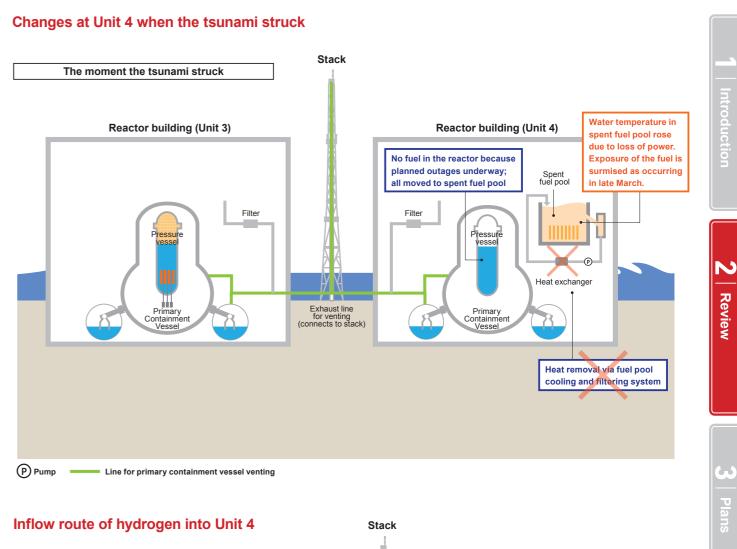
The spent fuel pool was made with steel-reinforced concrete measuring 140 to 185 cm thick. For that reason, although the exterior walls were damaged at Fukushima Daiichi Unit 4, it has been confirmed that there has been no change from before the earthquake in the spent fuel pool's seismic resistance ability. Even if another earthquake of the same strength as the Great East Japan Earthquake occurred (strong 6 on the Japanese scale) no problems in safety terms would arise.

However, to further improve safety construction, the bottom of the pool was reinforced with steel posts and concrete walls, improving seismic tolerance by 20% (Completed in July 2011).

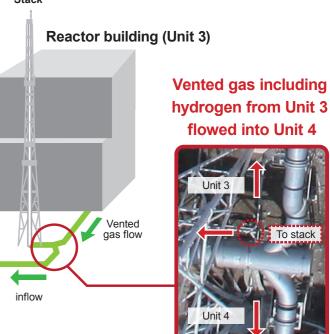
Reactor building (Unit 4) 5 F 4 F 3 F Exhaust duct 2 F 1 F

Unit 4 was not in operation because planned outages were being conducted, but a hydrogen explosion occurred in the reactor building in the early morning on March 15. The cause is presumed to have been hydrogen generated at Unit 3 that flowed into Unit 4 through the exhaust pipes.

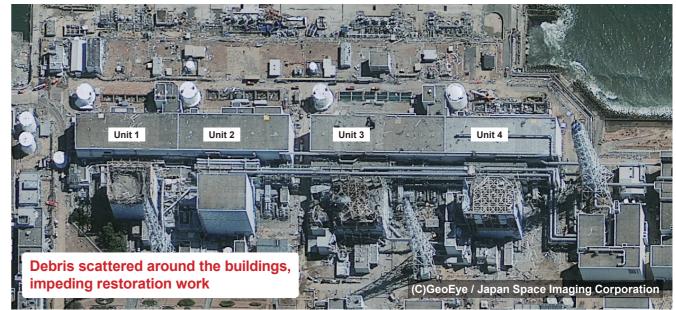
The damage at Fukushima Daiichi Nuclear Power Station Units 1-4, photographed March 19, 2011
