The 6th Progress Report
on the Investigation and Examination of
Unconfirmed and Unsolved Issues
on the Development Mechanism
of the Fukushima Daiichi Nuclear Accident

November 10, 2022

Tokyo Electric Power Company Holdings, Inc.

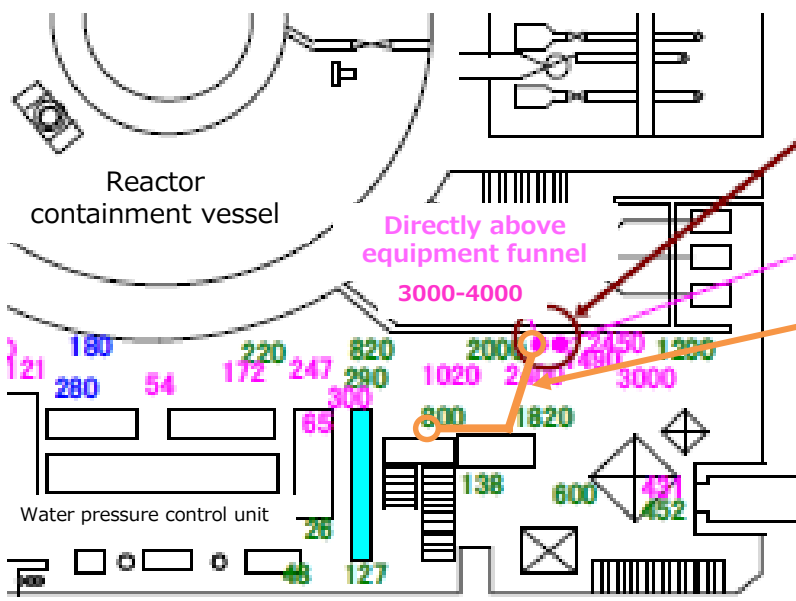
2011.6.3, after 16:00 steam discovery

Near floor penetration
Humidity: 55.7%
Temp.: 31.9°C
2011.6.3, 16:30

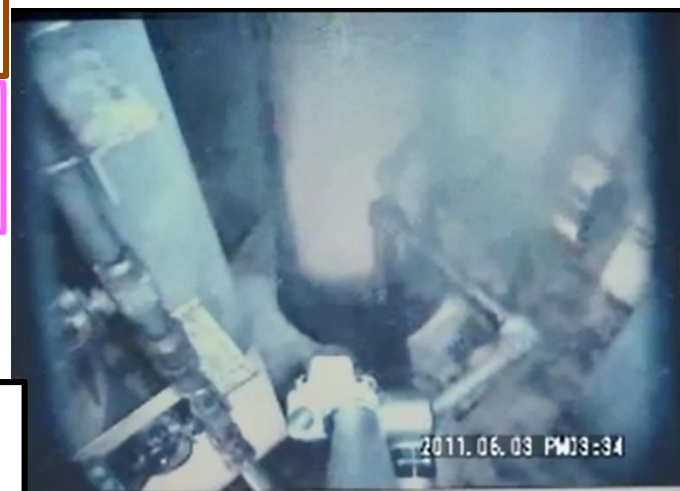
Steam observed at a floor penetration in the southeast area (June 2011 photo)

- During June 2011 survey, steam was observed flowing from the floor penetration connecting the southeast area to the torus room on 1st basement floor.
- High radiation dose rate of several thousand mSv/h was observed in the vicinity of the floor penetration.
- High radiation dose rate >1000mSv/h was observed in the torus room.

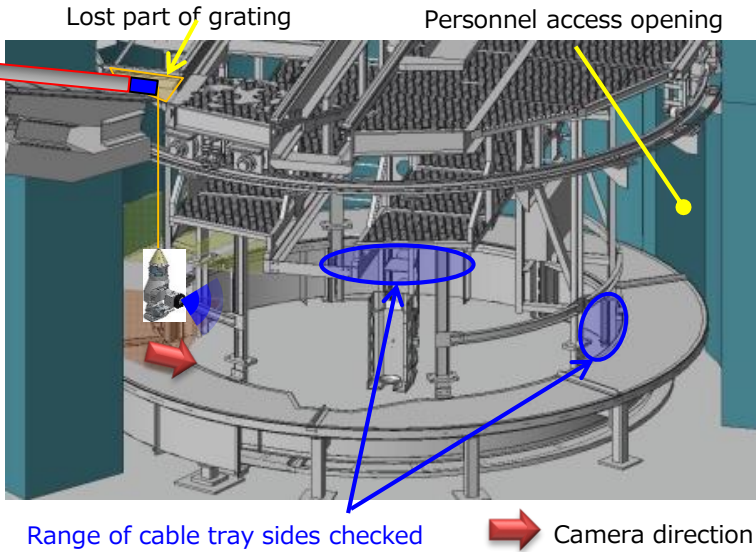
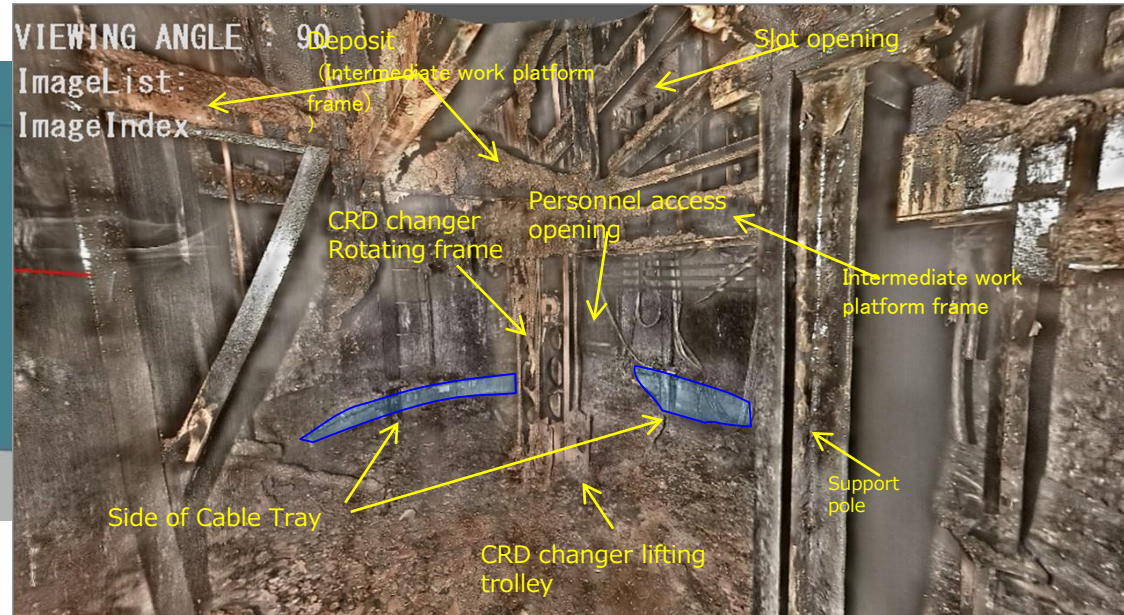
January 2018 investigation inside Unit 2 containment vessel confirmed state of the containment vessel bottom.

- Deposits looking like pebbles and clay were all over the pedestal bottom.
 - It was confirmed that there was no major deformation or damage to structures such as the rotating frame of the CRD exchange machine, the frame of the intermediate work platform, the struts, and the cable tray.
 - No deformation of the cable tray (stainless steel, 4mm thick) was observed, although it had a deposit that looked like solidified melt.
- ⇒ It was possible that when deposition on the cable tray started, the temperature of the deposited material was not at the temperature causing the tray thermal deformation.

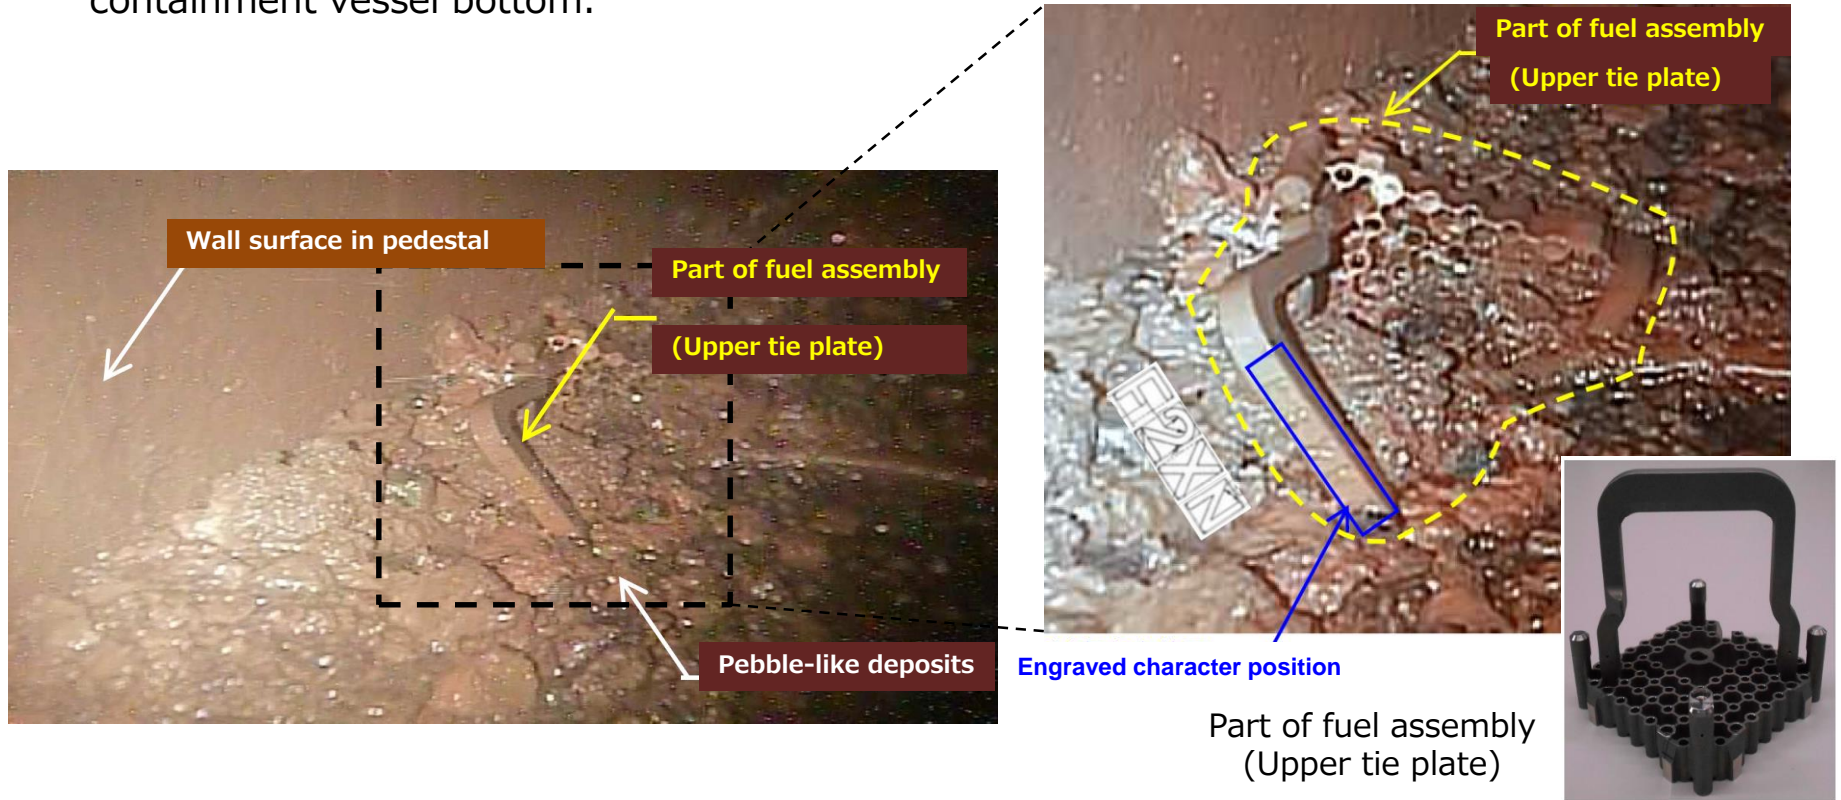
- A part of the fuel assembly (upper tie plate) from the reactor core was confirmed to be at the bottom (periphery) of the containment vessel inside the pedestal.
 - ⇒ It was estimated that at least a hole was made in the reactor pressure vessel to the extent that the upper tie plate fell through. Sediments around the upper tie plate and other areas were presumed to contain fuel components.
 - ⇒ However, since no damage was observed in the structure at the bottom of the containment vessel, fuel debris was presumed to contain a large amount of metal.
