Evaluation of the situation of
cores and containment vessels of
Fukushima Daiichi Nuclear Power Station
Units-1 to -3 and examination into unsolved
issues in the accident progression

Progress Report No. 6

November 10, 2022

Tokyo Electric Power Company Holdings, Inc.

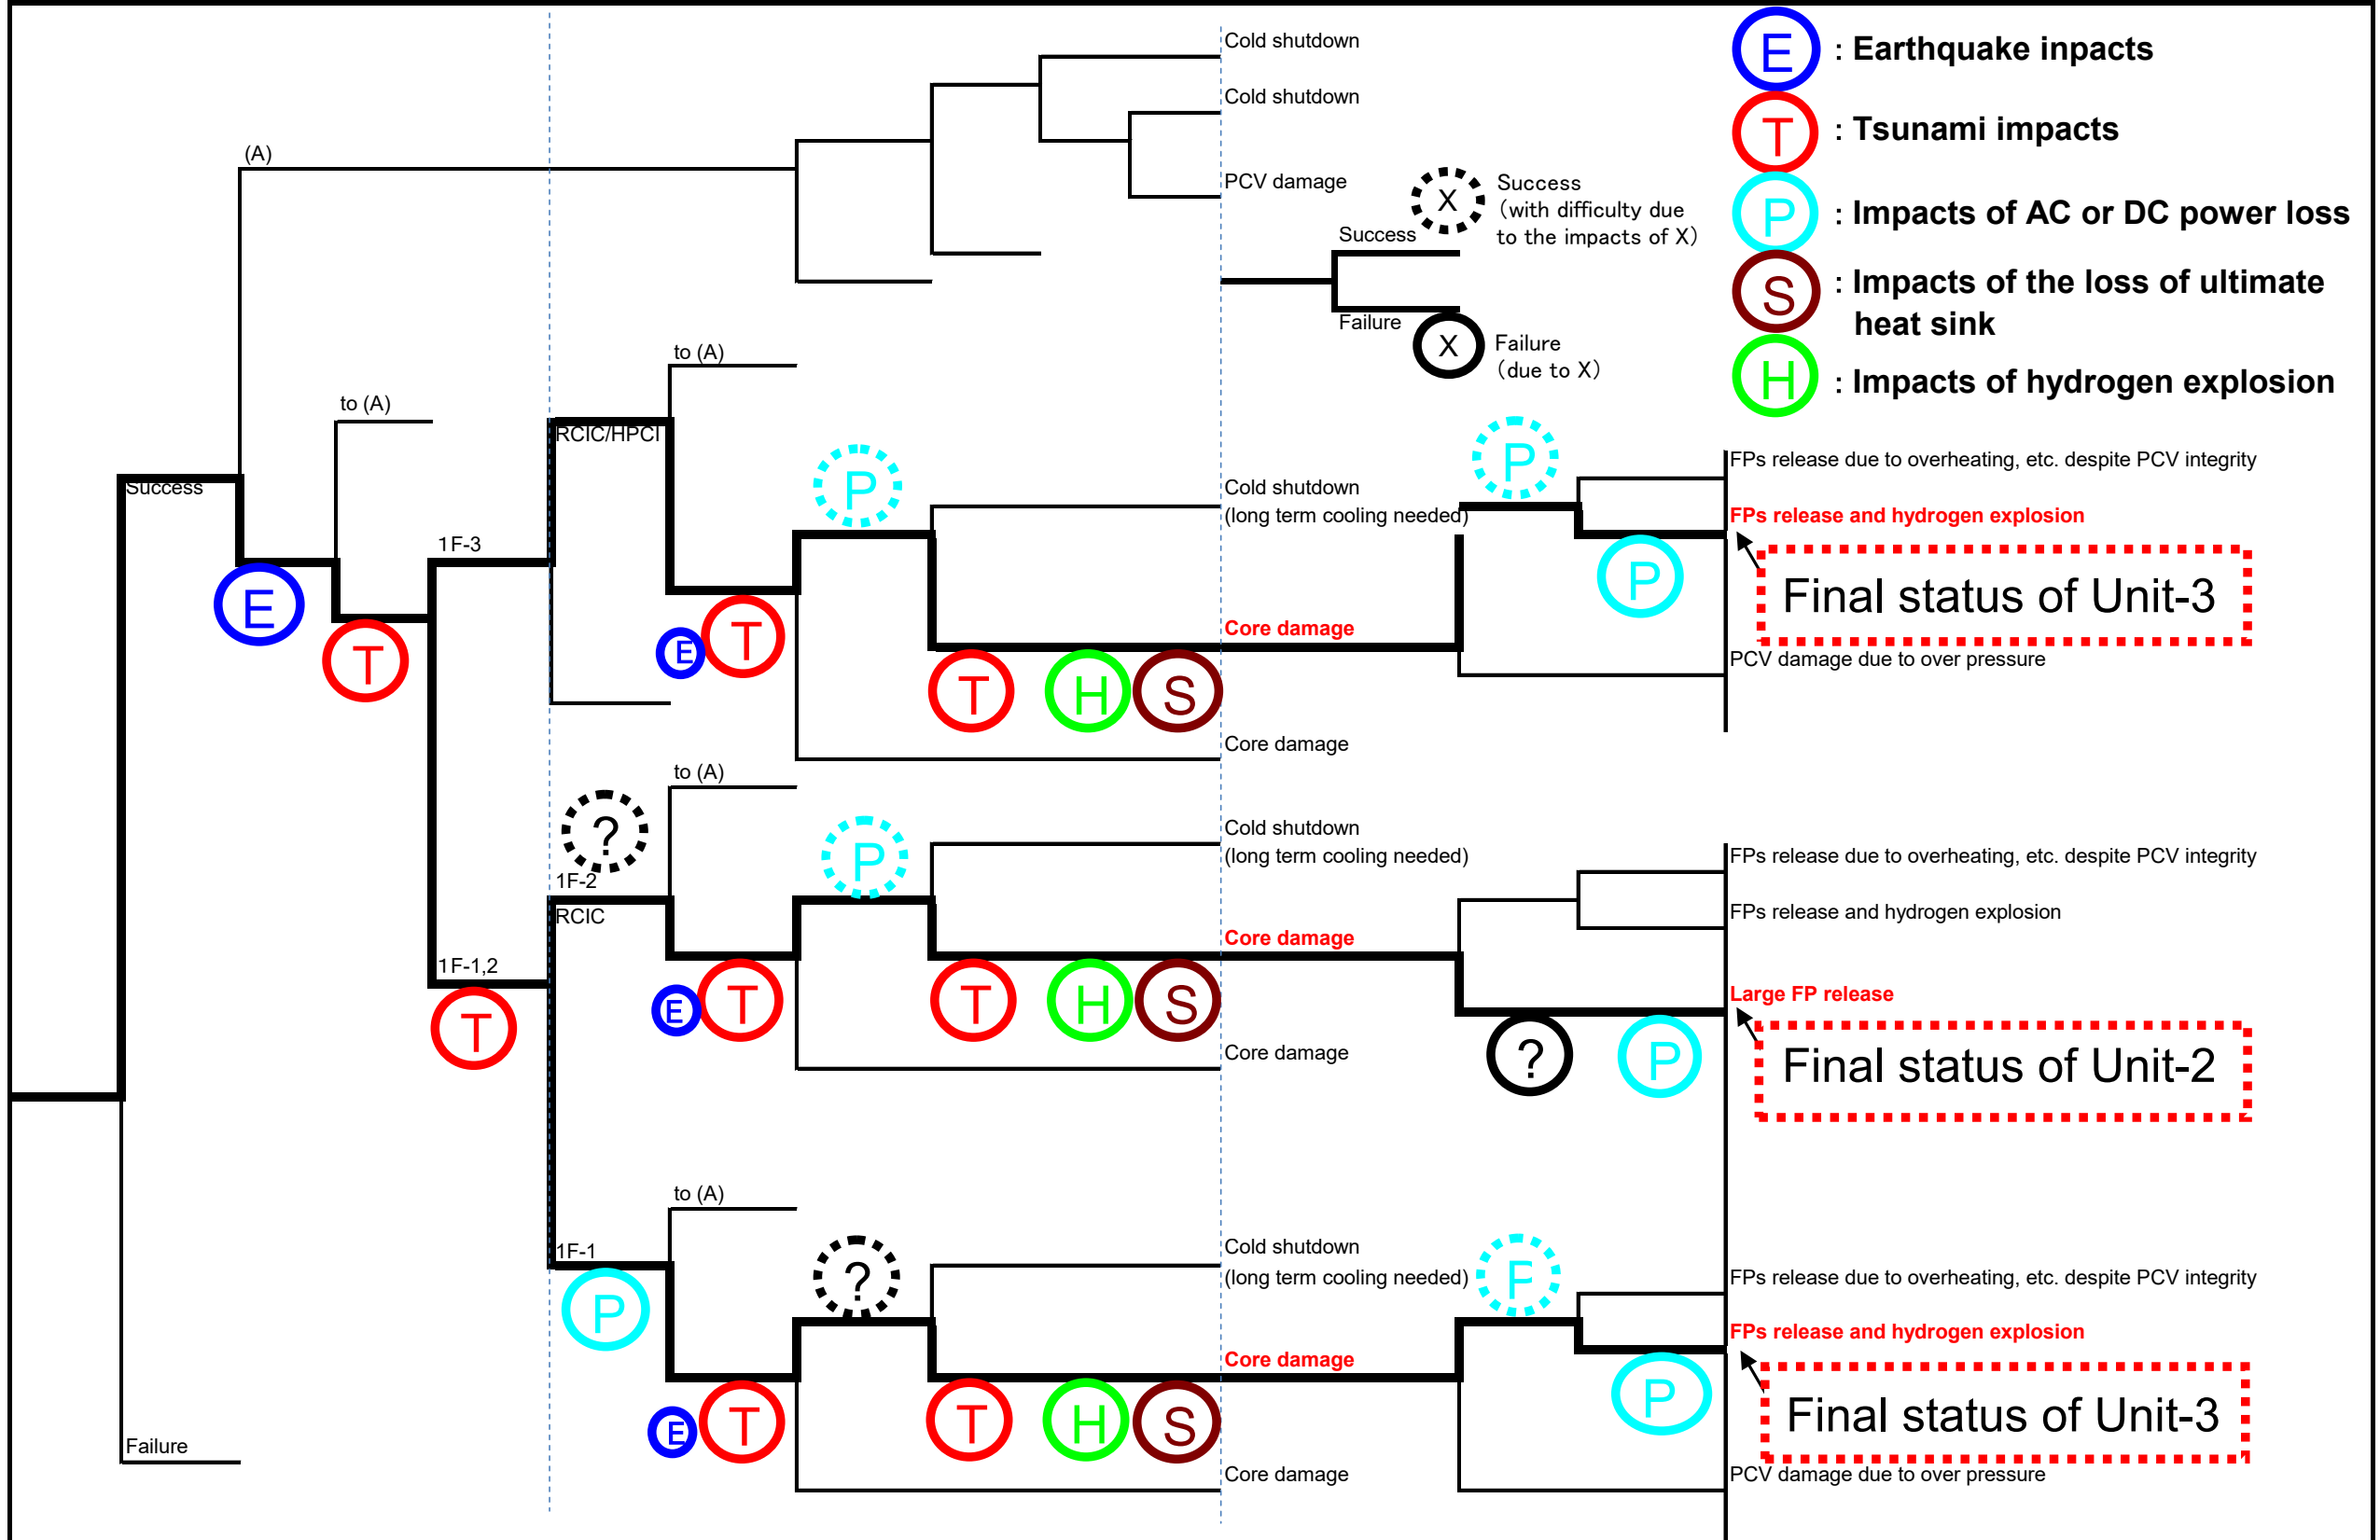
Figure 1 Event-tree analysis results of Units-1 to -3 of Fukushima Daiichi Nuclear Power Station

Initiating event	Reactor trip	AC power	DC power	Core cooling	AC power recovery	Ensuring of long term cold shutdown			Core state	Control of PCV	Control of Reactor Build.	Final status		
Earthquake (Great East Japan earthquake)	Reactor scram (High earthquake acc.)	Off-site power supply	Emergency D/G	DC power supply	Unit-1: IC Units-2/3: RCIC, HPCI	Off-site power, EDG, power source cross-ties	RPV depressurization (alternative meas. included)	Water injection (alternative meas. included)	RHR	RHR recovery	Cold shutdown, Core damage, PCV damage, etc.	PCV Vent	SGTS, ventilation, vent valve kept open etc.	Cold shutdown, Core damage, PCV damage, Reactor building damage etc.

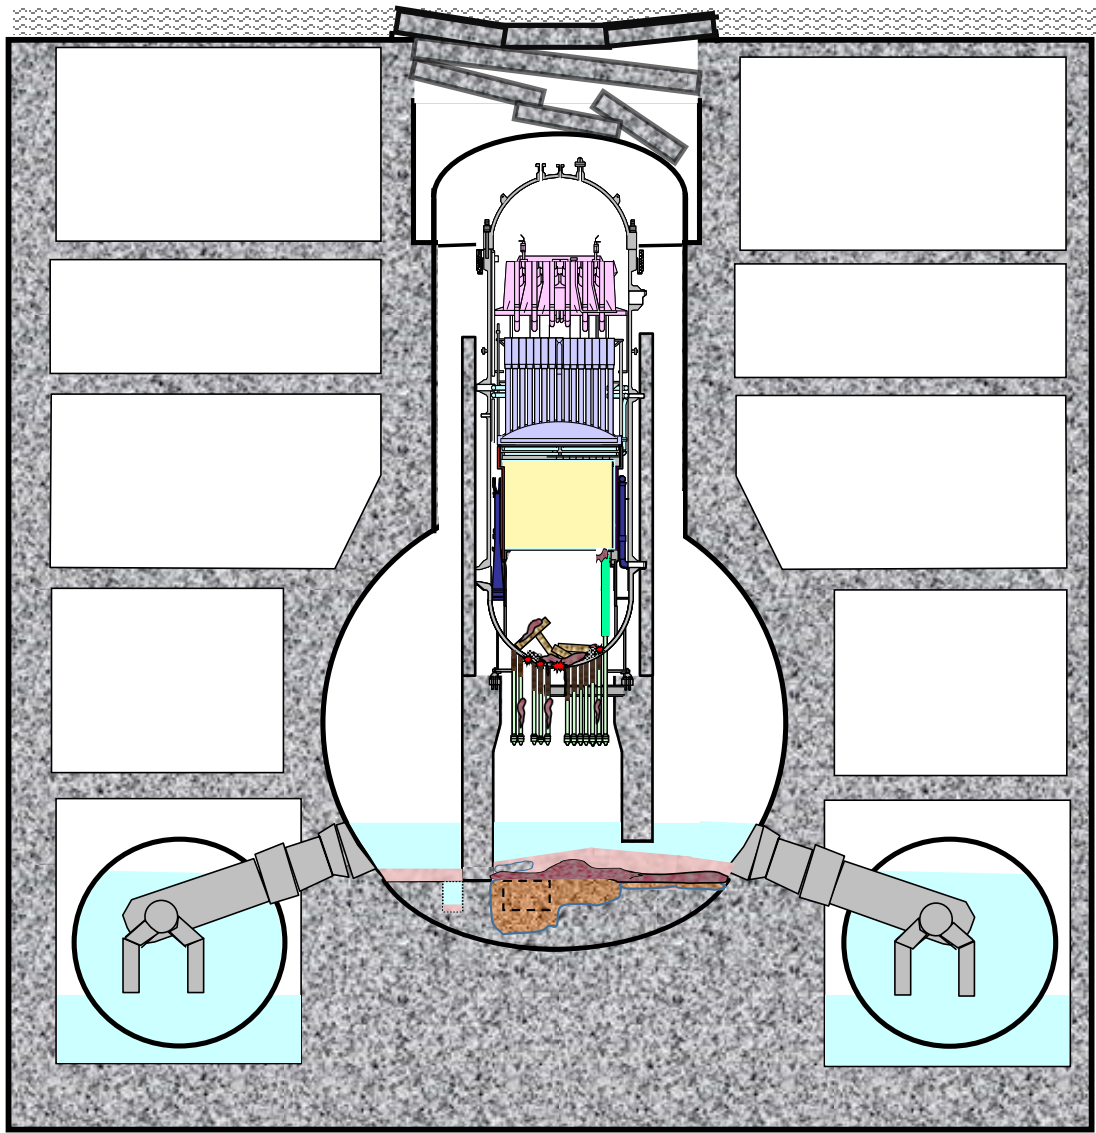
Figure 7.1.1 Estimated condition of the reactor core and containment vessel of Unit-1

accident progression was faster than the earlier estimation. In the figure, more fuel than before is assumed to have dropped to the PCV. On this matter, further detailed examinations are needed, including the molten core concrete interaction (MCCI) development behavior.

On the other hand, regarding water level in the D/W, at the in-containment investigation in FY2015, the D/W water level was found to be about 6.3m above the D/W floor. In May 2014, water leaks were witnessed around the expansion joint at the PCV penetration of the main steam piping D. This point is at the same elevation as the estimated water level in the containment vessel. This indicates most water leaks from the containment vessel occurred at this point. Currently, the height is approximately 5 m due to the earthquake that occurred on March 16, 2022, and the implementation of the water injection suspension test.
