List of issues to be investigated

Reference [1] "Safety measures at the Kashiwazaki-Kariwa Nuclear Power Station of Tokyo Electric Power Company (First version, March 2013)"

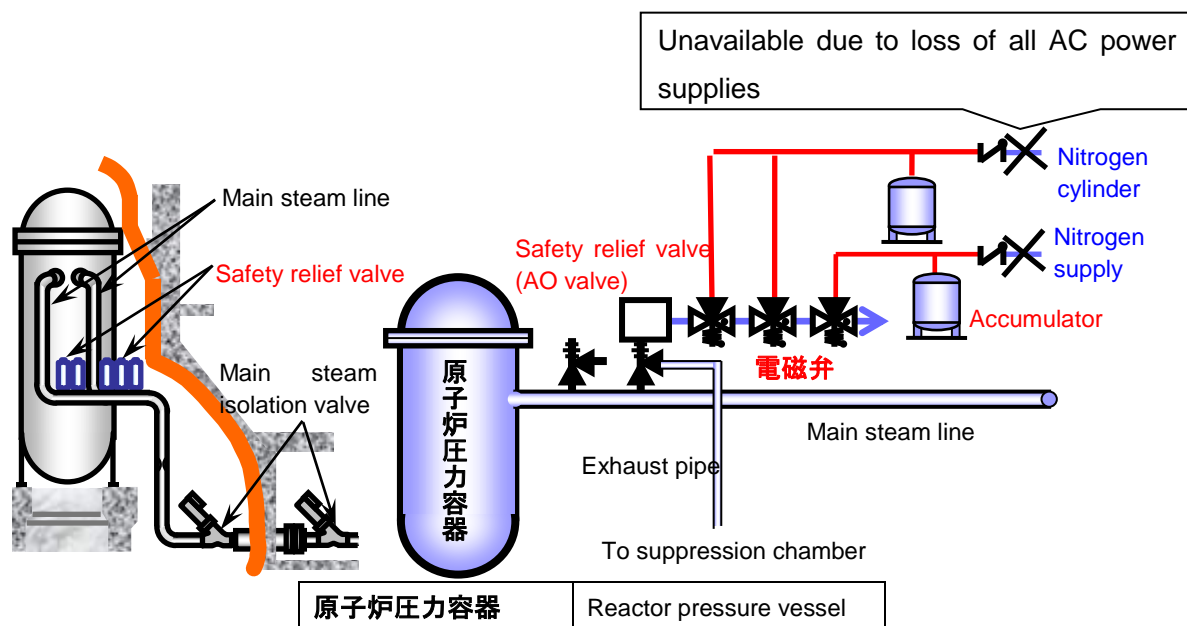
For example, at Unit-3, the SRV opening operation was attempted from the main control room (MCR) control panel after the HPCI had been manually shutdown at 02:42 on March 13, but no response was observed in the reactor pressure. Therefore, the operators recognized that the SRVs had not worked.

Possible causes of SRV failure to function may include insufficient pressure of driving nitrogen gas and the insufficient voltage to activate motor-operated valves. But other relevant matters, such as the SRV opening/closing operation after core damage or reactor pressure changes, are also to be examined in order to clarify the causes why the SRVs did not function, because there is not enough knowledge on the SRV functionality under severe accident conditions.

Figure Schematics of the main steam safety relief valves.

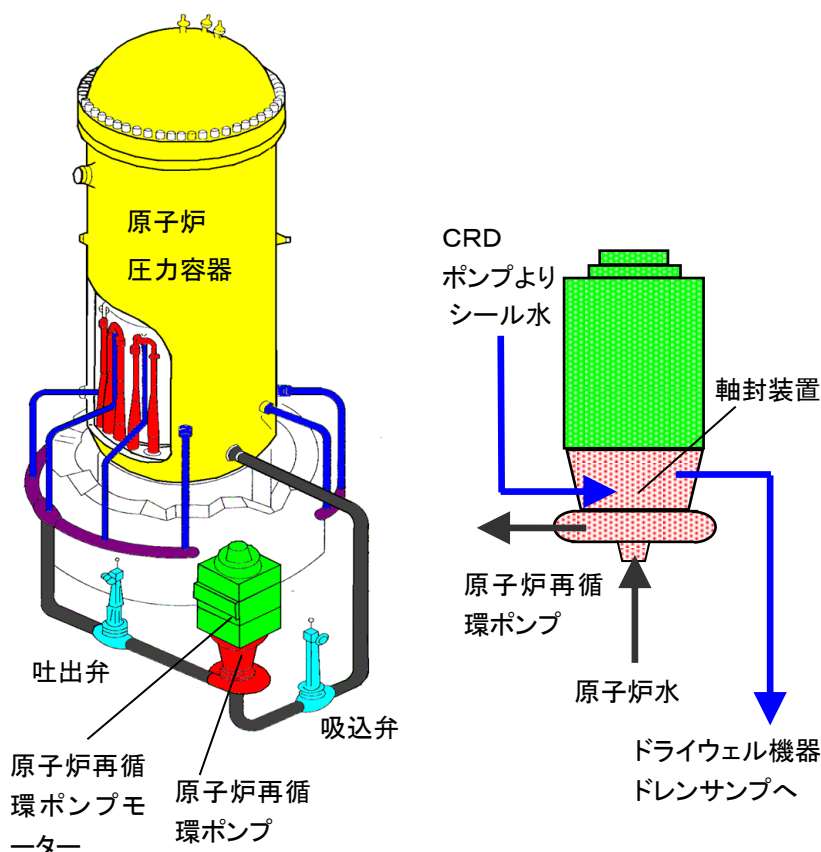
Mechanical seals are mounted on the primary loop recirculation (PLR) pumps as the shaft seal. During normal operations, sealing water for the shaft seals provided from the control rod drive (CRD) pumps prevents reactor water from leaking. When the external power supply is lost, CRD pumps are shut down and sealing water is lost from the CRD pumps; then the high pressure reactor water is discharged to the drywell (D/W) equipment drain sump via the PLR pump shafts and shaft seals.

As a matter of fact, at Unit-4 of the Fukushima Daini NPS, which did not need to run the D/W spray, it was found during a post-earthquake patrol in the PCV that water had filled the pedestal, which had housed the equipment drain sump, and reached even the diaphragm floor (the D/W bottom floor). Water discharge from the equipment drain sump stopped after the earthquake. Therefore, it is highly possible that this water was the leaked water from the reactor via the PLR pump shafts

As long as the mechanical seals are not damaged, the water leak from the reactor is expected to be below the design leak rate and has little impact on the reactor behavior. But, if the seal functions were lost in the process of accident progression, as O-ring damage for instance, the leak rate might have increased. It is necessary to clarify whether leaks actually occurred which might have influenced the reactor water levels, and the PCV temperatures, pressures and water levels.

Figure Illustration of PLR pumps

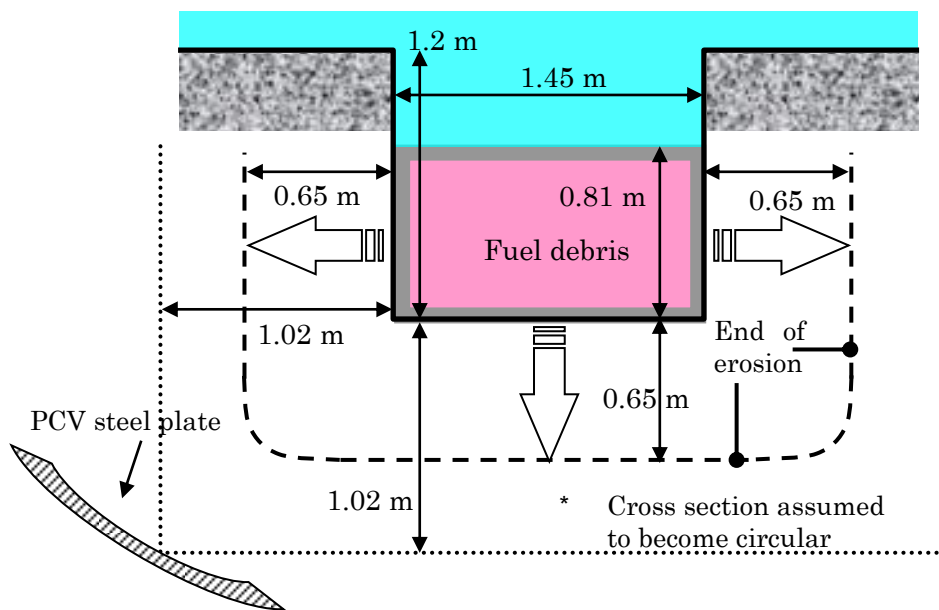
TEPCO presented the analysis results of core-concrete reactions at Unit-1, which was thought to have had the largest fraction of fallen fuel debris to the PCV, in the Technical Workshop on “Estimation of the damage status of reactor cores of Fukushima Daiichi Units-1 to 3” (organized by the former NISA and held on November 30th, 2011).

There is also a possibility of shell attacks which could open leak paths from the PCV by direct contact of molten fuel and PCV liners. However, no clear evidence has been observed to date which supports the occurrence of shell attacks: the pressures increased at Units-1 and 2 when nitrogen gas started to fill the PCV, while at Unit-3 the PCV water level was sufficiently high to have prevented them.

Figure Estimation of the scale of Unit-1 core-concrete reactions

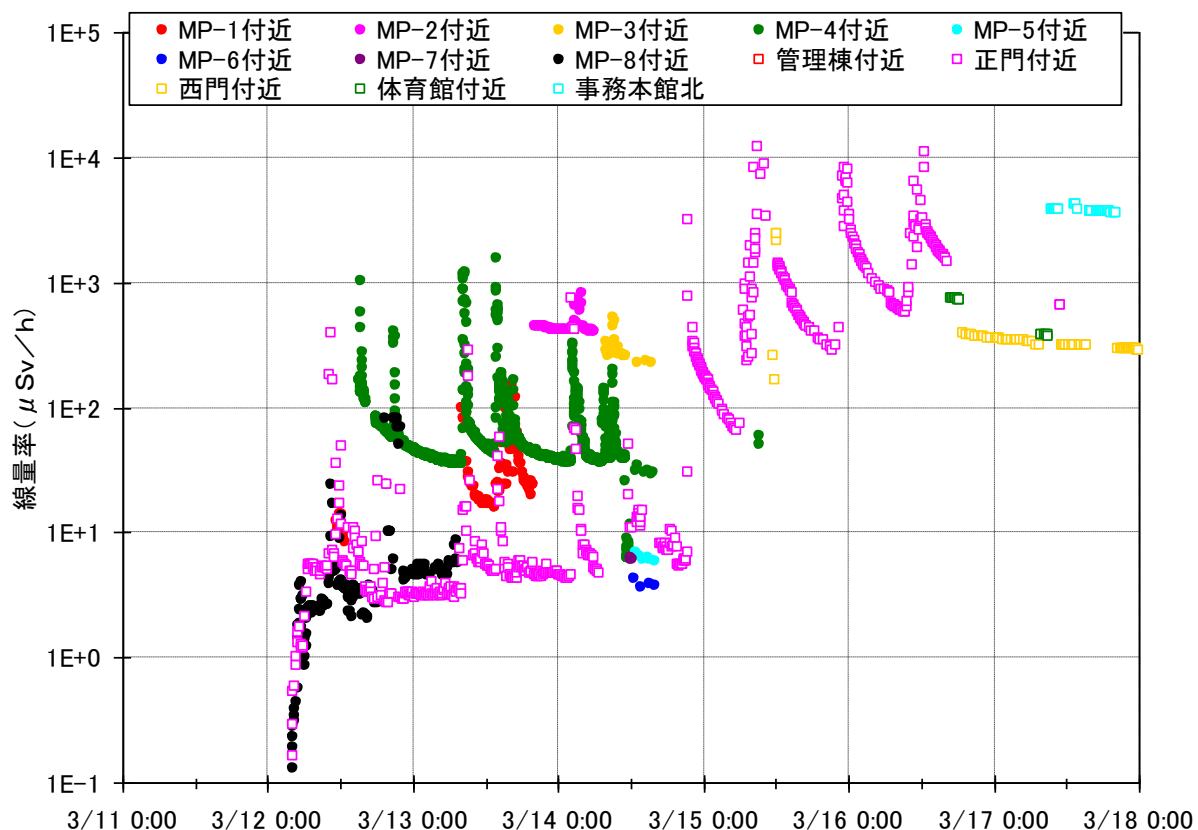
Some of the radioactive materials released from the fuel during the accident progression were eventually released to the air via the PCV venting, the reactor building explosion, direct leaks from the PCV, etc. To date, TEPCO has been investigating the amount of radioactive materials released to the air per each main incident in the course of accident progression, and the reason of high contamination in the northwest area of the Fukushima Daiichi NPS. The investigations are based on the air dose rates observed by the monitoring cars and the meteorological data such as precipitation observed at a meteorological weather station

However, not every correlation is clear yet between the air dose rate changes measured on the site boundary measured by the monitoring cars, etc. and the radioactive materials release behavior from their origin. The air dose rates do not tell everything about the release situation from the origin of the radioactive materials but these rates provide information that is useful in interpreting the release conditions. The attenuation behavior of air dose rates may provide some information relevant to the contribution of deposits of radioactive materials released or their nuclear species.

In order to interpret the accident progression resulting in the release of radioactive materials, it is necessary to evaluate the air dose rate changes and the correlation of these rates with the timings, origin and paths of the radioactive materials released.

Figure Air dose rate changes on the site during March 11th to 18th.

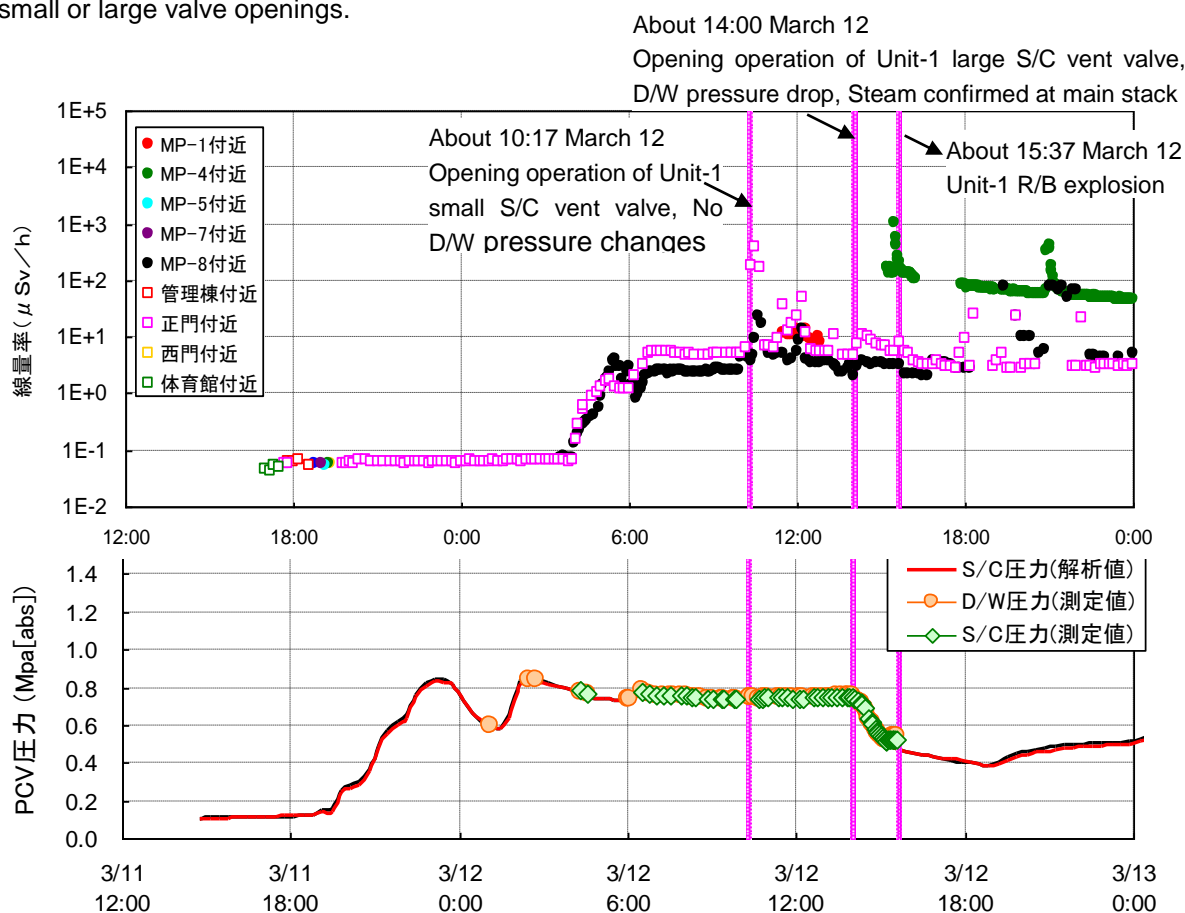
At Unit-1, three attempts were made from the MCR to open the small S/C vent valve, at 10:17, 10:23 and 10:24 on March 12th. No clear decrease was noticed in the D/W pressures, but the air dose rates near the main gate showed a short increase at 10:40. Thereafter, a temporary air compressor was connected to open the large S/C vent valve and it was activated at about 14:00 on the same day. Steam exhaust from the stack was observed on the live camera monitor and the D/W pressure showed a decrease through 14:30 to about 14:50. At this timing, no increase was noticed in the air dose rates measured by the monitoring car near the main gate (southwest) and near Monitoring Point 8 (south).

As seen in these incidents, the D/W pressures and the air dose rates at the monitoring car occasionally responded to the S/C vent valve operations, but occasionally they did not. This may indicate a possibility that a small release of radioactive materials through the small vent valve, not sufficient to cause noticeable D/W pressure changes, might have occurred, or a possibility that a direct release to the air from the reactor building might have occurred. The opening of the small vent valve causes only a small vent flow rate change and the D/W pressure decrease may be too limited to notice. It is necessary to clarify the radioactive materials release behavior in detail upon PCV venting by the small or large valve openings.

Figure Air dose rate changes from March 11th to 12th, and the changes of D/W and S/C pressures

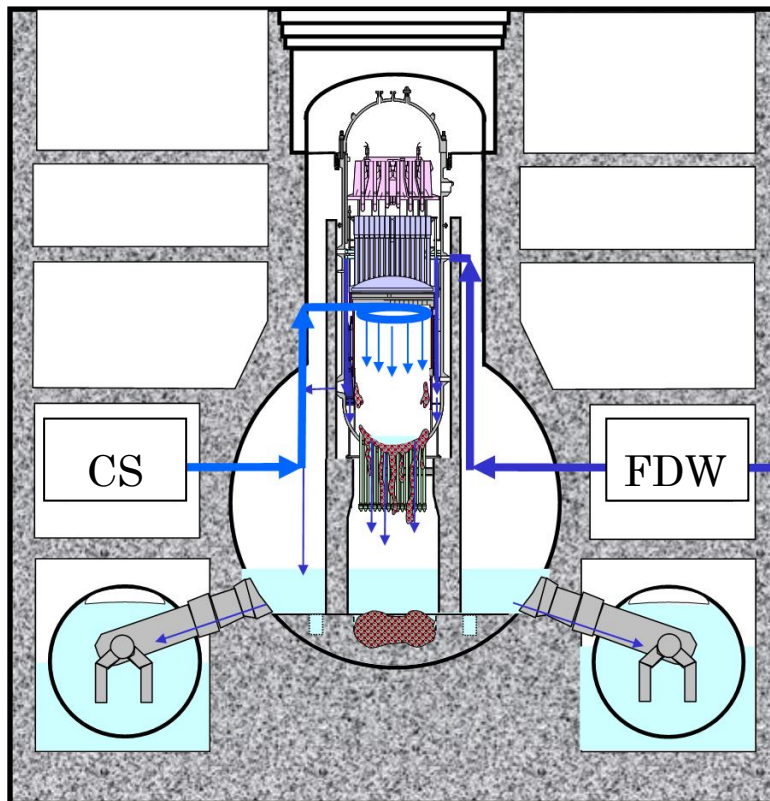
MAAP predicts that almost the whole Unit-1 core dropped to the RPV lower plenum and most of it fell further to the PCV pedestal, while the Unit-2 and Unit-3 cores remained in the core region, although there were partly molten fuel pools. Unit-1 lost all its existing water injection functions at an earlier stage and considerable time was taken to start water injection by fire engines. On the other hand, at Unit-2 and unit-3 the RCIC (Unit-2 and Unit-3) or HPCI (Unit-3) could continue injecting water to the reactor till a later stage. As a consequence, decay heat was lower when no more core cooling became possible by existing water injection means and less time was taken thereafter for the fire engines to start injecting water.

It should be noted, however, that MAAP analysis has uncertainties in setting its conditions, the analysis itself and the modeling. The results obtained have also uncertainties accordingly. MAAP predicts no RPV damage in Unit-2 and Unit-3, but the results depend greatly on the amounts of water injected to the reactor. As a matter of fact, the plant conditions thereafter indicate the reactor water levels were at very low levels and the RPVs are very likely to have been damaged. Further, core damage might have occurred even earlier at Unit-3 because the water injection by HPCI had been insufficient after the RPV pressure had decreased.

Currently, the location of debris, the ultimate result of the accident progression, is still unknown. It should be noted that the calculation results still have large uncertainties. Since this information is important input to decommission planning, further examinations are needed, based on the outcomes of the investigative research and development projects of the PCV and RPV, and other relevant projects.

Figure Estimated conditions of the core and PCV of Unit-1

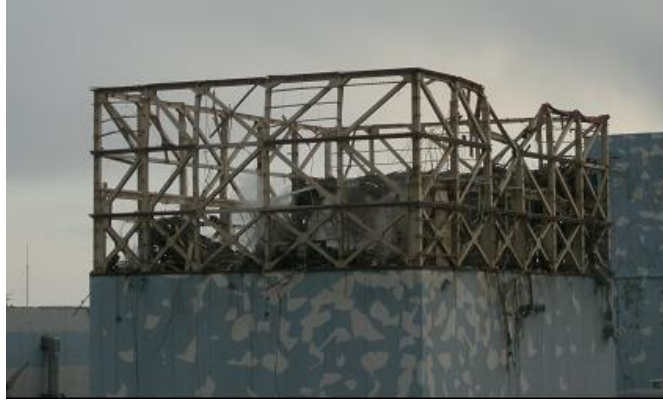
At Unit-1, the D/W pressure decrease was confirmed from 14:30 through around 14:50 on March 12th following the large S/C vent valve opening operation. At 15:36 on that day, hydrogen exploded in this reactor building and the roof and the outer walls of the top floor were heavily damaged.

These hydrogen explosions are considered to have been caused by hydrogen gas generated mainly by zirconium-water reactions which leaked out with steam to the reactor buildings. It is necessary to clarify the amounts of hydrogen gas generated and leak paths.

Figure Unit-1 reactor building after the hydrogen explosion

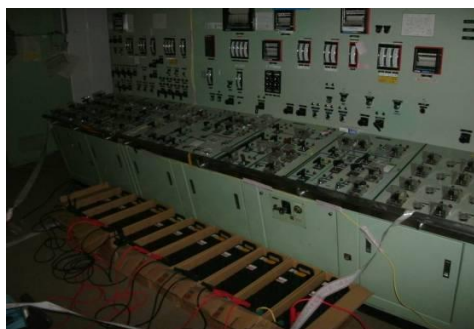
In the MCRs for Units-1 to 4, most instrumentation and control power supplies were lost after the tsunami had arrived and nothing was available for operators to monitor plant conditions or to take operational actions.

Connecting employees' private car batteries to power necessary instrumentations

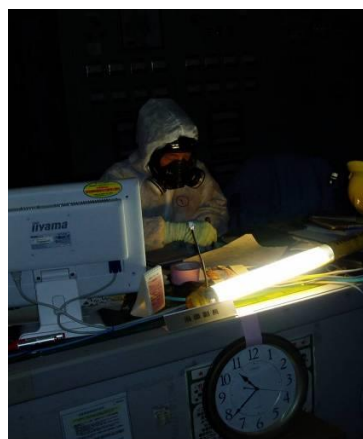
Photo of outer doors taken from indoors with no lights

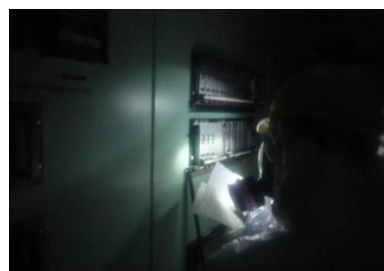
Indicator readings being checked with a flashlight in total darkness

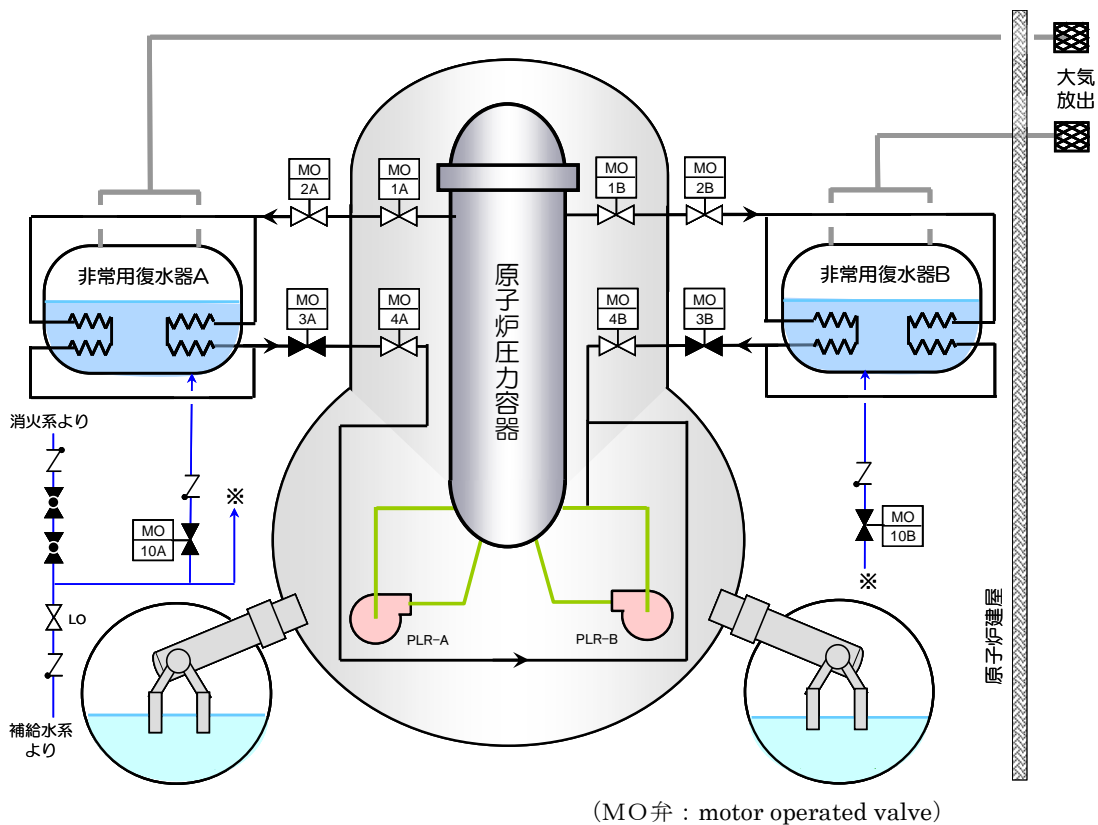
At Unit-1, the reactor pressure was being controlled after the earthquake by intermittent operation of the emergency isolation condensers (ICs). Immediately before all power supplies were lost due to the tsunami, the IC operation had been incidentally in a halted situation. In the station blackout condition, the shift operators in the MCR noticed the display lamps indicating the IC (Sub-system A) isolation valves (MO-2A, MO-3A) as “Closed” outside the PCV at around 18:00 on March 11th. They took opening action of the valves at 18:18 on March 11th, and confirmed the steam generating sounds and saw the steam when looking above the reactor building, but the amount of steam was limited and it stopped a while later. Concerned about the water inventory left in the IC shell side tank, at 18:25 the operators closed the isolation valve (MO-3A) on the return line.

It is considered that the non-condensable hydrogen gas generated by the water-zirconium reactions upon decrease of the reactor water level deteriorates the heat removal performance when it mixes in the IC cooling tubes. According to the analysis results, the reactor water level was slightly below TAF as of 18:18, and hydrogen gas might not have been being generated in large amounts. But hydrogen might have been generated by radiolysis as well. It is necessary to clarify how much the heat removal capability was actually deteriorated.

Figure Schematic illustration of IC systems

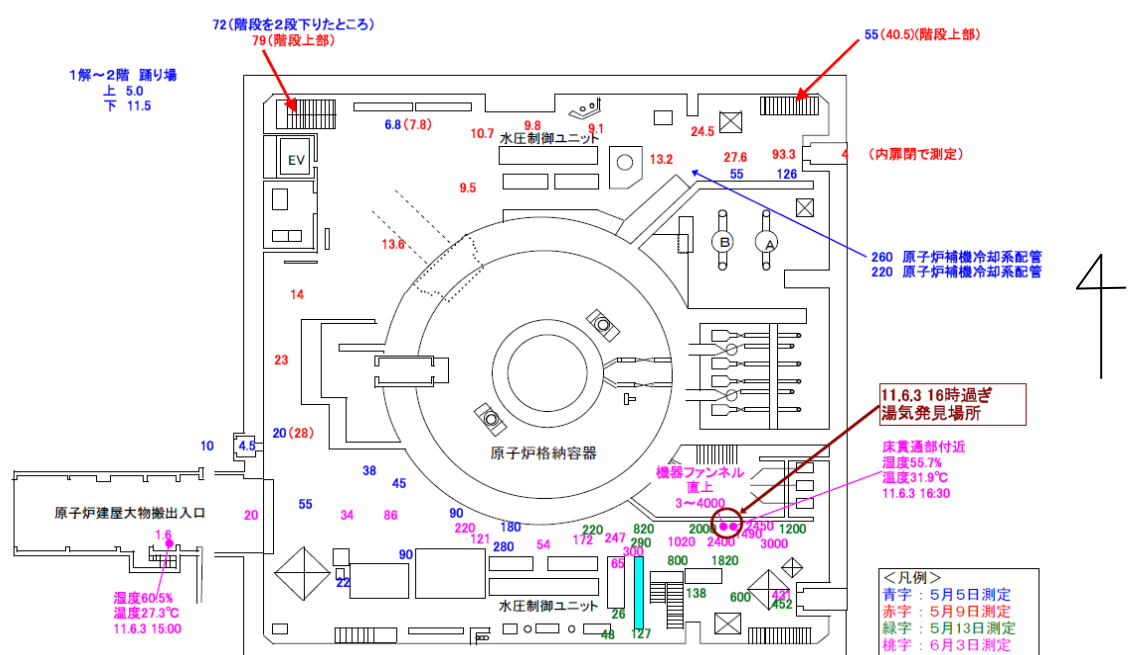
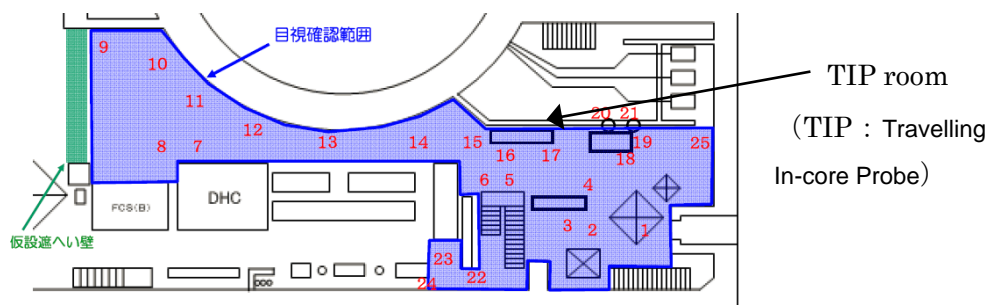
The investigations in May, June and October of 2011, and in July of 2012 located high dose rate areas of several thousand mSv/h in the southeast area of Unit-1 reactor building. In the June 2011 investigation, steam was also confirmed to be blowing out from a penetration of the floor in the area. In the July 2012 investigation, a robot attempted but failed to unlock the traveling in-core probe (TIP) room door in the area. The inside of the TIP room has not been investigated yet.

The high dose rate in the southeast area of the reactor building ground floor may be related to the steam blown from the floor penetration of the S/C venting line or possible damage of the TIP dry tubes due to the uncovered and overheated core. The causes of the high contamination are to be investigated.

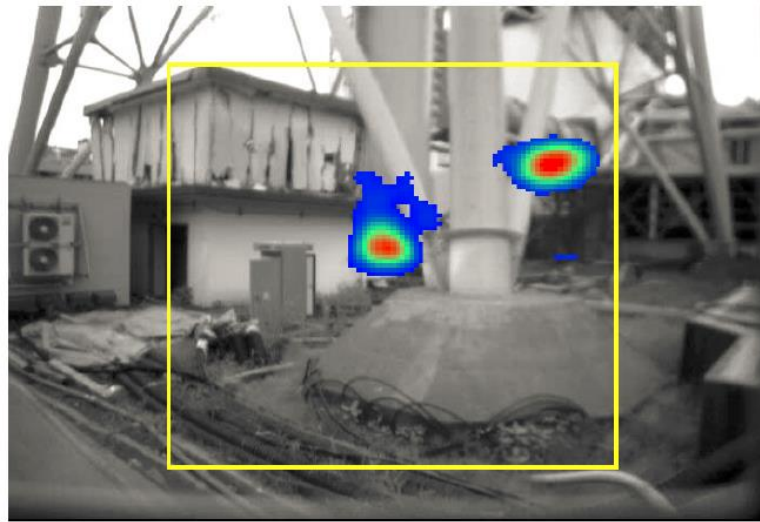
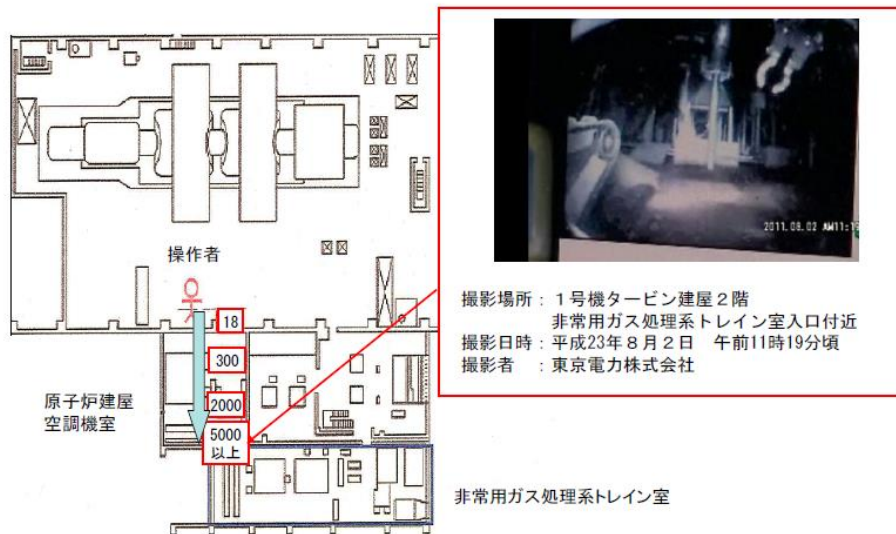
福島第一原子力発電所1号機タービン建屋2階 高線量検出箇所

The high dose rates near the SGTS piping can be considered to be caused by the deposited radioactive materials which were released from the damaged core. The detailed causes of the contamination are to be clarified.

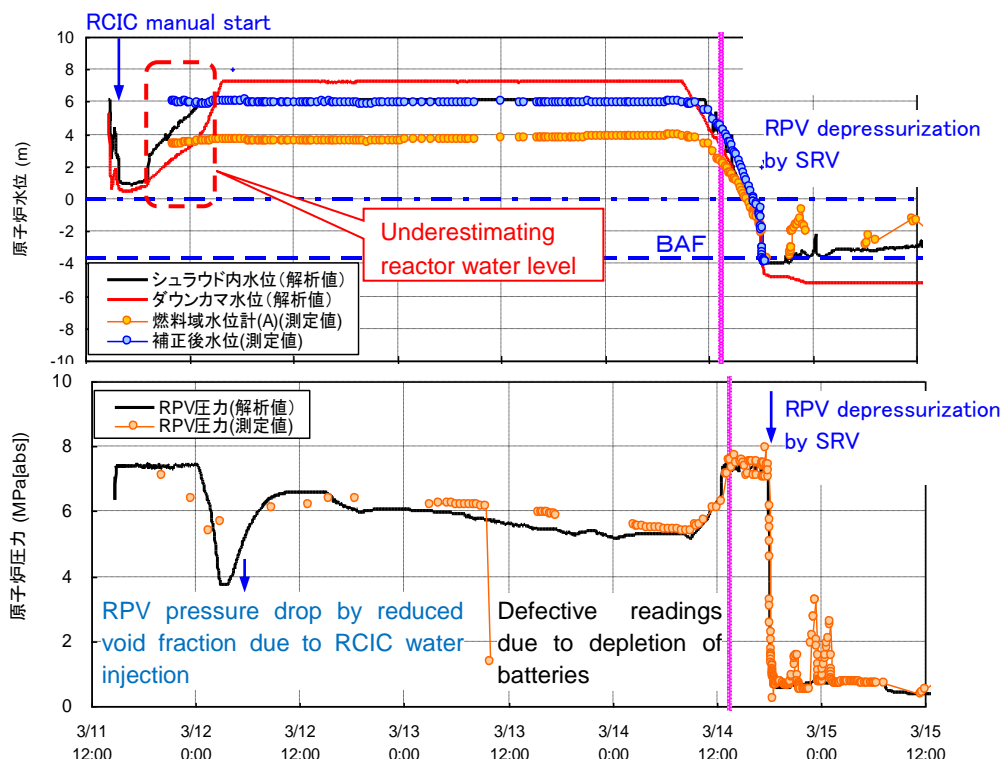
The RCIC operational conditions need to be clarified after the loss of the control power supply due to the tsunami.

Figure Reactor water level and pressure changes at Unit-2

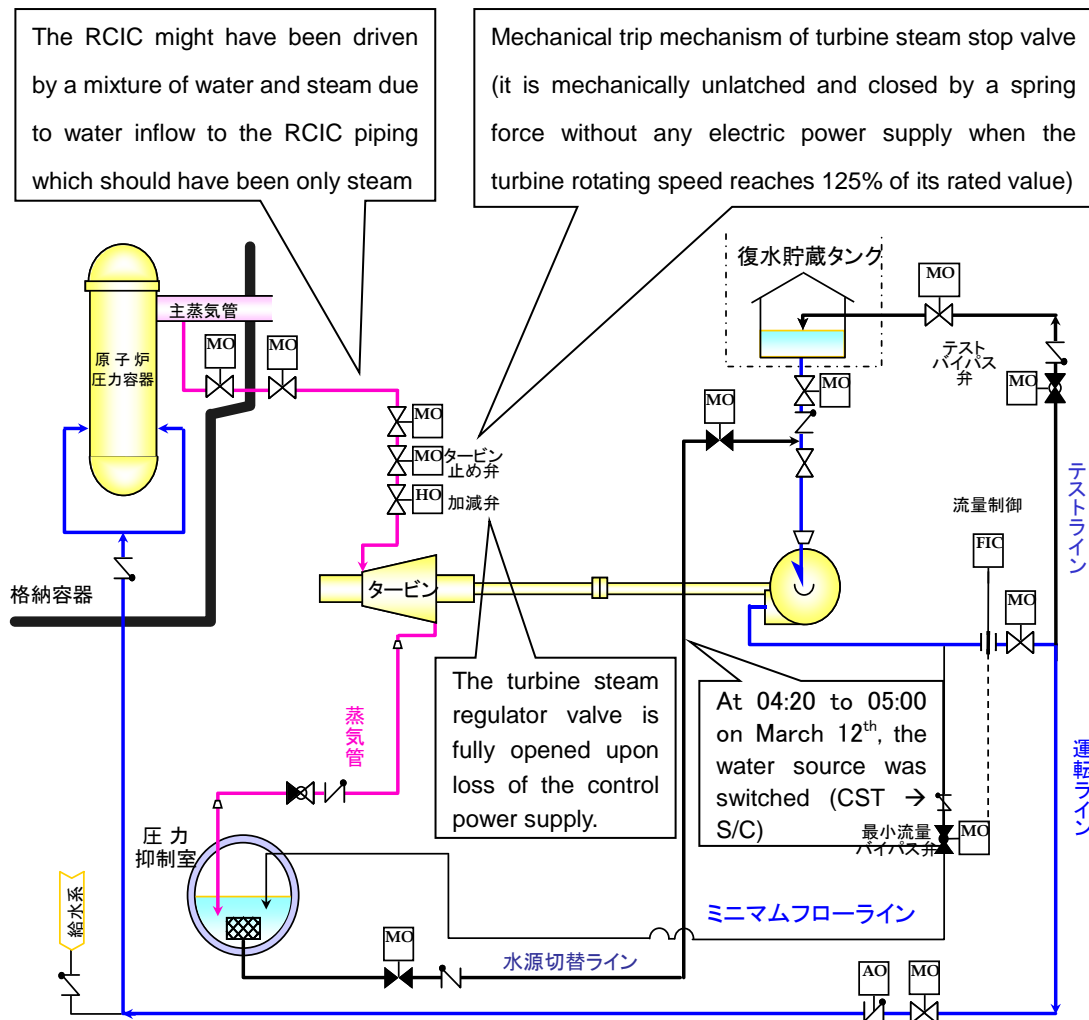
At about 09:00 on March 14th, the reactor pressure showed an increasing trend, and at about 12:00 noon the reactor water level showed a decreasing trend. The Emergency Response Center at the Fukushima Daiichi NPS concluded at 13:25 that the RCIC had lost its functions, but it is necessary to clarify why it lost them.

Figure RCIC schematic diagram

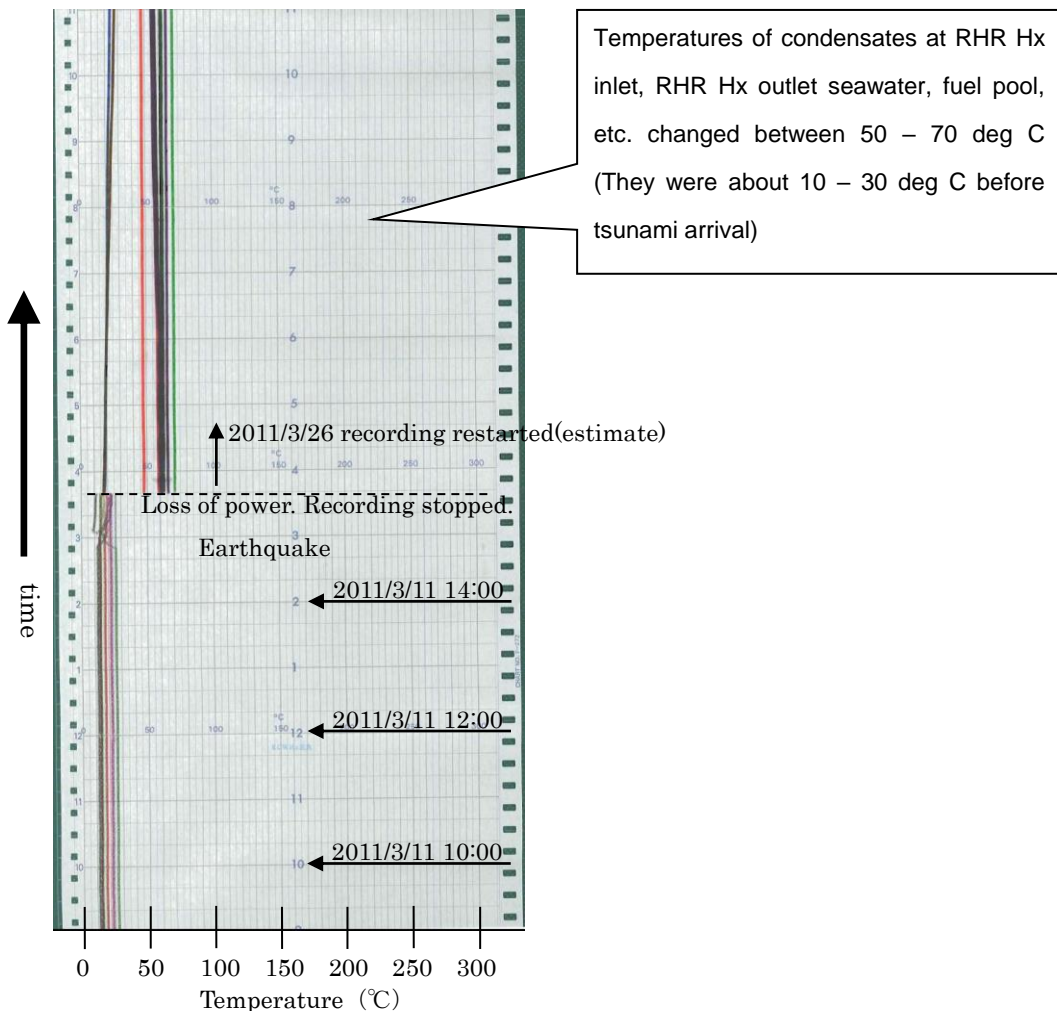
Examination will be done on the reason for the temperature increase and its possible connection to the post-earthquake RHR operation. , No temperature records are available for comparison at Unit-1 and Unit-3.

Figure Temperature recorder chart of Unit-2 (RHR and fuel pool temperatures)

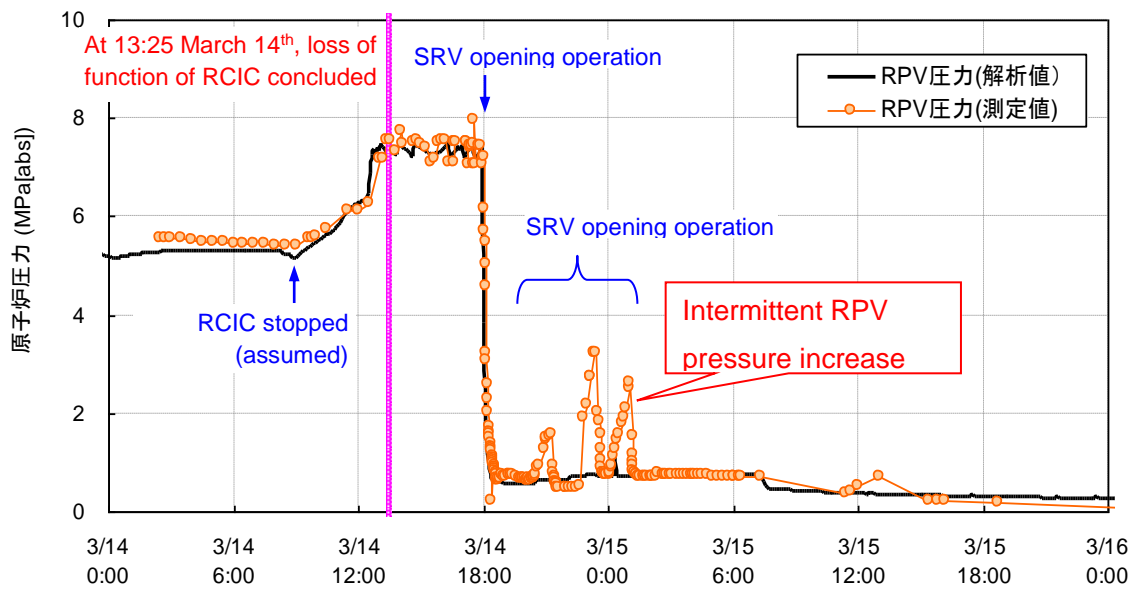
After the forced depressurization of the reactor, fire engines continued to inject water. Therefore, possible causes of the pressure increase are: steam production due to the increased water level; steam production due to corium slumping to the lower plenum; steam production by the zirconium-water reactions; or even the SRV closures. RPV and PCV pressure behavior after the reactor forced depressurization is to be examined.

Figure RPV pressure changes at Unit-2
