Status of investigation on estimating situation of cores and containment vessels

1. Introduction

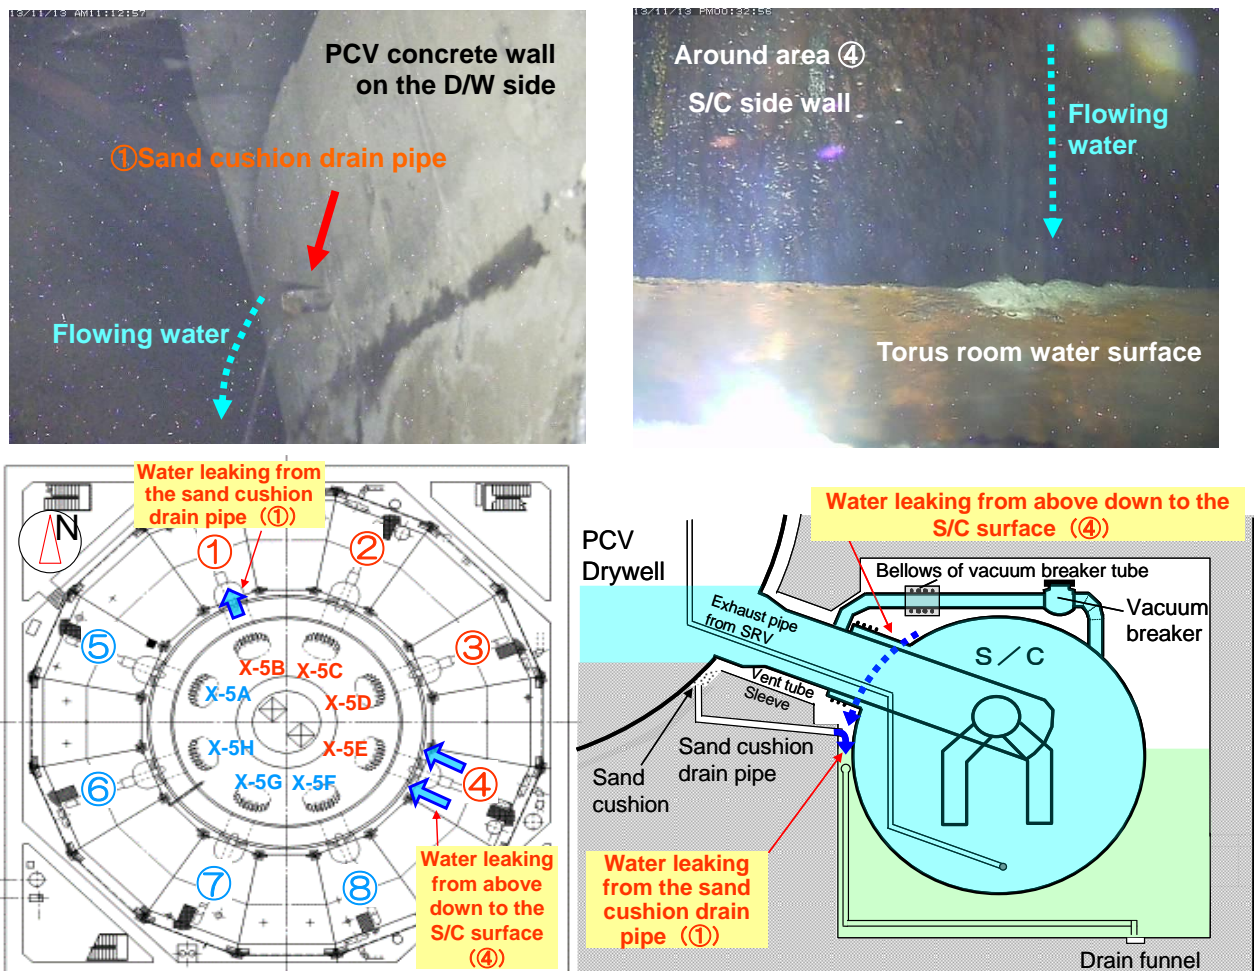
Figure 2-4 Camera images taken below the vent tubes in Unit-1 torus room (part)

Camera imaging confirmed water leaks at the following locations (Figure 2-4).

*Water leaks at ① were confirmed since the vinyl chloride pipe (connecting the sand cushion drainpipe and drain funnel with an insertion-type joint) had been displaced. Water leaks could not be confirmed at locations ② to ⑧, since the drainpipes had not been displaced. The concrete seams (joints) below the sand cushion drainpipe were observed to be wet all around on the concrete wall.

Water leaks into the sand cushion occur only when water leaks directly from the drywell. The leakage is probably from a low position of the drywell below the water level (for example, the containment vessel shell, pipe penetrations, etc.). The low location of the water leaks in the drywell would indicate the possible influence of molten fuel that fell to the PCV bottom. This information is of critical significance in estimating the conditions of the core and PCV.

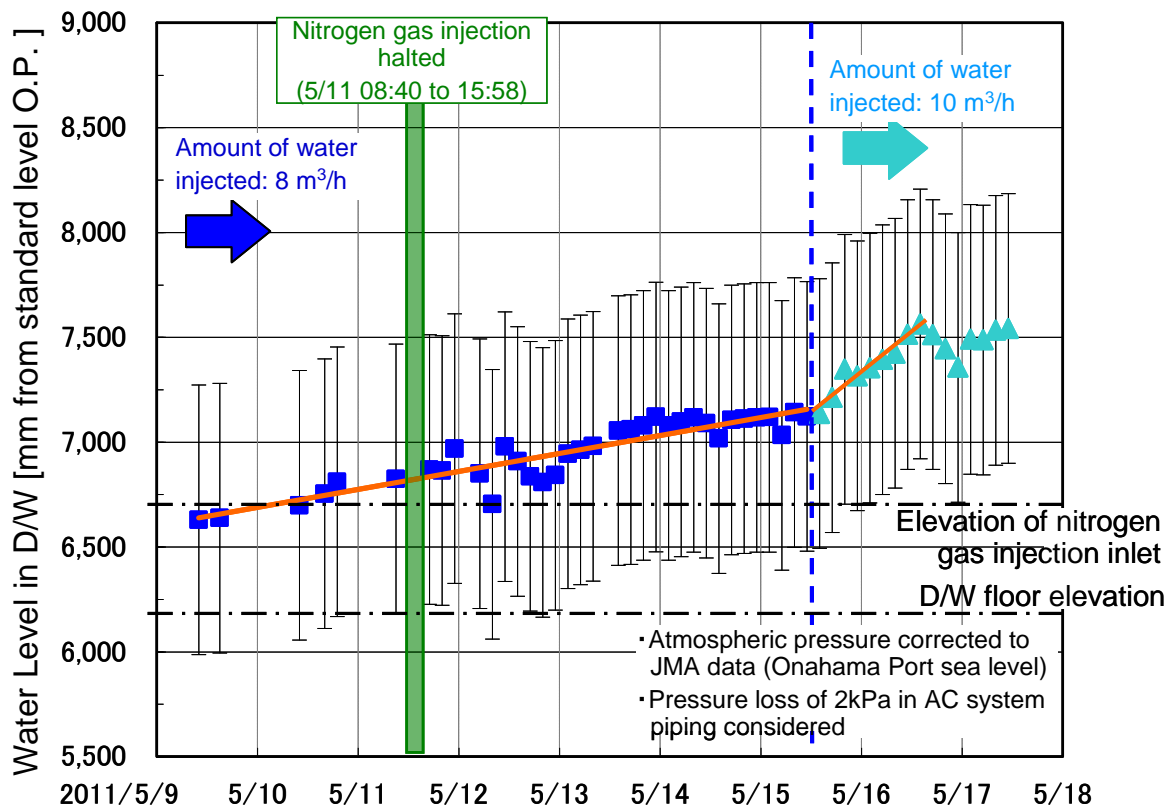
Figure 2-5 Estimated PCV water level changes during flooding operation of Unit-1 (May 2011)

Meanwhile, the water leakage down to the S/C surface around both sides of the vent tube X-5E indicates the possibility of water leaks from the vacuum breaker tube (its bellows, for example) immediately above the vent tube. This elevation of the vacuum breaker tube is about the same level as that of the upper limit of PCV water level which was reached in an attempt to flood the PCV by increasing the amount of water injected in May 2011; where the PCV water level was calculated from the injected nitrogen gas pressure. The nitrogen gas pressure was stopped from changing at a specified level, which means the PCV water level was leveled off, i.e., an indication of leak hole existence at the level (Figure 2-5).^[2-5]

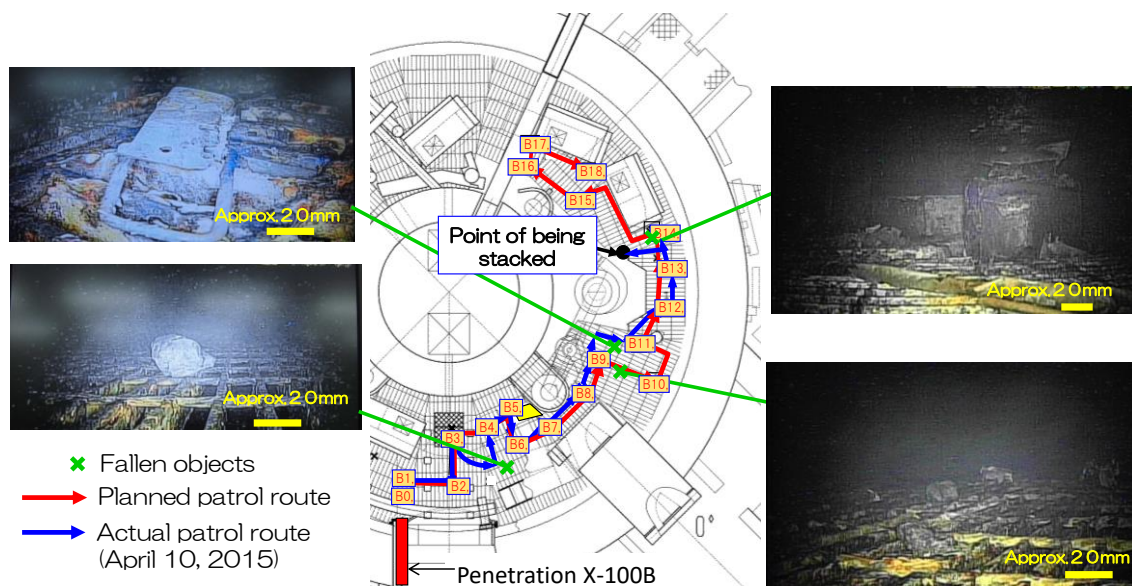
Figure 2-9 Photos taken during the anti-clock-wise patrol [2-9]

The grating floor on the ground level outside the pedestal of Unit-1 was investigated from April 10 to 18, 2015. A running robot machine was sent through the PCV penetration X-100B. The robot patrolled clock-wise and anti-clock-wise by about 180 degrees for investigating damaged conditions of existing structures and presence of obstacles. Figure 2-9 and Figure 2-10 present a part of the photos taken during the anti-clock-wise and clock-wise patrols, respectively. As seen in Figure 2-9, no big damage was recognized on the HVH (heating ventilating handling unit), PLR piping, pedestal walls, PCV inner walls, etc., although fallen objects were noticed on the patrol path.

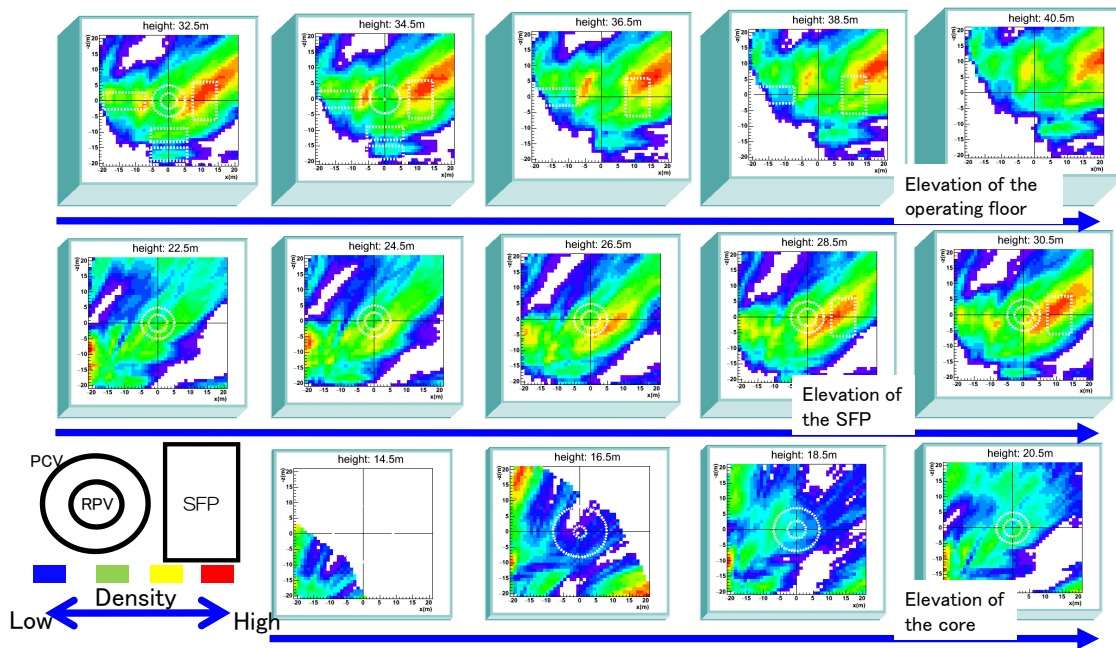
Figure 2-13 High density material distribution maps at three separate elevations [2-10]

X-ray (Roentgen) photography. High density objects absorb more muons and are photographed in black. In the image of the reactor as designed with intact fuel, a black portion is recognized corresponding to the position of the core. In the image of the actual reactor, on the other hand, some recognizable equipment such as the spent fuel pool and isolation condensers are found, but there is no high density object (fuel) at the core position.

From these considerations, no fuel is thought to be left at the core position. This is consistent with the estimated conditions of the core and PCV previously announced by TEPCO.

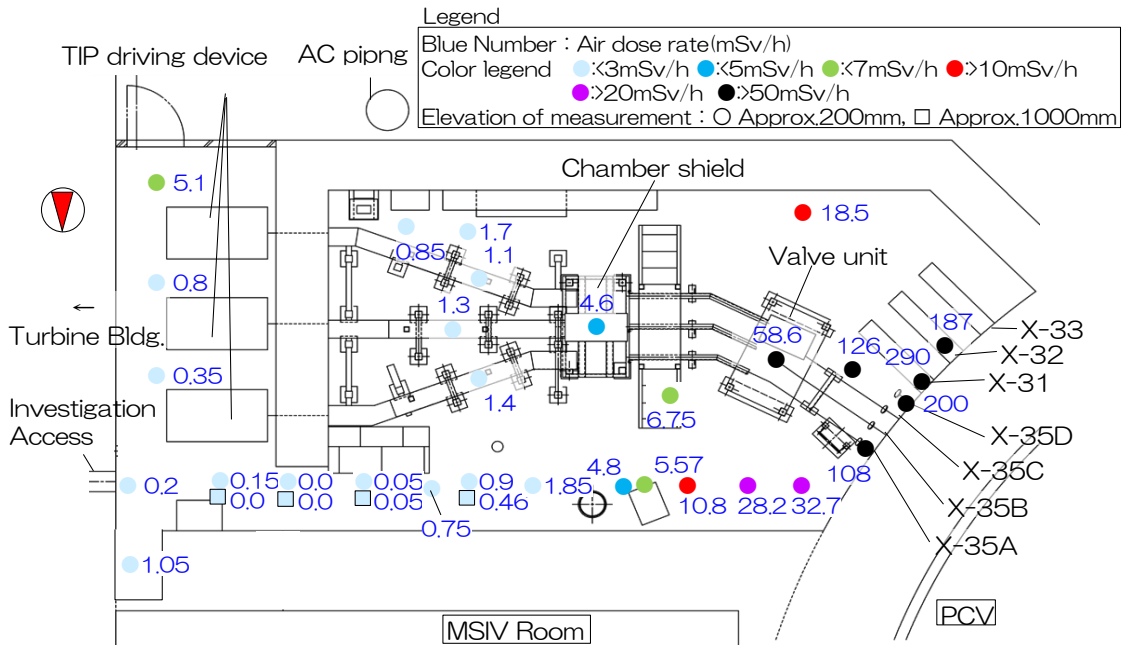
Figure 2-14 Air dose rates distribution measured in the TIP room [2-12]

Figure 2-14 presents the air dose rates measured in the TIP room and Figure 2-15 shows a γ -camera photo taken there. A high dose rate of above 100 mSv/h was observed near the PCV penetrations, especially around X-31, -32 and -33, while on the turbine side behind the chamber shield the dose rate was as low as below 2 mSv/h. The γ -camera photos located a radiation source near the penetrations X-31, -32 and -33 (Region 1 in Figure 2-15). No other outstanding radiation source was found in the room, including at the penetrations X-35A to -35D which were outside the view of the wide-angle lens camera (the area encircled by the broken line in Figure 2-15).

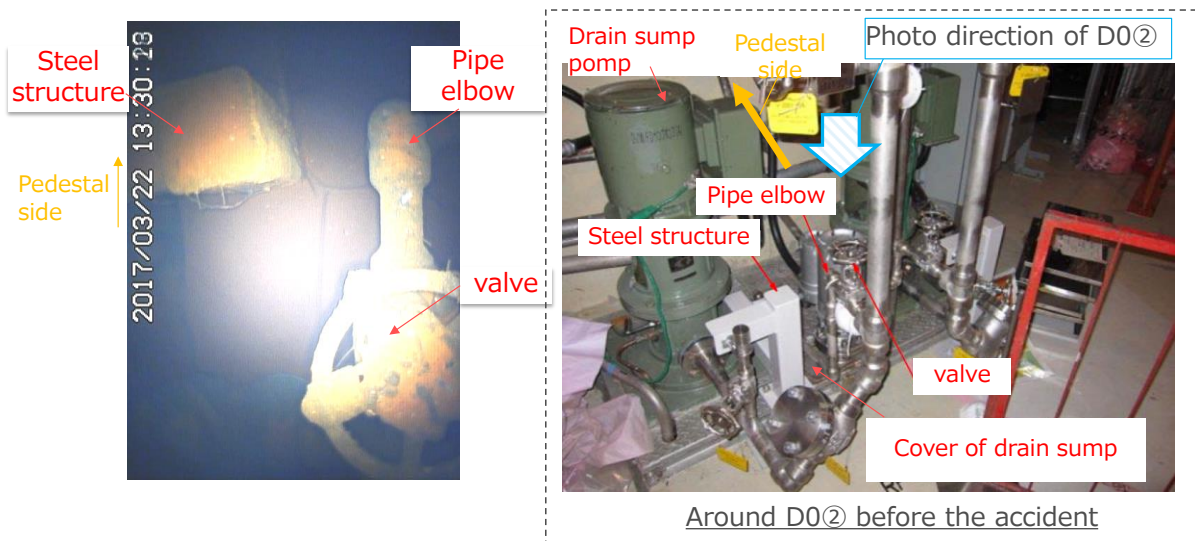
Figure 2-19 Observation from Point D0 [2-7]

Figure 2-19 presents the observation results by cameras from Point D0 near the drain sump outside the pedestal. No big damage or collapse of structures around the drain sump can be confirmed.

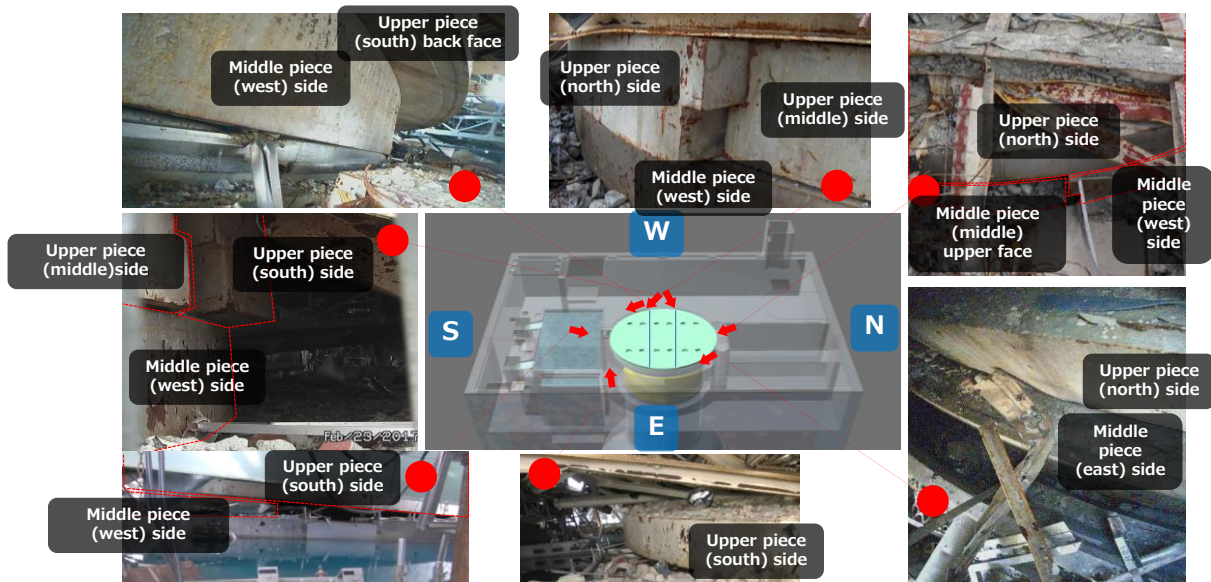
Figure 2-23 Well-plug pieces as they were observed on the operating floor [2-16]

Figure 2-23 shows the well-plug damage conditions as observed on the operating floor. The position of each well-plug is estimated to have moved, as shown in Figure 2-24. The north piece of the upper well-plug was found to have moved to the west by about 720 mm. The center and north pieces of the upper well-plug were found to have been deformed downward by a maximum of 155 mm and 84 mm, respectively.

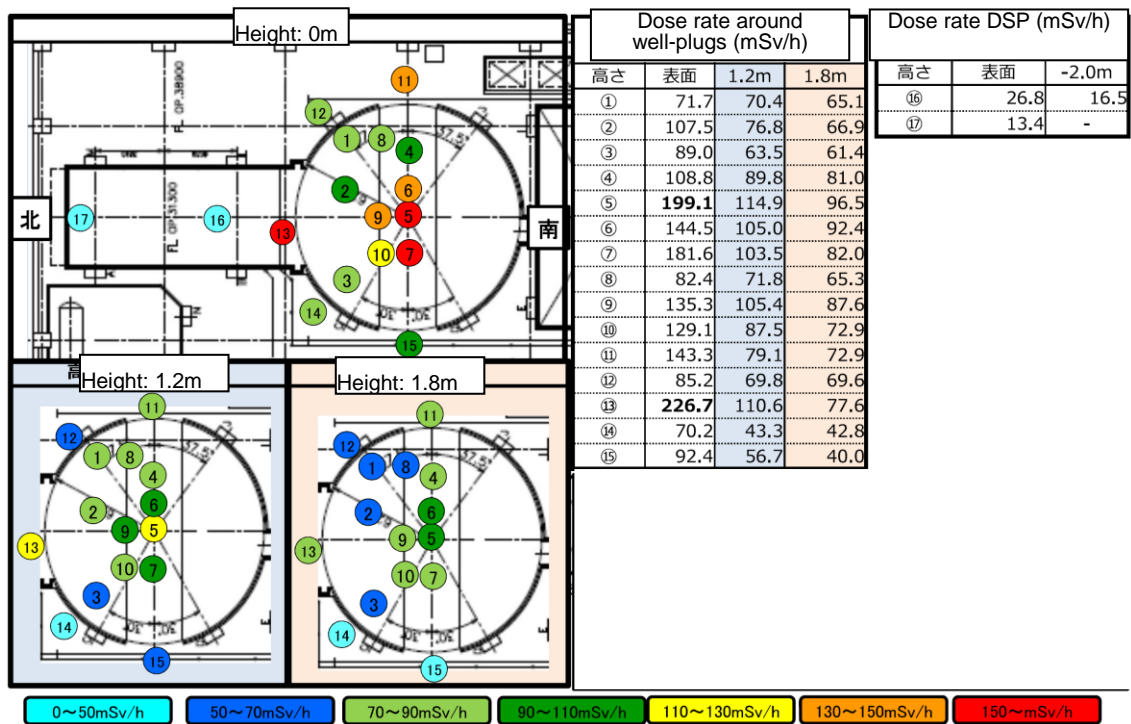
Figure 2-26 Dose rates on the operating floor [2-18]

Figure 2-26 shows the results of dose measurement. Dose rates were found to be higher at the central part on the well-plugs and in the north side around the well-plugs.

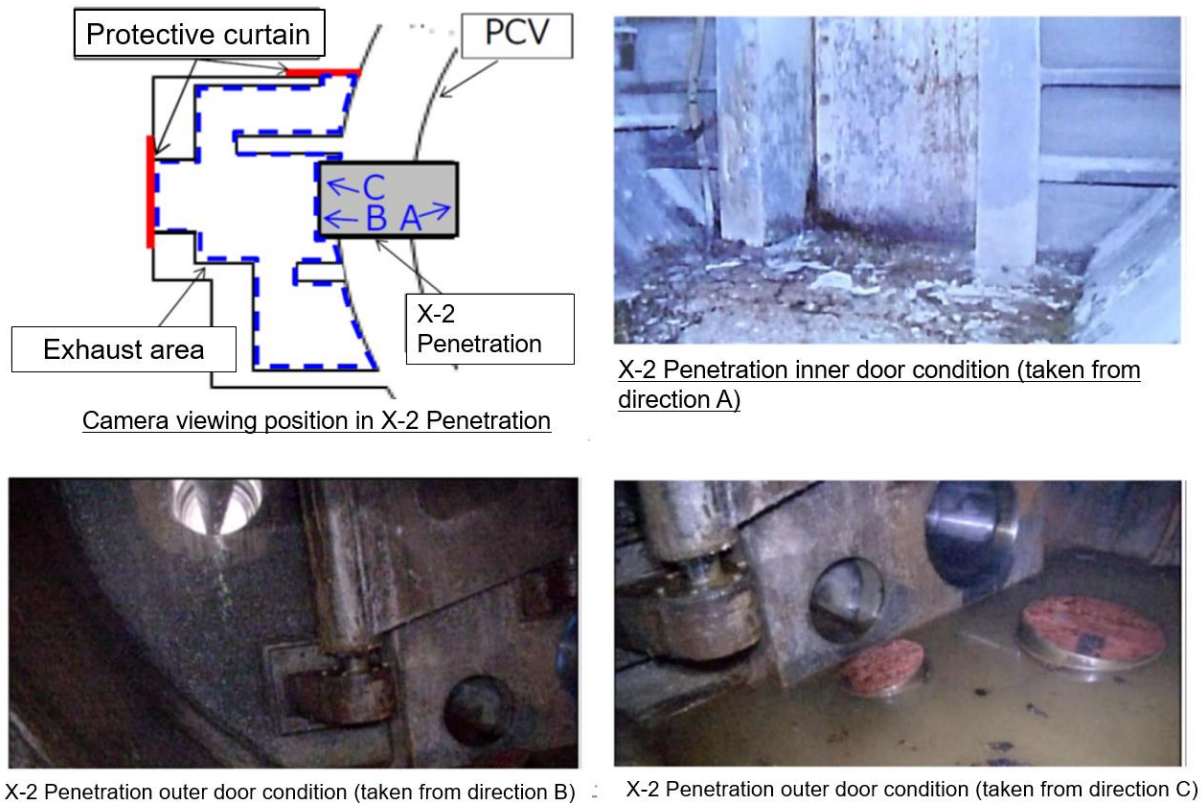
Figure 2- 35 Status in X-2 penetration [2-21]

Drilling of the X-2 penetration outer door was carried out from April to May 2019 to confirm the internal conditions. As a result, matter presumed to be paint was peeled off and deposited in front of the X-2 penetration inner door (Figure 2-35).

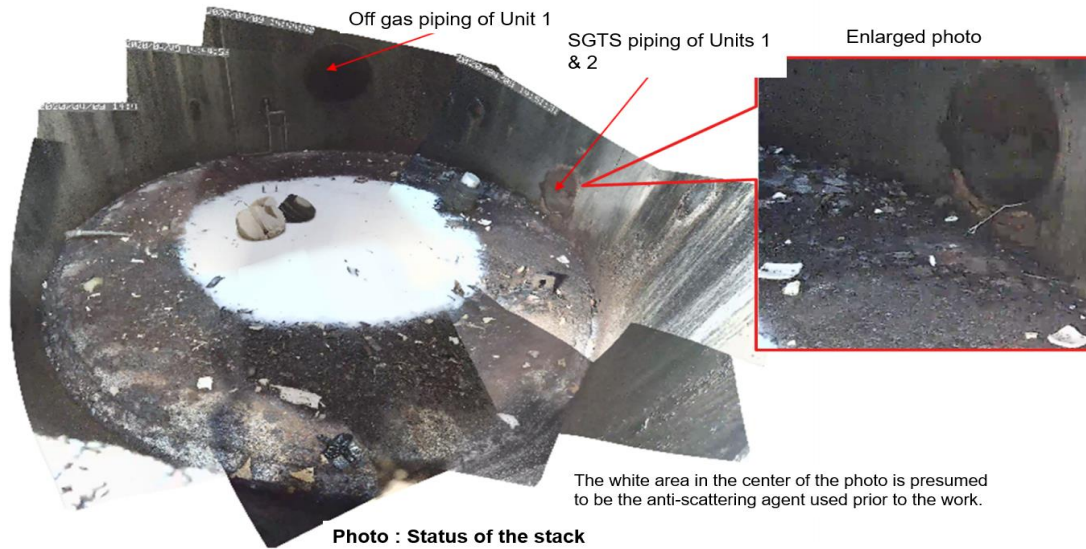
Figure 2-42 Condition at the bottom of the exhaust stack [2-25]

As a result of checking the stack interior, deposits such as sludge were found at the bottom of the stack (Figure 2-42). These deposits were considered to be rust, sand, and gravel inside the exhaust stack and lining pieces that had deteriorated over time.

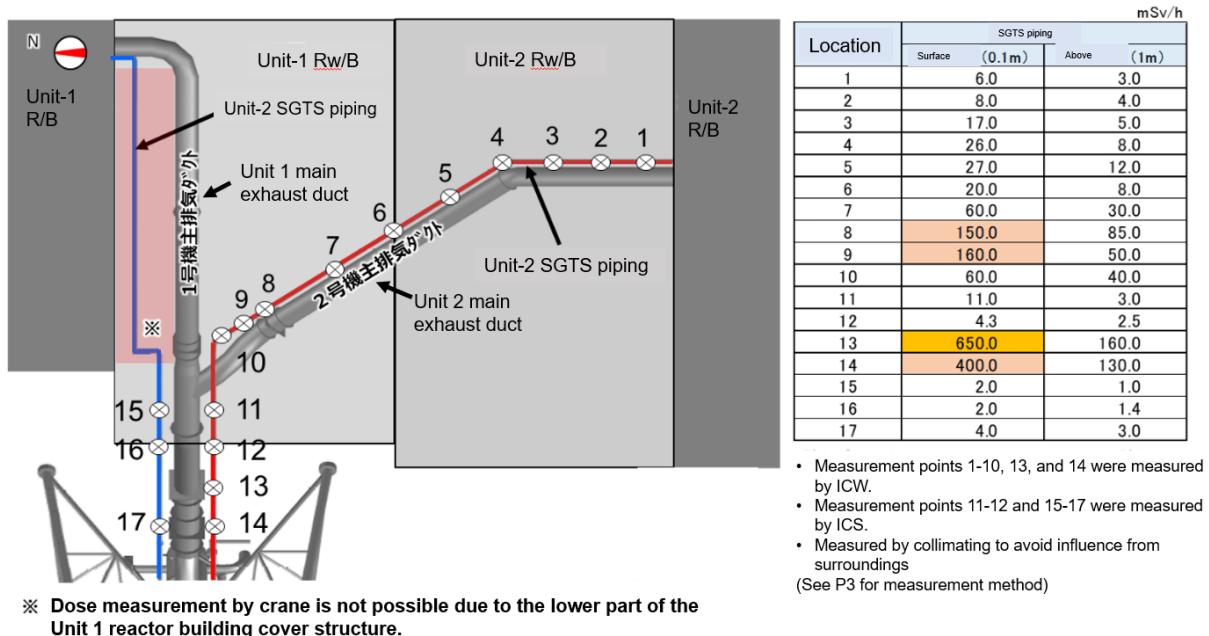
Figure 2-43 Results of dose rate survey near SGTS piping (conducted in 2020) [2-25]

As a result of measuring the dose rate near the SGTS piping, the highest value of approximately 650 mSv/h was confirmed at a height of 0.1 m from the surface of the SGTS piping in Unit-2 (Figure 2-43, measurement point No. 13). Since butterfly valves are installed near measurement points No.13 and No.14, where high dose rates were confirmed, it is considered to be an environment where radioactive materials can easily concentrate. On the other hand, No. 8 and No. 9, where the next highest dose rates were observed, were in the horizontal piping area (Figure 2-44).

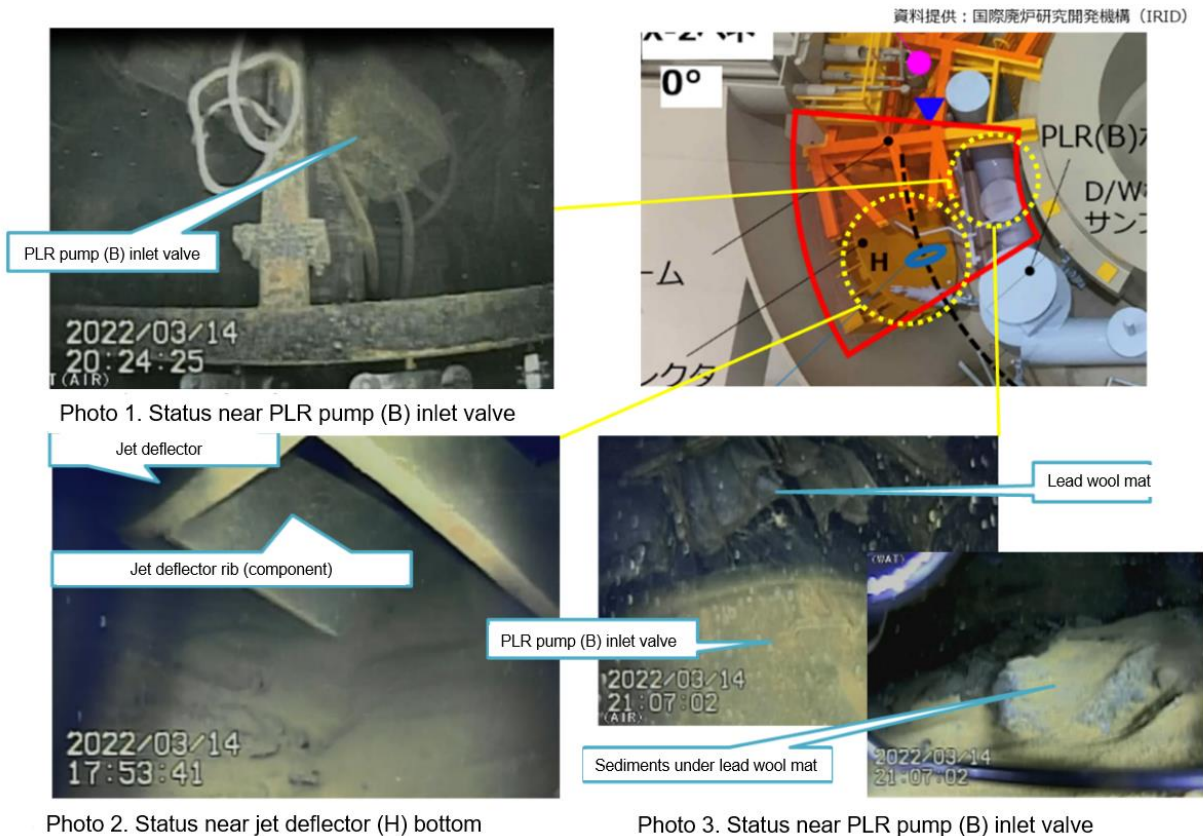
Figure 2-54 Status near the PLR pump (B) and near the jet deflector (H) [2-32]

- No major external damage was observed in the existing structures of the primary loop recirculation system (PLR) (B) piping, pumps, jet deflector, pedestal foundation, etc. (Figures 2-54 to 2-61).

- Sediments were observed below the lead wool mats near the inlet valve of the PLR (B) (bottom of the PCV) and near the jet deflector (F) (Figure 2-54, Photo 3; Figure 2-59, Photo 2).

- Sediments were observed behind the jet deflectors (H, G, F, E, D) (on the side of the pressure suppression chamber) (Figures 2-55, 2-56, 2-58, 2-65, and 2-70).

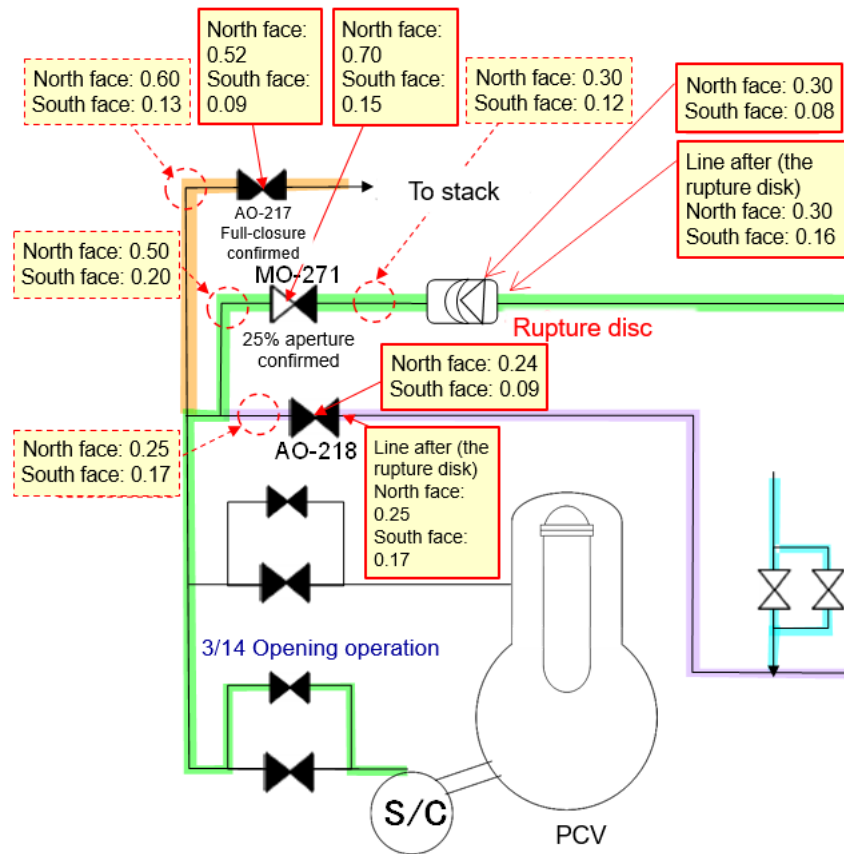
Figure 3-9 Dose rate observed around the rupture disk (mSv/h)

Furthermore, there exists a consistent tendency in the surrounding area that the dose rate on the north face are higher than those on the south face. This may indicate that the observed radiation levels were influenced by some unknown high level radioactive source existing on the north side of the rupture disk area, i.e., the radiation levels observed on the north face of the venting line and the rupture disk were actually measurements of radiation coming from that unknown high level radioactive source on the north side without the shielding effect of the piping, while the radiation levels obtained on the south face were actually measured after being shielded by the piping. Therefore, it is highly likely that the rupture disk and the piping around the disk are the least contaminated.

Although the survey did not identify any contamination in the vicinity of the rupture disk, it was not possible to determine whether the Unit-2 rupture disk was actuated.

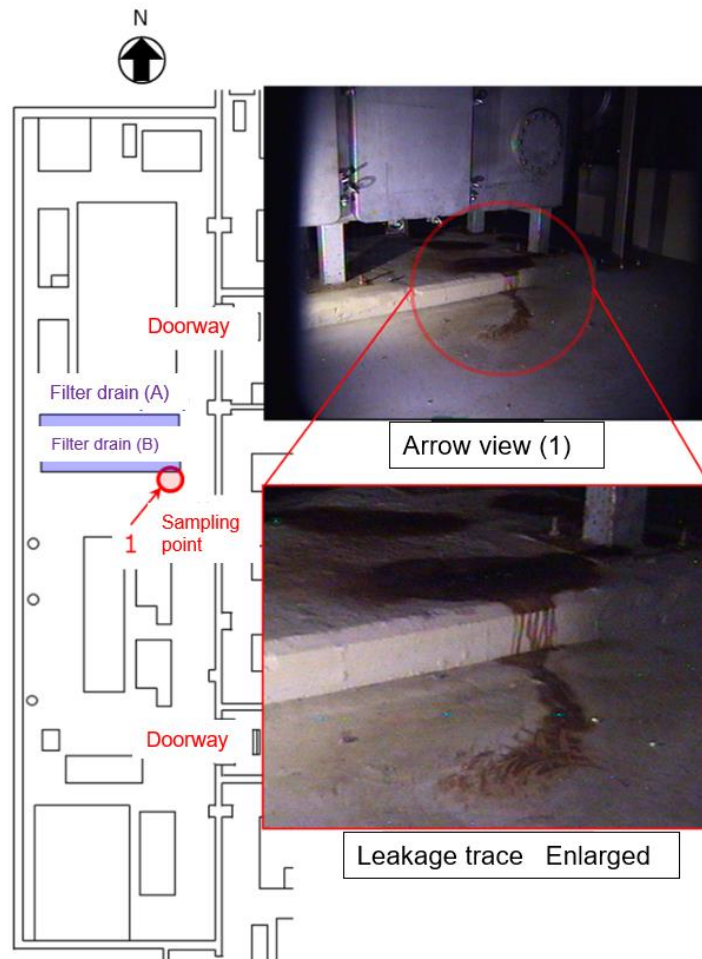
Figure 3-16 Leakage traces observed downstream from filter train B [3-9]

A spot that appeared to be a leak was confirmed on the downstream side of the filter train B system (Figure 3-16). At the time of confirmation, no leak had occurred, and the leak trace itself was not wet. In Units-3 and -4, accumulated water was confirmed in the filter train, so it is thought that in Unit-2 as well, water remained in the filter train and leaked into the passage. The Nuclear Regulation Authority also conducted an investigation in the same room from July to August 2021, and since the location of the leak traces and the drain pipe of the filter train are different, the possibility is high that the leak is not from the filter train. [3-8]
