Additional examination of station black-out due to tsunami

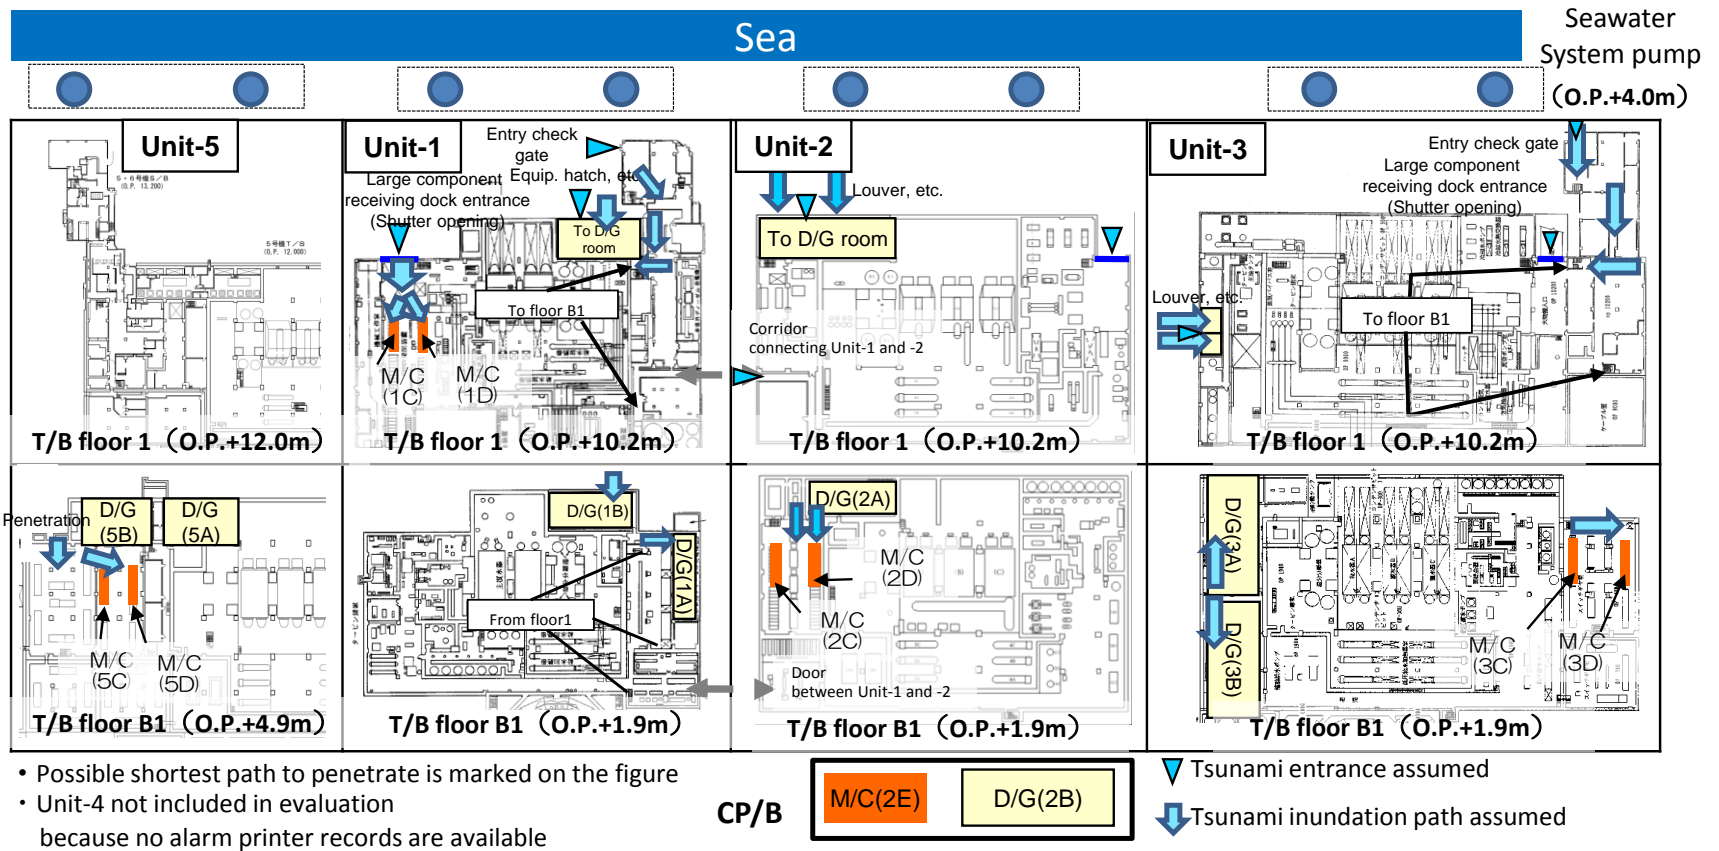
Figure 2 Locations of power equipment of each unit and main paths assumed of tsunami inundation

In Figure 2, the triangle marks pinpoint the location of tsunami entrances to the buildings being interpreted from the building investigations to date, while arrows indicate main tsunami inundation paths assumed. The figure illustrates the paths considered as shortest. The tsunami inundation path length to a power equipment item was estimated by adding the distance from the reference point to the tsunami entrance point assumed, and the shortest distance from the entrance point to the power equipment (the floor elevation difference being considered) along the arrow-marked paths, the distances being measured on the drawings. In the path length calculation, the distances from the reference position to the mountain side were treated as plus and to the seaside as minus, while elevation differences on the ground or in the building were treated as plus or minus distance differences as appropriate.

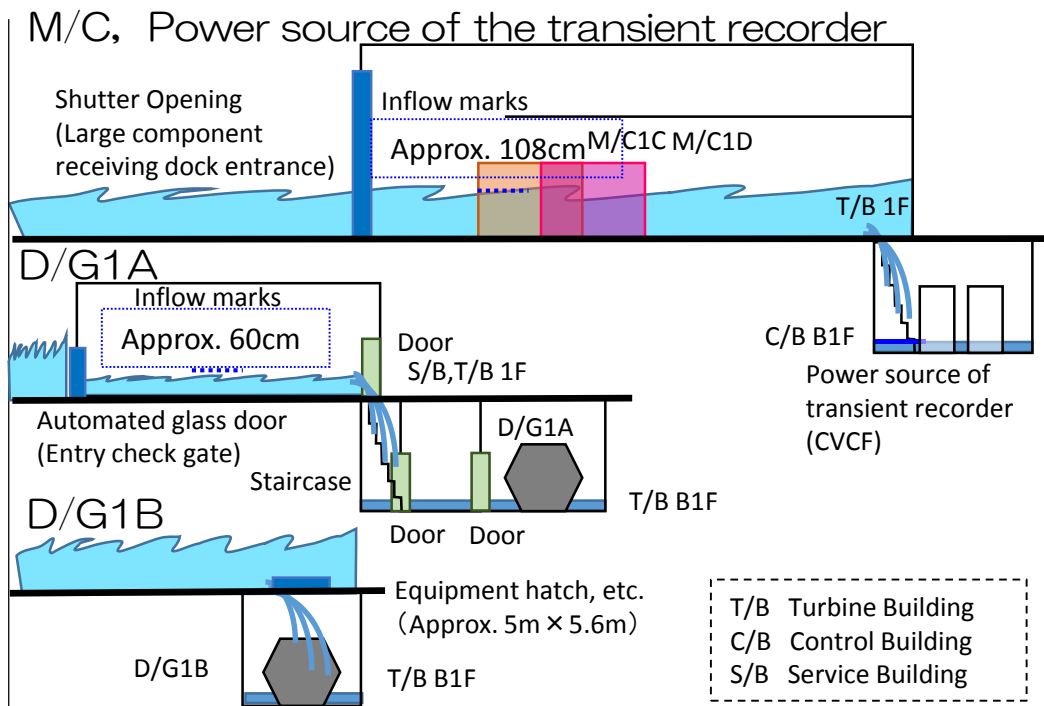
Figure 4 An image of tsunami inflow into Unit-1 turbine building

Figure 4 illustrates a tsunami inundation image for Unit-1 T/B. The drawing depicts the tsunami inflow from the reference position to the power equipment along the inundation path assumed.

The upper part of the figure shows that the large component receiving dock entrance stands just before the M/C. The entrance had a protection door and shutter. Usually, they both would be closed, but the door of Unit-1 was open at the time of the tsunami arrival [2]. On that day, the protection door had been opened for scheduled work. The door was left open, upon evacuation of the workers immediately after the earthquake, until the time of the tsunami arrival. If the protection door had been closed, the tsunami flooding might have been controlled to a certain degree, but with the door being left open, the shutter was deformed and broken by the tsunami and drifting wreckage, and inflow of a large amount of seawater was allowed. Consequently, the M/C located near the large component receiving dock is considered to have been inundated at an earlier timing in the overall trend between the tsunami inundation path lengths and function loss timings.

As seen above, the reason that the power equipment of Unit-1 lost their functions at an earlier timing in the overall trend can be considered that, because the protection door had been kept open at the large component receiving dock, the shutter had been greatly deformed and broken by the tsunami and drifting wreckage, allowing a large amount of tsunami inflow.

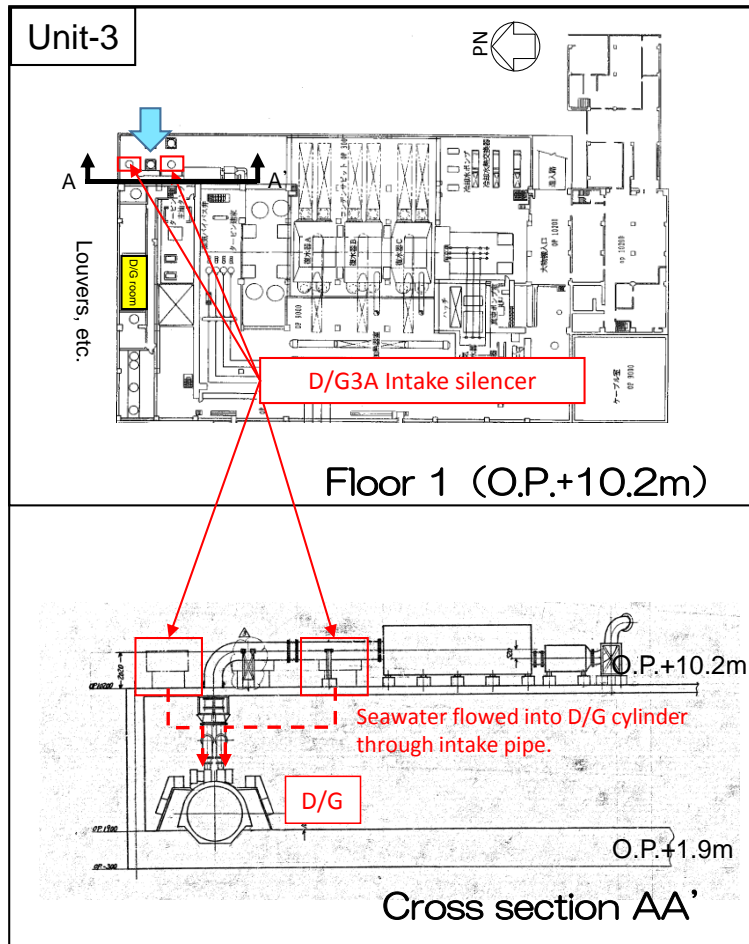
Figure 10 D/G3A Silencer position
(Top: T/B Plan view, Bottom: AA Cross-sectional view)

A possible scenario of the D/G3A having stopped is that seawater flowed into the D/G cylinder through the intake silencer. Figure 10 shows the installation location of the

silencer, and Figure 11 illustrates the operation of a 4-cycle diesel engine. The D/G3A silencer was installed on the seaside at a lower elevation, as can be seen in Figure 10. It is possible seawater flowed to the inside of the D/G engine through the silencer. If this seawater reached the cylinder via the intake pipe, as shown in Figure 11, it would have caused insufficient combustion in the diesel engine. Furthermore, if the seawater reached other cylinders, the D/G rotating speed would have gradually dropped, the voltage would have dropped and eventually the D/G would have stopped. It should be noted that silencers of Unit-1 D/G1A and 1B, and Unit-2 D/G2A were also installed on the seaside at lower elevations, like Unit-3 D/G3A. The inundation path lengths to all these silencers are not very different. Therefore, the tsunami could have eventually flowed into the D/G cylinders of Units-1 and -2 as well. But it is unlikely that seawater, having flowed into the cylinders, stopped Unit-1 D/Gs and Unit-2 D/Gs, because their power supply was stopped earlier than Unit-3 Line A, and their voltage and current drop behavior is different from the unique behavior of Unit-3 Line A. It should also be noted that no seawater would have flowed into the silencers of Unit-3 D/G3B, Unit-5 D/G5A and 5B, because the silencer of Unit-3 D/G3B was installed at an elevated position, and those of Unit-5 D/G5A and 5B were enclosed by side-walls.

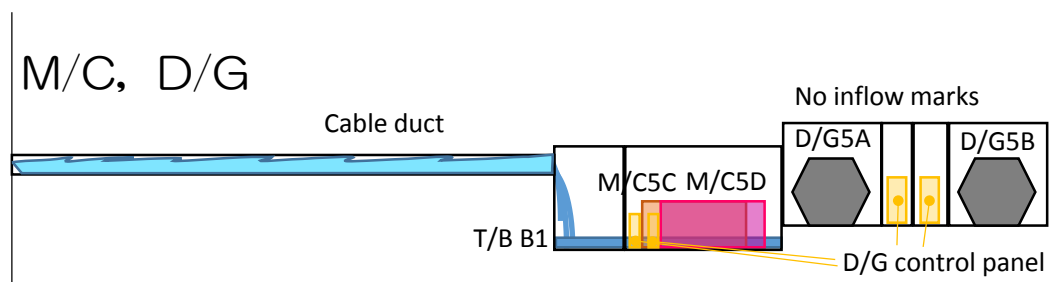
Figure 12 An image of tsunami inflow into Unit-5 turbine building

Figure 12 is an image of tsunami inflow into the Unit-5 T/B. The M/C5C and 5D were installed in the electrical equipment room of Floor B1, while the D/G5A and 5B were in the D/G cell on a slightly higher floor level than that of the electrical equipment room. D/G control panels were partly in the electrical equipment room. As shown in Figure 3, there is not much difference in tsunami inundation path lengths to the above power supply systems. It is unlikely that the power was lost by the flooded D/Gs, because no tsunami marks were left in the D/G cell. To reach the electrical equipment room, the tsunami is estimated to have flowed from cable penetrations via underground cable ducts, since tsunami marks could be recognized on the cable penetrations in the electrical equipment room. Even if the M/C main circuits were not flooded and did not lose bus bar voltages, the D/Gs could have lost their functions due to energized terminals in the D/G control panel when flooded.

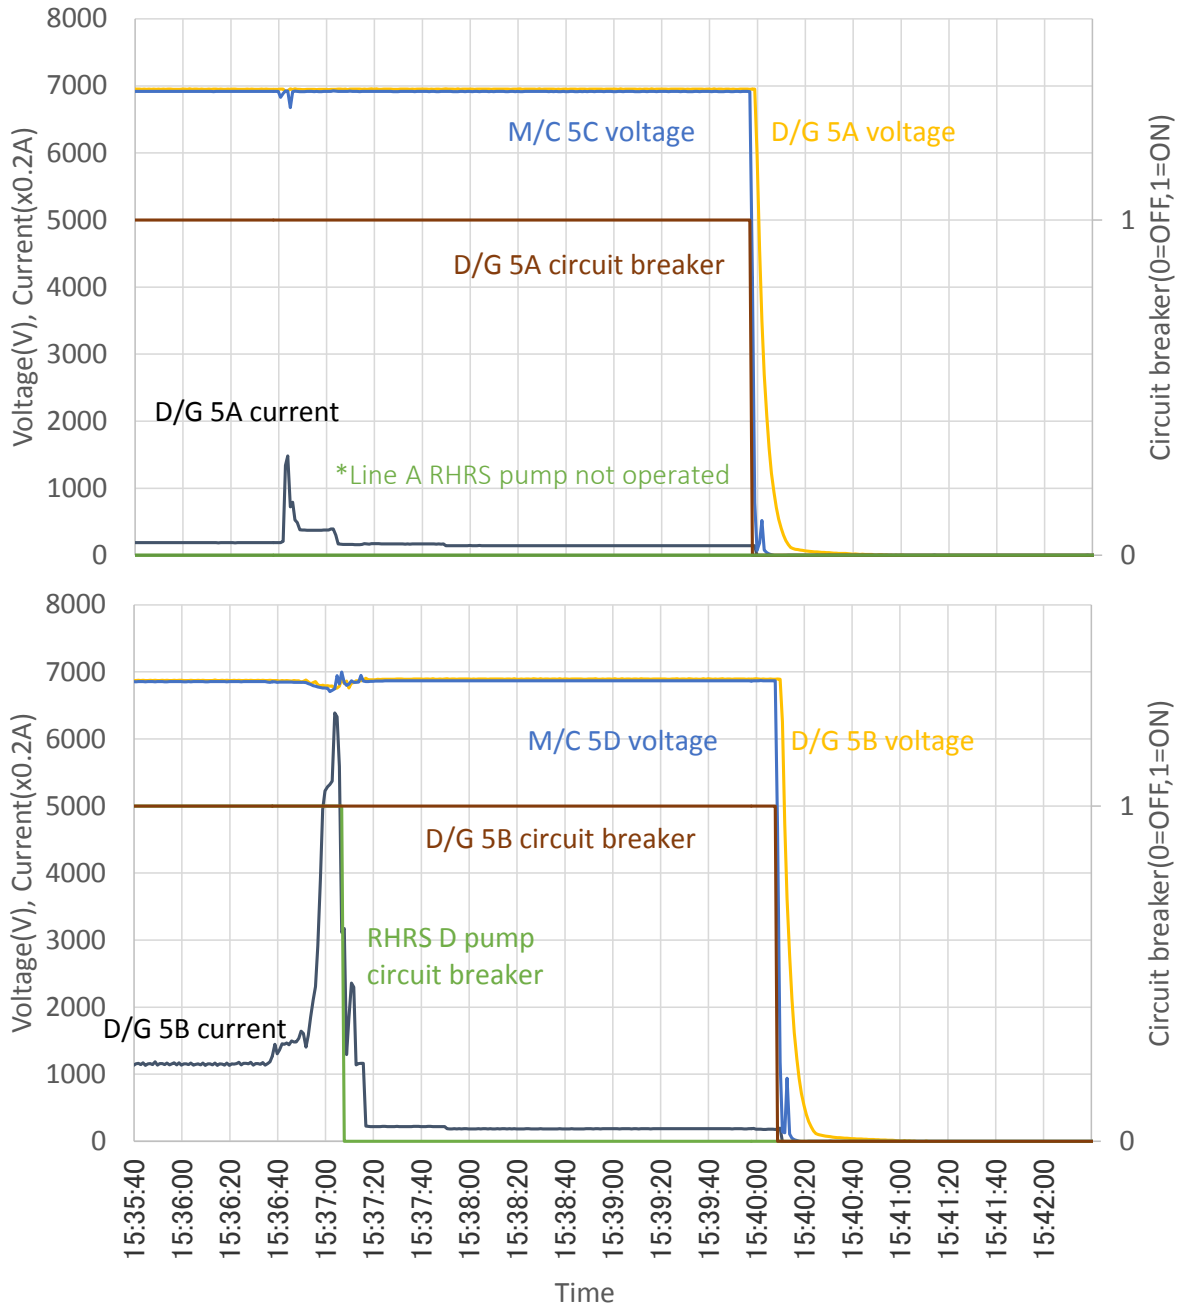
Figure 13 Unit-5 process computer records (Top: Line A, Bottom: Line B)

Figure 13 gives the process computer data of Unit-5 power supply systems. Both on Line A and Line B, the D/G circuit breakers opened at about 15:40:00, and D/G currents, D/G and M/C voltages sharply dropped to zero (Possible Cause ③ excluded). No electrical accidents occurred to the D/G and M/C, since no spike-shape currents are recorded (Possible Cause ① excluded). Consequently, it is likely that the power was lost due to the activated lockout relay when the DGSW pump tripped or the terminals in the D/G control panel were energized upon flooding, as was the case in Unit-2 Line A and Unit-3 Line B (Possible Cause ② holds).

Thus, both Line A and Line B lost power due to the tsunami.
