Relocation behavior of molten fuel to below the core

This document examined the molten fuel relocation behavior to below the core for Units-1, -2 and -3 of the FDNPS, in order to facilitate clarification of the accident progression and estimation of the conditions of the core and PCV for each unit. For the examination, surveys were made of previous test studies relevant to the molten fuel relocation behavior to below the core as well as the latest research upgrading analysis codes.

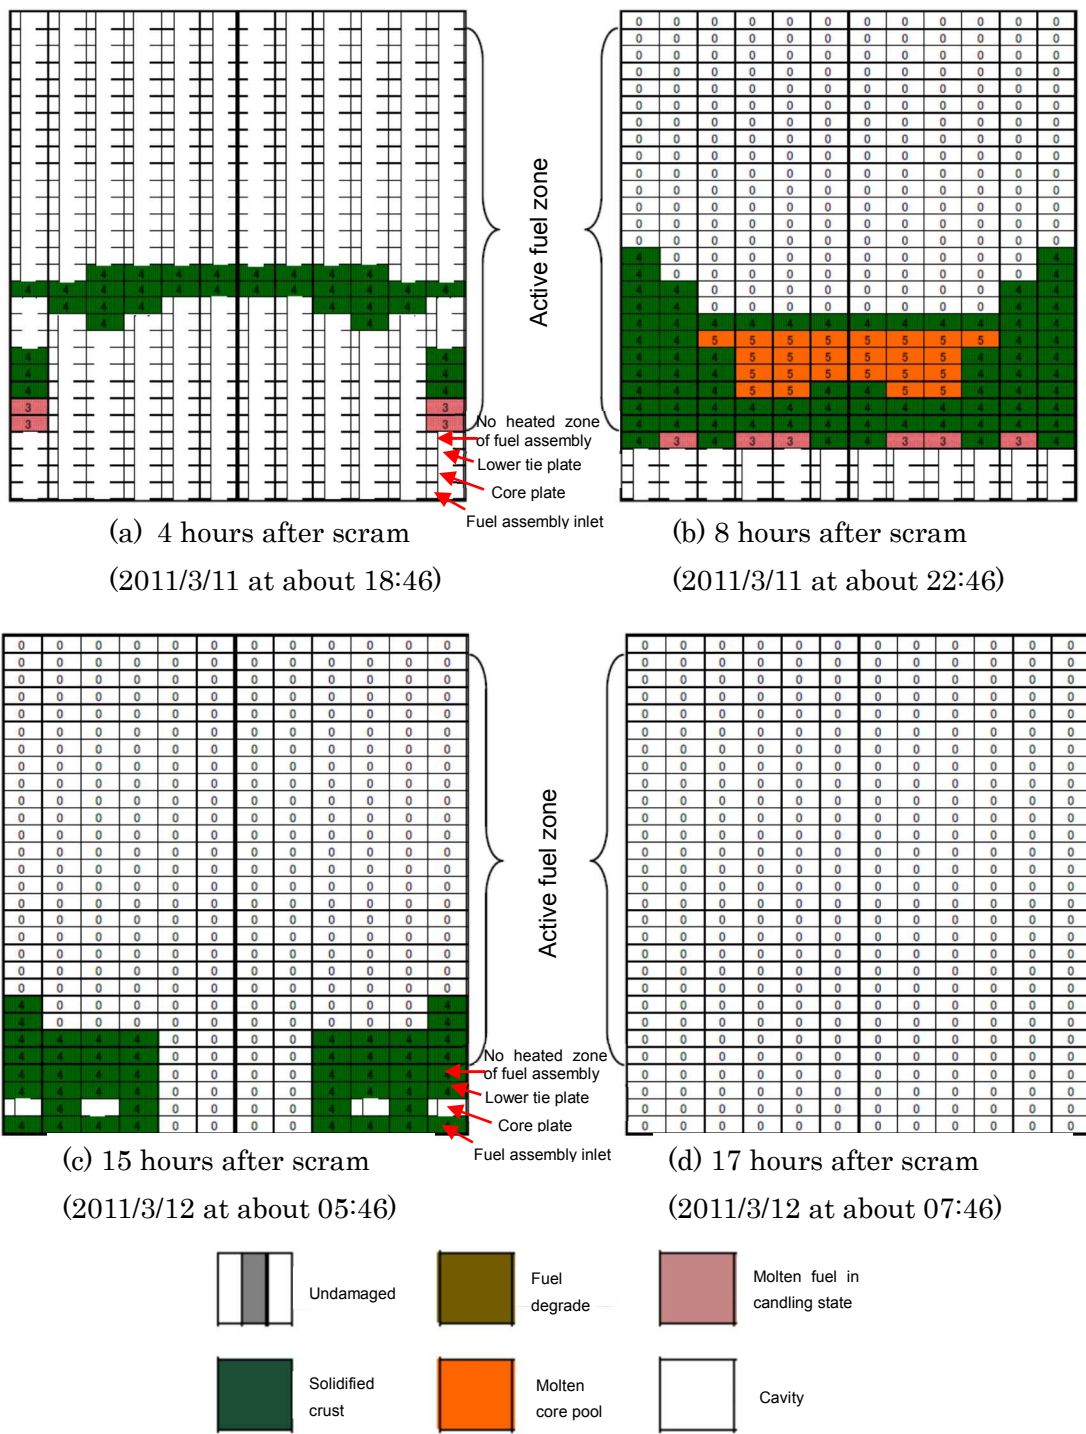
Figure 4.1 Conditions of damaged core (Unit-1)

After the molten fuel pool was formed, the shroud was damaged. Further, molten fuel relocated to below the core upon the central part of core plate being damaged. Afterward, the molten fuel left in the peripheral area of the core relocated to the paths via the inlet orifice of the fuel supports and control rod velocity limiters. Eventually, the whole core plate was degraded and no more molten fuel was left in the core region.

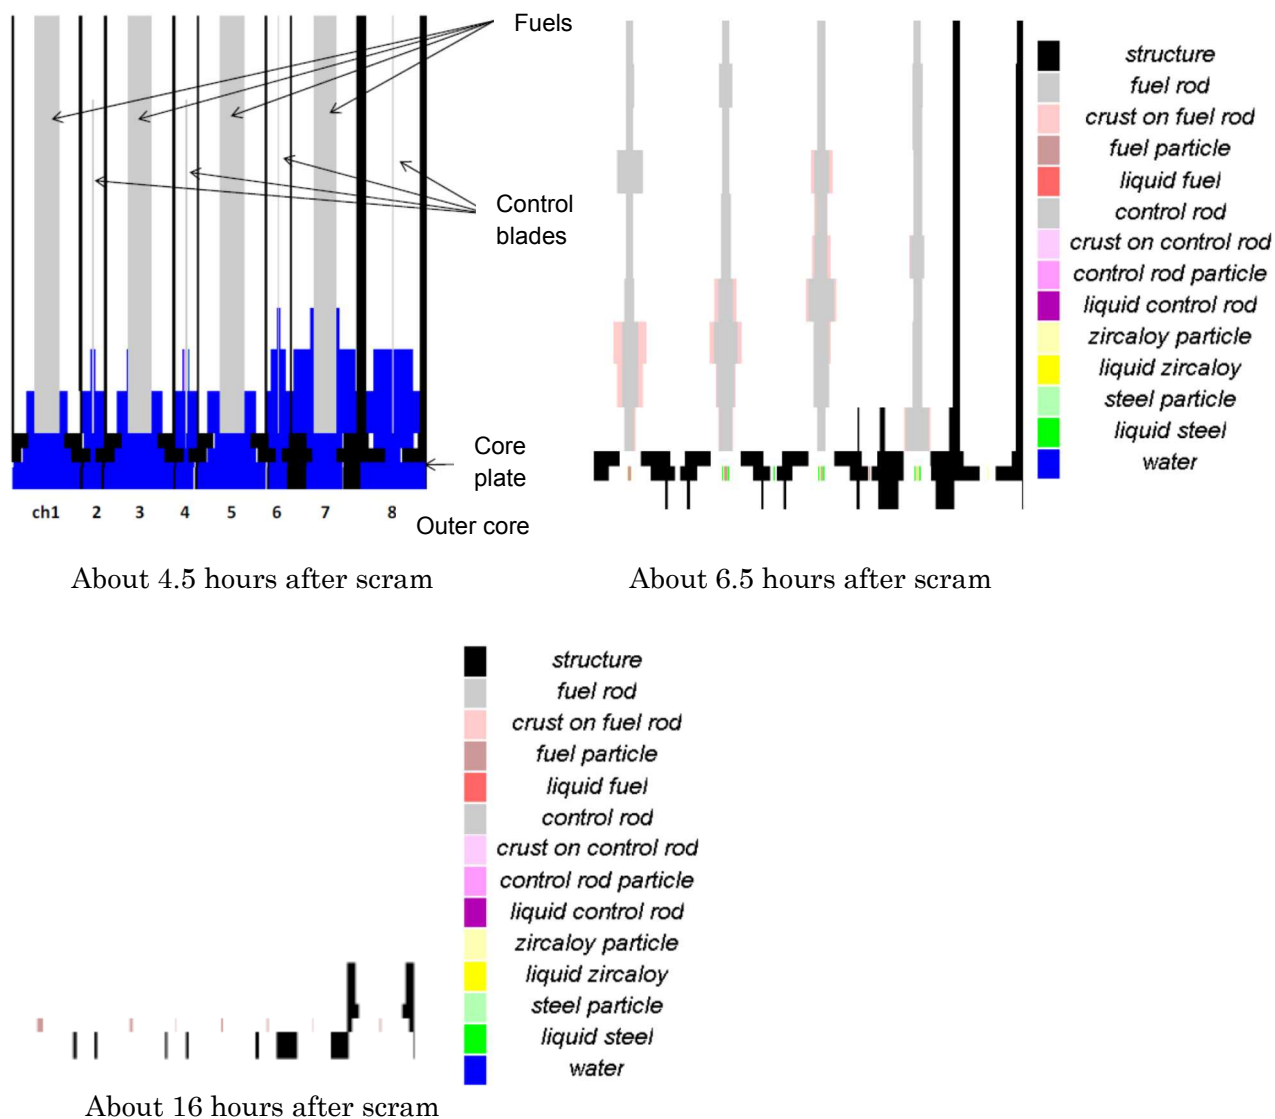
Figure 4.4 Conditions of damaged core of Unit-1 (Volume fractions)

The core plate was melted when it contacted with part of the molten fuel and all structures in the core region dropped to below the core. The molten fuel which relocated to the CRGT melted the control rod velocity limiters. Eventually, no molten fuel was left in the core region. The lower part of the shroud was also melted.
