Estimation of causes of high contamination of RCW piping at Unit-1

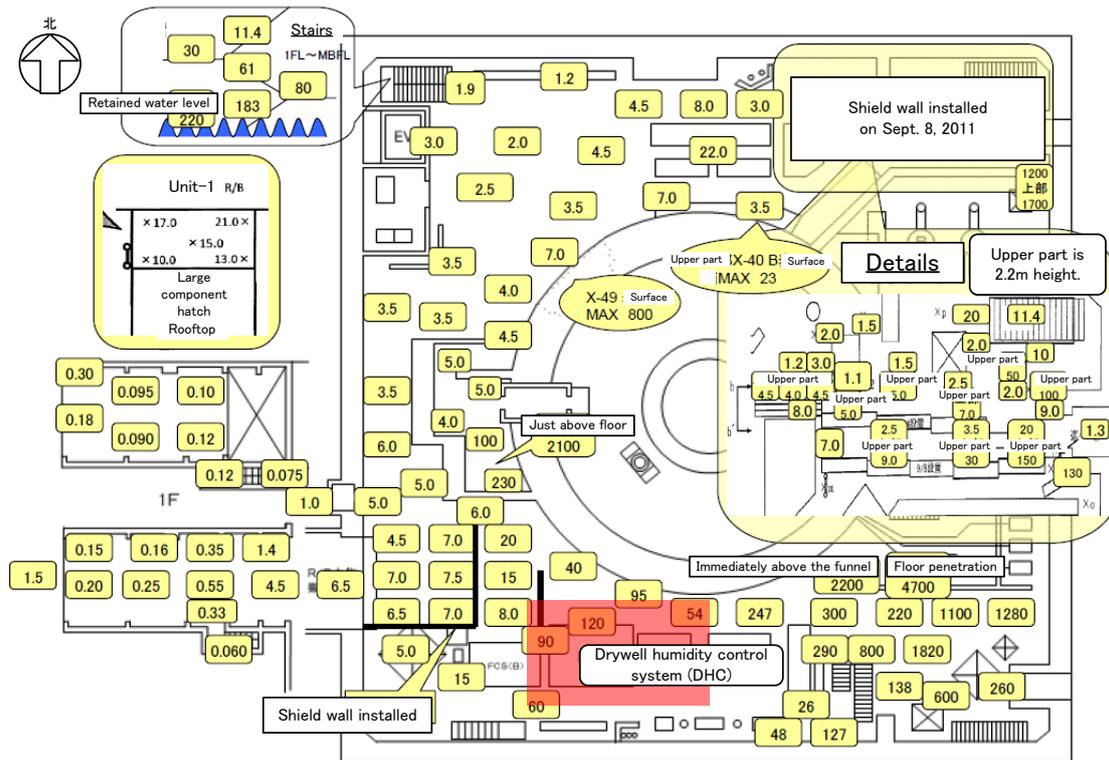
Figure 2 Air dose rates measured on Floor 1 of Unit-1 R/B (mSv/h) [1]

On the R/B Floor 1, high dose rates were measured in the southeast area (Figure 2). For this spot, a correlation with the vent line of the PCV vent (wet well (W/W) vent) is suggested [2]. Therefore, the possibility of high dose rate contamination due to RCW piping damage can be considered as low. Besides the southeast area, high dose rates (120mSv/h) were measured in the vicinity of the dry-well humidity control (DHC) system in the southwest area. The DHC is one piece of auxiliary equipment to be cooled by the RCW system.

radioactive materials could be deposited therein. This estimation is consistent with the high dose rates observed around the RCW heat exchanger on R/B Floor 2 (Figure 3). It is also consistent with the high dose rates near DHC on R/B Floor 1 (Figure 2).

- High dose rates near the dry-well humidity control system (DHC) in the southwest area on R/B Floor 1 (the high dose rate in the southeast area was excluded from evaluation, because it came probably from other reasons)
- High dose rates near the RCW heat exchanger in the south area on R/B Floor 2
- High dose rates near the surge tank in the southwest area on R/B Floor 4

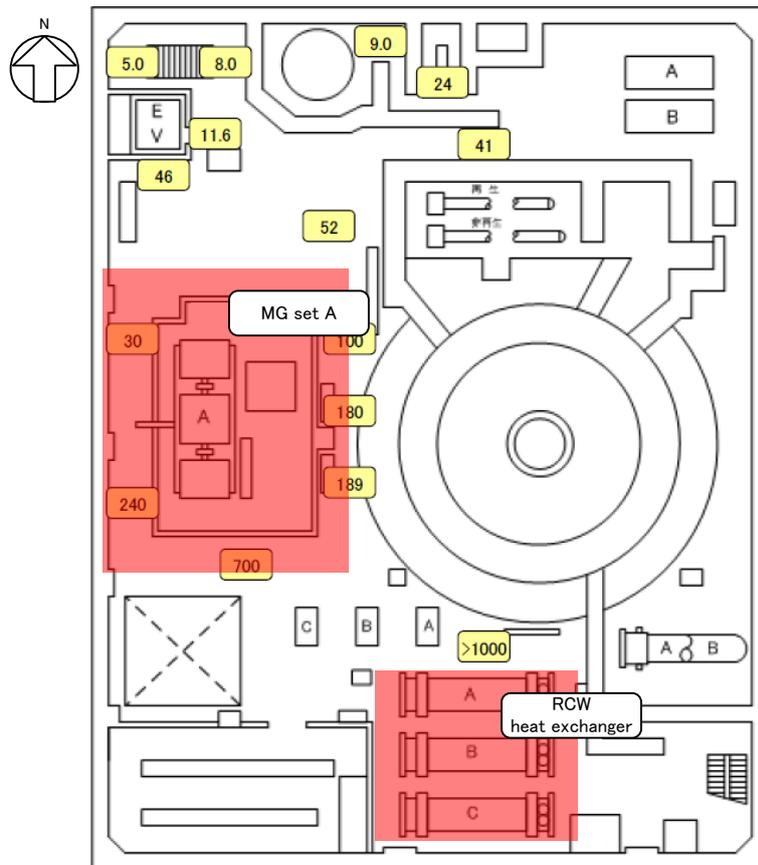
Figure 3 Air dose rates measured on Floor 2 of Unit-1 R/B (mSv/h) [1]

On Floor 2, high dose rates were measured in the south area (higher than 1,000mSv/h) and in the west area (30 to 700mSv/h) (Figure 3). An extremely high dose rate was measured in the

south area, where the RCW heat exchanger was installed. In the west area, the MG set oil cooler (A) was installed, which was cooled by the RCW system. In the west area, the highest dose rates were measured in the lower area on the figure (700mSv/h) and the lowest dose rates in the left area on the figure (30mSv/h). This hints at possible impacts from the high dose rates in the vicinity of the RCW heat exchanger in the south area.

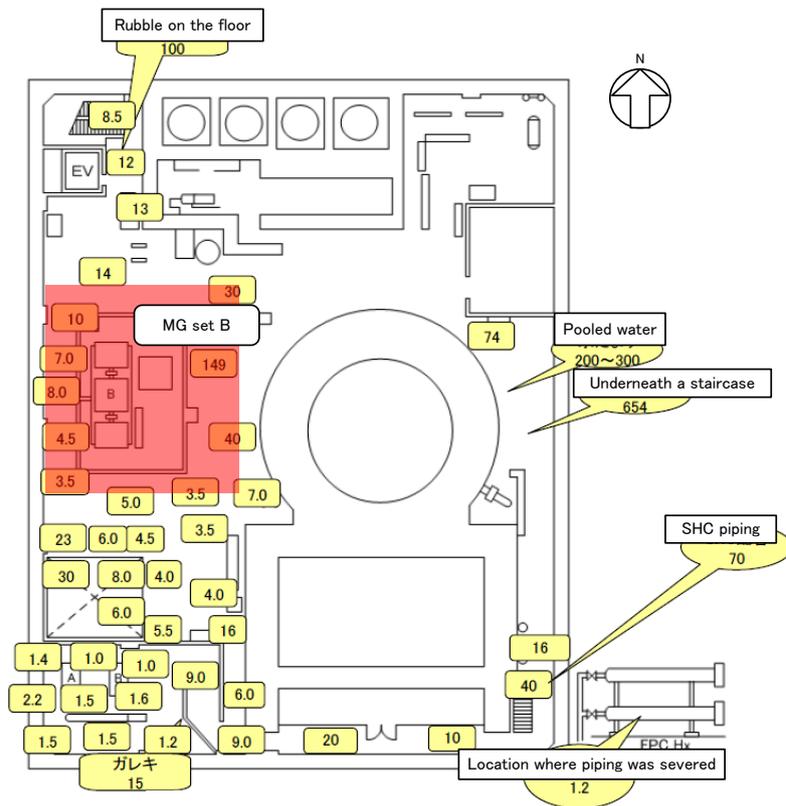
Figure 4 Air dose rates measured on Floor 3 of Unit-1 R/B (mSv/h) [1]

On Floor 3, high dose rates were measured in the west area (149mSv/h) (Figure 4). A possible cause is the MG set oil cooler (B) in the area, but other causes may be possible because the air dose rates in the surrounding area were low (3.5 to 40mSv/h). On Floor 4, dose rates in several tens of mSv/h were measured in the west and southwest areas, the highest value being 90mSv/h measured in the southwest area (Figure 5). The RCW surge tank which adjusts the RCW water inventory was installed in this area.

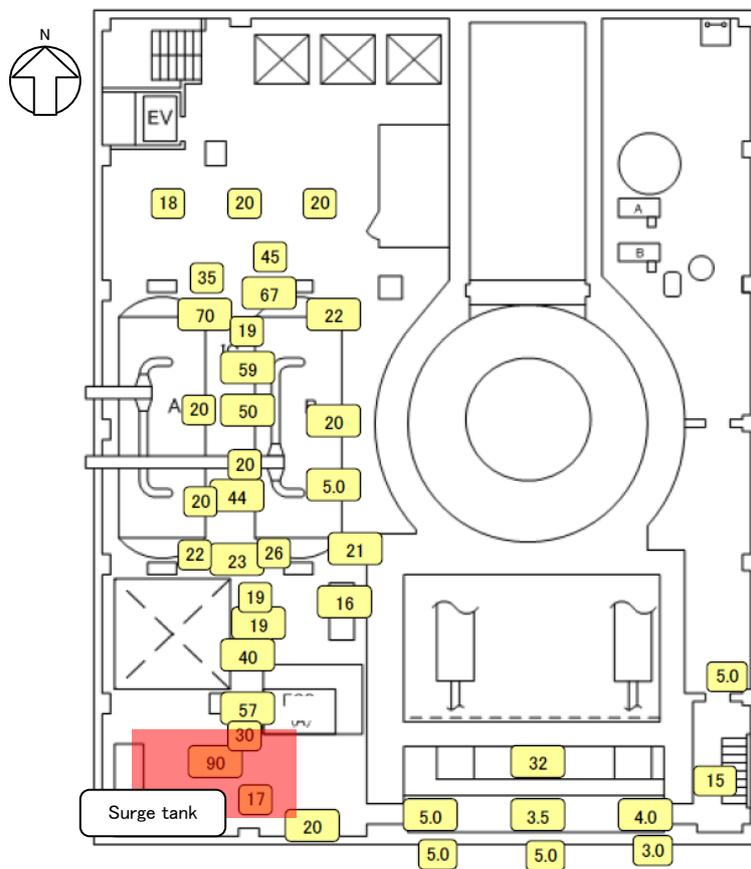
Figure 5 Air dose rates measured on Floor 4 of Unit-1 R/B (mSv/h) [1]

The RCW piping ② has four branch lines. The line to the surge tank is likely to be at about atmospheric pressure at its end and therefore the radioactive materials could have tended to migrate in the direction of the surge tank. This is consistent with the high dose rates observed

around the surge tank on the R/B Floor 4 (Figure 5). Migration to other lines depends on the distance and paths to the destination equipment or on the elevational relations with the surge tank, which is an easier destination for migration. But all downstream lines return to the heat exchanger outlet line in a closed circuit. Therefore, the line pressures are considered close to the RCW pressures and it can be considered to have been hard for radioactive materials to migrate to these lines. It should be noted that the relatively high dose rates observed in the vicinity of the MG set (A) could have been affected by the RCW heat exchanger, as mentioned in Section 2, and they could have been caused not only by the contamination in the piping.

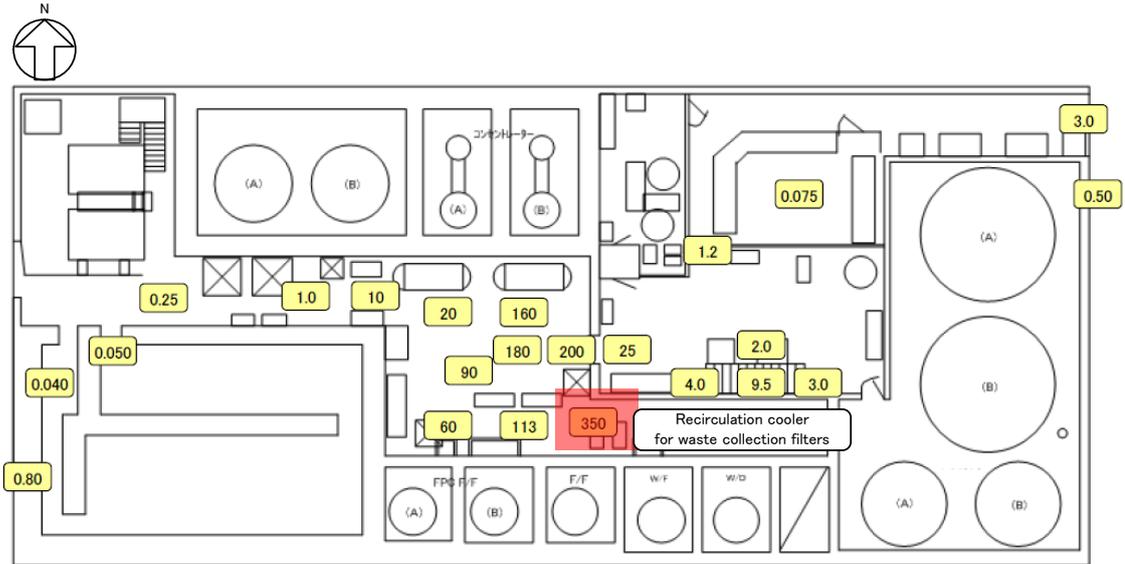
Figure 6 Air dose rates measured on Floor 1 of Unit-1 R/B (mSv/h) [1]

On the R/B Floor 1, a high dose rate (350mSv/h) was measured in the south area (Figure 6). In this area, a recirculating cooler for waste collection filters was installed, which was one piece of equipment to be cooled by the RCW system.

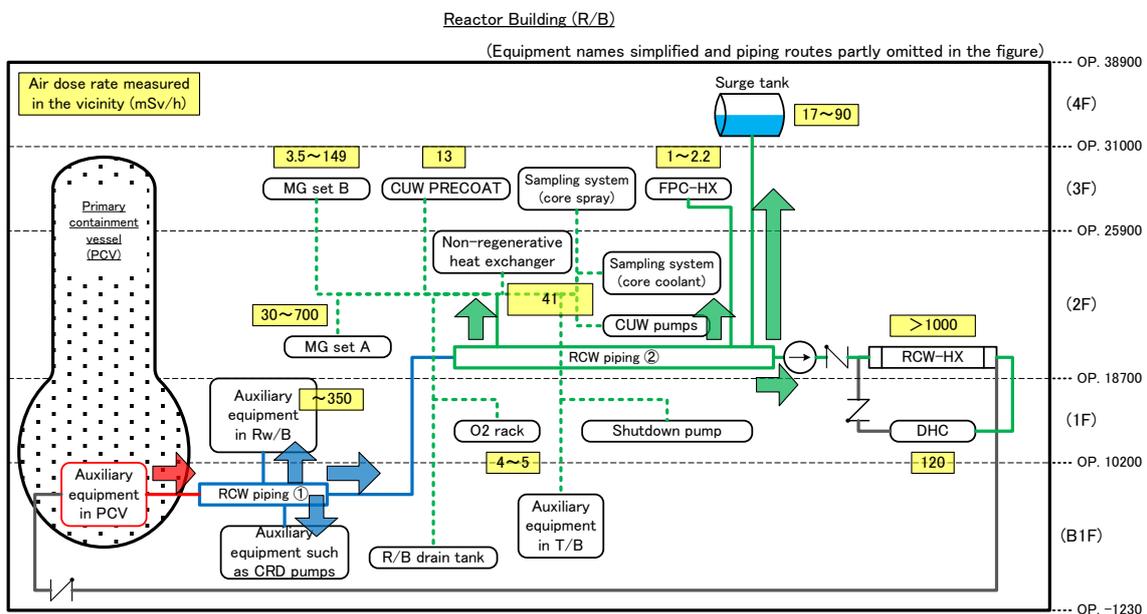
Figure 8 Migration of radioactive materials in the case of high PCV pressures

Radioactive materials migrate from the PCV to the RCW piping, since the PCV pressure at the location of damage (of the RCW piping) is higher than the pressure at the surge tank with the elevation difference and other factors being taken into account. Figure 8 shows the evaluation results of radioactive material migration in the RCW piping for the high PCV pressure situation, based on the RCW piping routes shown in Section 2 (Figure 1). When the RCW piping in the PCV pedestal is damaged, radioactive materials migrate into the RCW piping ① in Figure 8. The other side of the piping (upstream) was excluded in the evaluation, because it has a check valve near the inlet to the PCV and therefore the radioactive migration was considered to be insignificant. The RCW piping ① has three branch lines: the junction to the R/B is located closer to the PCV; the line goes to the CRD pumps and other auxiliary equipment in the Basement Floor 1; and the last line, the RCW main piping ② has a surge tank downstream. None of these three lines would have presented particular difficulties for radioactive materials to migrate through, although it is difficult to show this quantitatively. It should be noted that the high dose rates observed on the R/B Floor 1 could be due to the radioactive materials migrating to the R/B. The situation in the R/B Basement Floor 1 has not yet been investigated; it is the installed location of CRD pumps and other auxiliary equipment.

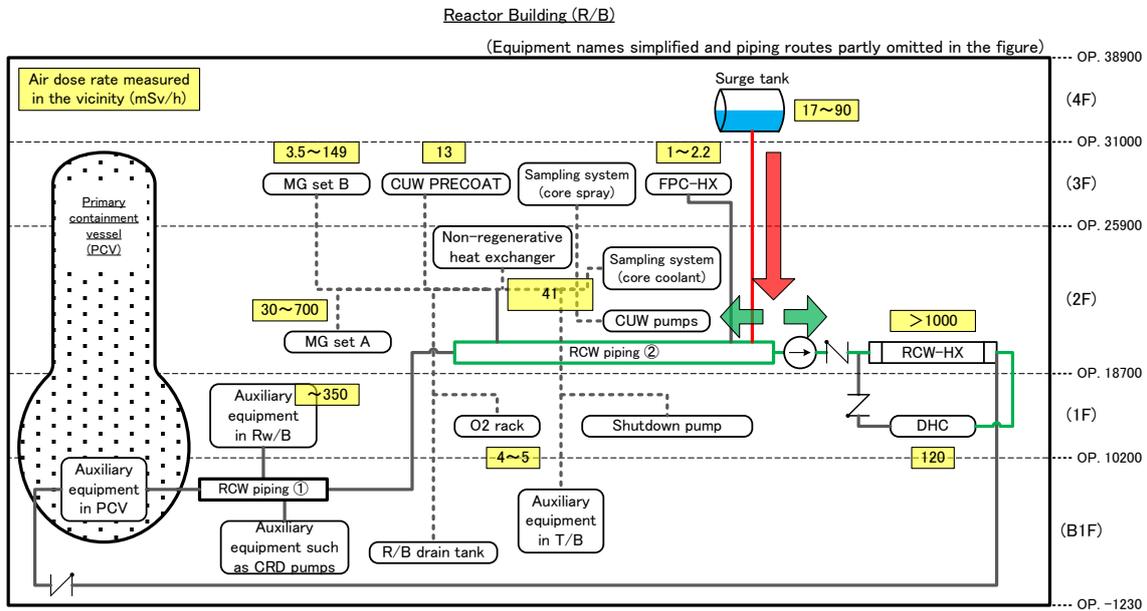
Figure 9 Migration of radioactive materials in the case of low PCV pressures

At Unit-1, the PCV pressures decreased from 14:30 to 14:50 on March 12th on the occasion of W/W venting. The radioactive materials which migrated to the surge tank when the PCV pressures were high would come down to the level where the pressures balanced with the PCV pressures. Figure 9 shows feasible migration paths for the radioactive materials accumulated in the surge tank.

When the radioactive materials being accumulated in the surge tank migrated to the RCW piping ②, they would proceed to the RCW piping ① (to the left in Figure 9) or the RCW heat exchanger (to the right). The heat exchanger had a large surface area and a large amount of
