Analysis of the hydrogen explosion at the Unit-1 Reactor Building

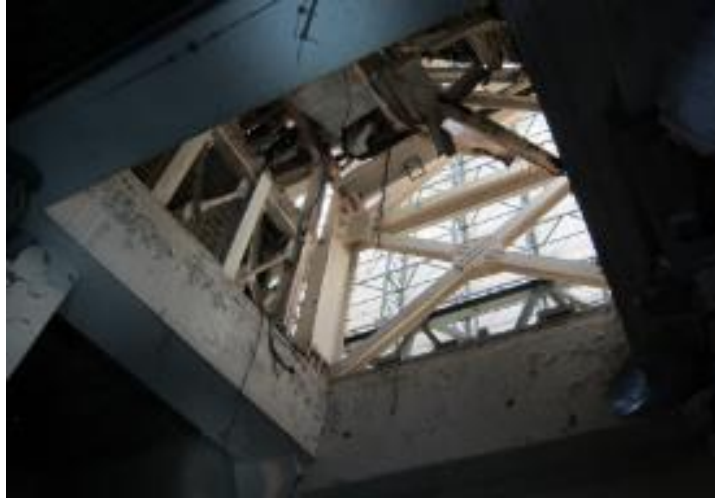
Figure 7 Equipment hatch after hydrogen explosion
(view from Floor 4 to Floor 5)

the Floor 5 floor surface and the cover could be smoothly operated for opening/closing using the wheels attached to its side ends. The hatch cover, as shown in Figure 7, was blown away and has not been found.

In the analysis, the hatch cover was assumed to have been opened and blown away by the pressure difference between Floor 4 and Floor 5. In a case of higher pressure for Floor 4 than for Floor 5, the cover was assumed to open when the pressure difference reached an adequate value to lift up the cover. In a case of higher pressure for Floor 5 than for Floor 4, the cover might be deformed and opened by the pressure applied from Floor 5³, but such a pressure value is not known. Four different pressure values were applied to the cover from above in a sensitivity analysis: 10%, 30%, 50% and 80% of the pressure to destroy the Floor 5 side wall. In the 80% pressure analysis, the cover did not open before the Floor 5 side wall broke and almost no blast appeared on Floor 4 and below. This situation is inconsistent with the actual R/B damage conditions as described later. In all other cases, the explosion development was similar. In the analysis, the pressure difference to open the hatch cover was set at about 5 kPa, 30% of the pressure to destroy the Floor 5 side wall. This value is equivalent to about 70 times the allowable load capacity (200 kg mentioned above) of the hatch cover. The cover is considered to have been deformed accordingly.

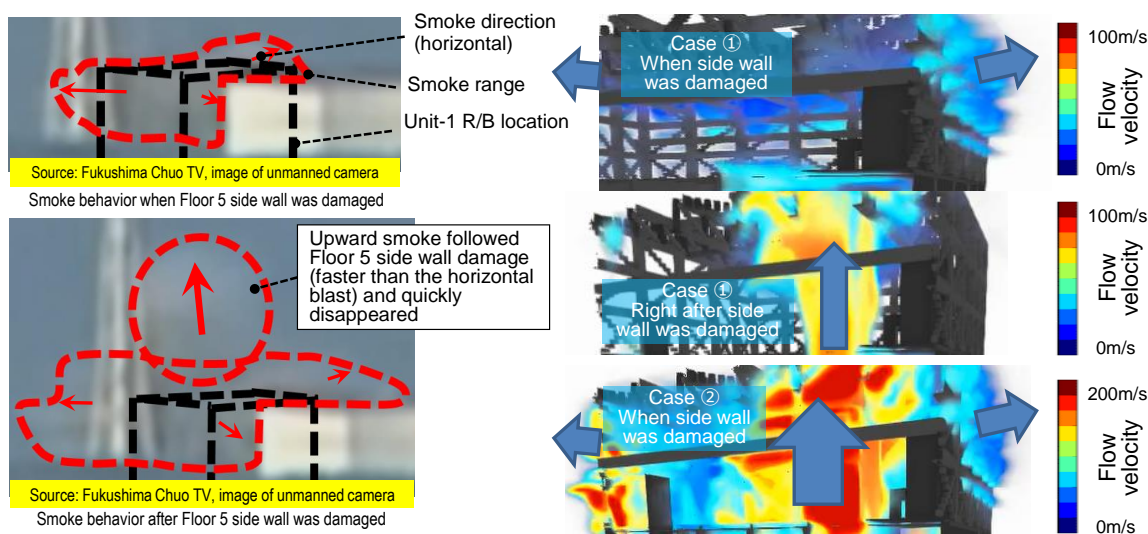
Figure 15 Blast images at the time of the hydrogen explosion and analysis

the video (A) with the results obtained by the analysis (B). In (A), there were horizontal blasts when the side wall was damaged, and a while later upward blasts of high speed were observed. The analysis results shown in (B) tell different development scenarios after the side wall on Floor 5 was damaged: in Case ①, upward blasts of high speed followed the horizontal blasts with a delay, similar to the video records; in Case ②, upward blasts occurred simultaneously with the horizontal blasts; in Case ③, a second upward blast followed after the first one in Case ① as mentioned above in 2.3 (3).; and in Case ④, the development was similar to that of Case ①.

The following findings are drawn from the comparison. The video may have recorded the upward blasts after the side wall had been damaged as indicated in Case ① and Case ④, in which hydrogen leaks were assumed to have occurred on Floor 5. On the other hand, in Case ② and Case ③, in which leaks on Floor 5 and Floor 4 were assumed, the development was different from what was seen in the video records; the timings of horizontal and upward blasts in Case ②, and the number of upward blasts in Case ③.

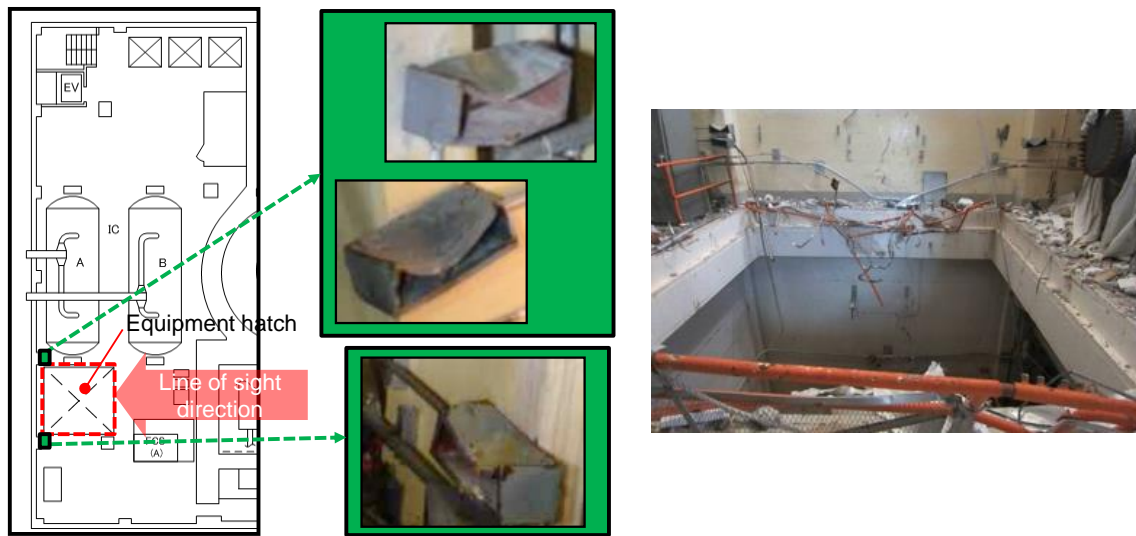
Figure 16 Deformed pull box and damaged handrail near equipment hatch

Figure 16 shows the damage conditions near the equipment hatch. The pull box in (B) seems crushed from above.

From these comparisons, it is concluded that: the deformed shape of the pull box near the equipment hatch on Floor 4 is consistent with the blast directions in Case ① and Case ④ when hydrogen leaks on Floor 5 were assumed; whereas, it is inconsistent with the blast directions in Case ② and Case ③ when hydrogen leaks on Floor 5 and Floor 4 were assumed.

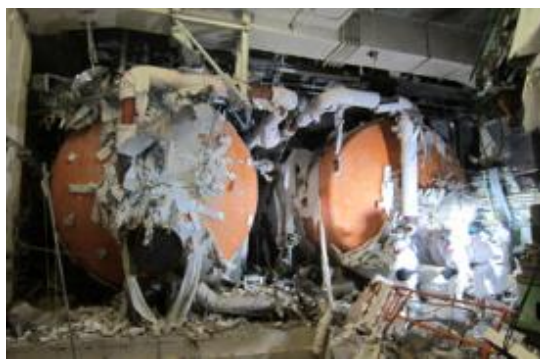
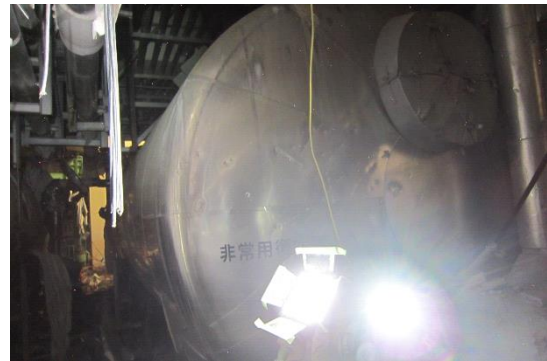
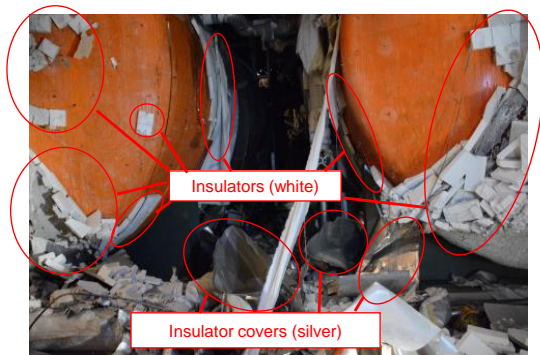
Figure 19 Damage conditions of IC tank insulators and insulator covers

Damage conditions of IC tank thermal insulators and covers are shown in Figures 19 (A) to (C). Figure 19 (D) gives the directions in which the camera was pointed. The IC tank body looked orange-colored. The IC tank was originally covered by white-colored thermal insulators (C) having silver-colored insulator covers (B). On the IC tank south side, the insulator covers were peeled off, exposing the insulators (A). On the IC tank north side, the insulator covers remained intact (B). It should be noted that part of the insulator and their covers had flaked off and remained in the vicinity of the IC tank south side (C).

From these comparisons, it can be understood that: the damaged conditions of insulators and their covers seem to be consistent with Case ① and Case ④, when hydrogen leaks were assumed on Floor 5; while blast velocities may be too big in Case ② and Case ③, when hydrogen leaks were assumed on Floor 5 + Floor 4.

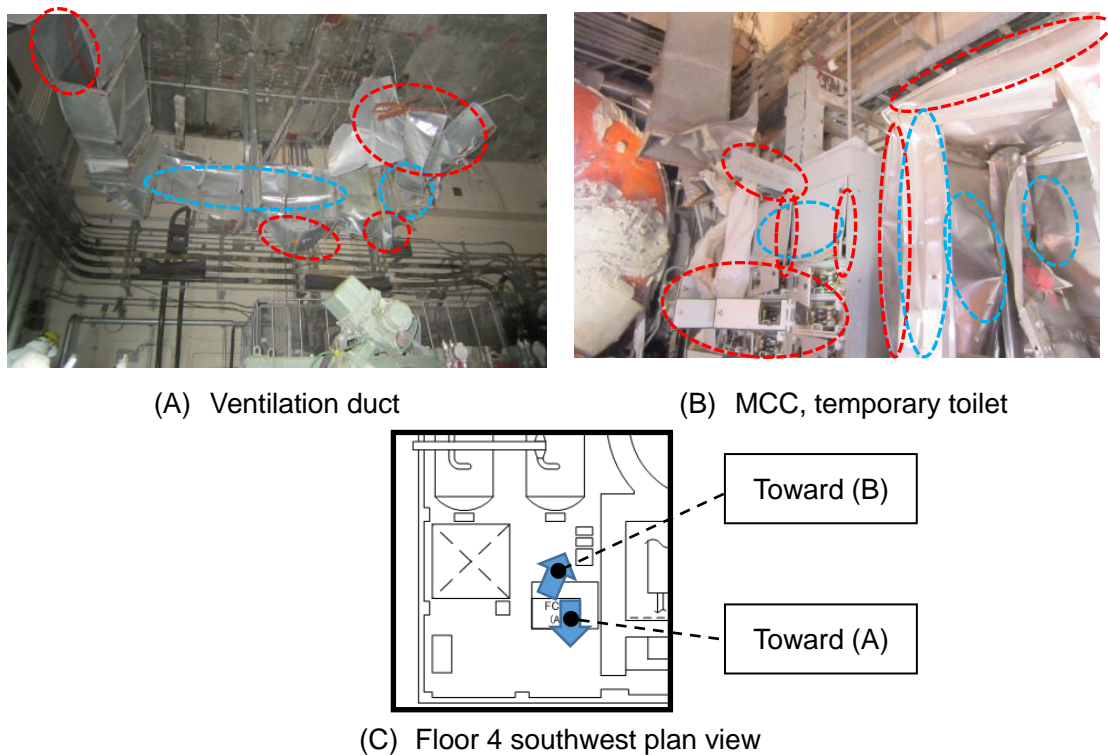
Figure 21 Deformed ventilation duct, MCC and temporary toilet

Damaged conditions of the MCC, temporary toilet and ventilation duct, are shown in Figures 21 (A) and (B). Figure 21 (C) gives the directions in which the camera was pointed. Locations encircled in red in the figure are deformed outward and those encircled in blue are deformed inward.

A similar pressure difference could have been generated in hollow structures of the ventilation ducts, MCC and temporary toilet, and consequently inward and outward deformations as was seen in Figure 21 might have been caused in the course of the R/B pressure increase and decrease. Figure 22 shows the results in Case ① as an example, but the above correlation (pressure difference between inside and outside the ventilation duct) is commonly observed in all cases and none of them is considered inconsistent with the damage conditions.

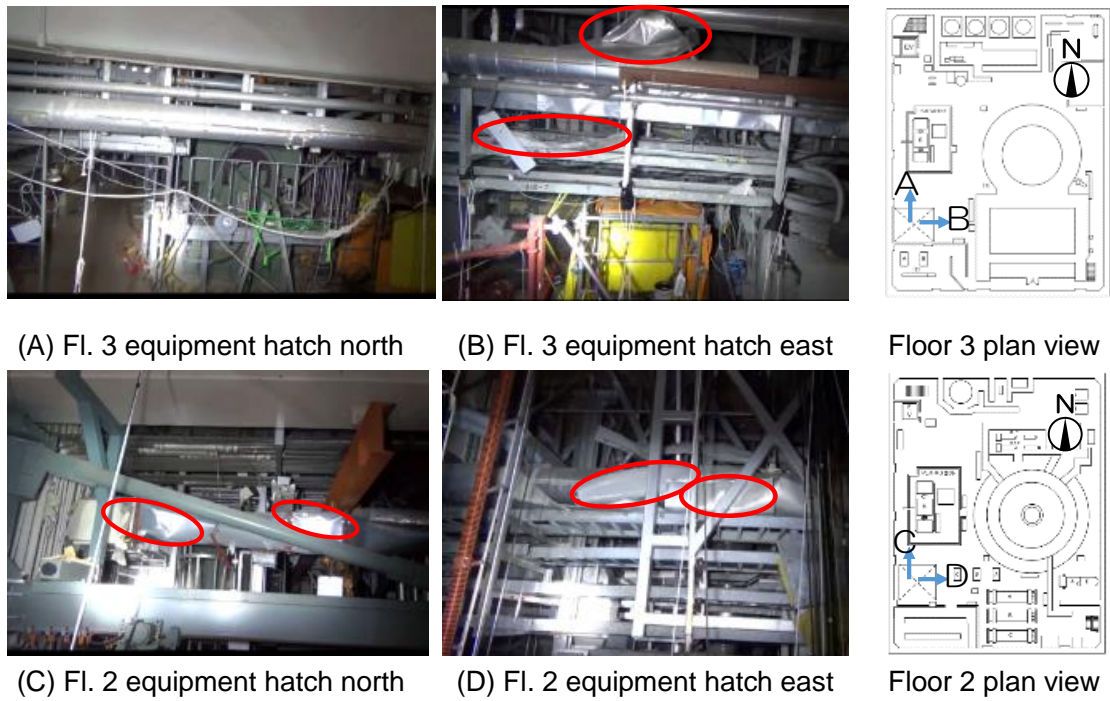
Figure 24 Conditions around equipment hatch on Floor 3 and below

Figure 24 shows conditions around the equipment hatch on Floor 3 and below. Some damage can be noticed (encircled in red) on relatively thin structures. But almost no damage is noticeable on other structures. The damage is less than that on Floor 4 in the west side area discussed in Section 3.2 and no strong blast marks are noticeable.

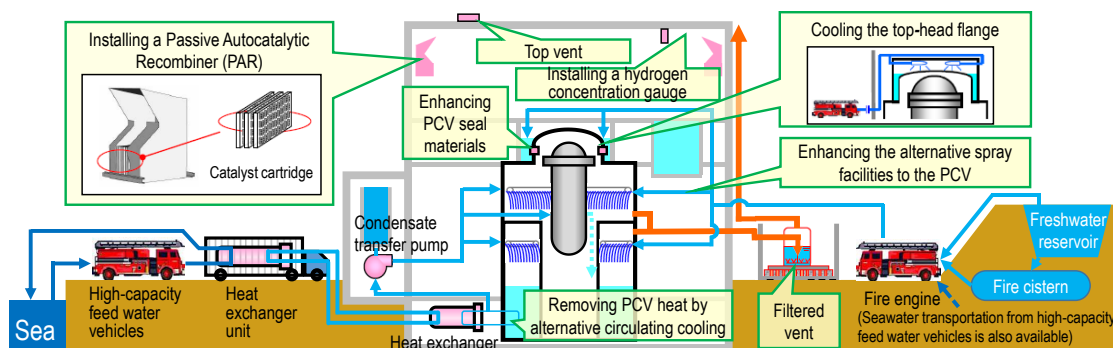
Figure 26 Preventive measures against PCV leaks and hydrogen explosions at Kashiwazaki-Kariwa Nuclear Power Station

The current study reaffirmed the possibility that hydrogen had leaked from the PCV top head flange at Unit-1 of the Fukushima Daiichi Nuclear Power Station. Therefore, it is necessary to take measures to prevent hydrogen leaks from the PCV. Measures are also required to keep hydrogen concentration in the R/B low enough to prevent hydrogen explosions, even when leaks have occurred, including localized accumulations.

As preventive measures against PCV leaks, the following steps will be taken at the Kashiwazaki-Kariwa Nuclear Power Station in order to prevent PCV damage due to overheating and overpressure: strengthening PCV seal materials, strengthening alternative means of PCV spray, implementing top flange cooling, implementing alternative circulation cooling and a filtered vent, etc. It should be noted that pipes penetrating the PCV are designed to be automatically isolated by the isolation valves, as soon as anomalies in accident conditions are detected.

As preventive measures against hydrogen explosions, hydrogen concentration measuring instruments are being installed for early leak detection at locations where leaks can occur (R/B top floor above the PCV top head, and at a small cell for the equipment hatch or airlock). Measures will be taken to control excessive hydrogen leaks to the R/B by depressurizing the PCV through implementation of a filtered vent as soon as a set hydrogen concentration limit is exceeded on the R/B top floor. Further, installation of passive autocatalytic recombiners (PARs) on the R/B top floor, hydrogen discharge from the R/B via the top vent, and other means are being considered. Figure 26 outlines the concept of these measures. Even when hydrogen leaks from the equipment hatch or airlock, hydrogen is led to the top floor via ventilation ducts and others. With these measures, it is estimated the hydrogen concentration in the R/B will not reach the combustion limit.
