Identification of causes of high dose rate observed in the southeast area on the 1st floor of Unit 1 reactor building

1. Introduction

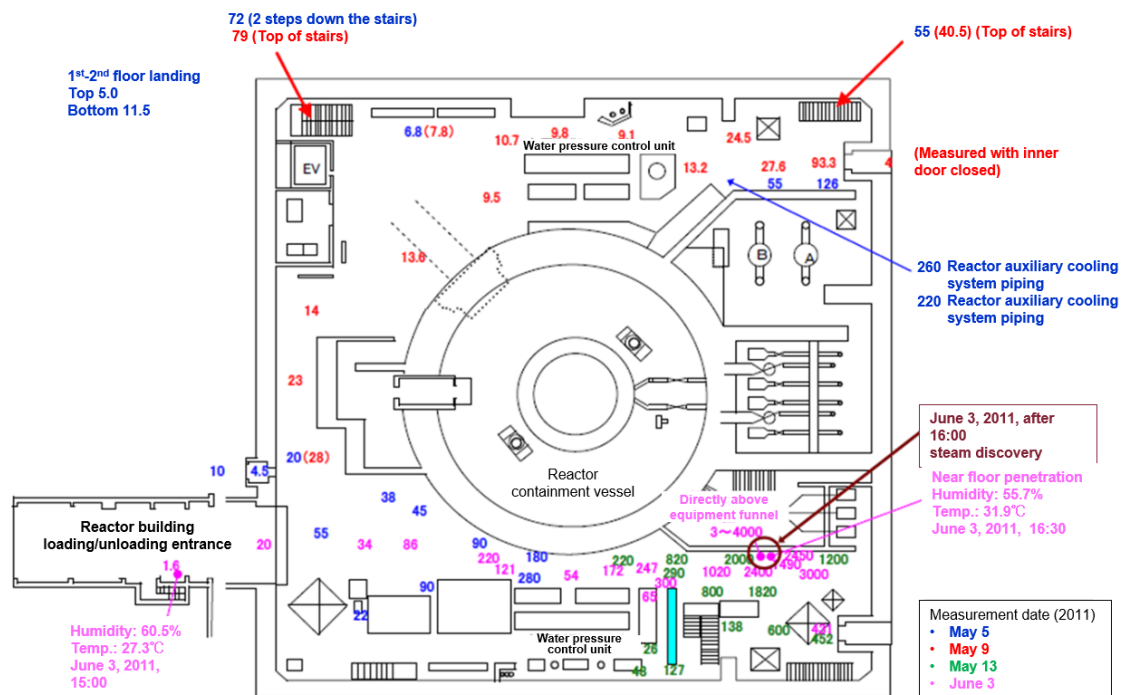
In Unit 1, high dose rate of several thousand mSv/h were observed in the southeast area of the first floor (1st floor) of the reactor building (R/B) in surveys conducted in May, June, and July 2011 and 2012, as shown in Figures 1.1 and 1.2, and the cause is set as Unit-1/Issue-8 in this report.

Figure 1.1 Air dose rate on the 1st floor of Unit 1 R/B (May-June 2011) [1]

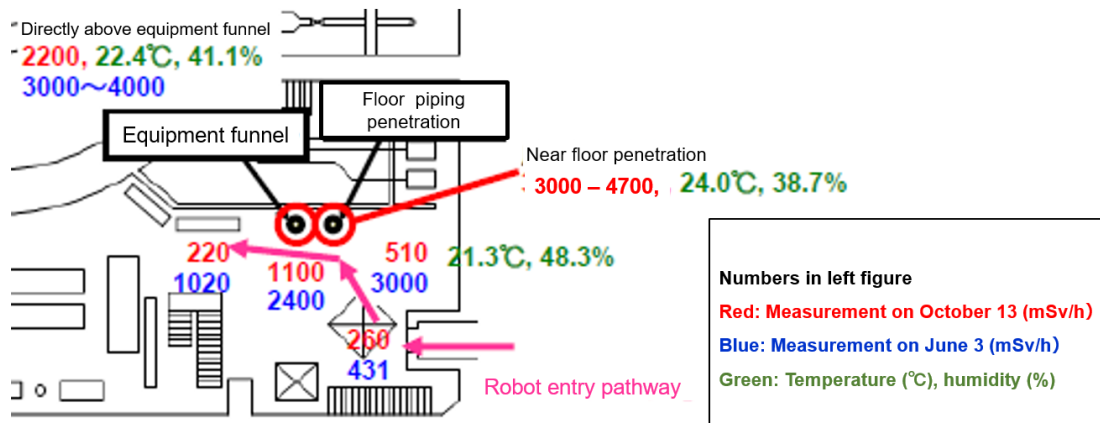
Figure 1.2 Air dose rate in the southeast area of the 1st floor of Unit 1 R/B (July 2012) [2]

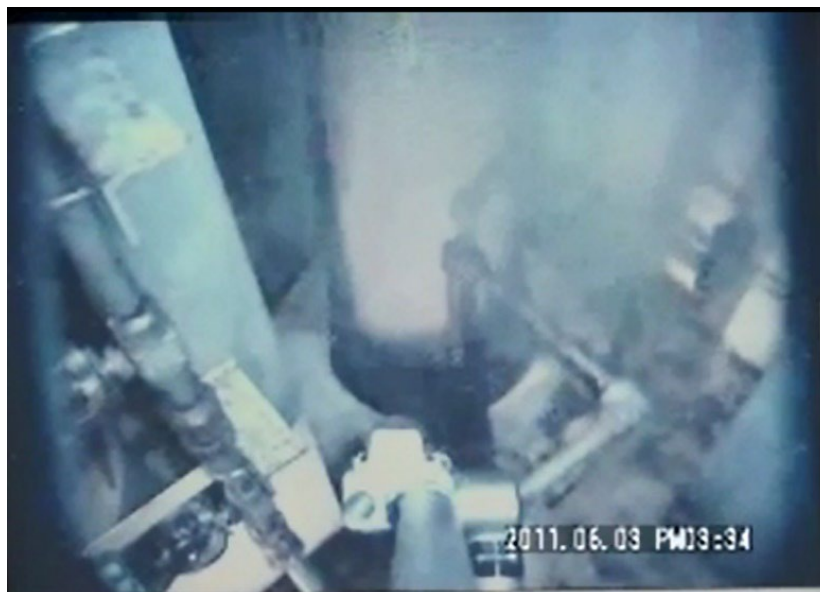
As shown in Figure 1.3, a survey conducted in June 2011 confirmed that steam was leaking from the floor penetration in the southeast area. In addition, inert gas system (AC) piping used for the containment vessel (PCV) venting is laid in the vicinity of the southeast area, and this examination focused on these and other possible causes of the high dose rate observed in the southeast area.

Figure 1.3 Steam observed at the southeast floor penetration of the 1st floor of Unit 1 R/B (June 2011) [3]

During a survey on June 3, 2011, it was confirmed that steam was leaking from the torus room through the floor penetration in the southeast area. The same area was also surveyed on May 13, 2011, but no outflow of steam was confirmed at that time. There are two possible sources of the steam: (i) stagnant water in the torus room and (ii) stagnant water in the PCV.

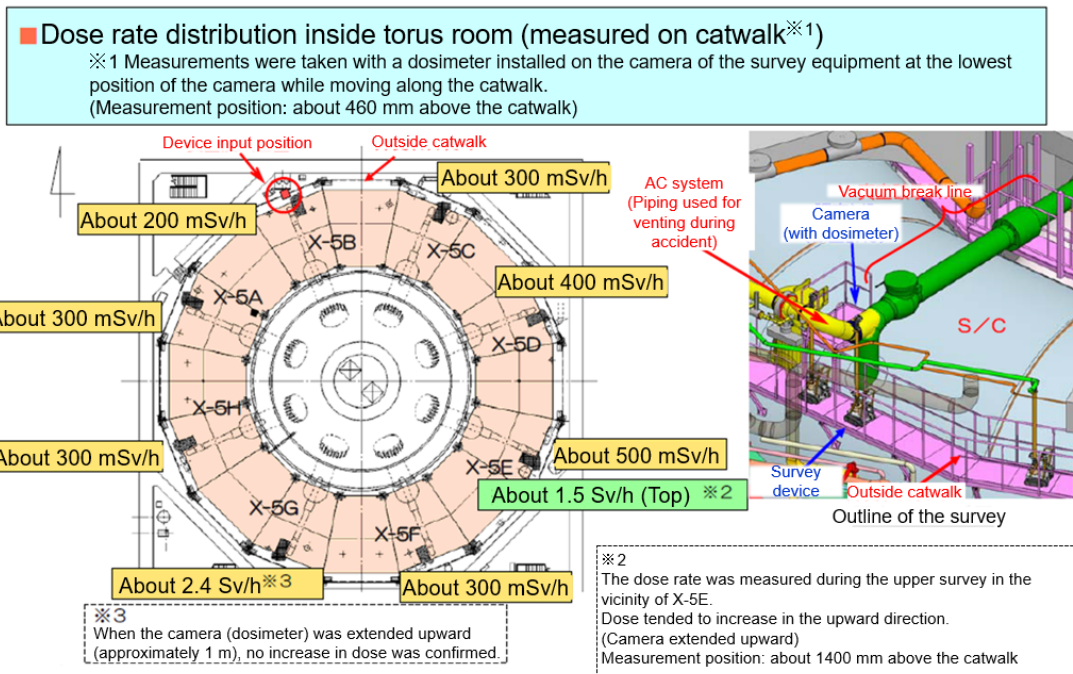
Figure 2.3 Air dose rate in the torus room on the basement floor of Unit 1 R/B (May 30, 2014) [5]

The distribution of air dose rate in the torus room is shown in Figure 2.3, and dose rate of several hundred to 2400 mSv/h have been observed on the catwalks. However, the effect of radiation from the contamination source inside the torus room is sufficiently attenuated in the southeast area of the 1st floor due to the shielding of the torus room ceiling concrete (650 mm thick), so the effect on the high dose rate observed in the southeast area of the 1st floor is considered small.

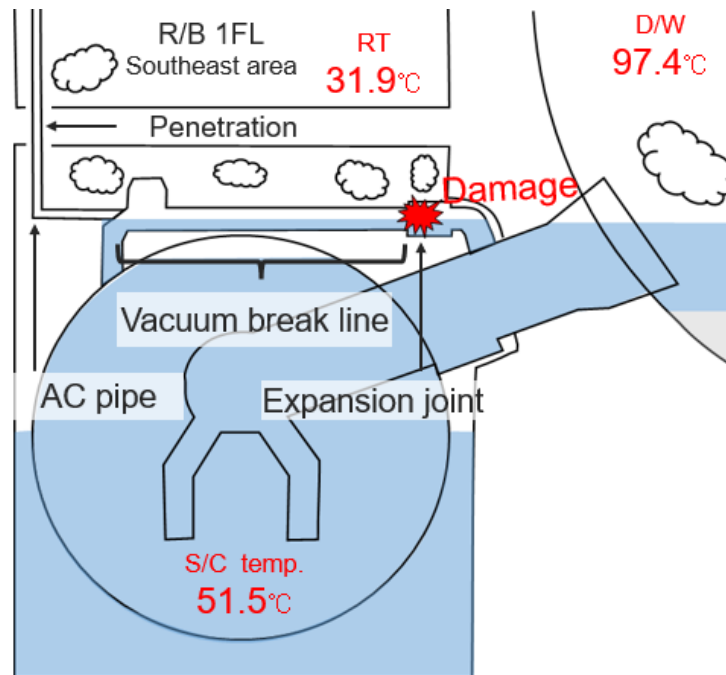
The damaged part of the vacuum break line expansion joint is located above the X-5E vent piping in the southeast area of the torus room, almost directly below the 1st floor penetration where the steam was leaking, which is consistent with the fact that no steam was confirmed from other floor penetrations. At the time of the steam discovery date (June 3, 2011), decay heat was still high, and the D/W ambient temperature was 97.4 °C, as shown in Figure 3.1.1. Therefore, it is considered that the water in the PCV was evaporating due to the heat source of the fuel that migrated to the bottom of the D/W. The RPV water injection rate at the time of the steam discovery was 5 m<sup>3</sup>/h, and the RPV water injection rate on May 13, 2011, when no steam was observed from the AC piping penetration, was 8 m<sup>3</sup>/h. Therefore, it is possible that the PCV water level dropped as the water injection rate decreased, causing the gas phase to leak from the damaged expansion joint of the vacuum break line, resulting in the steam outflow.

Based on the above, it is highly likely that the steam observed in the southeast area of the 1st floor was generated from high-temperature stagnant water in the PCV and flowed out of the PCV from the damaged expansion joint of the vacuum break line located southeast of the torus room, passing through the floor penetration and into the southeast area of the R/B 1st floor.

Figure 3.1.1 Temperatures around the torus room on the day the steam was discovered and the estimated path of the steam (June 2011) [1]

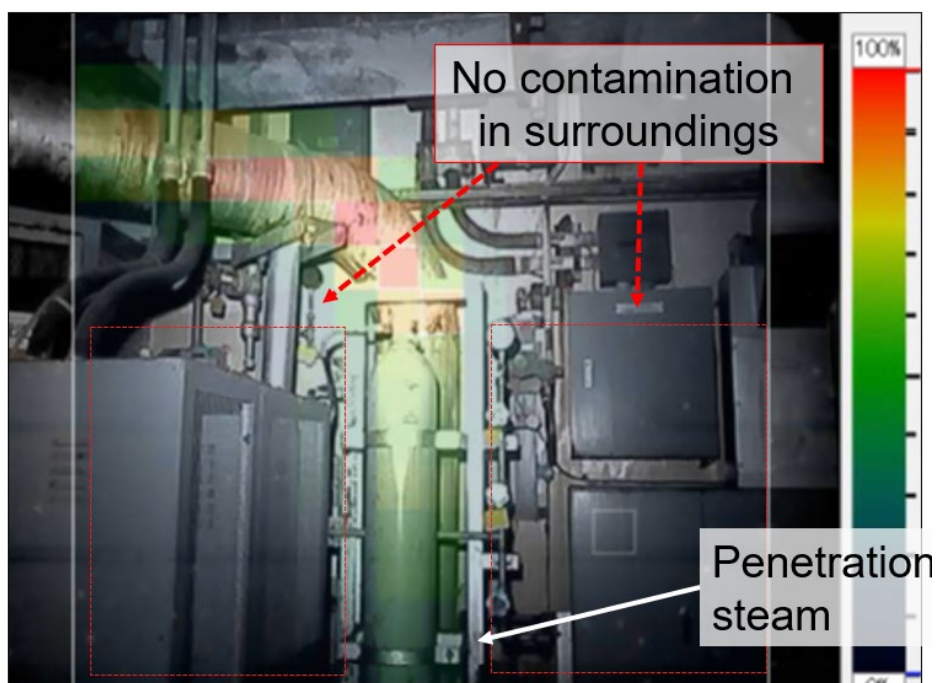
Figure 3.1.2 shows a gamma camera photo of the floor penetration in the southeast area of the 1st floor where the steam was outflowing. The piping where the high dose rate is confirmed in the center of the photo is AC piping. Contamination of AC piping is discussed in Section 3.2. If steam is the contamination source, there should be conspicuous contamination in the passages of steam, including AC piping penetrations, and in surrounding structures where steam would have adhered. However, from the gamma camera photo, it was found that the contamination along the AC piping was predominant, and no contamination comparable to that of the AC piping could be confirmed in the penetration and surrounding structures.

Figure 3.1.2 Gamma camera photo of the floor penetration in the southeast area of the 1st floor (partially modified from [6])

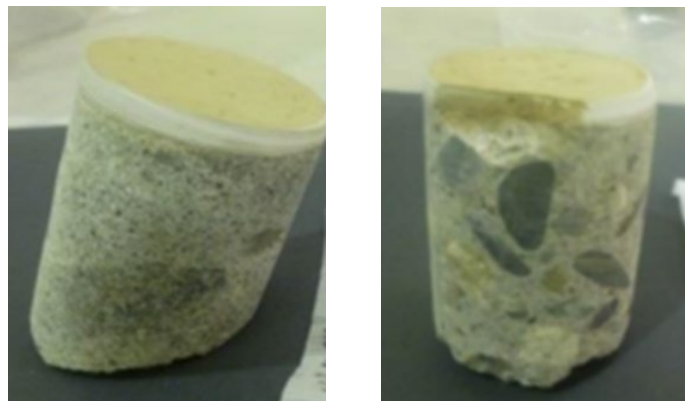
Figure 3.1.3 shows the floor sampling locations in the southeast area on the 1st floor, and Figure 3.1.4 shows the floor samples collected. Table 3.1.1 lists the surface dose rate measurement results for floor samples. Sample A was collected near the X-6 penetration and had a surface dose rate of 0.14 mSv/h, with no water marks on the surface. Sample B was collected near the AC piping penetration where the steam flowed out, and had a surface dose rate of 0.38 mSv/h, with water marks on the surface. The measured surface dose rate of sample B was

2.7 times higher than that of sample A, but it is not a significant enough value to cause the air dose rate of several 1000 mSv/h observed in the southeast area. In addition, the air dose rate in the southeast area measured in December 2013 shown in Figure 3.1.5 is characterized by being higher at 150 cm above the floor than at 5 cm above the floor. Given that floor contamination is the dominant contamination source in the southeast area, this cannot be considered to be the dominant contamination source because it is inconsistent with the contamination characteristics of this area.

Figure 3.1.4 Floor samples collected in the southeast area of the 1st floor [7]  
 (left, Sample A; right, Sample B)

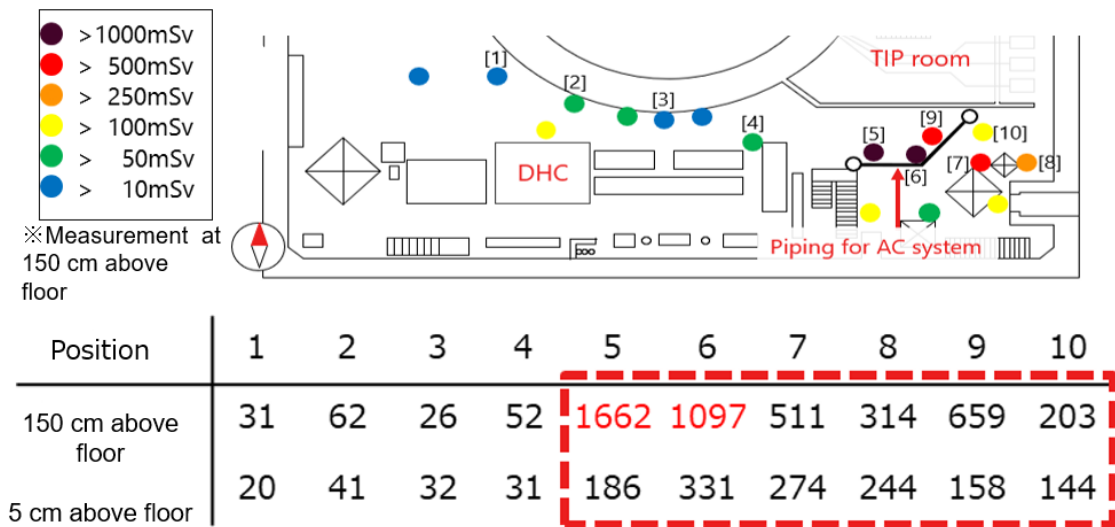
Figure 3.1.5 Air dose rate (December 2013) on the south side of the 1st floor (partially modified from [6])

A contamination survey was conducted in December 2013 around the southeast area of the 1st floor where the AC piping is laid, as shown in Figure 3.1.5. Figure 3.2.1 shows the gamma camera measurement locations in the southeast area of the 1st floor, and Figures 3.2.2 and 3.2.3 show gamma camera photos of this area. According to the gamma camera measurement survey, the air dose rate due to the AC piping at 150 cm above the floor was estimated to be approximately 900 mSv/h, which is generally consistent with the air dose rate in the southeast area of the 1st floor. In addition, the AC piping used for venting was laid so that it rises from the 1st floor penetration where the steam was outflowed, passes 200 cm above the floor in the southeast area of the 1st floor parallel to the floor surface, and exits to the 2nd floor. Therefore, the air dose rate on the upper side of the 1st floor is expected to be higher, which is consistent with the characteristic that the air dose rate at 150 cm

above the floor is higher than that at 5 cm above the floor shown in Figure 3.1.5.

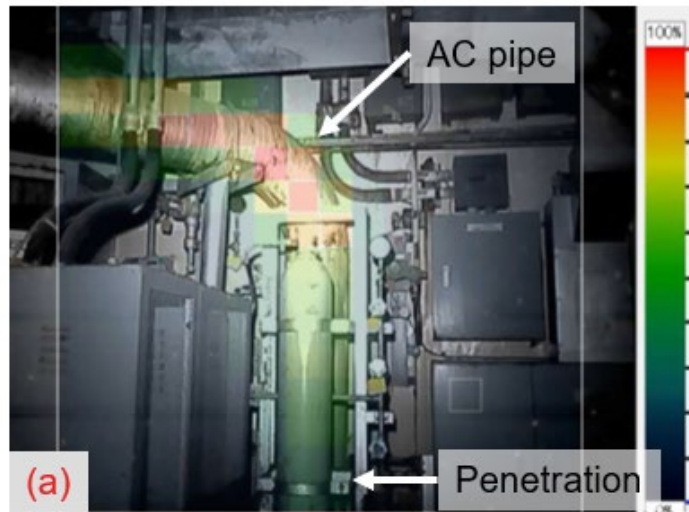
From the gamma camera photos in Figures 3.2.2 and 3.2.3, no dominant contamination sources can be seen on the floor, walls, or structures in the southeast area, and only contamination along the AC piping can be seen. Therefore, there is no possibility that radioactive materials that passed through the piping leaked from the AC piping in the southeast area, and it is considered that the contamination is still inside the piping.

Figure 3.2.2 Gamma camera photo of the southeast area of the 1st floor (1) (December 2013) [6]

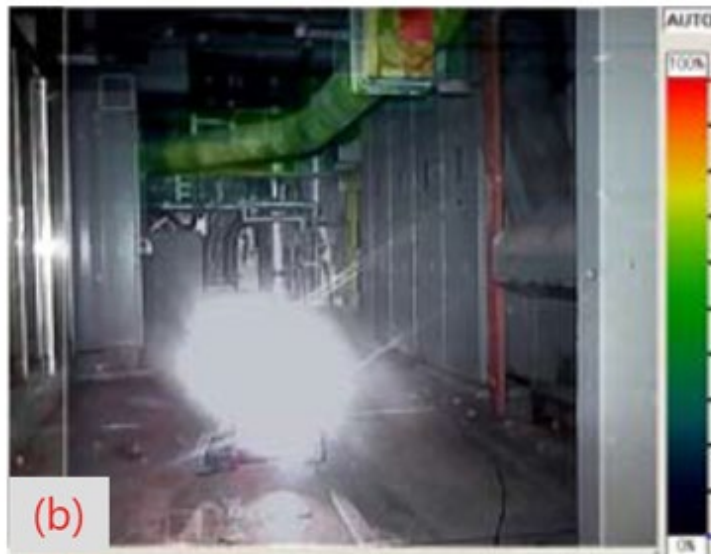
Figure 3.2.3 Gamma camera photo of the southeast area of the 1st floor (2) (December 2013) [6]

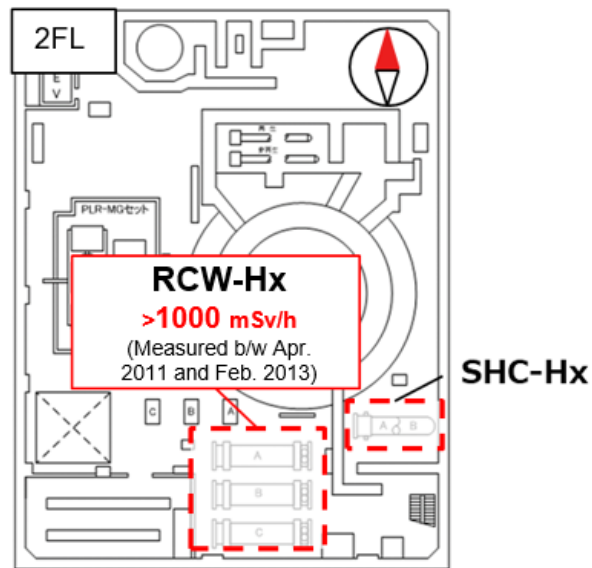
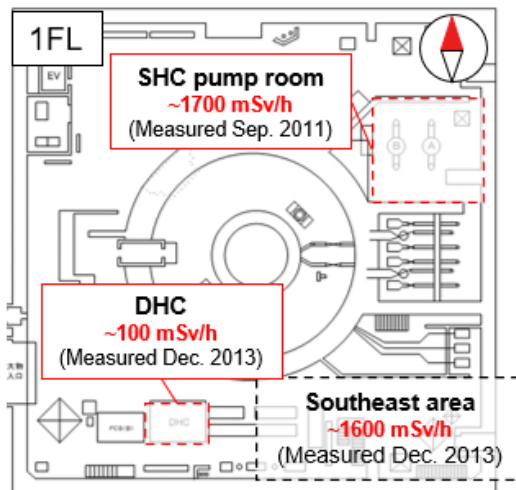
Figure 3.3.1 shows the RCW loads and respective dose rate on the 1st and 2nd floors of the R/B. The RCW load around the southeast area on the 1st floor is the drywell humidity control system (DHC), and dose rate of about 100 mSv/h have been observed around it, but they are not enough to be a dominant factor in the southeast area. On the other hand, high air dose rate equivalent to the air dose rate in the southeast area (about 1600 mSv/h) are observed around the heat exchanger (RCW-Hx) on the 2nd floor (over 1000 mSv/h) and in the shutdown cooling system (SHC) pump room on the 1st floor (about 1700 mSv/h). Therefore, the dose rate contribution from the contamination sources in the RCW-Hx and SHC pump room to the southeast area was discussed.

The concrete thickness of the R/B 2nd floor concrete is 600 mm, which indicates that the radiation from the 2nd floor RCW-Hx is sufficiently attenuated in the southeast area. The concrete thickness from the SHC pump room to the southeast area is shown in Figure 3.3.2, and it is clear that the radiation from the contamination source in the SHC pump room is sufficiently shielded by the frame.

Figure 3.3.1 Load and nearby dose rate of RCW systems in the vicinity of the southeast area [4][6]

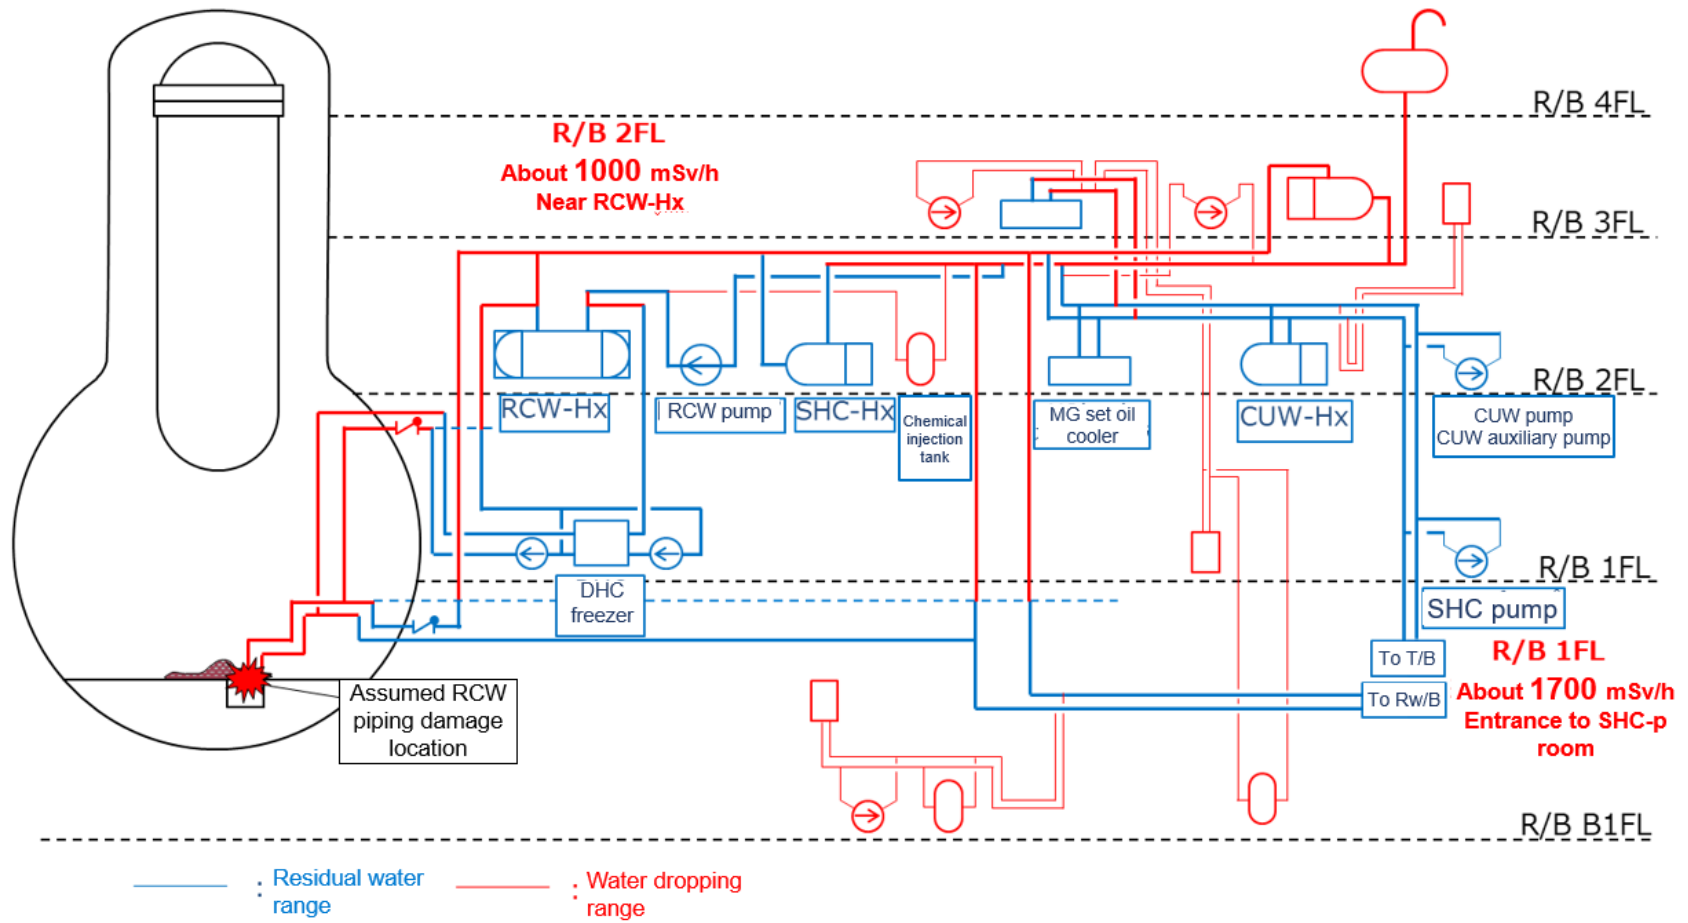
The RCW is a closed-loop system, and system water is supplied to each device from the main piping that passes through the upper part of each floor. No damage has been confirmed to date in the R/B. If the RCW system water spills only from the damaged point in the PCV, the system water in the main piping will drain, but the system water will remain in the piping of each device. Figure 3.3.3 shows the assumed residual water situation in this case. Around the southeast area of the 1st floor, it is considered that the system water remains in the DHC on the 1st floor, and in the RCW-Hx and SHC-Hx on the 2nd floor. If residual high-dose

system water leaked and flowed into the southeast area, it could cause a high dose rate in the southeast area; therefore, it is necessary to examine whether there is leakage to the southeast area.

Figure 3.3.3 Residual water in RCW system assumed if water drops only from the damaged area in the PCV

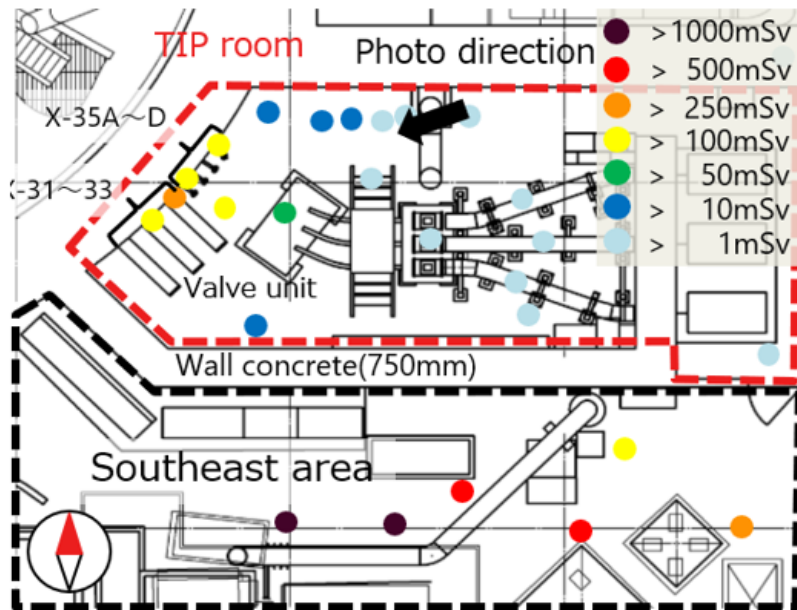
The maximum air dose rate inside the TIP room is about 300 mSv/h (October 2015). On the other hand, the air dose rate in the southeast area is more than 1000 mSv/h, even when converted from the measured value in December 2013 to the air dose rate in October 2015, considering the half-life, and the dose rate in the TIP room is lower than that in the southeast area; therefore, the TIP room is not considered the dominant contamination source of the southeast area. Furthermore, the thickness of the frame concrete between the TIP room and the southeast area is 750 mm, indicating that the effect of radiation from the TIP room is sufficiently attenuated in the southeast area. Therefore, the effect of radiation from the TIP room is considered negligible.

Figure 3.4.1 Air dose rate in the TIP room (September 2015) and in the southeast area (December 2013) (Modified from reference [6][8])

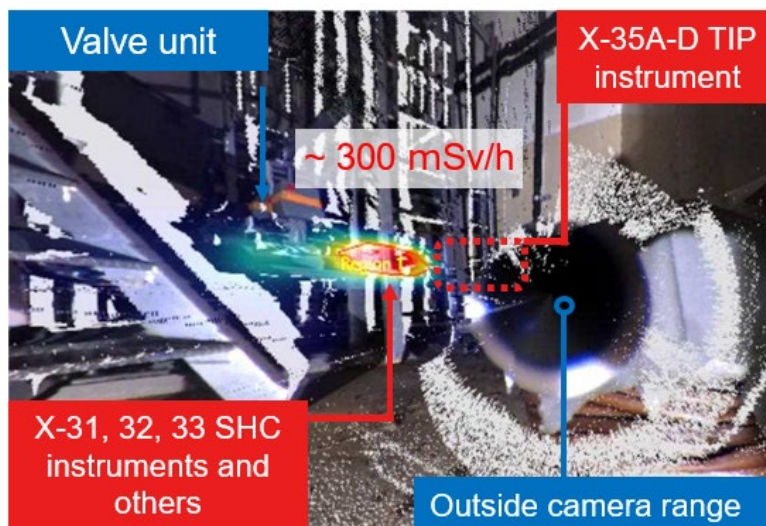
The air dose rate in the TIP room obtained during the Unit 1 TIP room survey from September 24, 2015, to October 2, 2015 are shown in Figure 3.4.1 and a gamma camera photo around the PCV penetration is shown in Figure 3.4.2. The TIP instrumentation penetrations (X-35A~D), which were initially feared to be contaminated, were not found to be contaminated, but the adjacent X-31 penetration was found to be contaminated at approximately 300 mSv/h. The main steam instrumentation and SHC instrumentation is installed in the X-31 penetration, but it is unclear which instruments are contaminated.

Figure 3.4.2 Gamma camera photo of the TIP room (partially modified from reference [8])

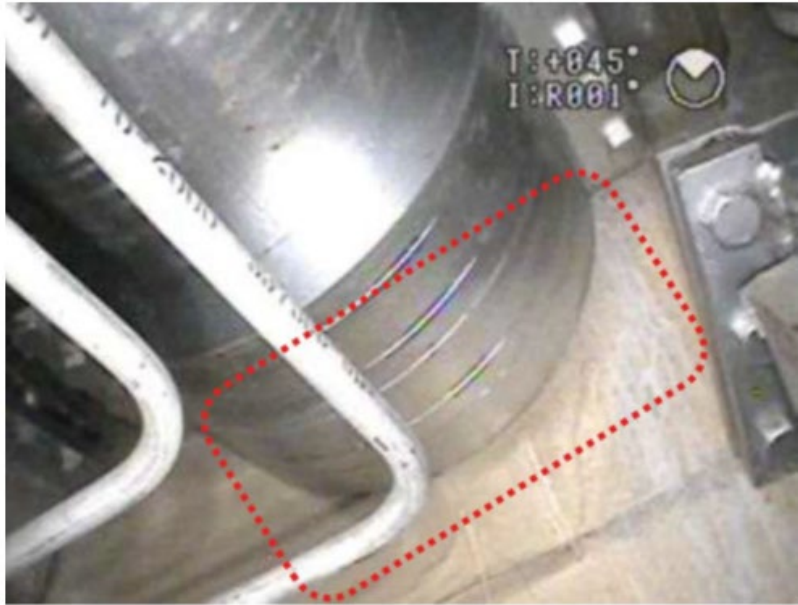
Figure 3.4.3 shows an image of the X-31 penetration and Figure 3.4.4 shows an image of the X-35 penetration. No leakage traces can be seen in the X-31 penetration, which is confirmed by the gamma camera to be contaminated. On the other hand, although brown marks can be seen in the lower part of the X-35A penetration, the gamma camera confirmed no contamination. In addition, Figure 3.4.1 shows that the air dose rate in the TIP room decreases on moving away from the X-31 penetration, suggesting that the contamination of the X-31 penetration was confined to the penetration area and that there was no migration of radioactive materials into the TIP room.

Figure 3.4.3 Image of X-31 penetration [8]

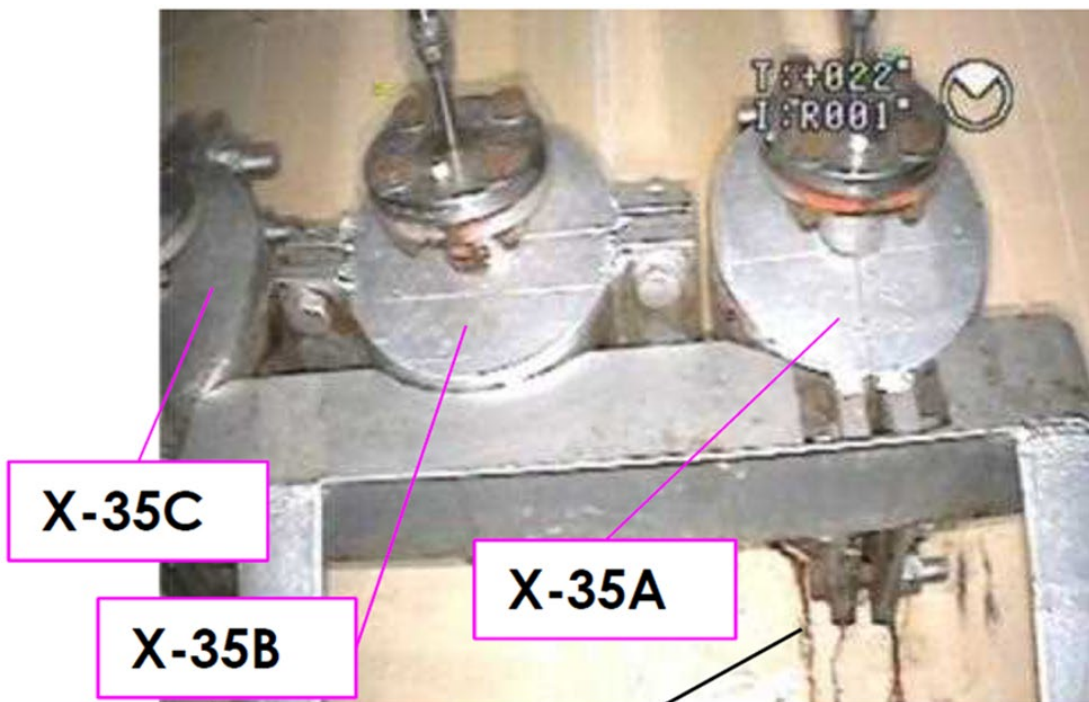
There is a brown mark only on the lower part of X-35A

Figure 3.4.4 Image of X-35 penetration [8]
