Estimation of the reasons for high dose rate not being observed in Unit 2 reactor building cooling water system

■ 1. Introduction

On the other hand, in the air dose rate survey for Unit 2, high dose rate was not observed around the RCW system in R/B and Rw/B as in Unit 1. The cause of this difference is discussed.

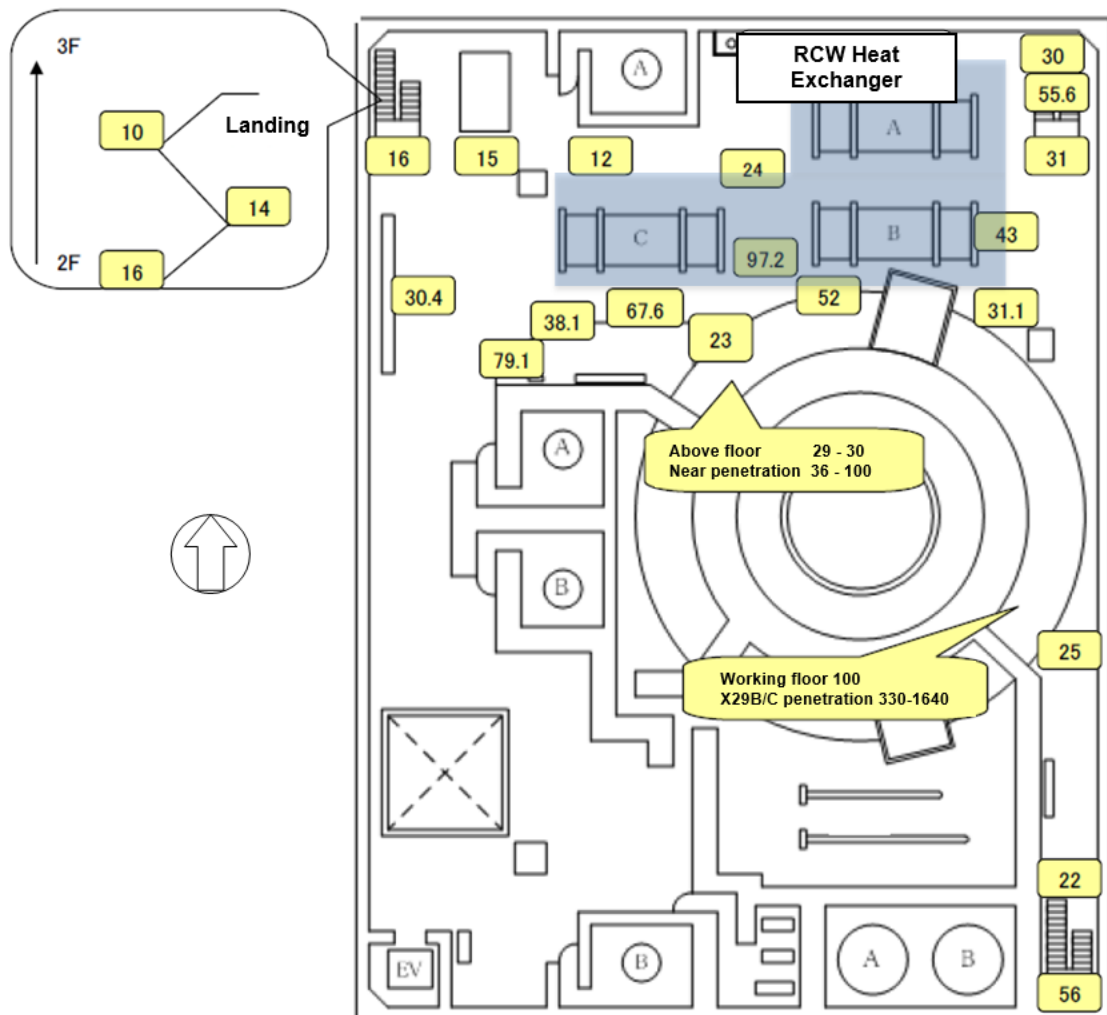
Figures 1 to 4 show the air dose rate measurement results for Unit 2 R/B 2nd to 4th floors and Rw/B 1st floor announced by TEPCO. Although dose rate was not necessarily measured at the same time in Units 1 and 2, the figures indicate that high dose rate tended to be observed around the equipment loaded in the RCW system of the Unit 1 R/B, as described in Attachment 1-9, while this high dose rate tendency was not observed around the same

In addition, for the purpose of contrasting the contamination situation in the Unit 1 RCW system equipment listed in Attachment 1-9, Table 1 summarizes the air dose rate around the RCW heat exchangers, the drywell dehumidification system (DHC) equipment, recirculation system (PLR), the MG set oil coolers, the RCW surge tank, and the recirculation coolers for waste collection filters. Although it is not appropriate to simply compare the same equipment between Units 1 and 2 because the locations of each piece of equipment in the buildings differ between Units 1 and 2 and the piping routings are also different, it can be seen, for example, that the dose rate for the RCW heat exchanger installed on the same 2nd floor was lower in Unit 2 than in Unit 1.

Figure 1 Air dose rate at the 2nd floor of Unit 2 R/B (unit: mSv/h) [1]

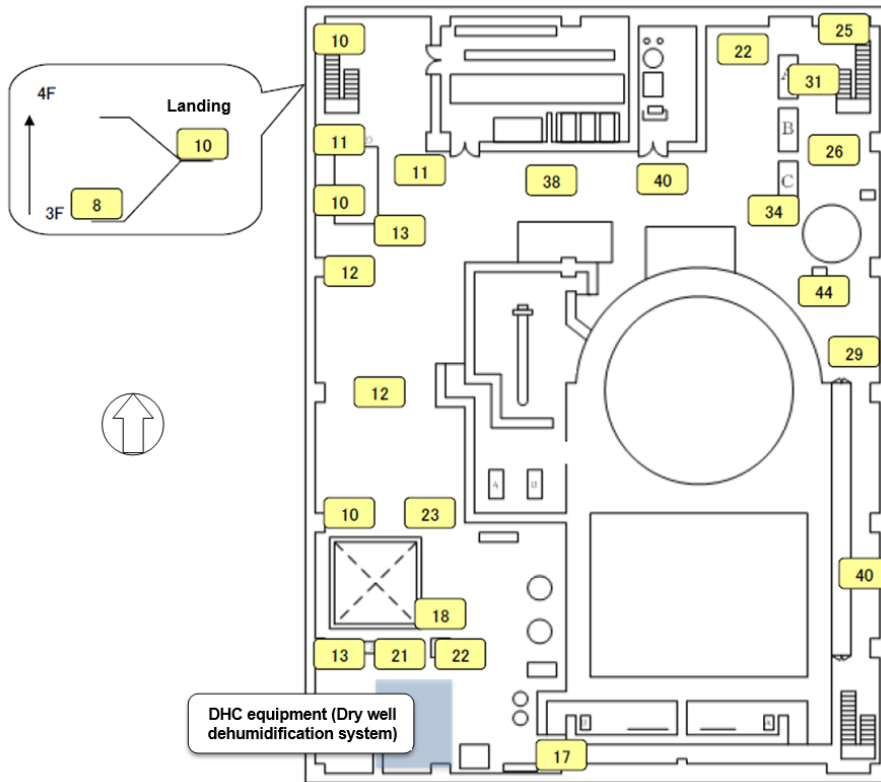
Figure 2 Air dose rate at the 3rd floor of Unit 2 R/B (unit: mSv/h) [1]

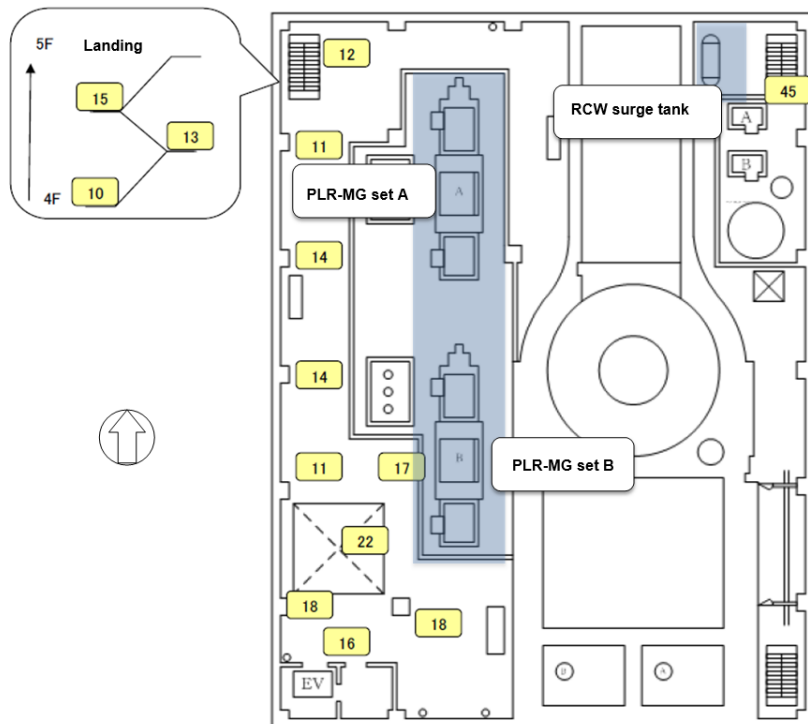
Figure 3 Air dose rate at the 4th floor of Unit 2 R/B (unit: mSv/h) [1]

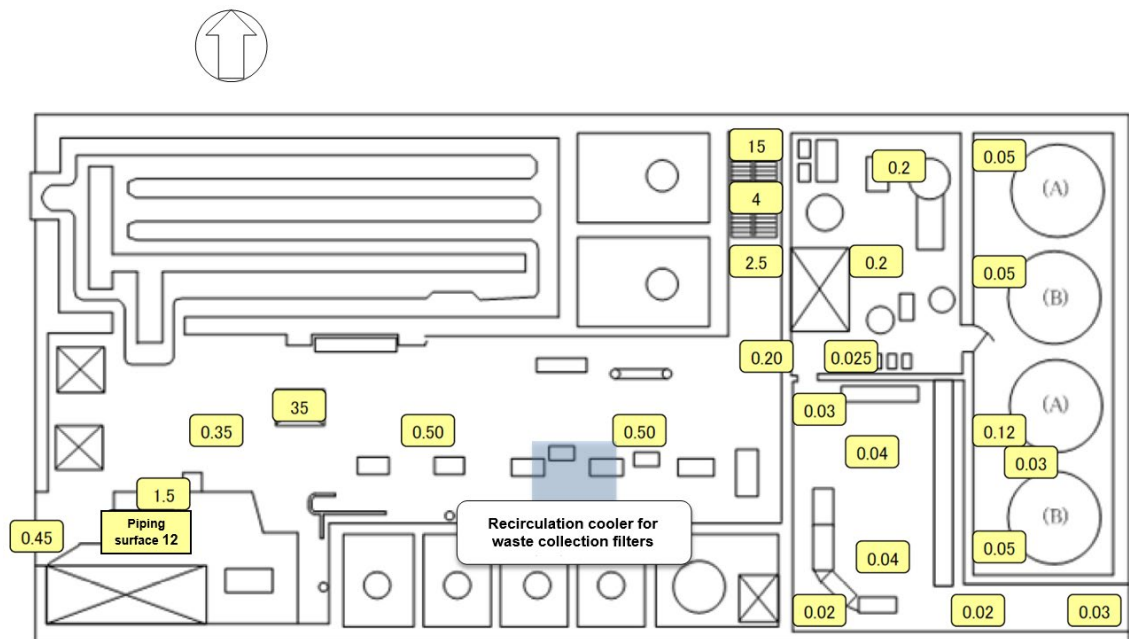
Fig. 4 Air dose rate at the 1st floor of Rw/B, Unit 2 (unit: mSv/h) [1]

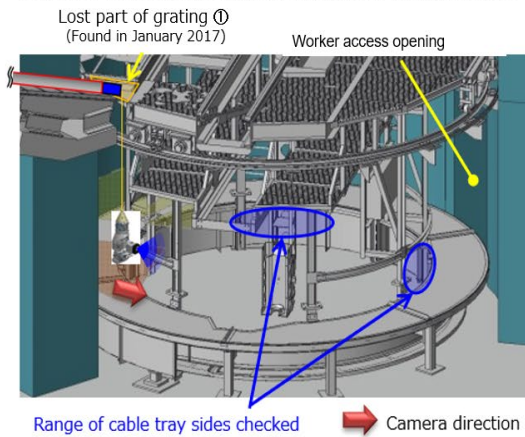
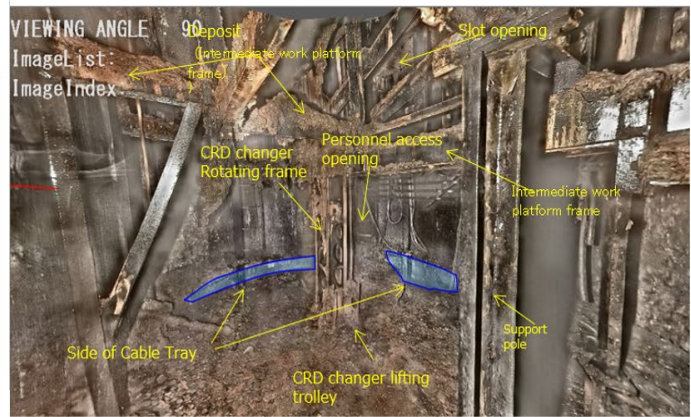
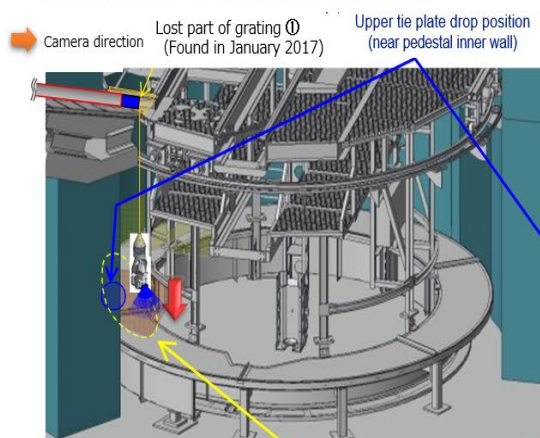
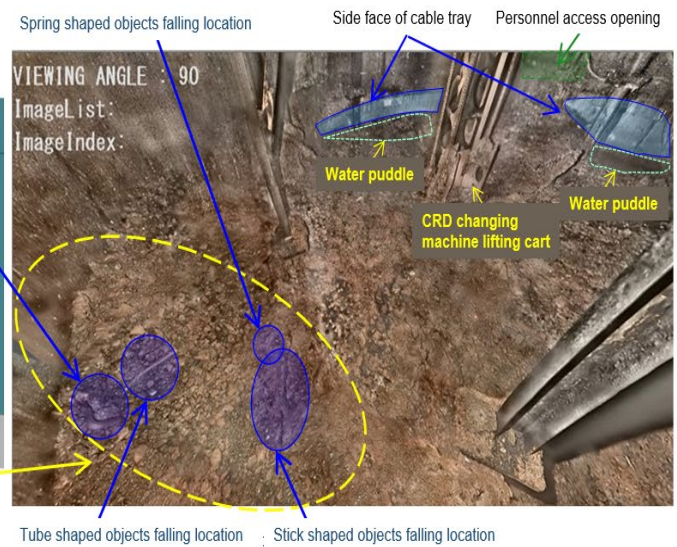
Figure 5 Unit 2, bottom of pedestal (part 1) [2]

The images obtained from the survey showed that sediments were spread over the entire bottom of the pedestal (Figure 5). In addition, as shown in Figure 6, the upper tie plate of the fuel assembly can be seen as having fallen to the pedestal floor. Assuming that the fuel debris also fell through the hole in the RPV through which the upper tie plate fell, the deposits near the upper tie plate that fell to the pedestal floor are considered to contain fuel debris. Although the height of the deposits varies depending on the location, the deposits including fuel debris are spread over the entire pedestal floor, and thus the deposits are considered to have fallen and accumulated in a somewhat fluid state.

State of structures and distribution of sediments

Detailed state of sediment distribution

Areas with relatively high sediment heights
(Near directly below the platform grating lost part ①)

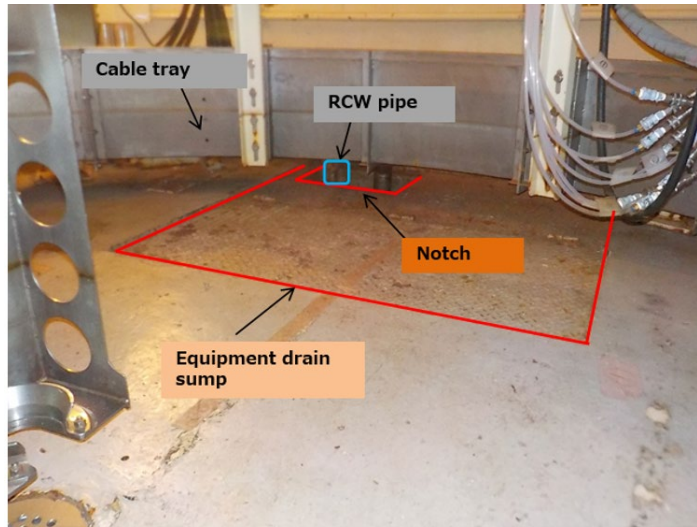
Figure 7 Unit 5 equipment drain sump area (similar structure in Unit 2)

The RCW piping in the D/W of Unit 2 is routed from outside the pedestal into the pedestal through the worker access opening of the pedestal. The RCW piping is routed along the inner wall side of the pedestal at a height of about 40 to 50cm above the floor, and then led into the equipment drain sump. Figure 7 shows the area around the equipment drain sump in Unit 5. Unit 2 has a similar structure. It can be seen that the RCW piping is leading into the equipment drain sump.

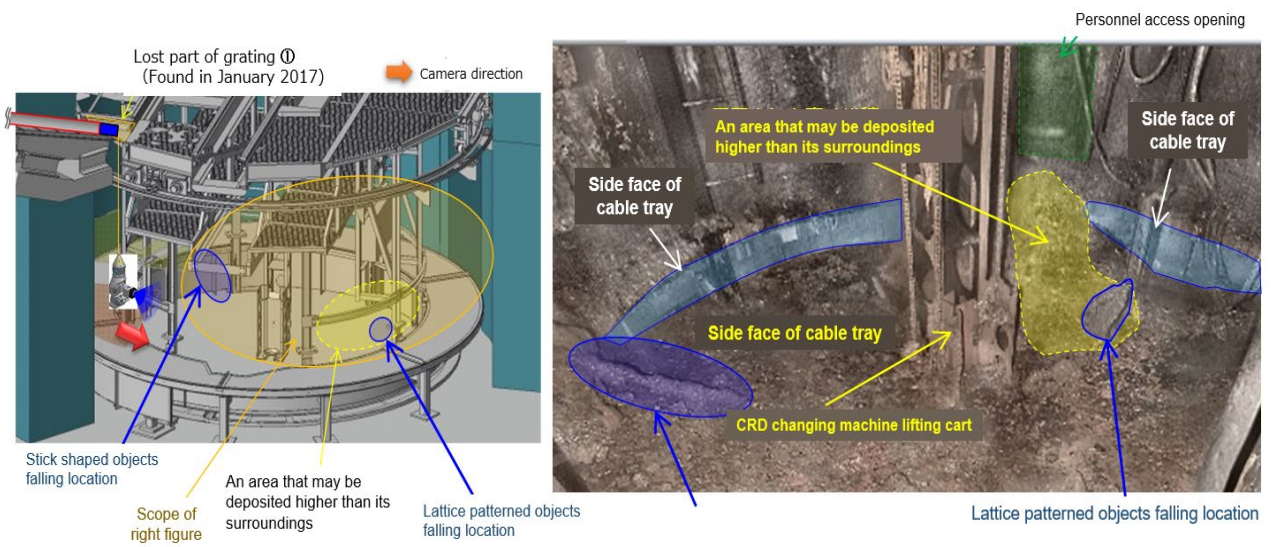
Figure 8 Unit 2, bottom of the pedestal (part 3) [2]

As shown in Figure 8, the area near the worker access opening is an area where sediments may have accumulated higher than the surrounding area (there is a damaged opening of the RPV directly above and sediments including fuel debris may have fallen from above). The top of the cable tray is approximately 70cm high, and sediments appear to be deposited above it as well, which suggests that it is higher than the approximately 40-50cm height of the CRD changer lifting cart buried near the center of the pedestal. Therefore, it is quite possible that the RCW piping is in contact with sediments including fuel debris deposited at the bottom of the pedestal.

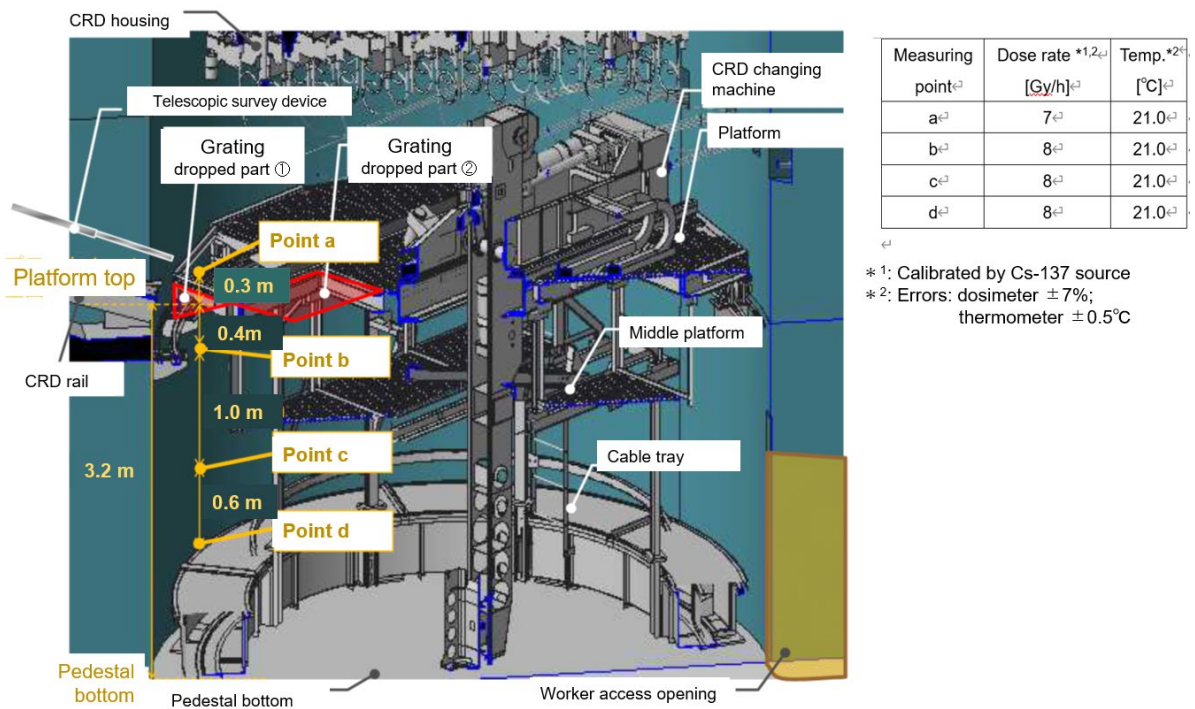
Figure 9 Unit 2, dose rate and temperature measured during investigation inside PCV [2]

The air dose rate and temperature in the lower part of the pedestal were also measured during the containment interior survey in January 2018, and there was almost no change in the dose and temperature conditions when approaching the pedestal floor from the platform (air dose rate, 7-8 Gy/h; temperature, 21.0 °C, which were almost constant regardless of the location in the height direction (Figure 9). In other words, the contribution of the radiation dose from the sediments including the fuel debris that fell on the pedestal floor and the contribution as a heat source are not considered to be large at present.

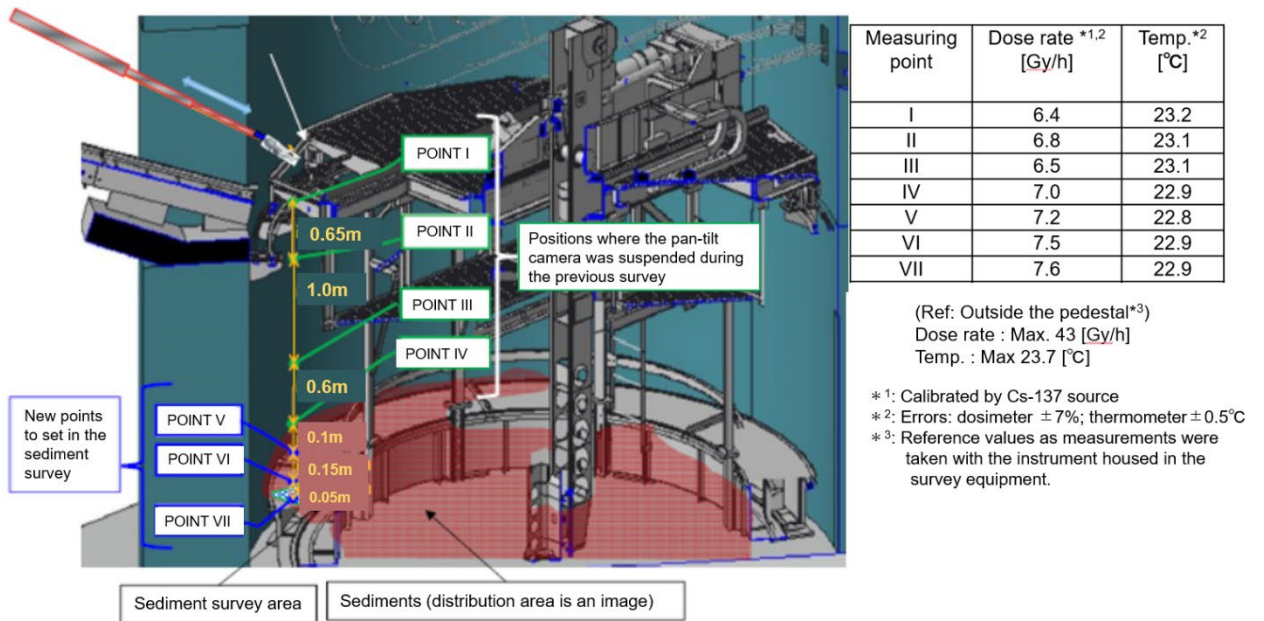
Figure 10 Unit 2, dose rate and temperature measured during investigation inside PCV [3]

Similarly, dose rate and temperatures in the height direction in the lower part of the pedestal were measured during the February 2019 PCV interior survey, and while there were a slight increase in air dose rate as the floor surface was approached and a slight decrease in temperature, the changes were generally not significant (Figure 10). Together with the fact that there was no noticeable damage to the structure below the pedestal, it is possible that the fuel debris on the pedestal floor is metal-rich with a relatively small dose and decay heat.

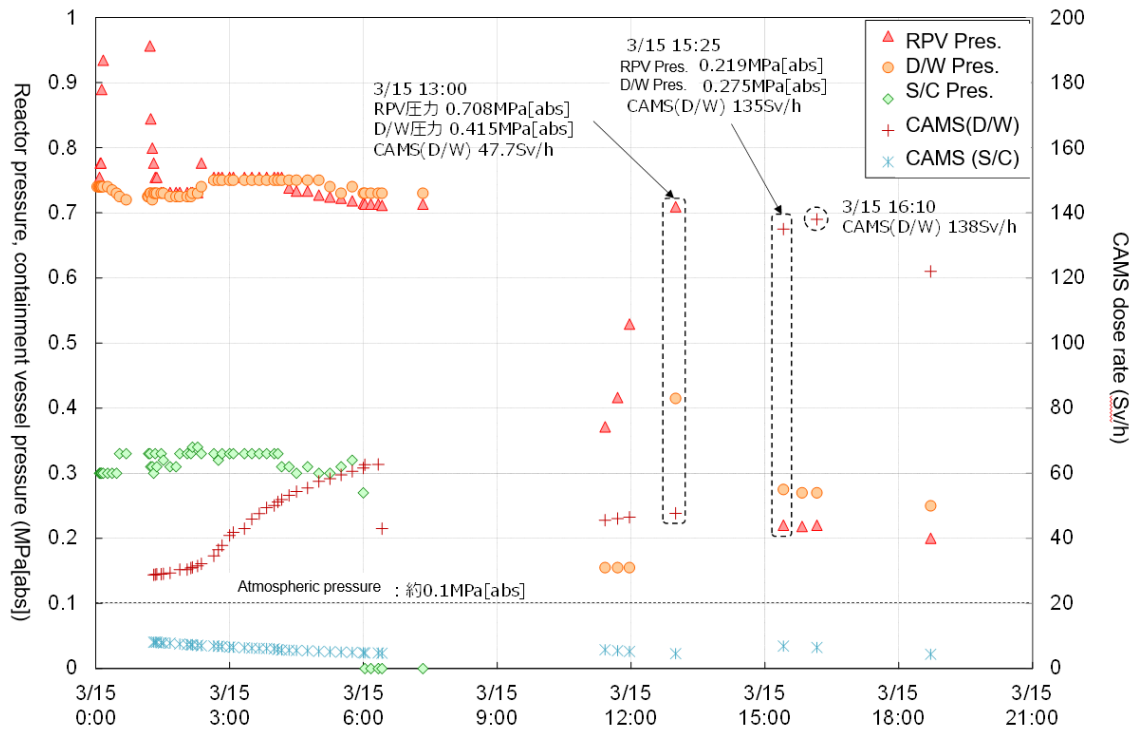
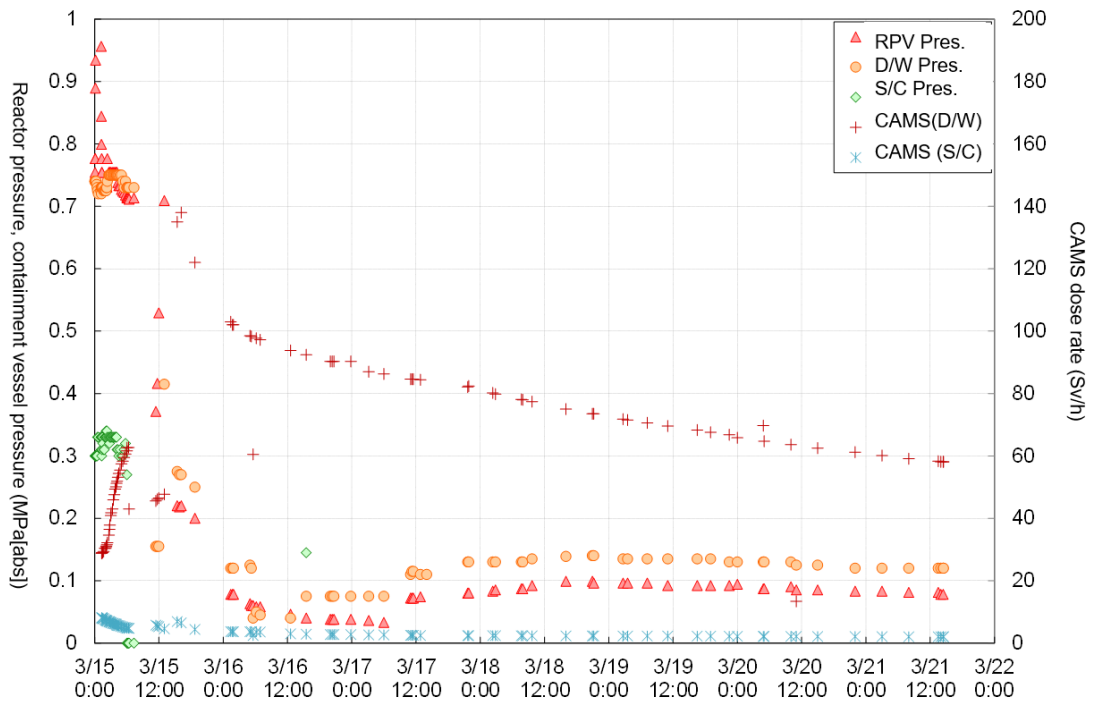
Then, Figure 11 shows the measured dose rate from the RPV pressure and PCV pressure and the containment atmosphere monitoring system (CAMS) in Unit 2. During the accident, the maximum value of D/W CAMS among those measured was 138Sv/h at 16:10 on March 15, indicating that the dose rate increased rapidly between 13:00 and 15:25 on March 15. As detailed in Attachment 2-11, this increase in dose rate may have been caused by damage to the bottom of the RPV. In terms of pressure changes, there was a large pressure difference of about 0.3MPa between the RPV pressure and the D/W pressure at 13:00 on March 15, but both pressures equalized at 15:25 (the RPV pressure was lower than the D/W pressure because of the high temperature in the D/W due to the accident and the water level in the RPV pressure measuring pipe). One of the reasons for the RPV pressure and D/W pressure equalizing is the possibility of a large leakage from the RPV to the D/W. In other words, the bottom of the RPV may have been damaged between 13:00 and 15:25 on March 15.

Figure 11 RPV pressure, PCV pressure, and CAMS measurements of Unit 2 (part 1)

Figure 11 RPV pressure, PCV pressure, and CAMS measurements of Unit 2 (part 2)

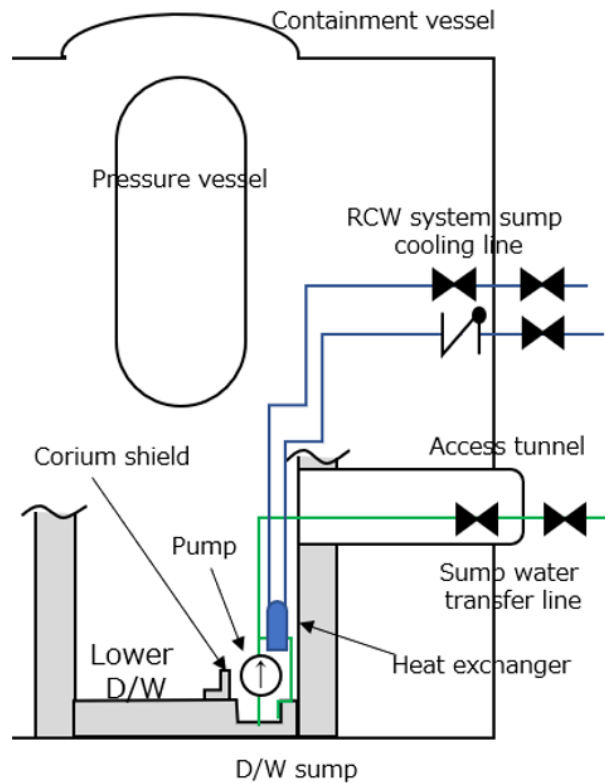
Figure 13 Isolation valves in RCW system and sump water transfer line

At the Kashiwazaki-Kariwa NPS, RCW system piping that penetrates the PCV has PCV isolation valves (or check valves) installed both inside and outside the PCV at locations close to the PCV penetration (Figure 13). These valves are designed to detect a drop in the reactor water level or an increase in D/W pressure and automatically isolate, and by closing them before the RPV fails and molten fuel migrates to the lower D/W (check valves prevent backflow from inside the PCV to the outside), the spread of contamination to piping outside the PCV is prevented. In addition, the drive power supply for the PCV isolation valves described above is enhanced by a gas turbine generator, inter-unit power supply and power truck, which improve the reliability of the isolation operation. The D/W sump has a line for transferring sump water outside the PCV, and this line is equipped with isolation valves with automatic isolation functions inside and outside the PCV penetration, as in the RCW system. In addition, a corium shield is installed in the lower D/W to prevent molten fuel from entering the sump.
