Behavior of the S/C pressure gauge of Unit 2 after 21:00 on March 14

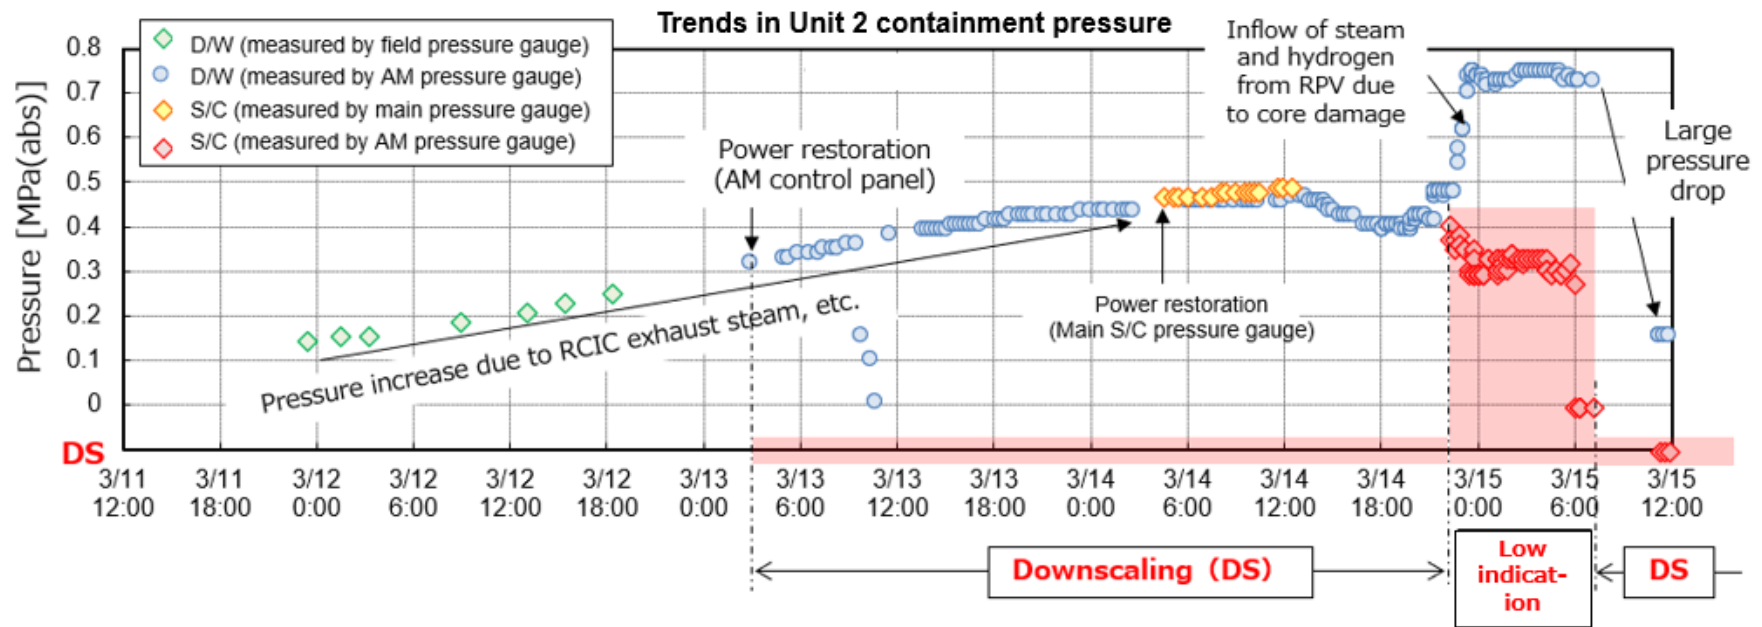
Figure 1.1 Trends in Unit 2 containment pressure

The D/W pressure in Unit 2 gradually increased during the RCIC operation period and started to decrease around 13:00 on March 14 after the RCIC was shut down. Subsequently, an increase in D/W pressure was observed at around 21:20 and 22:40, which was thought to be caused by hydrogen produced in the pressure vessel migrating to the containment side due to the SRV opening operation and it rose to around 0.75 MPa[abs].

Since the containment structure is such that D/W pressure and S/C pressure inherently behave in tandem due to the action of the vacuum break valve, such a discrepancy between D/W pressure and S/C pressure cannot occur. It is extremely likely that the S/C pressure gauge for AM was not the one that indicated the real pressure, since there were periods when it indicated DS or 0 MPa[abs]. This issue is set as Unit-2/Issue-3 in this report.

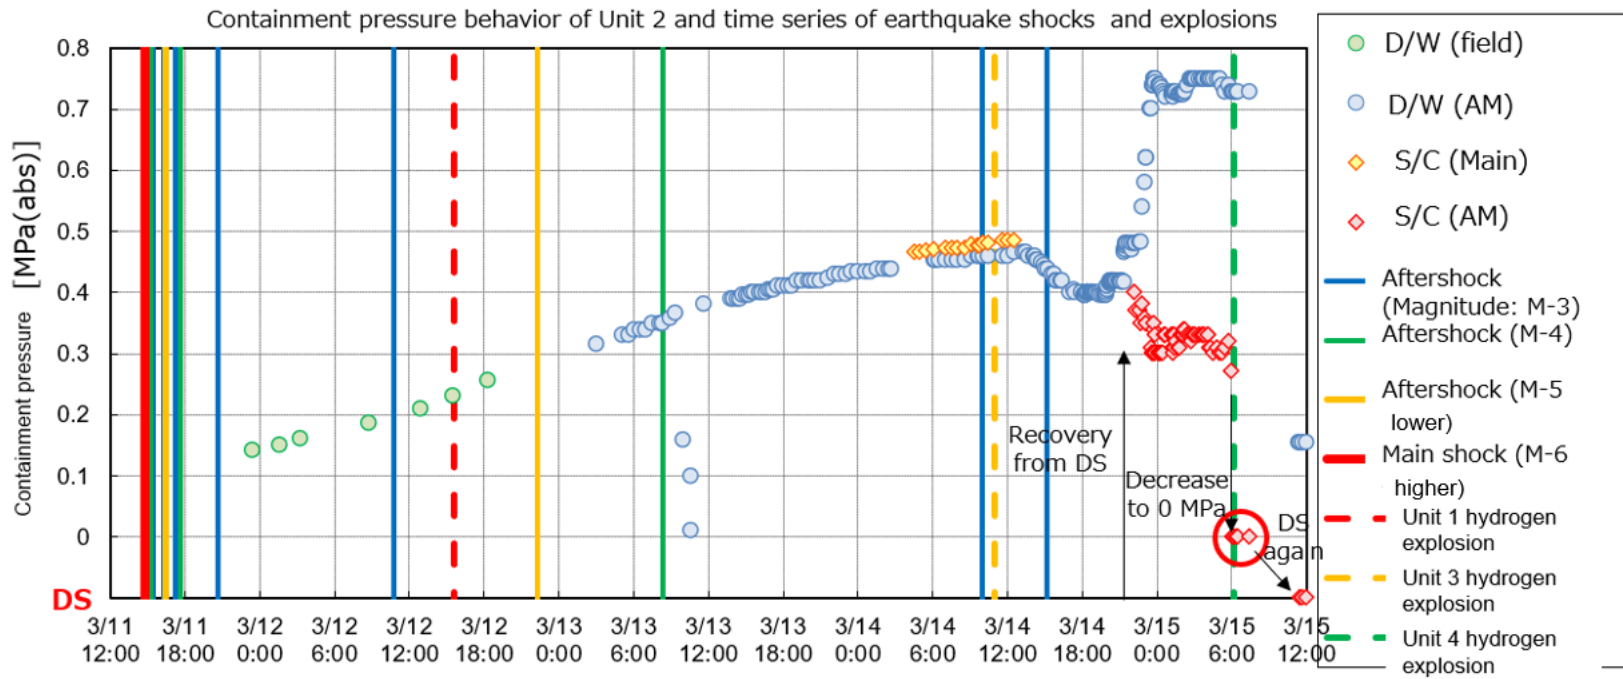
Figure 4.1.1 Trends in Unit 2 containment pressure and time series of earthquakes and explosions

It can be seen that multiple earthquakes and the hydrogen explosion in Unit 1 occurred before the S/C pressure gauge for AM was restored, but it is unlikely that the pressure gauge was damaged by these factors before March 15, because if the pressure gauge itself was damaged or the cable was broken by these factors, it is unlikely that the indicated value would return from DS.

The pressure gauge indicated value dropped sharply to 0 MPa[abs] at 06:02 on March 15, but no earthquake occurred immediately before or after that time. The hydrogen explosion in Unit 4 occurred very close by, but the time it occurred is considered to be 06:12. Therefore, the hydrogen explosion in Unit 4 is not considered to be the direct cause of the drop in the indicated value.

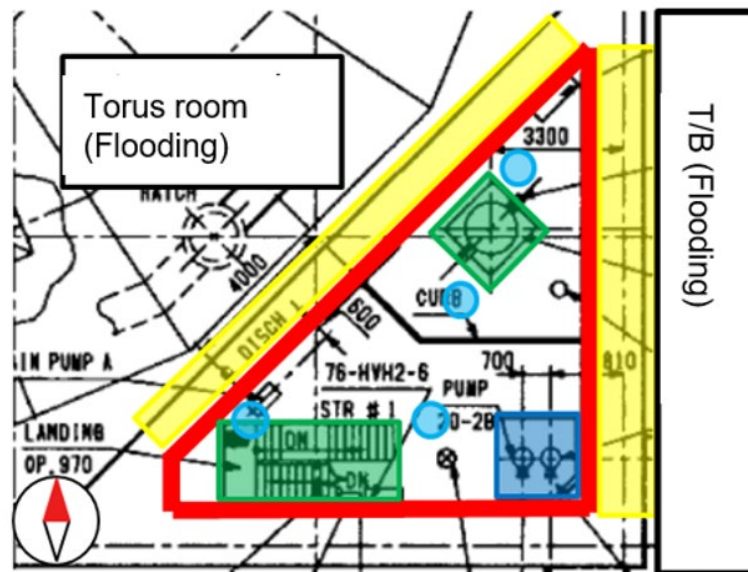
Figure 4.1.2 Tsunami ingress paths to the southeast triangular corner (colors in the figure correspond to Table 4.1.3)

Based on the above, there are multiple paths of tsunami ingress into the southeast triangular corner, but none of them is a direct ingress path. Therefore, it is difficult for the tsunami to reach there while maintaining wave force, and it is unlikely that the pressure gauge was damaged by the tsunami impact.

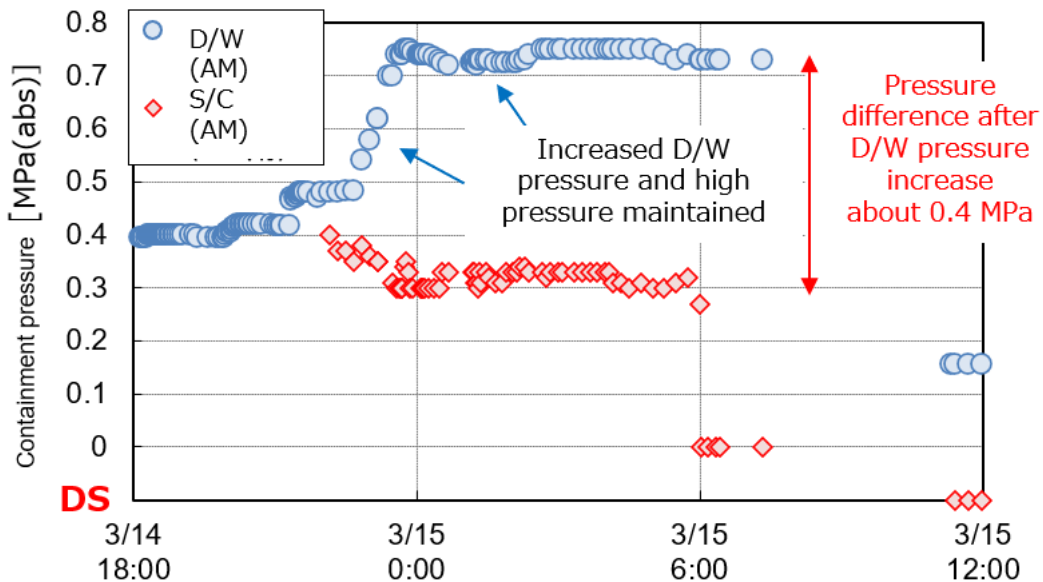
Figure 4.2.1 Containment vessel pressure in Unit 2 after 18:00 on March 14

Assuming that all the water in the condensation tank piping is lost, the height difference between the condensation tank and the pressure gauge is about 10 m, which means that there is about 0.1 MPa decrease in water pressure, corresponding to this height. On the other hand, the actual measured values shown in Figure 4.2.1 indicate that the difference between the D/W pressure and the S/C pressure during the decrease in the indicated values was maintained at about 0.4 MPa, and it is difficult to explain the decrease in the indicated values even if all the water in the condensation tank piping is lost. Therefore, the following discussion examines the possibility that "factors related to the measurement principle" may have partially contributed to the decrease in the indicated values.

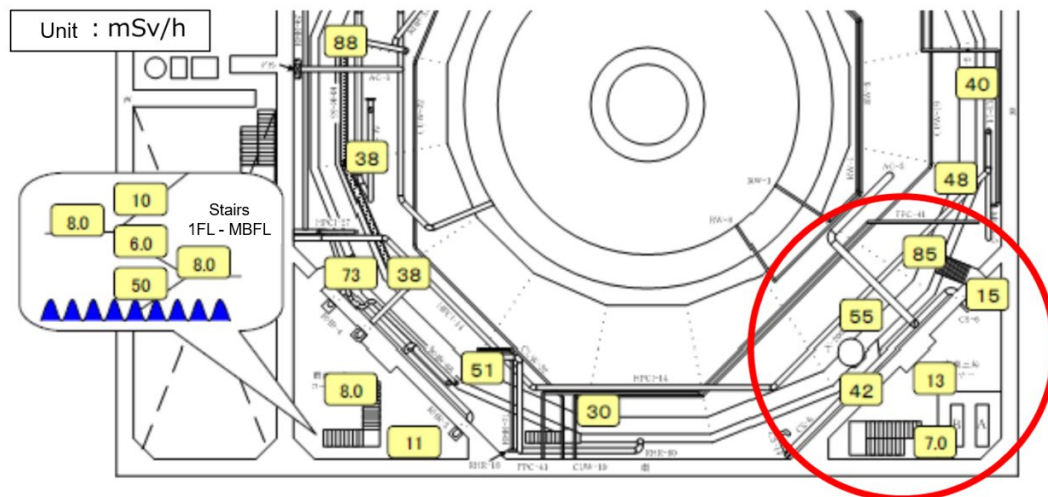
Figure 4.2.3 Measured air dose rates after the accident (April 2011 - February 2014) [5]
(Torus room catwalk, southeast triangular corner of middle basement floor)

If a condensation tank piping breaks (or is partially damaged) due to an earthquake or other impact and water leaks from the piping, gases in the S/C are simultaneously released from the leakage point, and since the time of interest is after the core damage, it is possible that the ambient air dose may increase. However, based on the post-accident measurements in the torus room and the southeast triangular corner of the middle basement floor, the dose rates on the southeast side, where the condensation tank piping is located, do not differ significantly from that at other locations (Figure 4.2.3).

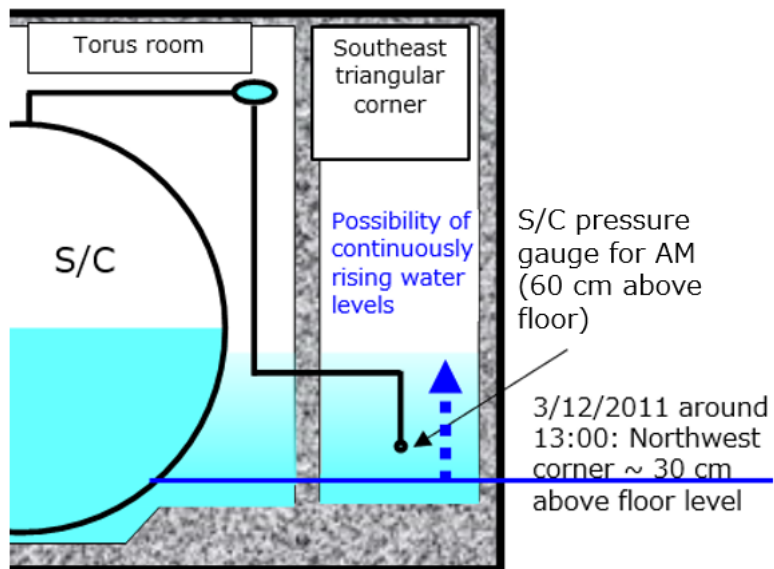
Figure 4.3.4 Water level change in the basement floor of Unit 2 R/B (image)

Based on the above, the water level at the southeast triangular corner rose continuously from about 30 cm above the floor during the March 12-15 period of interest, and it is highly likely that the S/C pressure gauge for AM installed at a height of 60 cm above the floor was submerged (Figure 4.3.4).

Therefore, it is possible that the S/C pressure gauge for AM was submerged for a long period, causing seawater to enter through the electrical wiring connection port and flood the terminals of the pressure gauge (Figure 4.3.5). In addition, submerged tests of the same type of pressure gauges conducted by the manufacturer also showed that water entered the inside through the electrical wiring connection port and flooded the terminals, and that water droplets entered the base of the pressure transmitter when the submerged height was raised (Figures 4.3.6, 4.3.7, and 4.3.8.) Therefore, it is highly likely that the S/C pressure gauge for AM was submerged at the time of the accident as well, allowing seawater to enter the interior and flood the terminals and base.

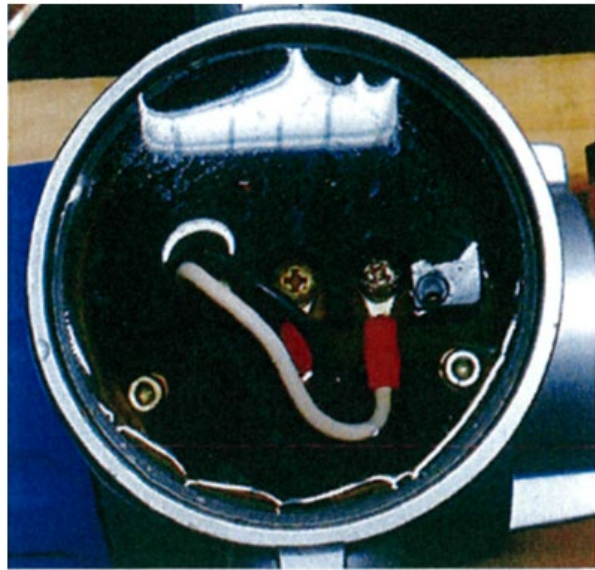
Figure 4.3.6 Photograph of the terminals after submersion test of a pressure gauge
(Assuming 4 hours of submersion to a flood height of 1.3 m)

Water leaking of terminals after testing

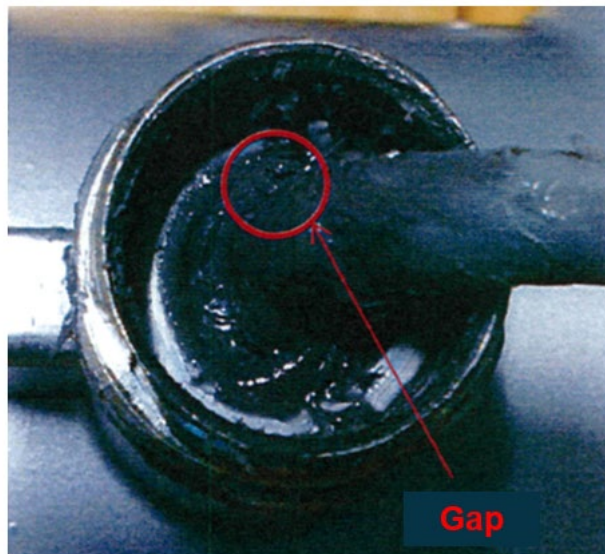
Figure 4.3.7 Photograph of electrical wiring connection port after submersion test of a
pressure gauge
(Assuming 4 hours of submersion to a flood height of 1.3 m)

Gap of O-ring seal of electrical wiring
connection port

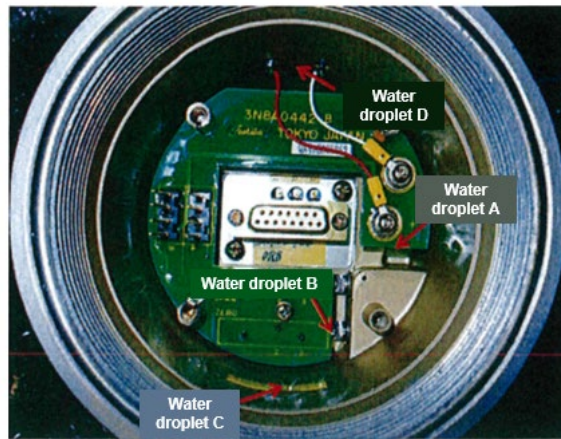
Figure 4.3.8 Photograph of the base of a pressure transmitter after submersion test of a pressure gauge

Water droplet penetration at base after test

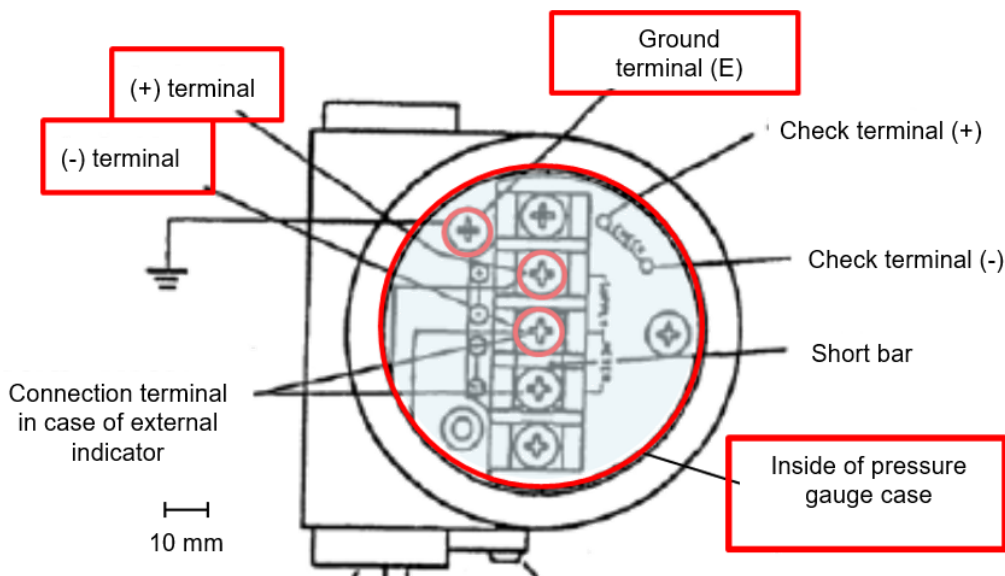
Figure 4.3.9 Enlarged view of terminals of S/C pressure gauge for AM

generating electrical abnormality, are as small as 10 to 20 mm (Figure 4.3.9). Therefore, when the terminals are flooded, the degree of contact of these terminals, etc. with seawater is about the same, so it is unlikely that a short circuit, ground fault, or insulation degradation occurred alone, and it is highly likely that the electrical anomalies occurred in a combined manner. As described in "2. Outline of the S/C pressure gauge for AM," the S/C pressure gauge for AM converts the S/C gas-phase pressure received by the diaphragm into resistance at the base and measures the S/C pressure from the change in current flowing in the circuit. If these electrical anomalies occur in combination, they may work to reduce the current reaching the S/C pressure gauge for AM, and it may well be possible to show DS or low indicated values that deviates from the D/W pressure by about 0.4 MPa.
