The cause of RCIC shutdown in Unit 3

1. Outline of the incident and issues to be examined

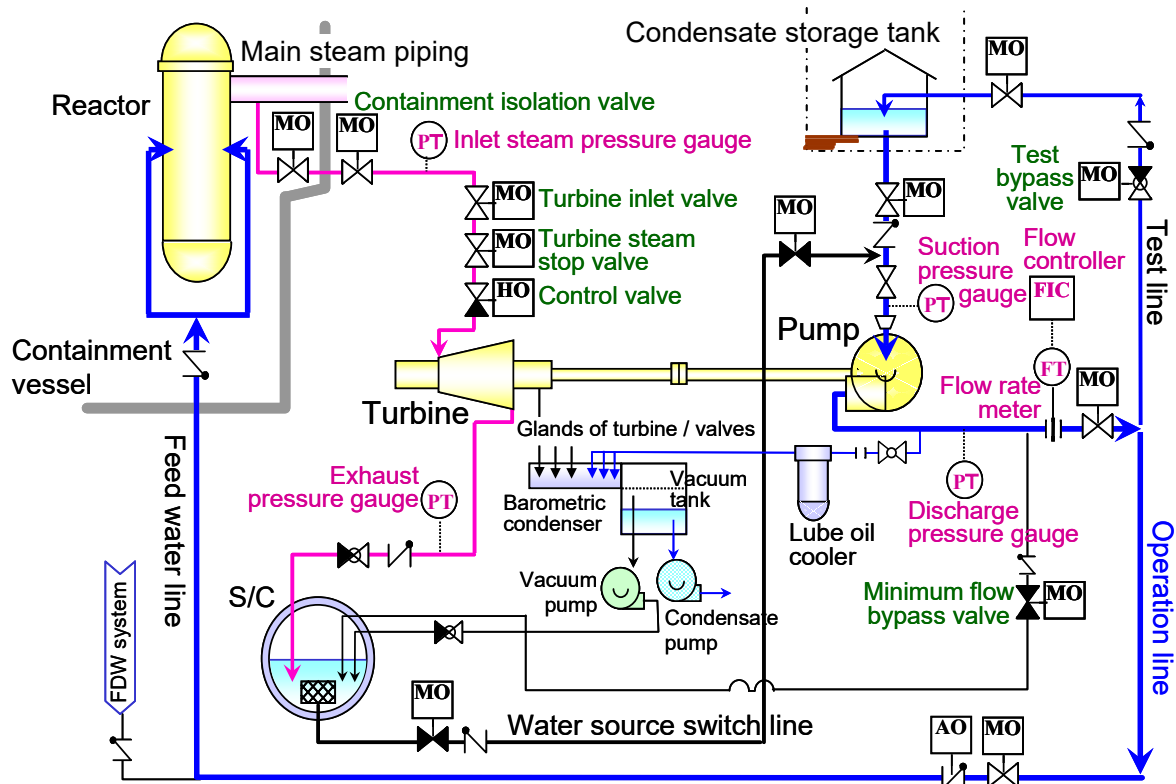
Figure 1 RCIC system diagram

The RCIC was automatically shut down at 15:25 on March 11th, due to a high reactor water level signal just before the tsunami arrival. It was manually started up at 16:03, as the DC power source was still available after the tsunami hit. Thus, the main steam relief safety valve (SRV) and RCIC could continue controlling the reactor pressure and water level of Unit 3.

Under these circumstances, the operators configured the water injection line through both the RCIC injection line and its test line by valve operations on the RCIC control panel. This was done to avoid battery depletion due to RCIC startup and shutdown, and to maintain the stable reactor water level by using the condensate storage tank (CST) as the water source. In order to ensure moderate transition of the reactor water level, the flow rate was controlled within a predefined range by adjusting the test line valve apertures and the flow indicator and controller (FIC). Figure 1 shows the RCIC diagram and the operational status.

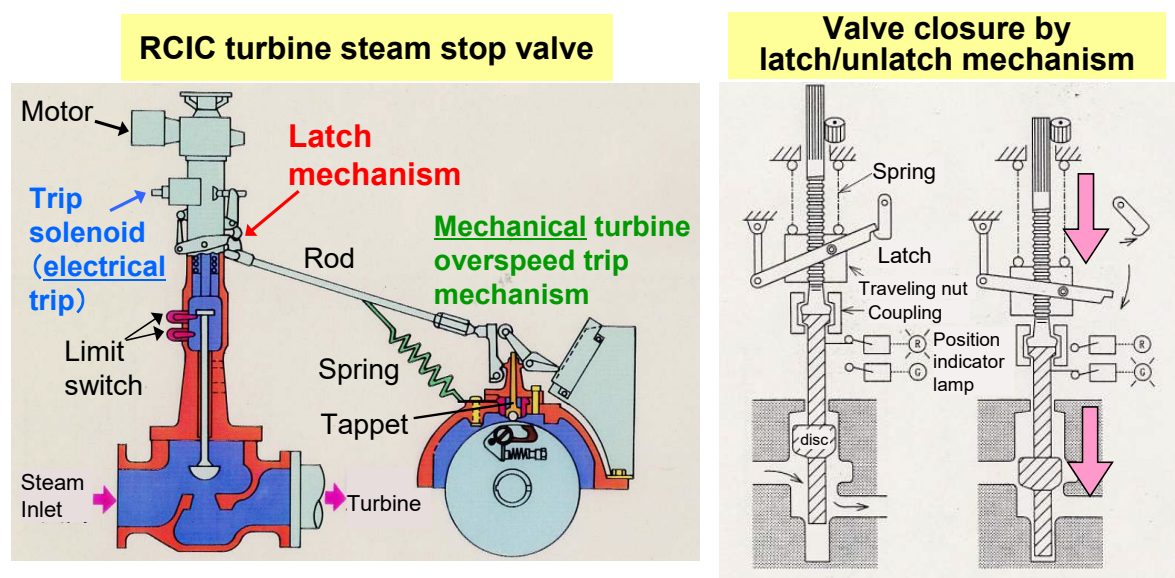
Figure 2 Schematics of RCIC turbine steam stop valve and its trip mechanisms

The RCIC turbine can be tripped by two different mechanisms: electrical trip and mechanical overspeed trip. In an unusual situation, the turbine trip stop valve is closed to cut the steam flow. Figure 2 shows a schematic diagram of the turbine steam stop valve and trip mechanisms.

A latch mechanism is built in the upper part of the valve where its stem is driven. In the electrical trip mechanism, the trip signal (an automatic trip signal from the interlock or manual trip signal) excites the trip solenoid and releases the latch. When unlatched, the spring in the valve cylinder expands and the steam stop valve is fully closed.

In the mechanical trip mechanism, the tappet in the overspeed trip mechanism is pushed upward, which works on the rod connected to the latch mechanism by spring forces, leading to the unlatching. The electrical mechanism needs a DC power source just as the RCIC needs it for operation and control, while the mechanical mechanism can work even if no DC power source is available.

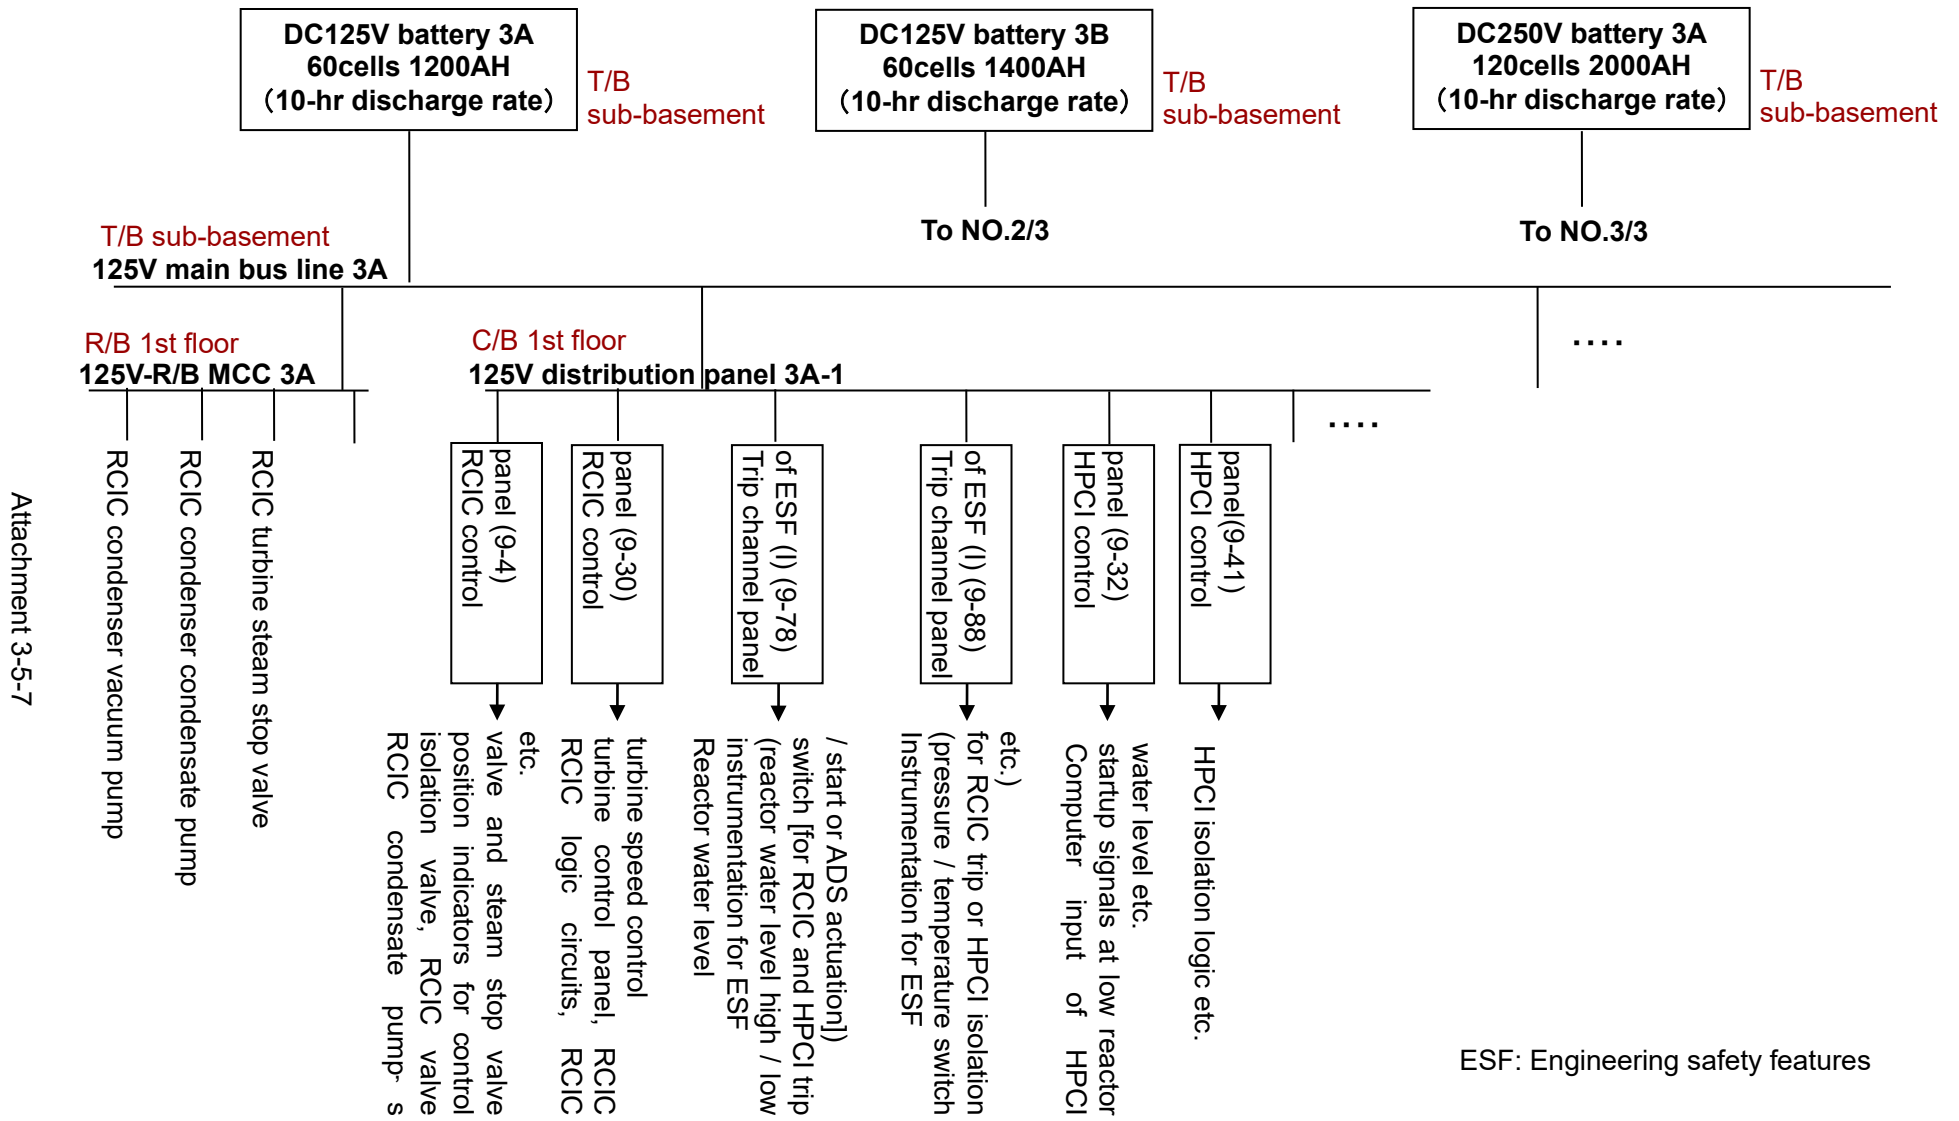
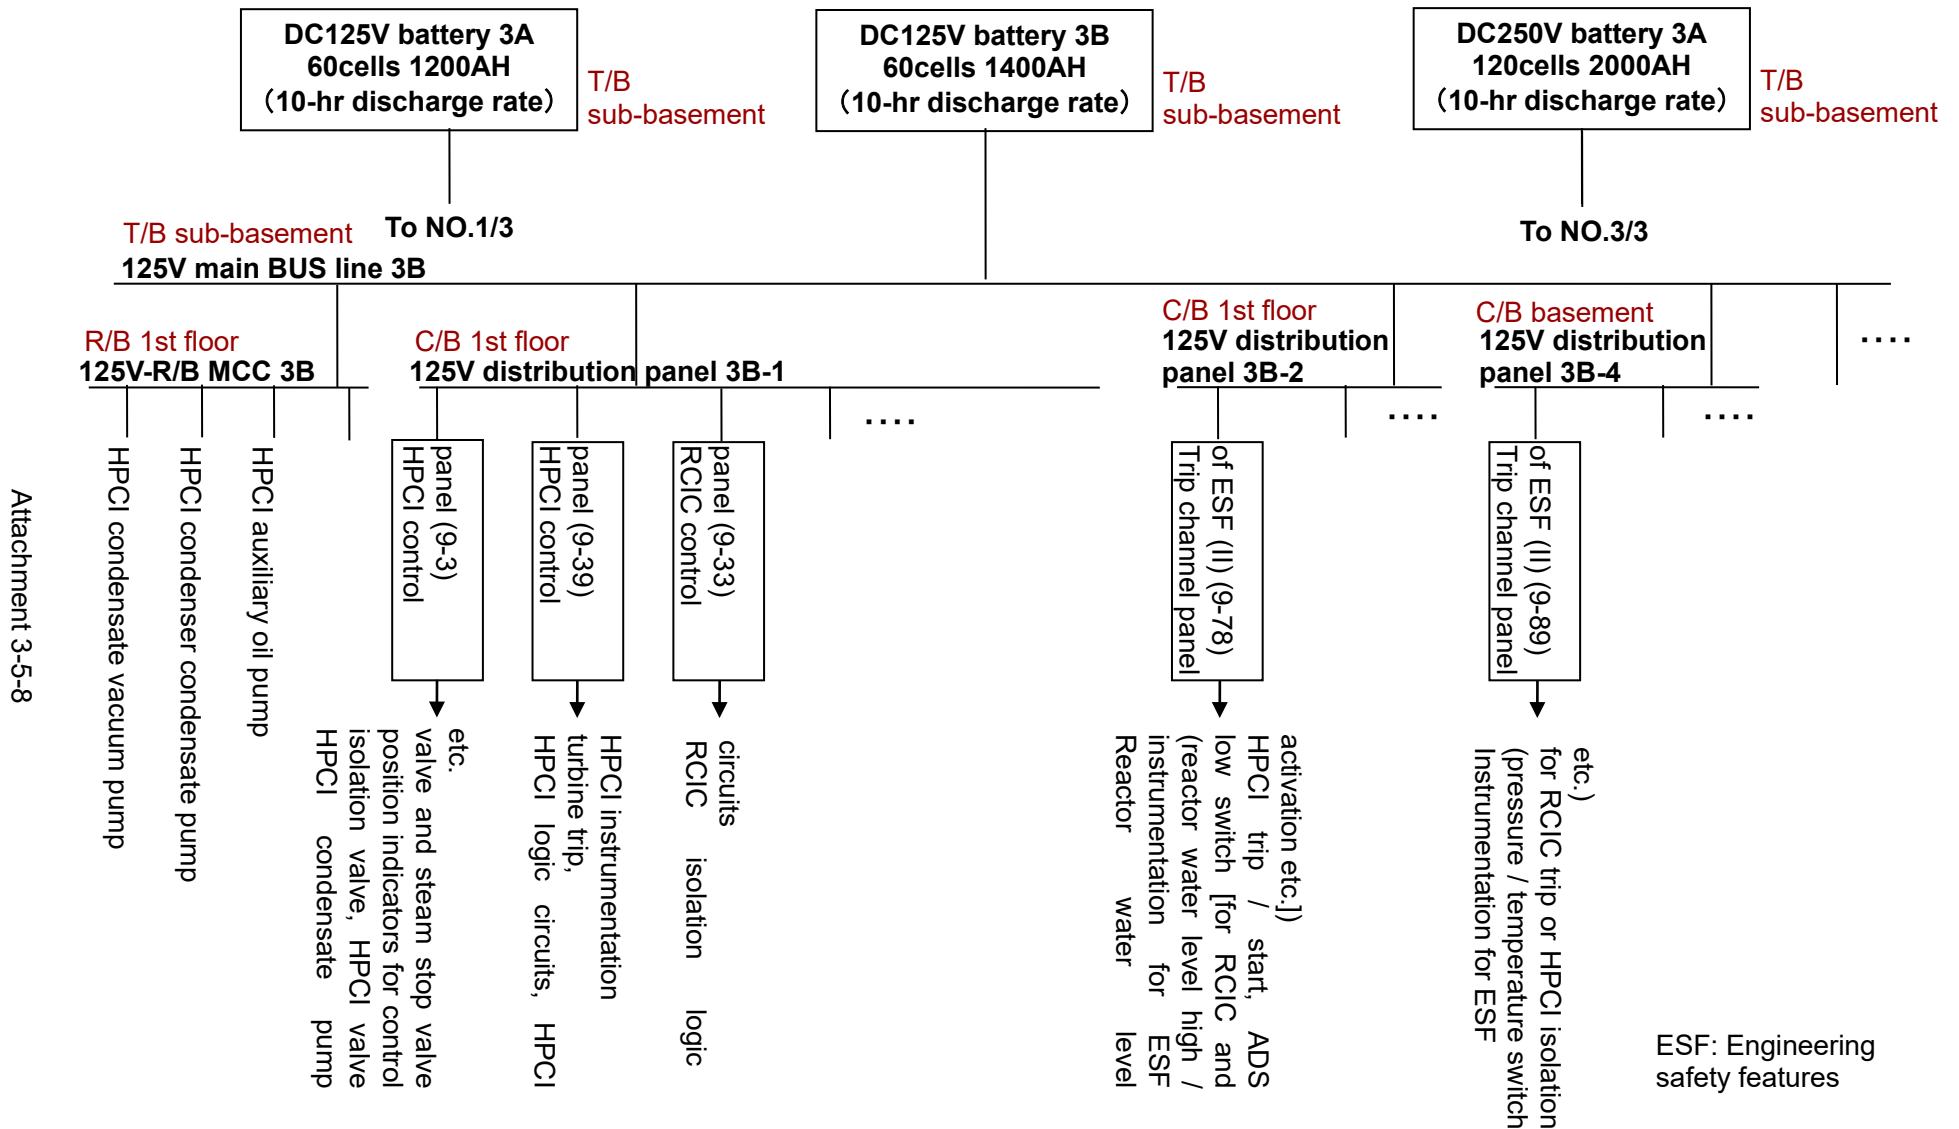
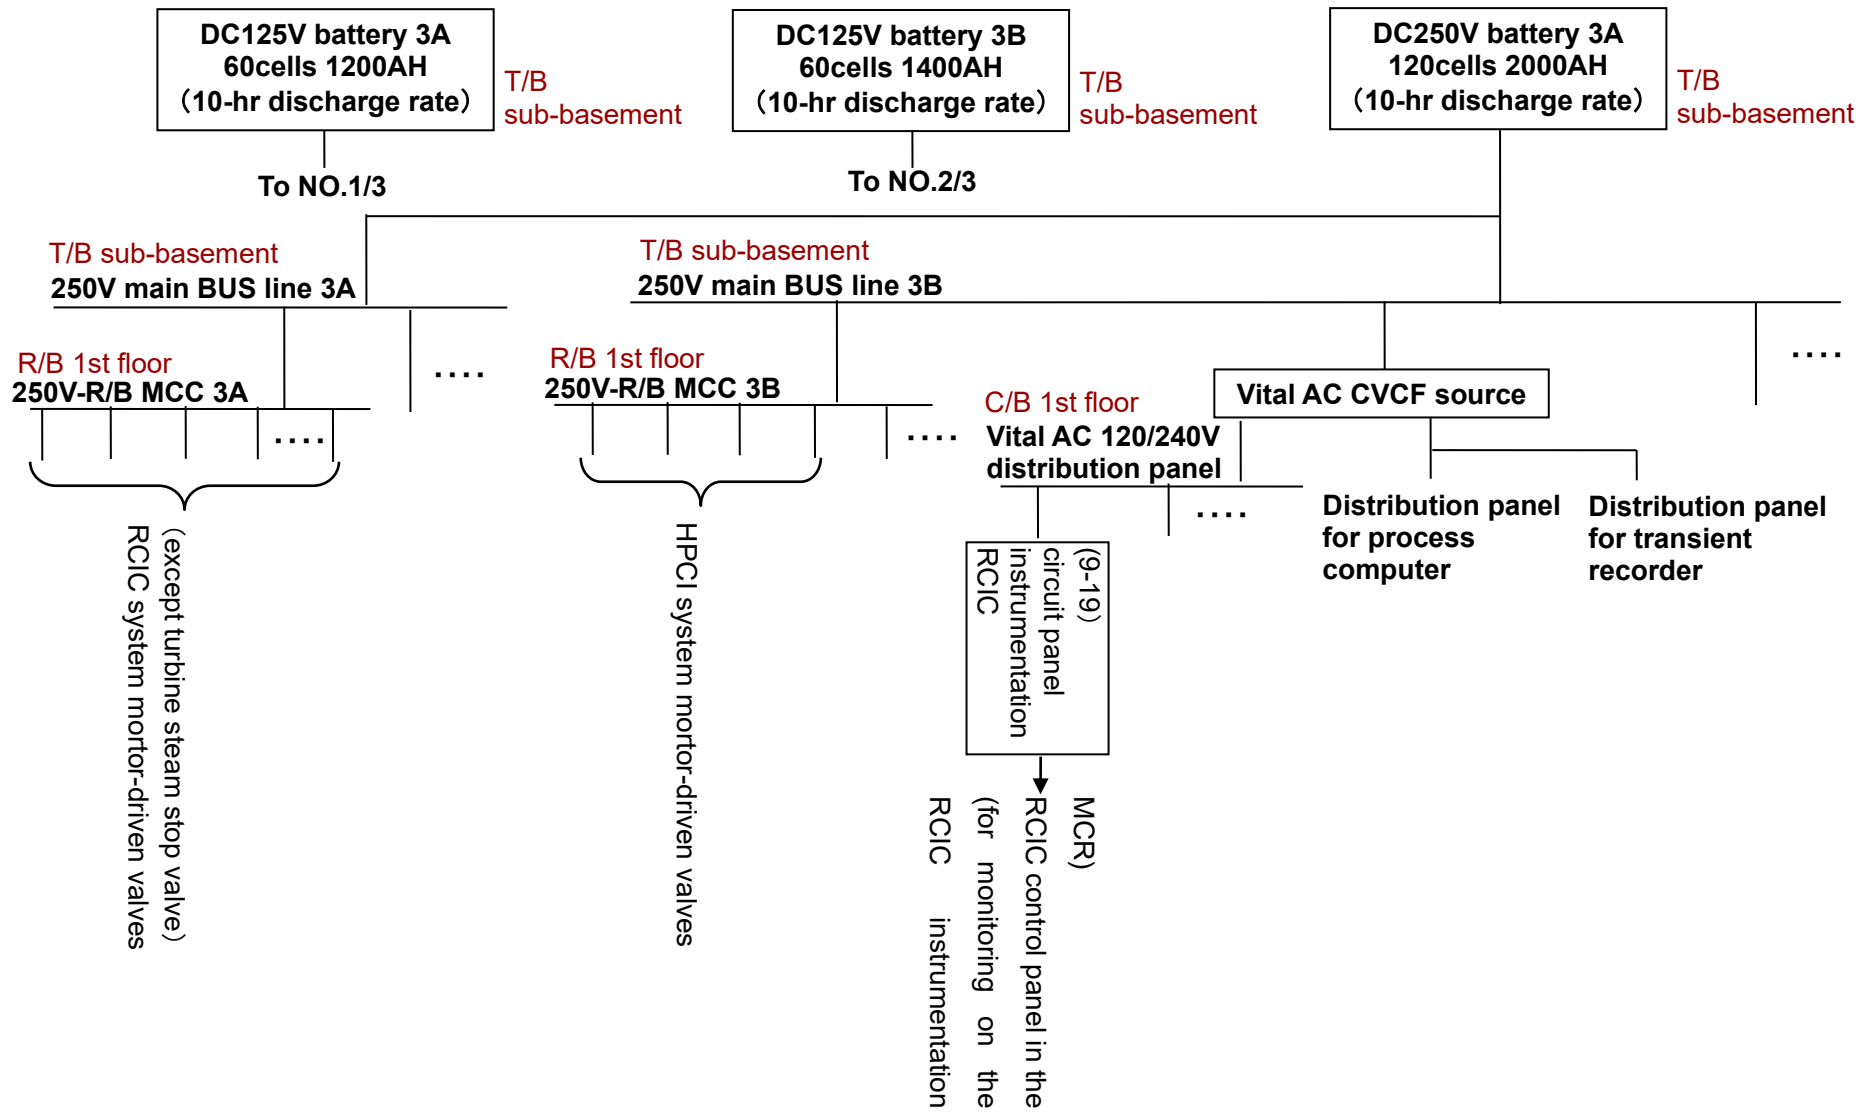
Figure 4 shows schematics of DC power distributions and loads relevant to the RCIC and HPCI of Unit 3. Batteries and DC power supply panels of Unit 3 were not destroyed by the tsunami, since they had been installed in a sub-basement of the turbine building, differing from the situation of Unit 1 and Unit 2.

But from the afternoon onward of March 12th, the battery DC125-3A is considered to have been unstable, indicating signs of depletion in vacuum pump trips, instrumentations becoming defunct, etc.

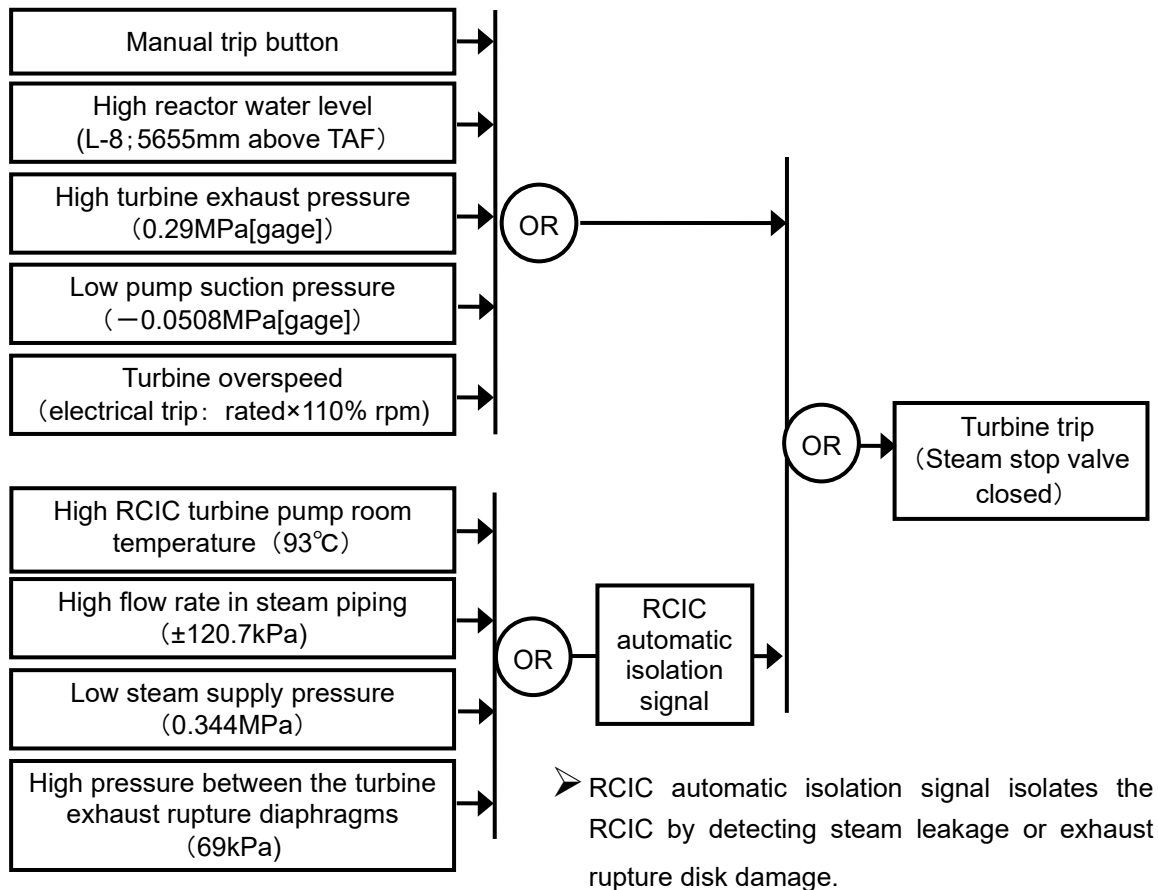
Figure 6 The interlock logic of RCIC electrical trips

The following subsections describe the feasibility conditions of each interlock logic, among which the highest likelihood is for high turbine exhaust pressure.

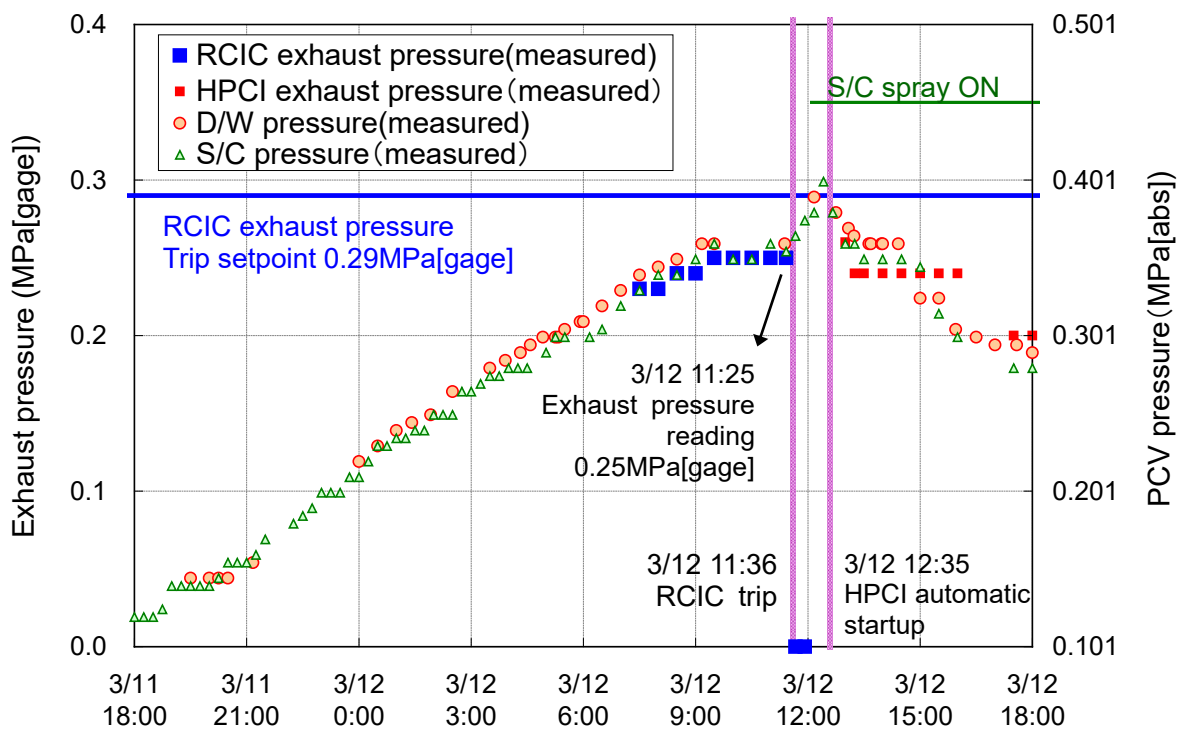
Figure 7 RCIC exhaust pressure change and PCV pressure change

Figure 7 shows the RCIC turbine exhaust pressure changes observed by the operators. Due to loss of heat removal functions, the exhaust pressure was increasing with the increase in both the D/W and S/C pressures, and as of 11:36 on March 12th, when the RCIC tripped, they were at a level very close to the preset high exhaust pressure trip level. The exhaust pressure reading was 0.25MPa[gage] as of 11:25 on March 12th, and had not reached the preset trip level (0.29MPa[gage]). Further, there is no record on the exhaust pressure at the very instant of the RCIC trip, and so no direct evidence of observation exists concerning the RCIC trip due to high exhaust pressure.

As was shown in Figure 7, the turbine exhaust pressure reading was about 0MPa[gage] after the RCIC trip at 11:36 on March 12th. This is because the steam in the exhaust piping was condensed and because the S/C pressure (back pressure) was blocked by the check valve in the downstream side of the exhaust piping.

Concerning the incident of repeated trips of the RCIC upon steam injection in restarting attempts after successful resetting, it can be interpreted by the following scenario: If a trip is triggered by the high turbine exhaust pressure, the exhaust pressure on the indicator decreases, the trip condition is cleared once, and later upon steam injection the RCIC trips again due to the increased pressure.

As a safety measure for the Kashiwazaki-Kariwa Nuclear Power Station, the trip setting value of the turbine exhaust pressure high interlock was raised from the viewpoint of continuing RCIC water injection even when the S/C pressure rises due to an assumed station blackout. The RCIC exhaust piping has a vent line equipped with a rupture disc for preventing overpressurization. This is because the RCIC is designed so that its pressure is released when the RCIC rupture disc physically ruptures, if the RCIC turbine exhaust pressure continues to increase as the S/C pressure increases, and reaches the rupture disc working pressure. Practically, however, the S/C

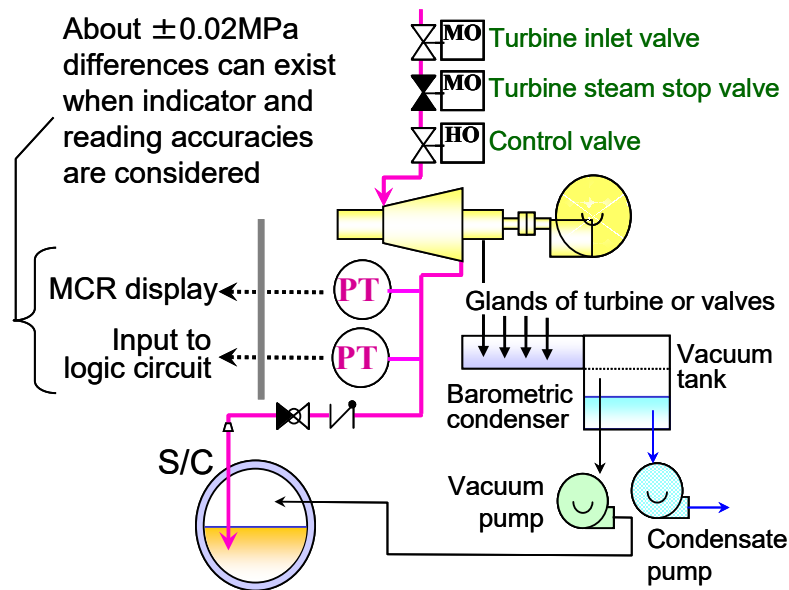
Figure 8 Positional illustration of RCIC exhaust pressure gauges

As is shown in Figure 8, exhaust pressure gauges for the MCR indicator and the logic circuit input are different, and about 0.02MPa difference could exist in these two instrumentations due to instrumentation accuracies and reading errors. Even taking these inaccuracies into account, the

pressure reading of 0.25MPa[gage] at 11:25 on March 12th is considered not to have reached the trip level (0.29MPa[gage]).

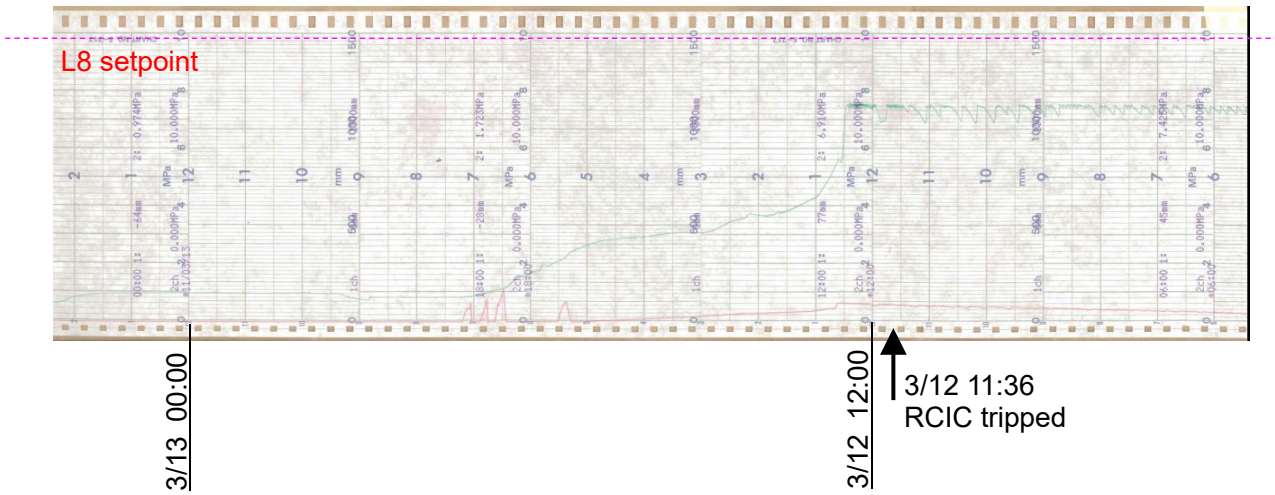
Figure 9 Chart record of reactor water level/pressure

Figure 9 shows the chart record of reactor water level (narrow range) and Figure 10 shows the measured water level changes which operators read in the indicators. The RCIC flow rate was being controlled by the FIC while monitoring the reactor water level, and as of 11:36 on March 12th, when the RCIC tripped, the reactor water level had not reached the level L-8. An RCIC trip due to high reactor water level interlock is not possible.
