Dose increase around March 20th, 2011

1. Background

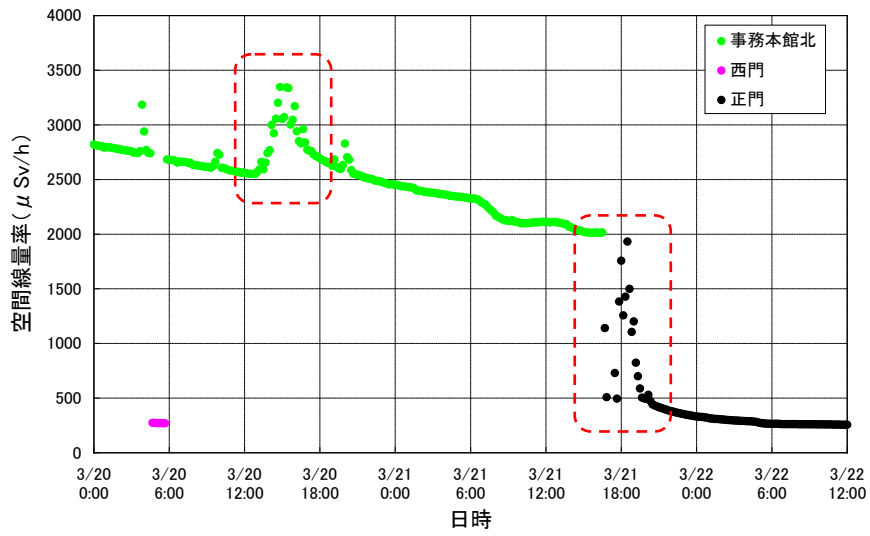
Figure 1 Dose increase on March 20th and 21st, 2011

Figure 1 shows the dose level change observed during March 20th and 21st in the area surrounding the Fukushima Daiichi NPS. The dose increase in question is described by the data enclosed within the dotted red lines. On March 20th the dose rose about 800 μ Sv/h in two hours from 12:50 to 14:50 in the north area of the main administration building. The dose remained above 3000 μ Sv/h till about 16:00, then began to decrease. On March 21st the dose jumped to about 1400 μ Sv/h in 100 minutes from 16:50 to 18:30 near the main gate. The dose decreased thereafter and returned to the level before the dose increase.

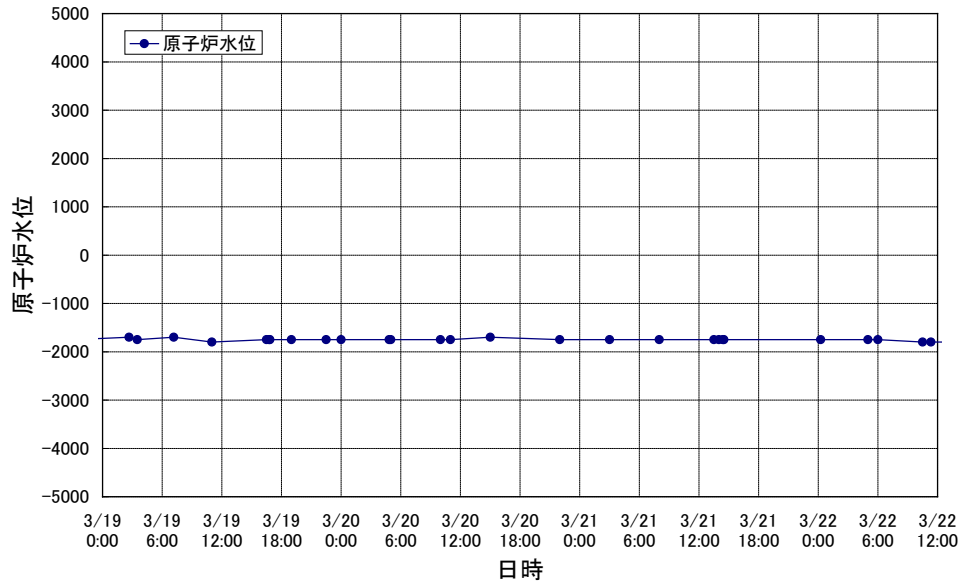
Figure 3 Reactor water level of Unit-1

Concerning Unit-1, Figure 3 and Figure 4 have no noticeable significant changes in the reactor water level, reactor pressure and PCV pressure during the time period when dose increase was observed, although the data points are limited. In Figure 5 CAMS (D/W) readings show a big drop after 12:00 on March 20th, which might indicate a possible release of radioactive materials from the containment vessel. But the PCV pressure shows no changes and the CAMS (S/C) data show no big changes during the period of interest. All in

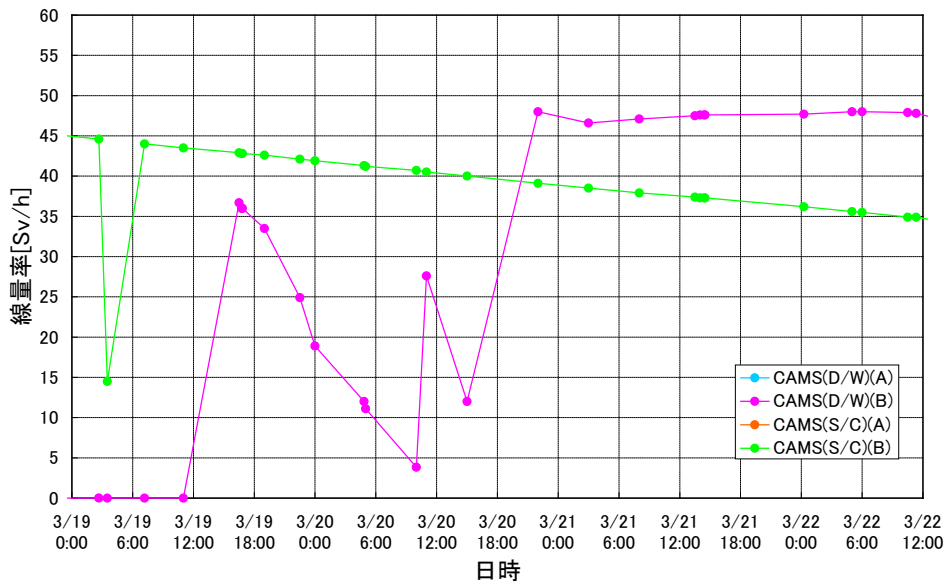
Figure 5 CAMS readings of Unit-1

all, the change in the CAMS (D/W) readings is reasonably attributed to defective individual readings.

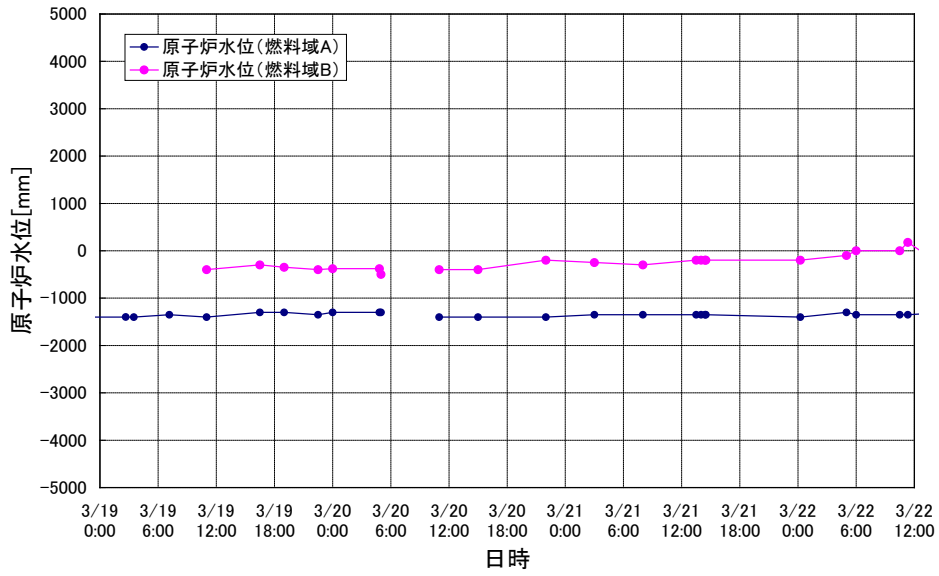
Figure 6 Reactor water level of Unit-2

Concerning Unit-2, Figure 6 and Figure 7 have no noticeable significant changes in the reactor water level, reactor pressure and PCV pressure during the time period when the dose increase was observed, although the data points are limited. In Figure 8 CAMS (D/W) readings show a lower value at 11:00 on March 20th than those before and after. But again the change in the CAMS (D/W) readings is reasonably attributed to defective individual readings, because of a discontinuity in particular readings and the CAMS (S/C) data show no changes over the same time period.

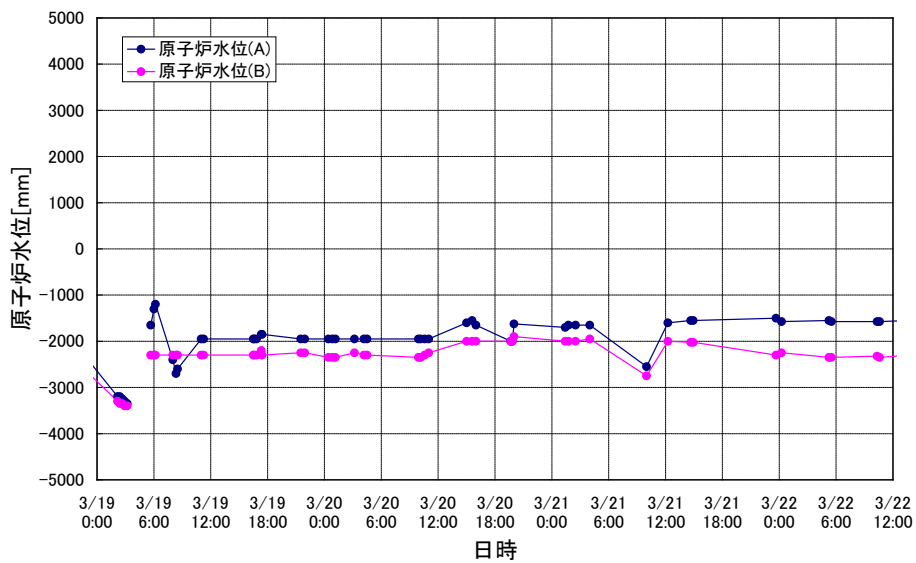
Figure 9 Reactor water level of Unit-3

Concerning Unit-3, Figure 9 and Figure 10 show a slight increase in the reactor water level and a slight decrease in the reactor pressure and D/W pressure during the time period when the dose increase was observed on March 20th. During this time period, the reactor temperature and PCV temperature showed a decreasing tendency [1]: the temperature of the feedwater nozzle (N4B) decreased from 210 deg C (at 11:00) to 140 deg C (at 15:00), that of reactor vessel bottom head from 244 deg C (at 11:00) to 220 deg C (at 15:00), and that of D/W HVH return line from 220 deg C (at 11:00) to 187 deg C (at 15:00). This leads to the understanding that the temperature decrease caused the pressure decrease of the reactor and PCV. In Figure 11 CAMS readings show no changes during the period of interest. From these considerations a new incident releasing radioactive materials during this time period of interest at Unit-3 seems unlikely to have occurred.

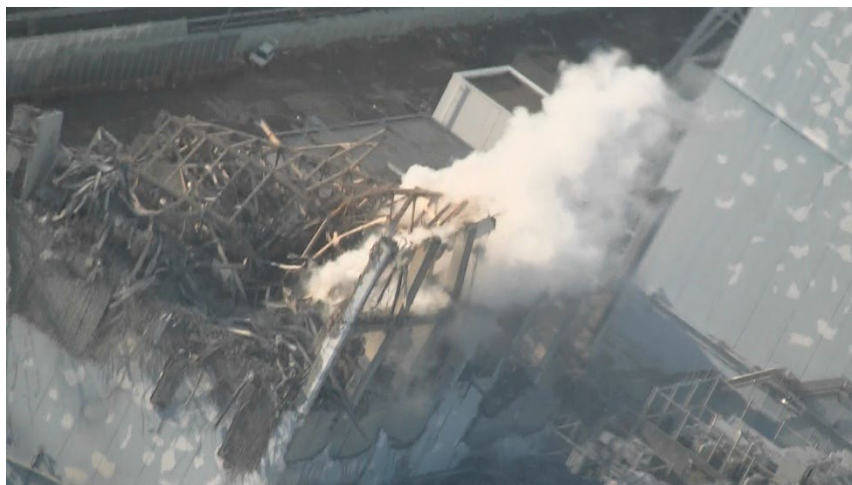
Figure 12 Aerial photo of Unit-3 (March 16th, 2011)

have been more or less continuously released from the containment vessel of Units-1 to 3. For example, steam and other gases rose from the Unit-3 containment vessel as white smoke that passed from the upper side of the building after it had been damaged by the hydrogen explosion. This situation can be seen in an aerial photo taken on March 16th (Figure 12).

Under the severe conditions that existed during the Fukushima Daiichi NPS accident, high temperature steam might have deteriorated silicon gum seals used in the containment vessel top flange or hatches (gaskets) causing loss of the confinement function. From this concern, the following measure was taken at the Kashiwazaki-Kariwa NPS: additional backup seal material was coated on the flange outside of such gaskets in order to strengthen the resistance to steam at elevated temperatures. Also because the silicon-based seal material has a tendency to deteriorate upon exposure to high temperature steam, it is being replaced with a more temperature resistant seal material (improved ethylene-propylene rubber material (EPDM)).

The seal material for the containment air-lock equalizer valves, fluoro-resin, may experience deterioration in its seal performance when exposed to radiation under severe accident conditions. In order to ensure the integrity (of the confinement capability) under severe accident conditions, a measure was taken: a blind flange was newly mounted on the reactor building side opening of the piping which connected the equalizer valves across the outer side door of the air-lock. The blind flange was equipped with a seal with high tolerance to environmental conditions. An alternative seal material is also being used in equalizer valves, which is more resistant to radiation than fluoro-resin and to high temperatures.

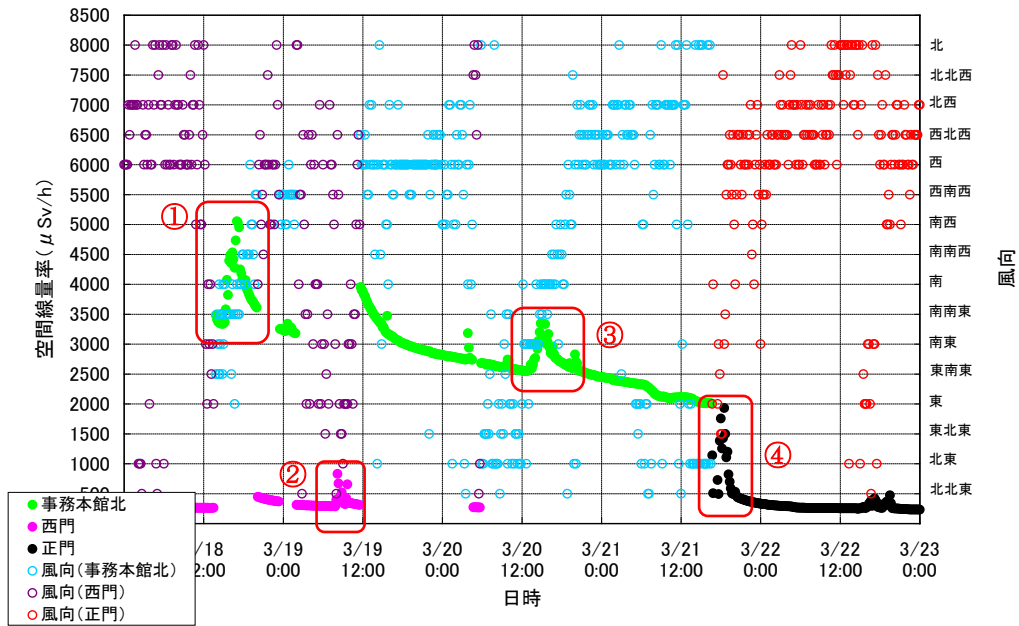
Figure 13 Air dose changes and wind direction

To assess this possibility, the car position at the time of the dose increase was checked as to whether it was downwind. Figure 13 shows the correlation between wind direction and air dose during the period of March 18th to 23rd [2]. The relation between the monitoring car position and wind direction was reviewed, especially at the time points ① to ④ in Figure 13, when the air dose increase had been observed. The monitoring car was positioned at these times at the north side of the main administration building, the west gate or the main gate.

As a general observation from Items 5.1 to 5.3 above, more measurement points seemed to have been downwind when the dose increase was observed, and on the contrary they seemed to have been in other wind directions when the dose decrease was observed. Consequently, the wind directions might have been relevant to the dose increase on March 20th and 21st.
