Leaks from Unit-3 PCV and steam release in a large amount

1. Background

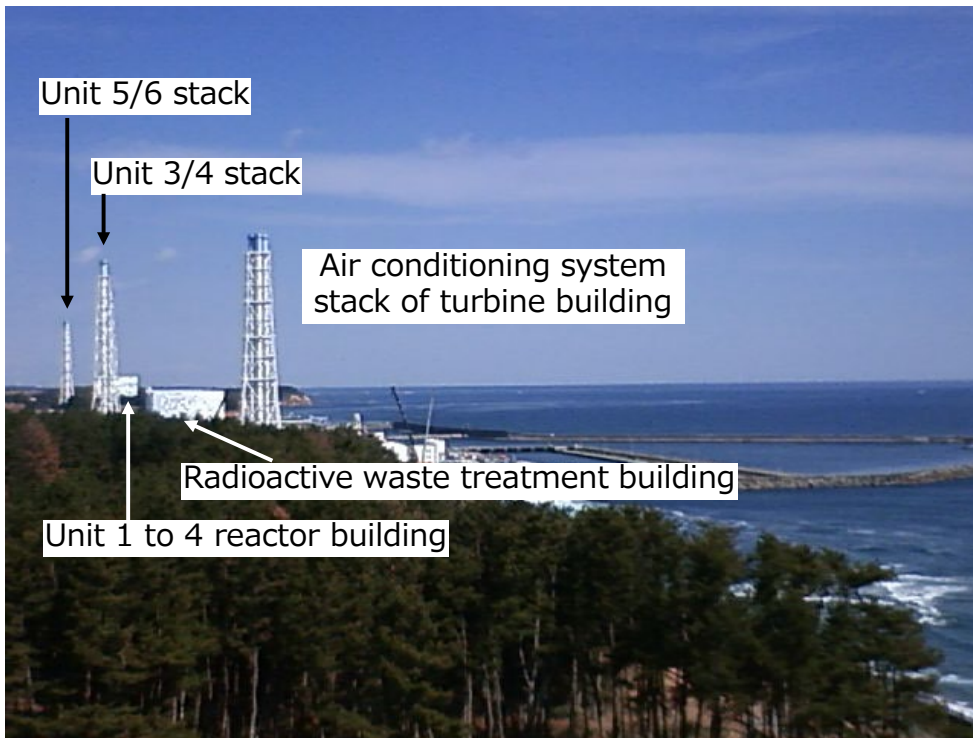
Figure 1 Photos by the live camera at the Fukushima Daiichi NPS (taken at 10:00 on March 11th) (Top: Full screen view of the live camera, Bottom: Enlarged R/B surroundings)

Figure 1 shows the photo recorded by the live camera at 10:00 on March 11th. This photo shows the Fukushima Daiichi NPS in sound conditions before the earthquake. A chimney type structure seen in the far left is the Unit-5/6 stack, a chimney type structure to its right is the Unit-3/4 stack and the last chimney type structure is the stack of the turbine building (T/B) ventilation system. The Unit-1/2 stack stands just behind the Unit-3/4 stack and is not visible in this photo. Occasionally the Unit-1/2 stack is visible in later live camera feed, because the live camera photo angle changes perhaps due to aftershocks.

A building near the T/B ventilation system stack is the radioactive waste treatment building (RW/B). A building behind the Unit-3/4 stack is the Unit-4 R/B, but Unit-1 to Unit-4 are almost on a single straight line from the live camera point, as seen in the enlarged photo, and it is difficult to compare Unit-1 to Unit-3 from the live camera feed.

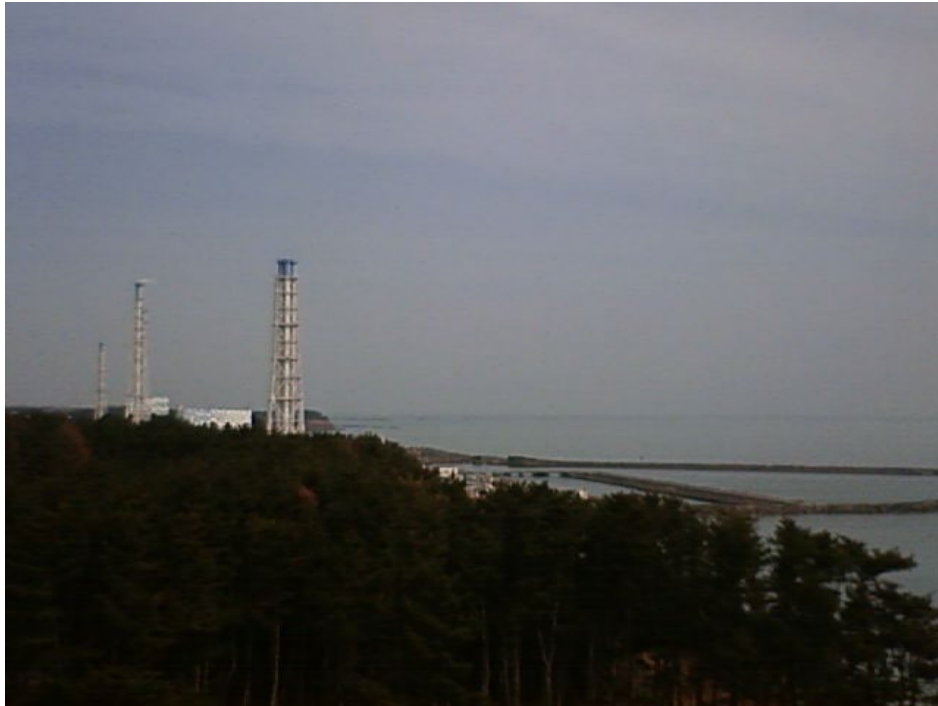
Figure 2 Photos by the live camera at the Fukushima Daiichi NPS (taken at 10:00 on March 13th) (Top: Full screen view of the live camera, Center: Enlarged Unit-3/4 stack, Bottom: Enlarged R/B surroundings)

Unit-3 is considered to have been successfully vented at about 09:20 on March 13th and Figure 2 shows a photo live camera taken at 10:00, about 40 minutes after the venting. As can be seen in the enlarged photo of the Unit-3/4 stack, steam was being discharging by venting. Meanwhile, no extraordinary conditions are recognized for the R/B.

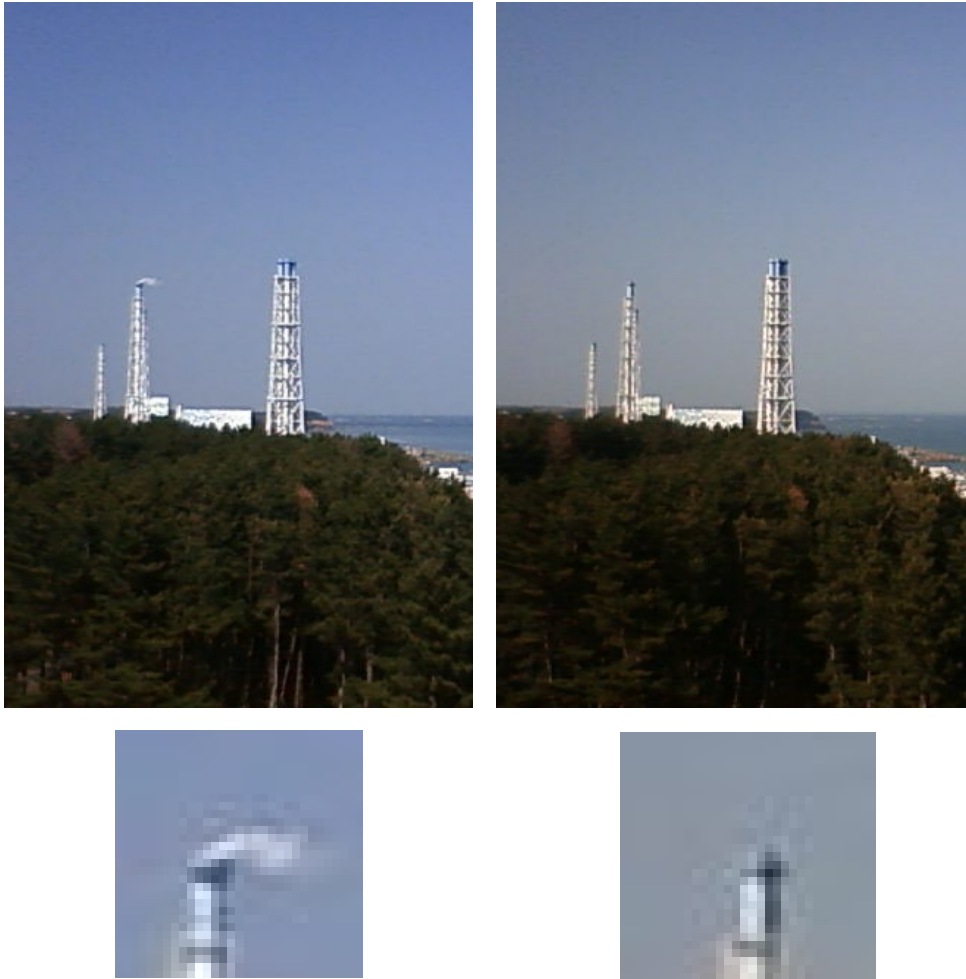
Figure 3 Photos by the live camera at the Fukushima Daiichi NPS (Part) (Left: taken at 13:00 on March 13th, Right: taken at 15:00 on March 13th) (Top: Live camera photos (excerpt), Bottom: Enlarged Unit-3/4 stack)

Figure 3 shows photos by the live camera at 13:00 and 15:00 on March 13th. It is recorded elsewhere that the vent valve closure was confirmed at 11:17 and the vent valve opening (second opening operation) was confirmed at 12:30. Therefore, the steam release as confirmed in the live camera photo of 13:00 is considered as the result of the successful venting. No clear steam release can be recognized in the photo of 15:00.

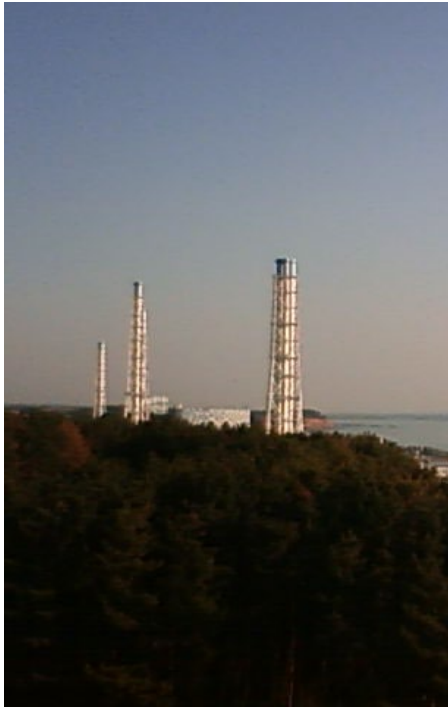
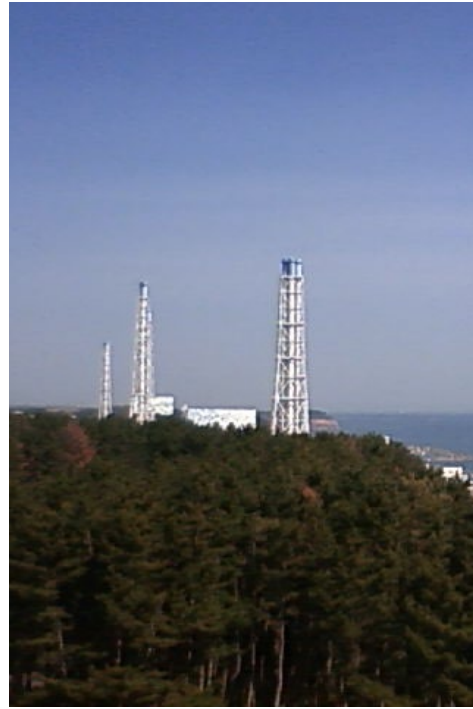
Figure 4 Photos by the live camera at the Fukushima Daiichi NPS (Part) (Left: taken at 07:00 on March 14th, Right: taken at 10:00 on March 14th) (Top: Live camera photos (excerpt), Bottom: Enlarged Unit-3/4 stack)

Figure 4 shows photos by the live camera at 07:00 and 10:00 on March 14th. In the records operation of the vent valve (small valve) was completed at 06:10 (fourth operation time). Steam release cannot be recognized clearly in either of these live camera photos. There is a possibility, though, that the steam released by the small vent valve operation was limited and not recognizable in live camera photos.

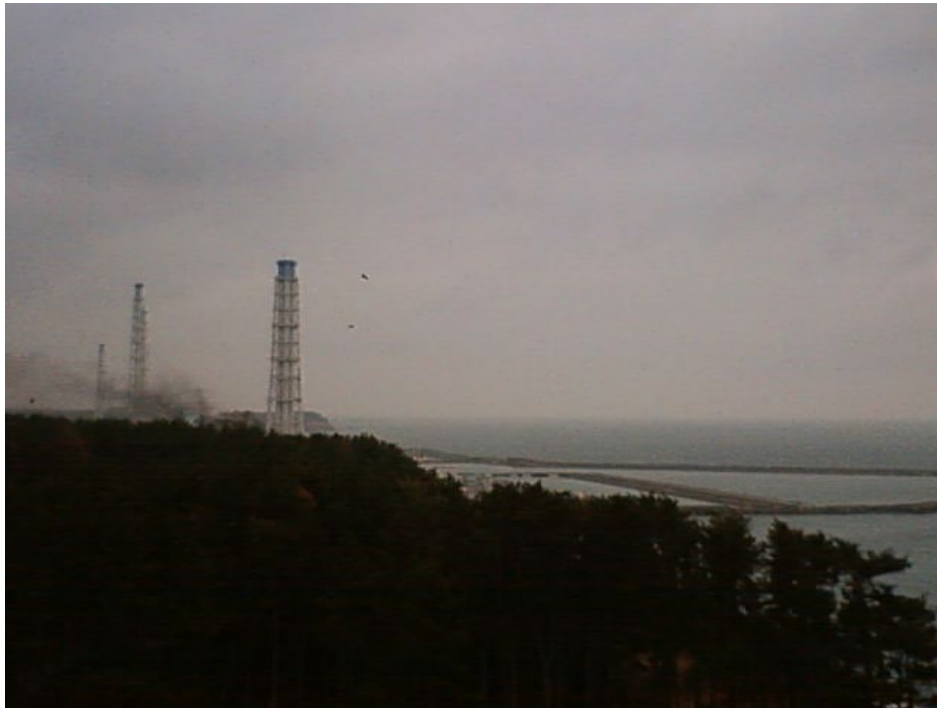
Figure 5 Photos by the live camera at the Fukushima Daiichi NPS (taken at 07:00 on March 15th) (Top: Full screen view of the live camera, Center: Enlarged Unit-3/4 stack, Bottom: Enlarged R/B surroundings)

Figure 5 shows photos by the live camera at 07:00 on March 15th. At this timing, steam release from the Unit-3/4 stack cannot be recognized, but from the enlarged photos around the R/Bs, steam release, probably from the top of the R/B of an unknown unit, can be recognized.

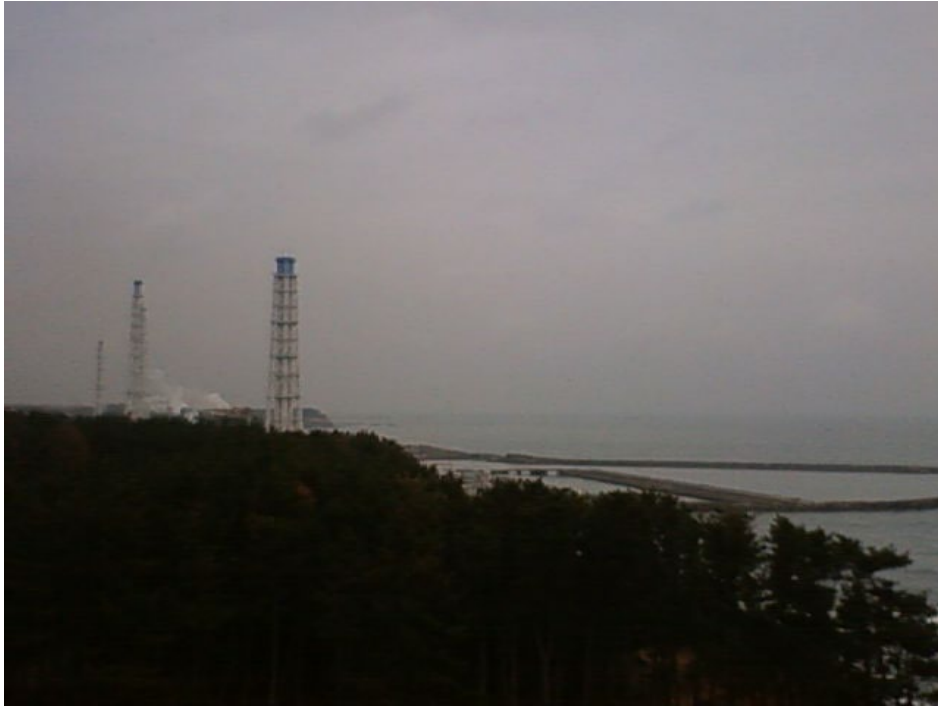
Figure 6 Photos by the live camera at the Fukushima Daiichi NPS (taken at 16:00 on March 15th) (Top: Full screen view of the live camera, Center: Enlarged Unit-3/4 stack, Bottom: Enlarged R/B surroundings)

Figure 6 shows photos by the live camera at 16:00 on March 15th. At this timing, steam release from the Unit-3/4 stack cannot be recognized, but from the enlarged photos around the R/Bs, steam release, probably from the top of R/B of an unknown unit, can be recognized.

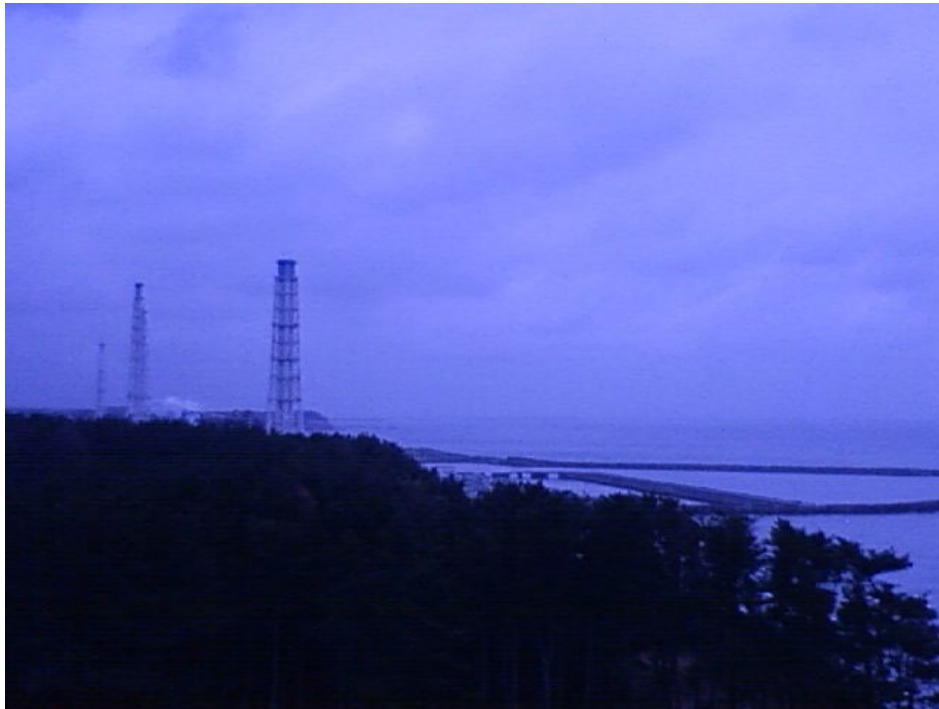
Figure 7 Photos by the live camera at the Fukushima Daiichi NPS (taken at 17:00 on March 15th) (Top: Full screen view of the live camera, Center: Enlarged Unit-3/4 stack, Bottom: Enlarged R/B surroundings)

Figure 7 shows photos by the live camera at 17:00 on March 15th. In the records, the small generator for opening operations of vent valves was replaced and opening operation was done for the fifth time, but no clear steam release can be recognized in the live camera photos.

Like in the photos at 16:00 (Figure 6), steam release, probably from the top of an R/B, can be recognized.

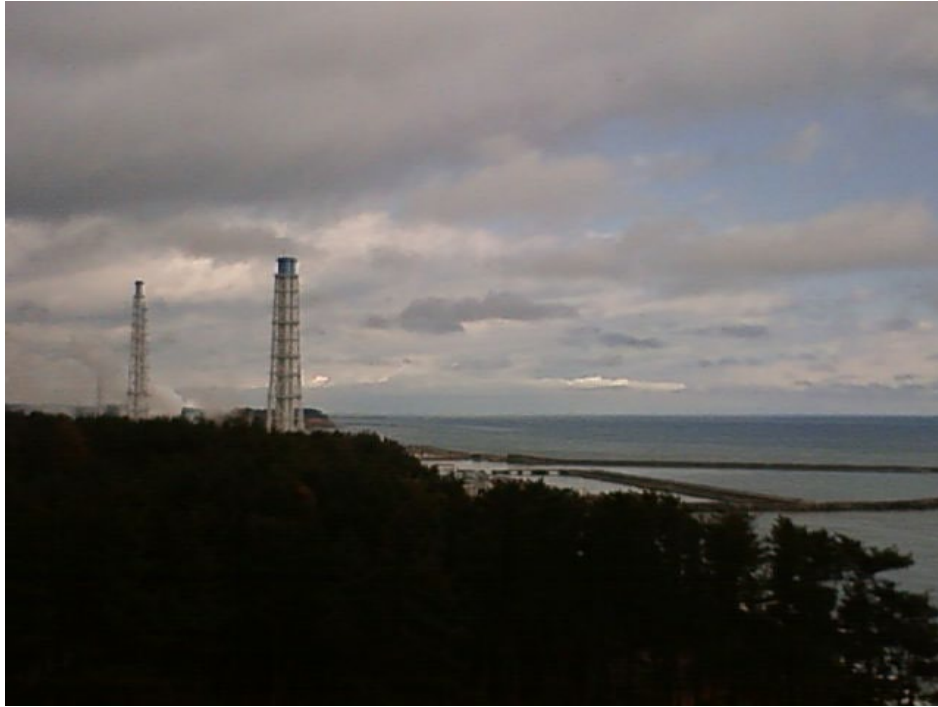
Figure 8 Photos by the live camera at the Fukushima Daiichi NPS (taken at 10:00 on March 16th) (Top: Full screen view of live camera, Center: Enlarged Unit-3/4 stack, Bottom: Enlarged R/B surroundings)

Figure 8 shows photos by the live camera at 10:00 on March 16th. At this timing, steam release from the Unit-3/4 stack cannot be recognized yet. But steam release probably from the top of an R/B can be recognized. In the earlier photos, the shape of the RW/B was clearly visible, but at this timing the RW/B was partially invisible due to the released steam. Therefore, the steam released at this timing from the R/B, i.e., leaks from PCV, can be considered as significantly large scale.

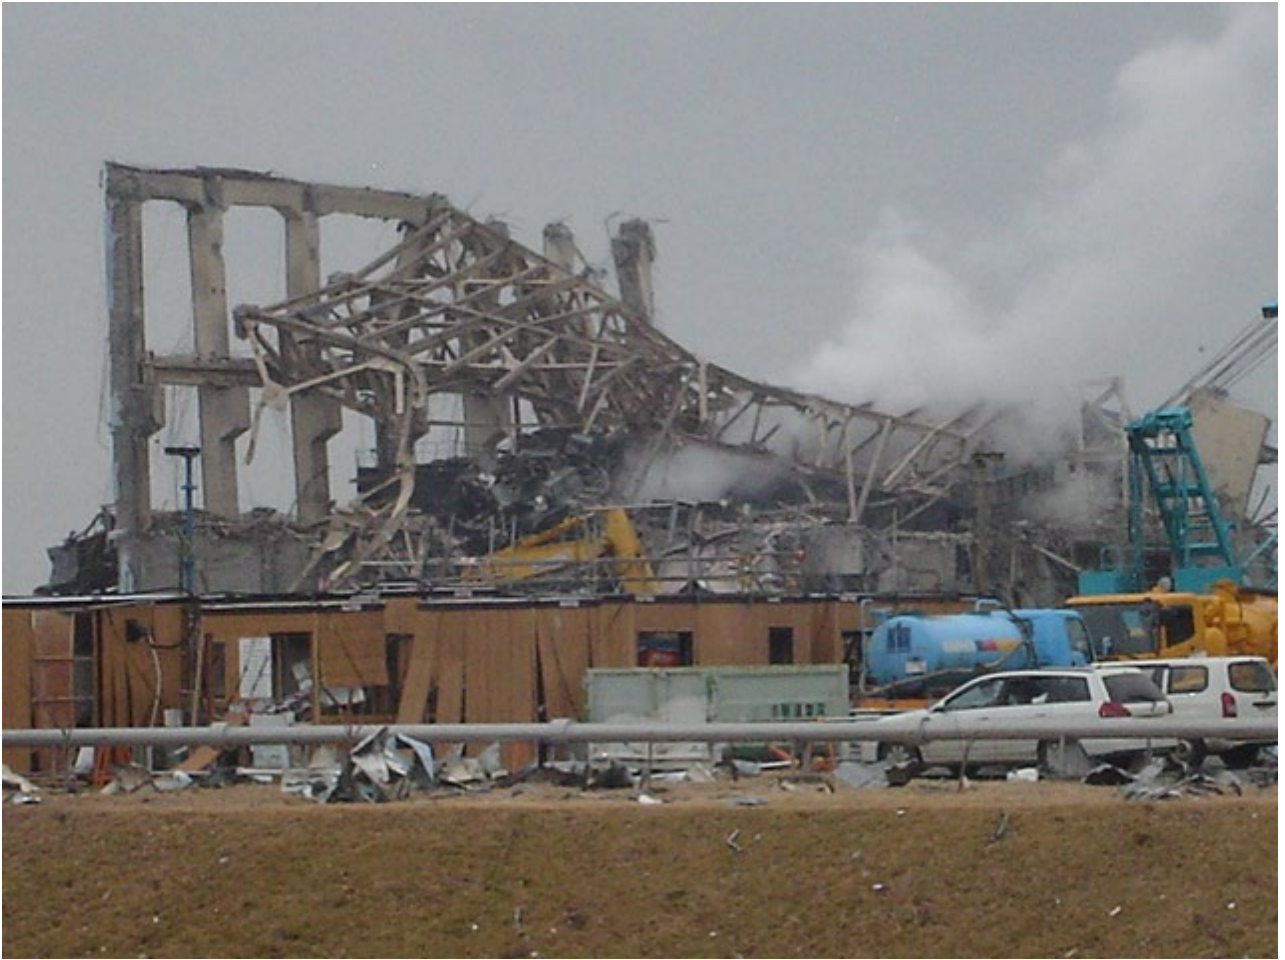
Figure 9 Steam release from Unit-3 (photographed at 07:31 on March 15th)

Figure 9 shows a photo taken by a digital camera in the morning of March 15th. It confirms that steam release from the top of Unit-3 R/B had started by this timing. The photo by the live camera at 07:00 on March 15th (Figure 5) also shows steam release. Therefore, the date information in the digital camera photo is roughly correct.

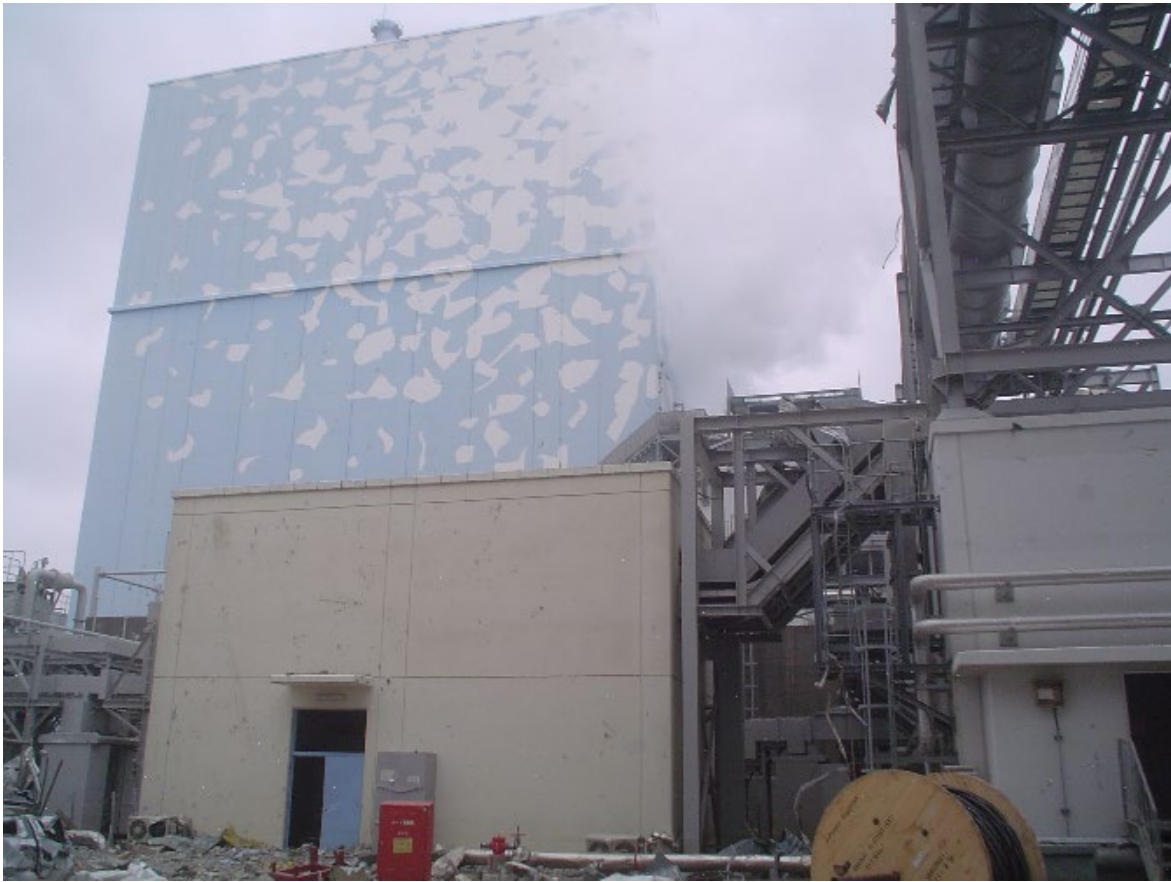
Figure 10 Steam release from Unit-2 (photographed at 08:58 on March 15th)

Figure 10 shows a photo of the Unit-2 R/B taken in the morning of March 15th. It is known that the blowout panel of the Unit-2 R/B opened at the time of the Unit-1 R/B hydrogen explosion and steam was being released through this blow-out panel. It is reported in Reference [1], too, that white smoke (like steam) was confirmed to be rising at 08:25 on March 15th from around the 5-th floor of the Unit-2 R/B. Therefore, this date information can be regarded as roughly correct.

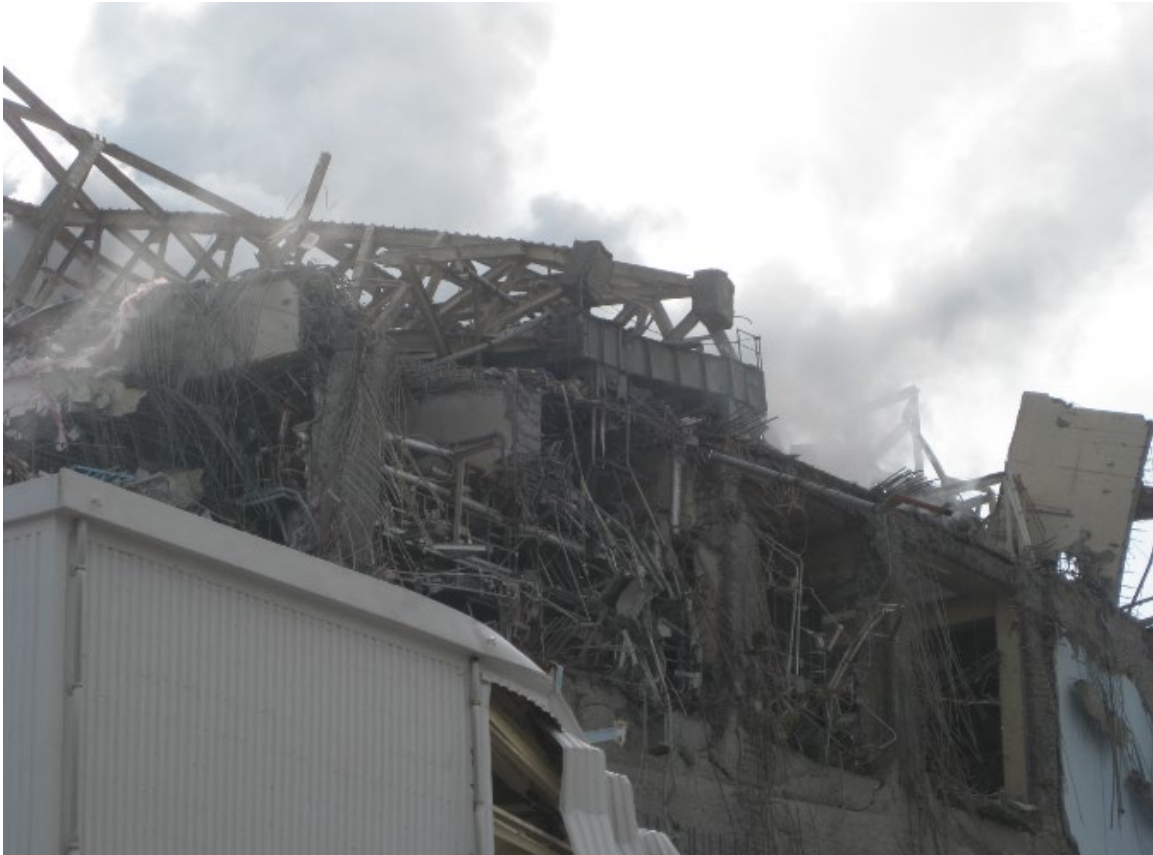
Figure 11 Steam release from Unit-3 (photographed at 09:51 on March 16th)

Figure 11 shows a photo taken in the morning of March 16th. It confirms that the steam release from the top of the Unit-3 R/B was still continuing. The amount of steam being released seems larger than that on the previous day. This is consistent with the live camera feed of 10:00 on March 16th. Therefore, this date information can be regarded as roughly correct.

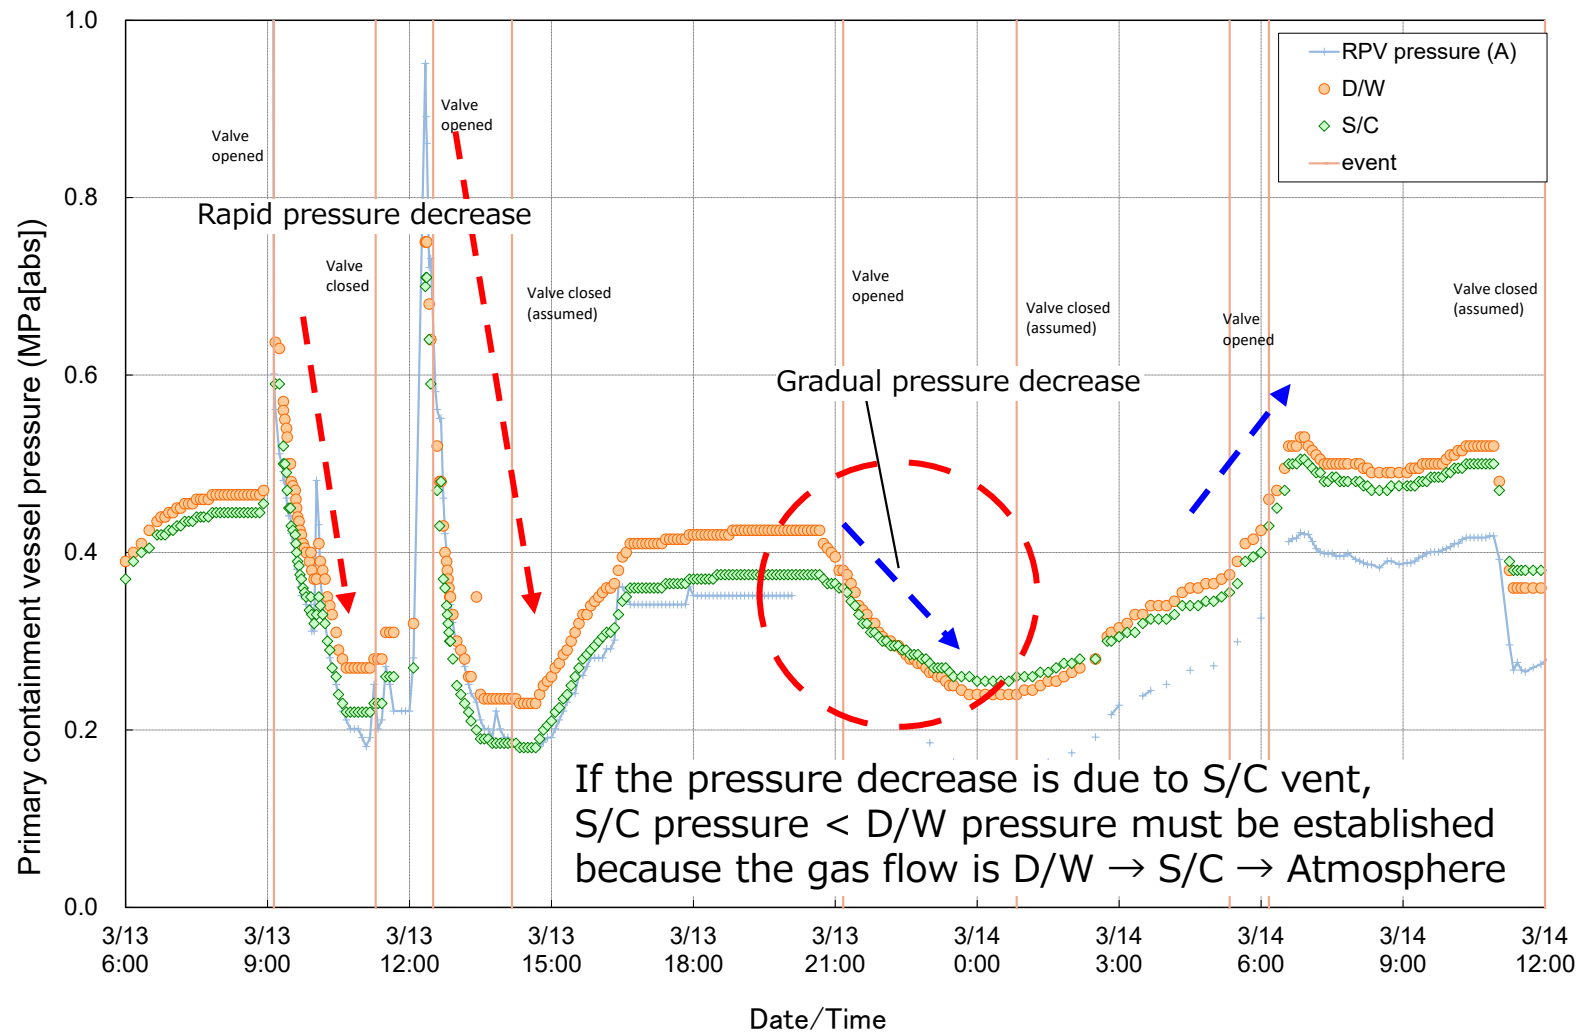
Figure 12 PCV pressure changes at Unit-3 (from 06:00 on March 13th to 12:00 on March 14th)

Figure 12 presents the PCV pressure changes over this time span. At Unit-3, the high pressure coolant injection system (HPCI) lost its water injection function before its manual shutdown (Attachment 3-3). Therefore, it is interpreted that the core was damaged by about 05:00 on March 13th and a large amount of hydrogen gas was being generated. This means the continuous PCV pressure increase till just before 09:00 is considered to be due to the inflow of non-condensable hydrogen gas into the PCV. At about 09:00 when the reactor was depressurized, the hydrogen gas in the reactor vessel was instantly released to the PCV and the PCV pressure increased high enough to activate rupture discs for venting.

At this first (1st) venting, the PCV pressure dropped fairly rapidly, about 0.4MPa in 90 minutes, that is, from 0.637MPa(D/W) and 0.590MPa(S/C) at 09:10 to 0.270MPa(D/W) and 0.220MPa(S/C) at 10:40.

At the second (2nd) venting, too, the PCV pressure dropped fairly rapidly, about 0.5MPa in 75 minutes, that is, from 0.750MPa(D/W) and 0.700MPa(S/C) at 12:20 to 0.235MPa(D/W) and 0.190MPa(S/C) at 13:35. The vent valves were judged based on the PCV pressure decrease to have opened, approximately when the reactor pressure increased rapidly to about 3MPa on the chart readings. The rapid PCV pressure increase prior to this timing could be explained by a scenario that, if the reactor pressure increase was this rapid, the PCV

From 19:00, at the mid-point of this time span, temporary compressors were connected for driving vent valves upon observing the PCV pressure increase. When the D/W pressure decreased at about 21:10, the vent valves were concluded to have opened (3rd venting). The PCV pressure decrease this time was very slow when compared with those of the 1st and 2nd vents: about 0.2 to 0.15MPa in 200 minutes from 0.425MPa(D/W) and 0.375MPa(S/C) at 20:40 to 0.240MPa(D/W) and 0.255MPa(S/C) at 24:00.

The relation between the D/W pressure and S/C pressure should draw more attention. At this timing the heat source is considered to exist in the D/W. It is reasonable, therefore, that the D/W pressure is higher than the S/C pressure. If gases are vented via the S/C, the gases move from the D/W to the S/C and then are released from the stack. In order to move gases from the D/W to the S/C, some pressure difference is required for the water to spill over in the S/C downcomer pipe. It is physically reasonable that there is a difference of about 0.05MPa between the D/W and S/C pressures until about 21:00. But, the pressures were reversed at 22:30 as 0.285MPa(D/W) and 0.290MPa(S/C) and at 24:00 the S/C pressure exceeded that of the D/W by 0.015MPa. If the PCV pressure had decreased by venting, gases must have moved from lower pressure points to higher pressure points, which is physically impossible.

It would be more natural, therefore, to interpret as follows: the cause of the PCV pressure decrease at the occasion assumed as the 3rd venting should be shifted to the D/W side, not by venting. Leaks from the D/W would be most probable from the PCV upper head due to deterioration of seal materials by the high temperature environment.

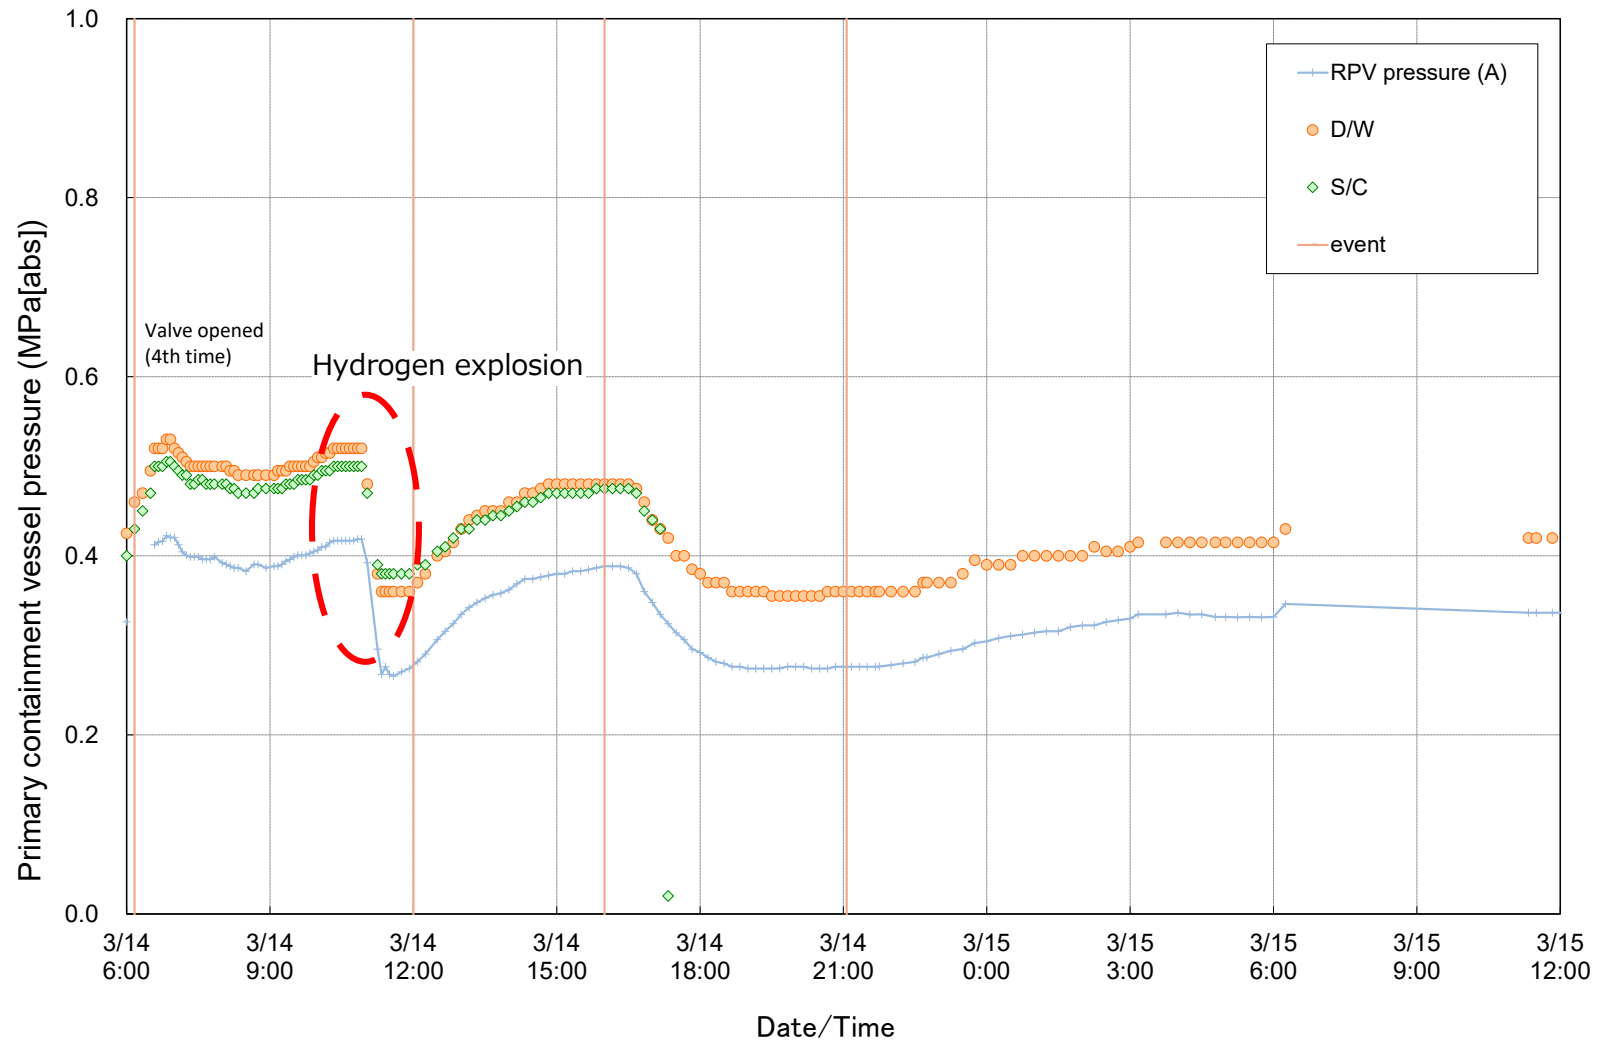
Figure 13 PCV pressure changes at Unit-3 (from 09:00 on March 14th to 12:00 on March 15th)

The pressure changes over this time span are shown in Figure 13. During this period, Unit-3 experienced the hydrogen explosion at 11:00 on March 14th. This explosion occurred due to the hydrogen gas leaked to the R/B. It is consistent with the actual accident progression to assume that the leak from the PCV to the R/B started by the time of the 3rd vent operation.

It should be noted that the PCV pressure dropped largely at the hydrogen explosion occurrence. The reason of this pressure decrease is not clarified. The D/W and S/C pressures are reversed again. If leaks occurred from the PCV, it would be from the D/W.

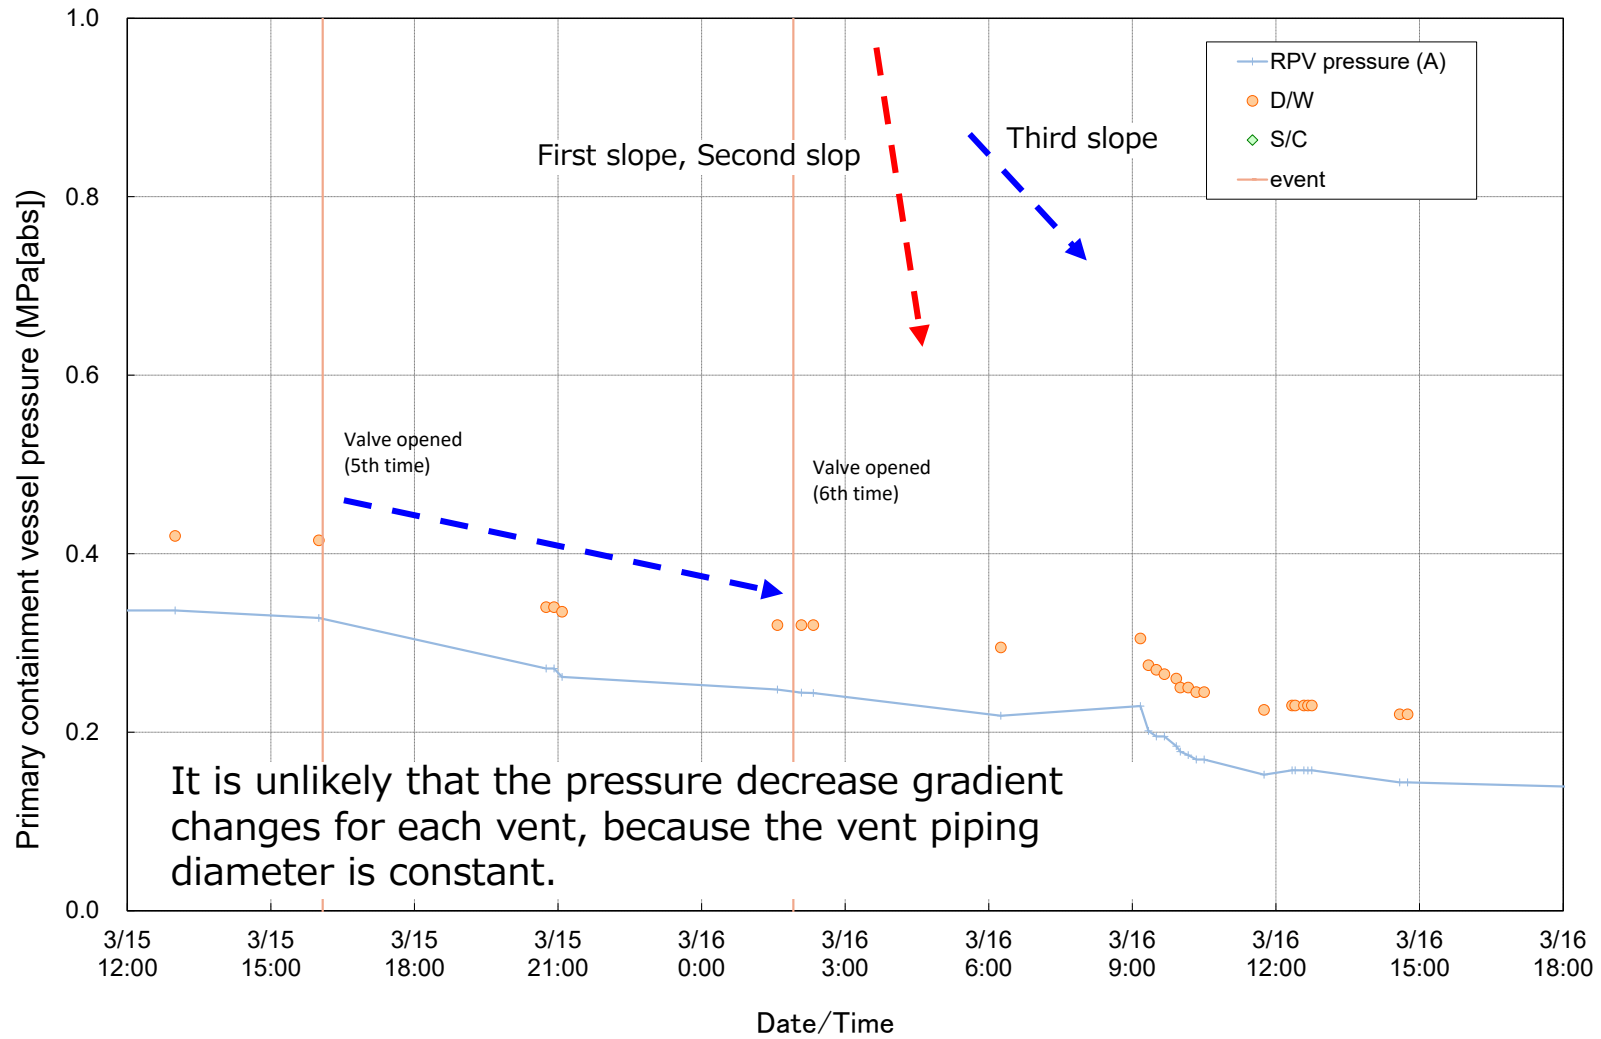
Figure 14 PCV pressure changes at Unit-3 (from 12:00 on March 15th to 18:00 on March 16th)

The pressure changes over this time span are shown in Figure 14. During this period, the 5th vent operation was implemented according to the records. The relevant part of Annex 2 to Reference [1] is cited below.

Although the opening operation of vent valves was taken, the result is not clarified. As a matter of fact the PCV pressure decrease of about 0.1MPa during 5 hours was lower than the anticipated rate by venting: from 0.415MPa(D/W) at 16:00 to 0.335MPa(D/W) at 21:05, although no data are available for the S/C pressures. From the morning of March 15th, steam release was continuously recognized from the top of Unit-3 R/B as shown in Item 2 above. Therefore, the PCV pressure decrease of this low rate probably comes from the direct release from the PCV.
