Estimation of status inside reactor pressure vessels
and containment vessels
after the accident at the Fukushima Daiichi Nuclear
Power Station

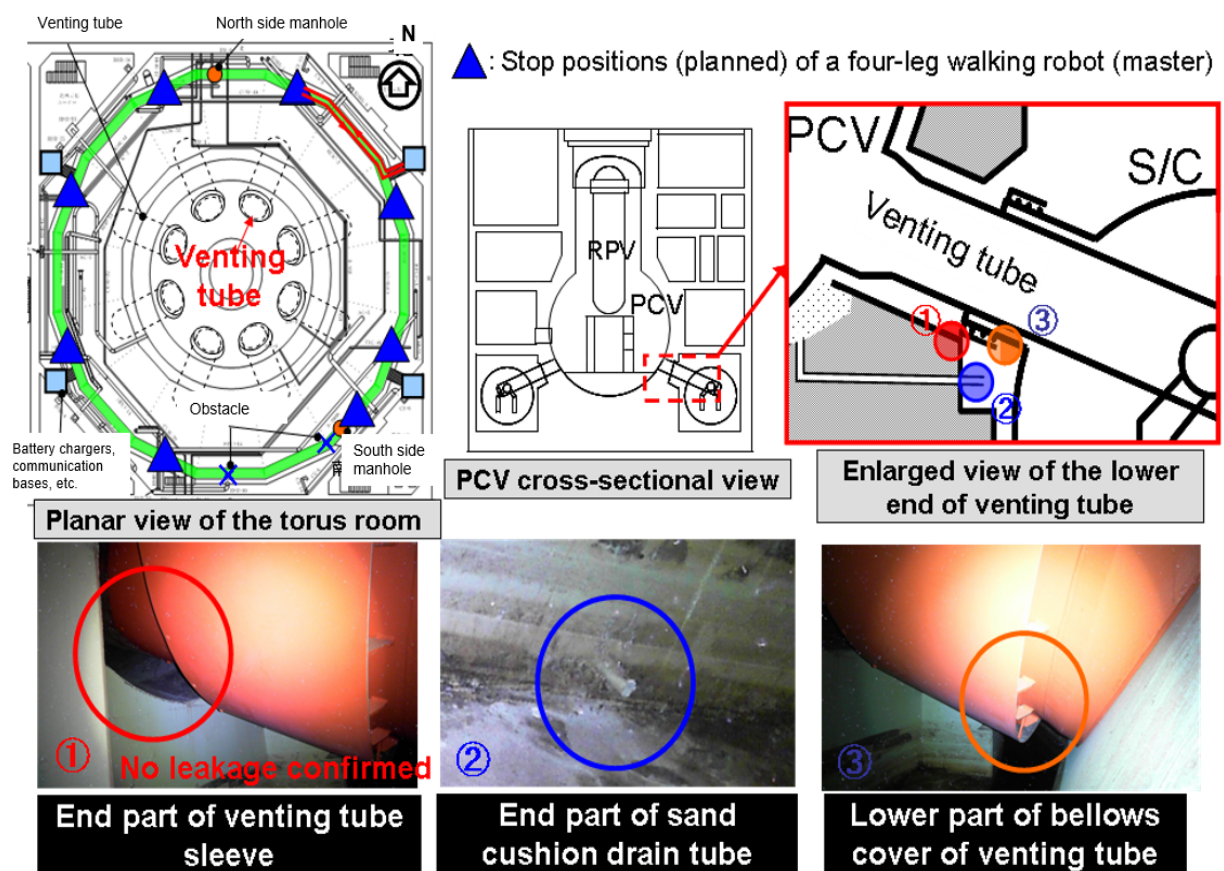
Figure 4.2.2-4 Camera images of the lower part of venting tube in Unit 2 torus room (excerpt) [2-4]

Although the location of the liquid phase leakage of the S/C was not identified, it was confirmed that there was no leakage from the lower end of the venting tube within the area that could be imaged (Figures 4.2.2-4 and 4.2.2-5).

※2
Sound information was also obtained.
No sound like leakage was confirmed at this time.

Based on the above, no observations indicating a behavioral tendency of D/W shell damage were confirmed, and even if the fuel debris that fell to the bottom of the PCV had reacted with the concrete, the extent of this reaction would have been limited.

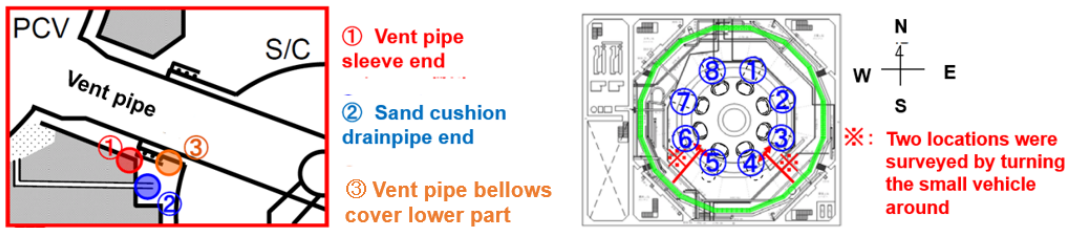
Figure 4.2.2-5 Investigation results around the lower part of the vent pipe in Unit 2 [2-4]

Note: ○ no leakage

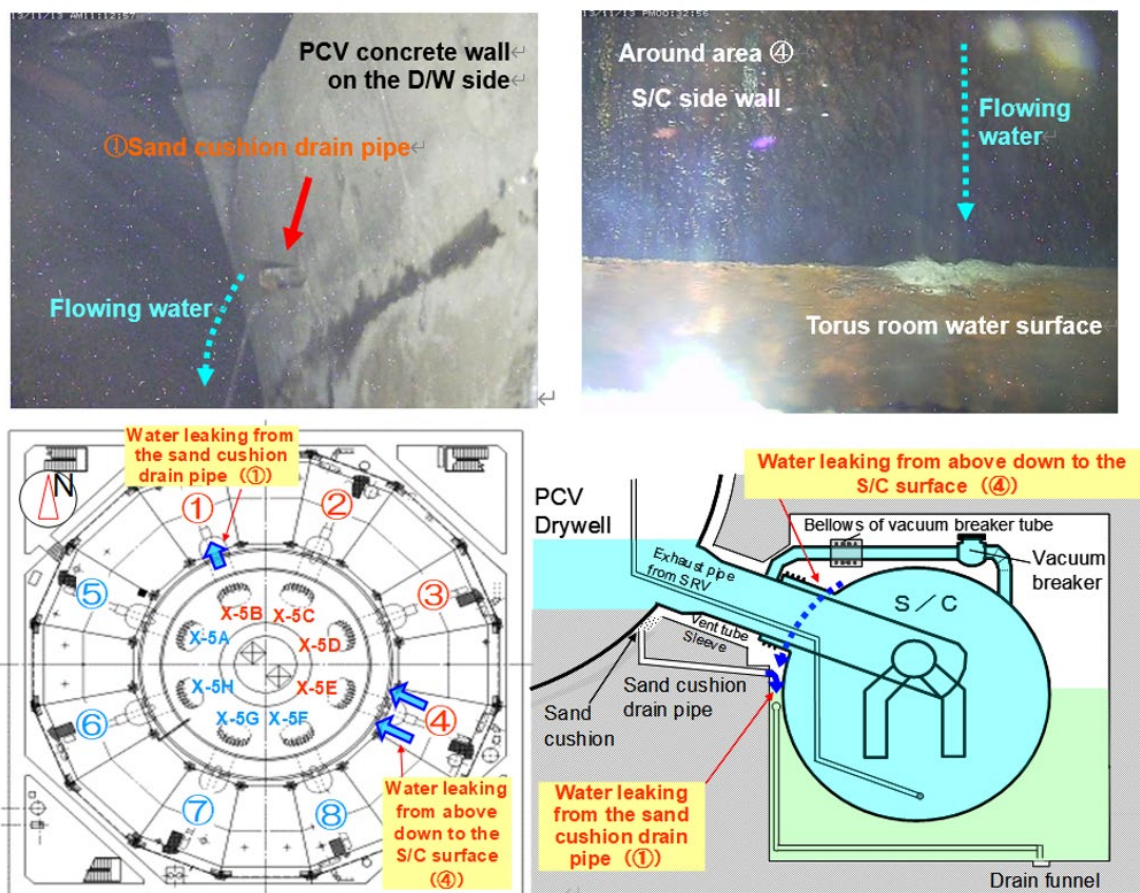
Figure 4.3.1-2 Camera images from the lower part of the torus room vent survey in Unit 1 (excerpt) [1-7]

* The sand cushion drainpipe connecting to ① in the figure was disconnected from the PVC piping (piping connecting the drainpipe to the drain funnel and connected by a plug-in joint), and water flow could be confirmed; however, ② through ⑧ drainpipes were not disconnected, so the presence of water flow could not be determined. In addition, it was observed to be wet all around the concrete joint under the sand cushion drainpipe.

Water intrusion into the sand cushion section occurs when there is a direct leakage from the D/W section, and the leakage point is considered to be at a low location below the water surface of the D/W (e.g., at the D/W shell or pipe penetration). This information is very important for estimating the state of the core and PCV.

In addition, water flowed from both sides of the X-5E vent piping through the surface of the S/C, suggesting that the leakage was coming from the vacuum breaker tube directly above the vent piping (e.g., the vacuum breaker tube bellows). The height of the bottom of the vacuum breaker tube is about 8.2m from the bottom of the S/C. This is the height at which the D/W water level stopped rising and leveled off when the amount of water injected into the reactor was increased to flood the D/W in May 2011, which was thought to be the height at which the leak port was located. The height of the leak (about 8.0m from the bottom of S/W) is almost the same as the height of the D/W (about 7500mm O.P. in Figure 4.3.1-3), where the leak was thought to occur.

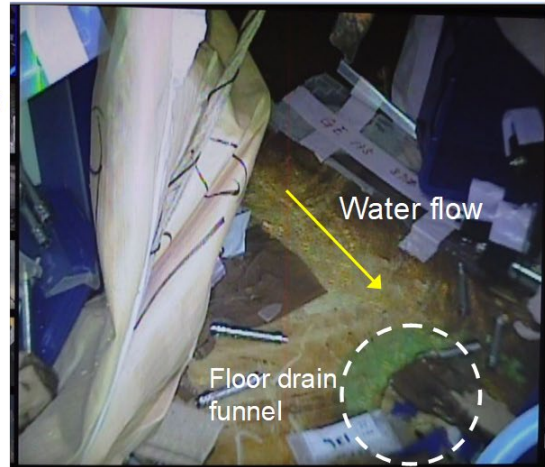
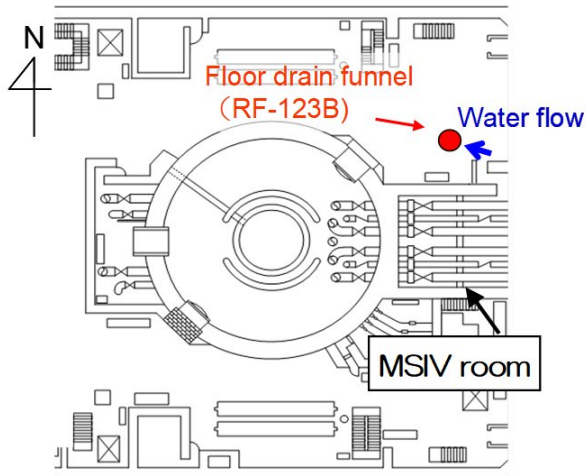
Figure 4.3.3-4 Confirmation of water leakage from near the MSIV room door of Unit 3^[3-5]

In January 2014, while checking camera images from the Unit 3 reactor building debris removal robot, it was confirmed that water was flowing from near the door of the MSIV room in the northeast area of the first floor of the reactor building toward the floor drain funnel installed in the vicinity (Figure 4.3.3-4).

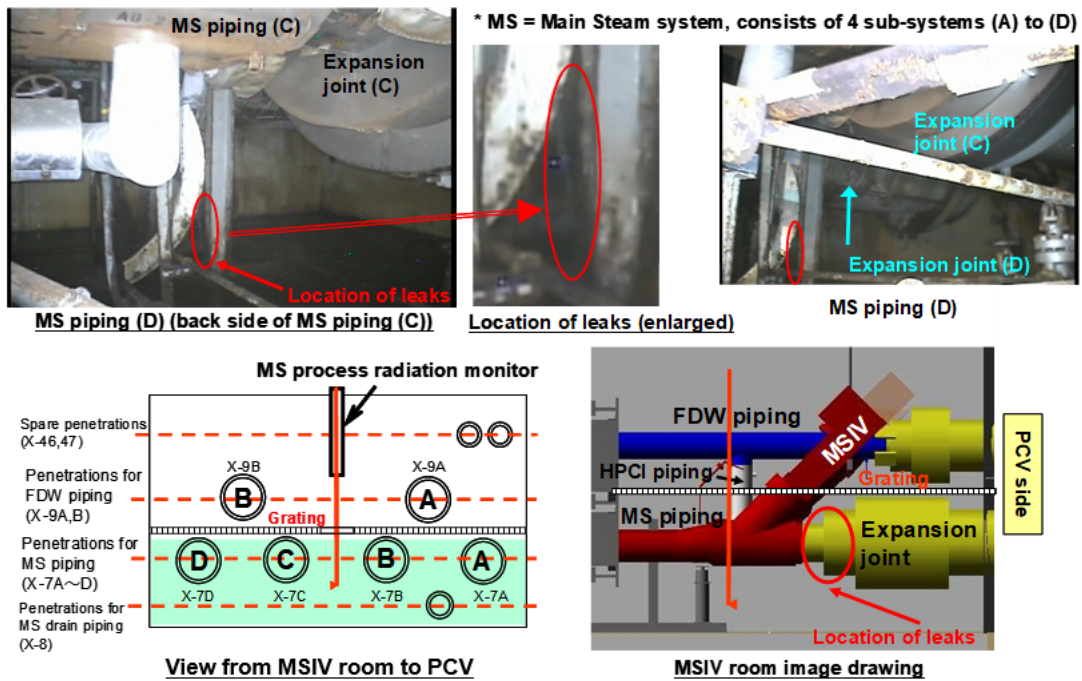
Figure 4.3.3-5 Confirmation of water leakage from main steam piping D in the MSIV room of Unit 3 [3-6]

The water level in the PCV (D/W) was about O.P. 12m (about 2m above the first floor of the reactor building), which is about the same height as the PCV penetration of the main steam piping, and it was estimated that the source of the water flow could be liquid phase leakage from the PCV penetration in the MSIV room. Therefore, in April and May 2014, to identify the source of the flowing water in the MSIV room, a device was inserted from the HVAC room on the second floor of the reactor building, and camera photography and dosimetry were conducted in the room. As a result, leakage was confirmed from around the expansion joint of the main steam piping D. No leakage was confirmed from main steam pipings A, B, C, or the main steam drain piping, and judging from the water flow on the floor, the leakage point was estimated to be only in main steam piping D (Figure 4.3.3-5).

The estimated height of the D/W water level in Unit 3 and the expansion joint height of the main steam piping D are about the same, and this height is considered to be the main leakage point of the water inside the D/W.

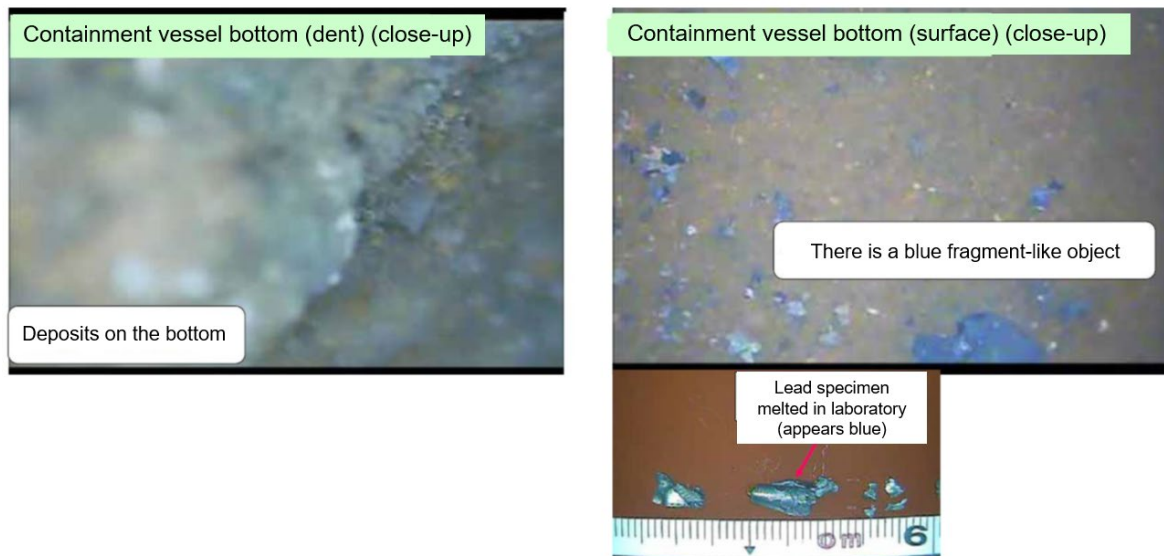
Figure 4.6.1-3 Images gotten on the PCV floor [1-14]

In October 2012, a CCD camera was inserted from the X-100B penetration to obtain images of the inside of the PCV (Figure 4.6.1-3). It was confirmed that deposits had accumulated at the bottom, but the matter was not identified. In addition, a blue fragment-like object was observed in the deposits, which is thought to be melted lead.

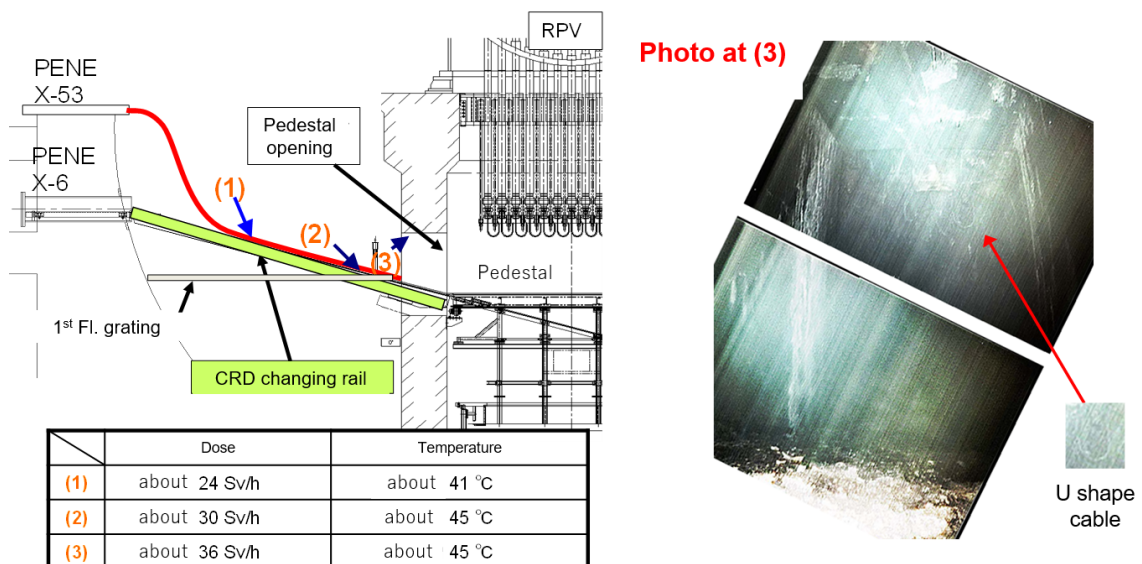
Figure 4.6.2-4 Images of the inside of Unit 2 pedestal [2-9][2-12]

- ④ The center of the CRD housings under the RPV is estimated to be damaged and fuel debris is inside these CRD housings.

As shown in Figure 4.6.2-4, survey equipment was deployed from the X-53 penetration in August 2013 to investigate the CRD replacement rail and the area near the RPV pedestal opening. U-shaped cables can be observed in the photograph taken from point (3) in Figure 4.6.2-4 looking into the pedestal. Next, Figure 4.6.2-5 shows the inside of the pedestal of Unit 5. The photo on the left was taken from the same angle as the photo in Figure 4.6.2-4, and the U-shaped cable can be observed as in Unit 2. Therefore, since the CRD housings do not appear to be damaged at the confirmed outer perimeter, it is estimated that the center of the housings was damaged.
