Start of Internal Investigation of the Fukushima Daiichi Nuclear Power Station Unit 2 Spent Fuel Pool (SFP)

<Reference Document>
June 10, 2020
Tokyo Electric Power Company Holdings, Inc.
Fukushima Daiichi Decontamination &
Decommissioning Engineering Company

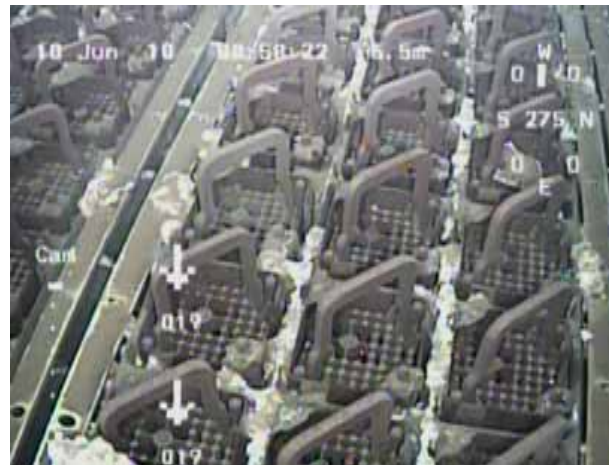
- During this investigation, we examined the condition of fuel, the area above the fuel rack, the pool gate and the surge tank inlet using a submersible Remotely Operated Vehicle (ROV). At current time, we have not encountered any circumstances that have the potential to interfere with fuel removal, such as damage to the fuel rack or fuel handles. However, we will carefully examine the photos that were taken.

【Fuel and area above the fuel rack in the SFP】

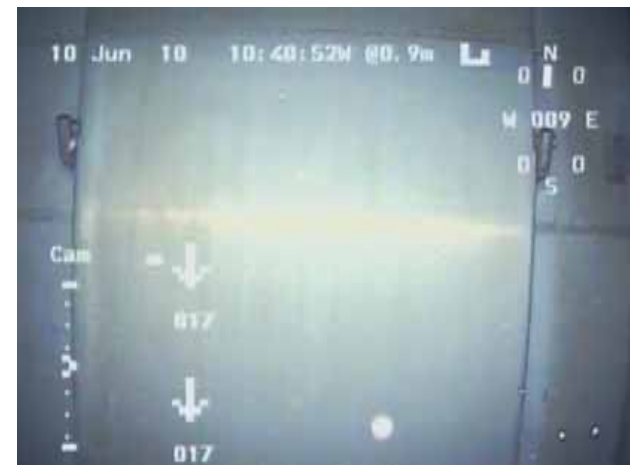
【Pool gate in the SFP】
