# Unit 2 Spent Fuel Pool Internal Investigation Results

July 2, 2020

Tokyo Electric Power Company Holdings, Inc.

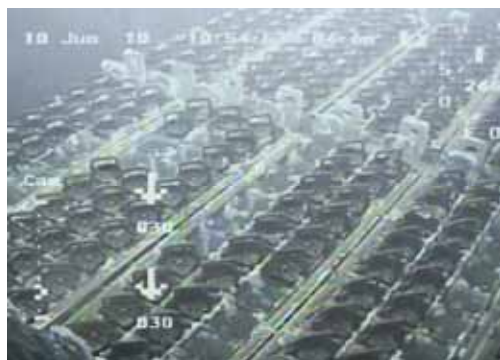
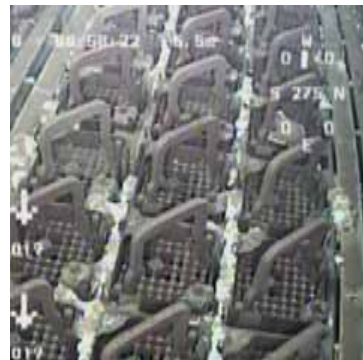
Fuel handles

Fuel handles (enlarged)

- No fuel handle deformation
- Thin paint fragments or tarps were found on the fuel but they are light and should be easy to remove, so there should be no impact on fuel removal. (Page 6)
- White deposits generated by the aluminum alloy fuel rack when seawater was injected during the disaster were found just like at Unit 3, but these deposits will not hinder removal.

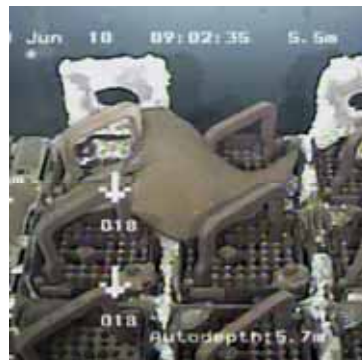
Obstructions on the fuel handles

Investigation target	Issue	Proposed countermeasure
① Fuel/fuel rack	<ul style="list-style-type: none"> <li>• Some tarp-like obstructions found on top of the fuel may interfere with grasping the fuel handles.</li> </ul>	<ul style="list-style-type: none"> <li>• Methods for removing the obstructions from the top of the fuel with gripping or suction tools and the like will be examined</li> </ul>
② Cask pit	<ul style="list-style-type: none"> <li>• Sandy deposits were found at the bottom of the cask pit that may make the casks unstable when put on the bottom and may also contaminate the surface of the casks.</li> </ul>	<ul style="list-style-type: none"> <li>• The sandy deposits will be removed with suction equipment and the like in accordance with how the casks are to be handled</li> </ul>
③ Control rods/control rod hangers	None	—
④ Pool gate	None	—
⑤ Skimmer surge tank entrance	None	—

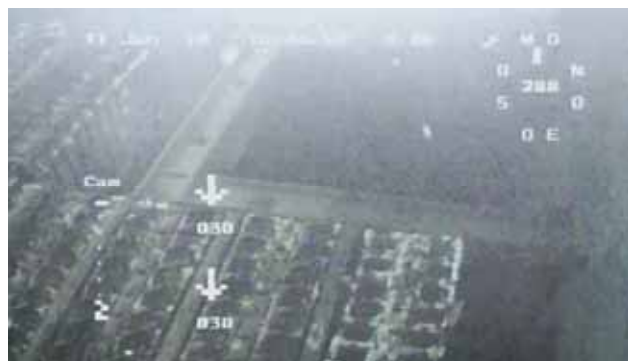
Girders at the top of the cask pit

- No deformation to cask pit girders
- Although sandy deposits were found at the bottom, there are no large obstructions so the impact on fuel removal should be small.

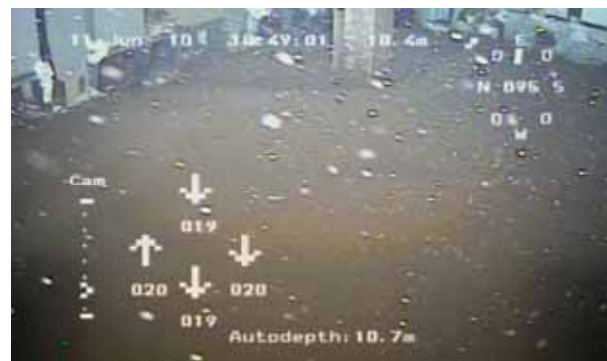
Bottom of the cask pit

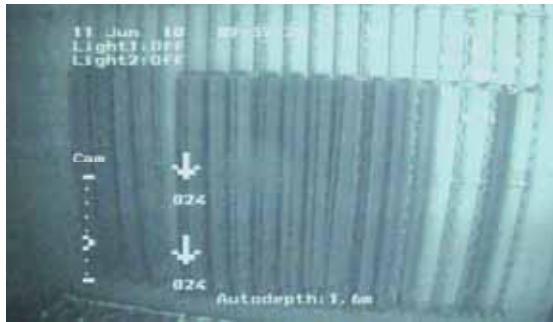
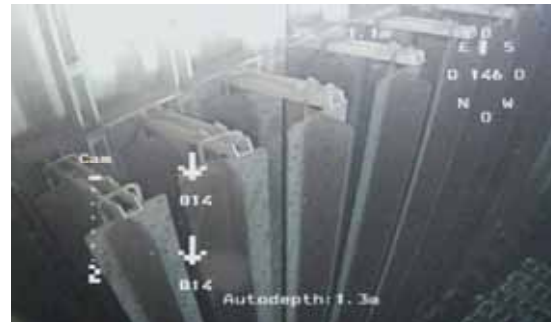
Control rods and control rod hangers

Control rod hangers (northeast side)

- Control rods are hanging on control rod hangers as normal, and no deformation or corrosion of the hangers was found

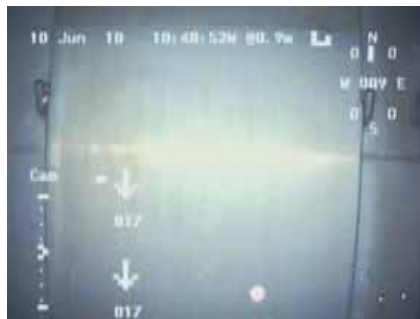
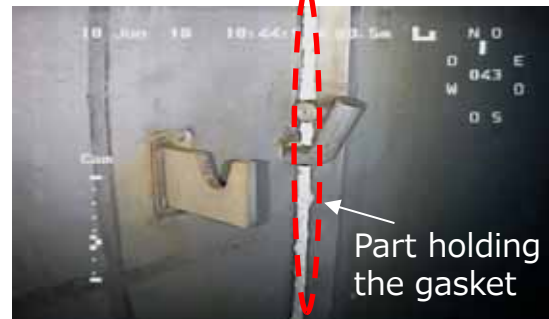
Front of pool gate

Pool gate support axis

- There is no deformation or leaning of the pool gate
- White products were found on the parts holding in the gaskets, but they are the same aluminum alloy as the fuel racks and it is assumed that they were formed the same way. Furthermore, the silicon seal that keeps the pool gate watertight has not been affected.

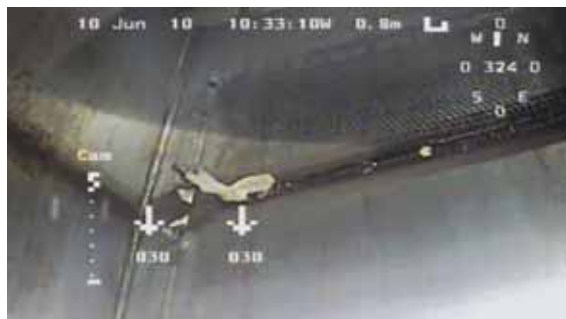
Front of skimmer surge tank entrance (northwest side)

- Thin paint fragments were found floating on the top of the water by the metal screen of the skimmer surge tank entrance, but they are not blocking the flow and are not having an effect on pool cooling.
- One of the bolts on the skimmer surge tank entrance (northwest side) movable weir is deformed and the nut has fallen off, but the three remaining bolts/nuts are intact and pool water level has not been affected.

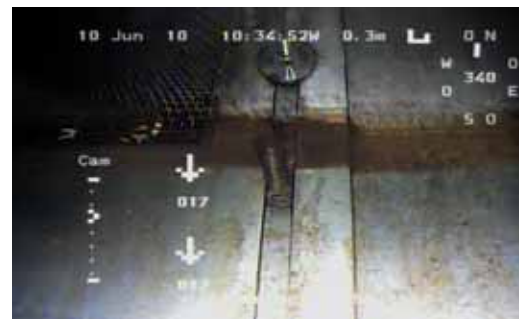
Movable weir bolts (bottom right of northwest side)

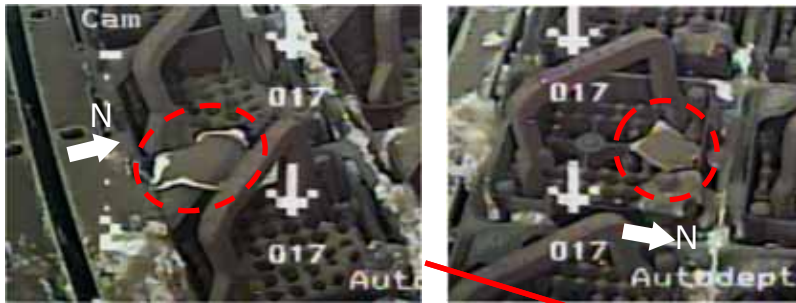
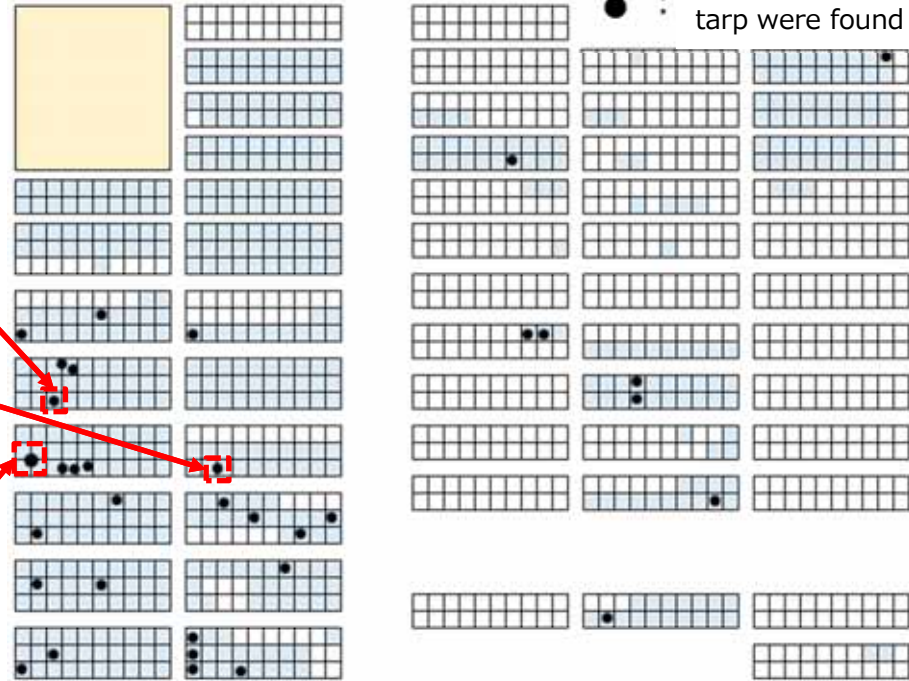
<Example of paint fragments found>

<Largest tarp fragments found>

- Dimensions: Approx. 200x250mm
- Thickness: Approx. 1.5mm

- The tarps that had been attached to railings around the SFP as part of foreign material exclusion measures cannot be found and correspond in thickness to the pieces of tarp found during this investigation, so it is assumed that some of these tarps fell into the SFP during the disaster.

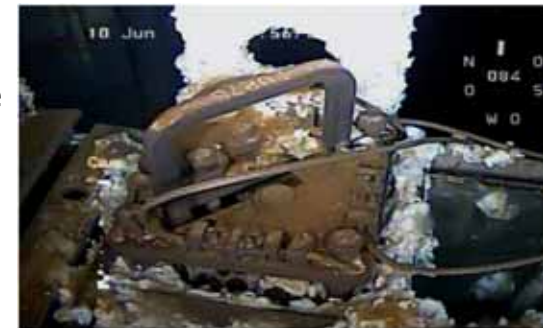
- The top of this fuel assembly was checked during this investigation and within the scope that the submersible ROV could see, no cut wires or displaced anchoring jigs were found.

TOP of wire-repaired fuel

- How to handle this fuel assembly is to be deliberated in light of the results of corrosion tests currently being performed on the wire that was used to repair it. A hoisting test will also be performed prior to handling this fuel assembly to ensure that it can be hoisted.
