# Seismometers installed in the Fukushima Daiichi NPS Unit 3 reactor building (Recommencement of trial usage)

March 19, 2021

Tokyo Electric Power Company Holdings, Inc.  
Fukushima Daiichi D&D Engineering Company

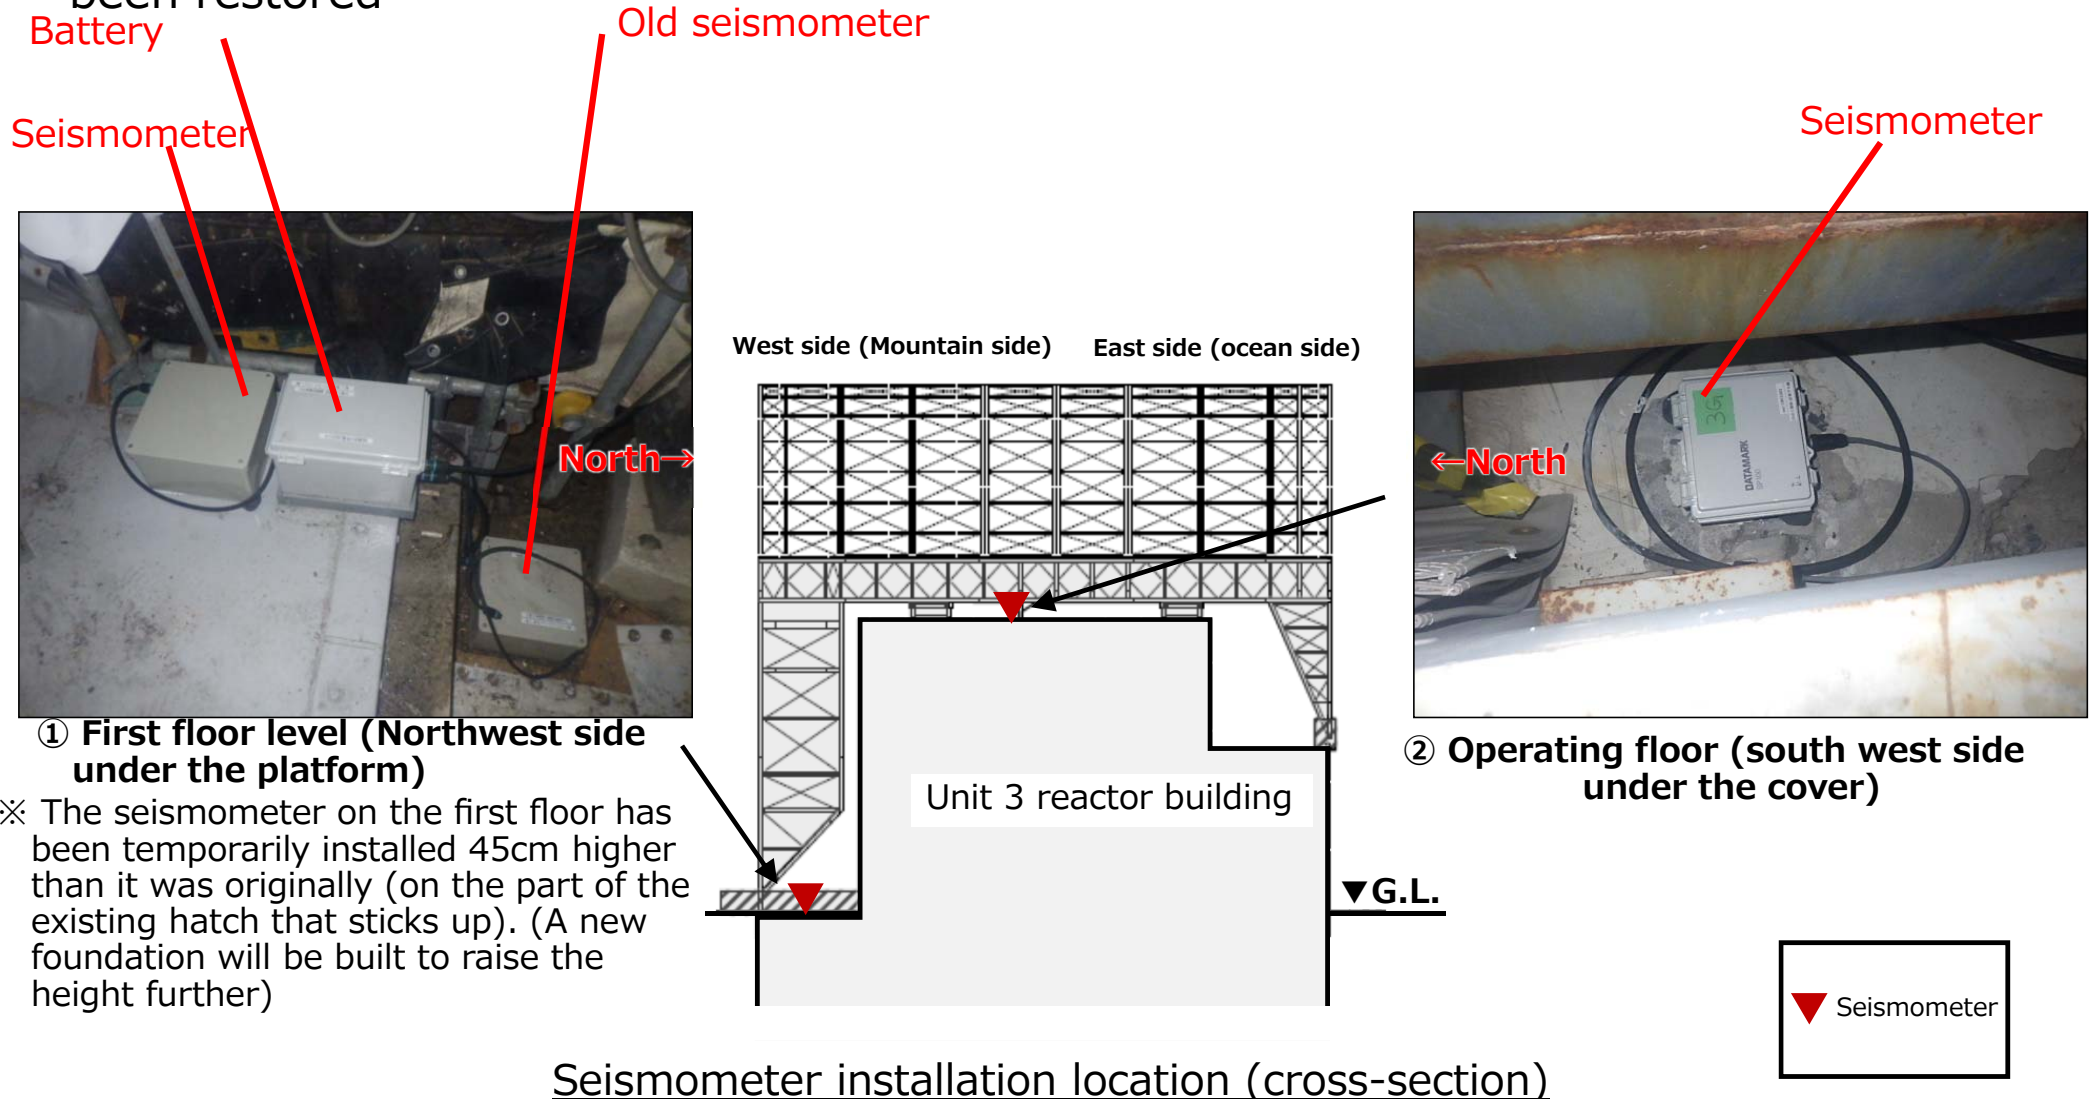
## Seismometer installation status (cross-section)

- Seismometer function on the first floor and the operating floor of the Unit 3 R/B has been restored

○As a rain countermeasure for the seismometer on the first floor, a new foundation (height: approx. 55cm) will be built to raise the installation location, but for now the new seismometer has been temporarily installed in a higher location (on the part of the existing hatch that sticks up) in order to quickly recommence data gathering.

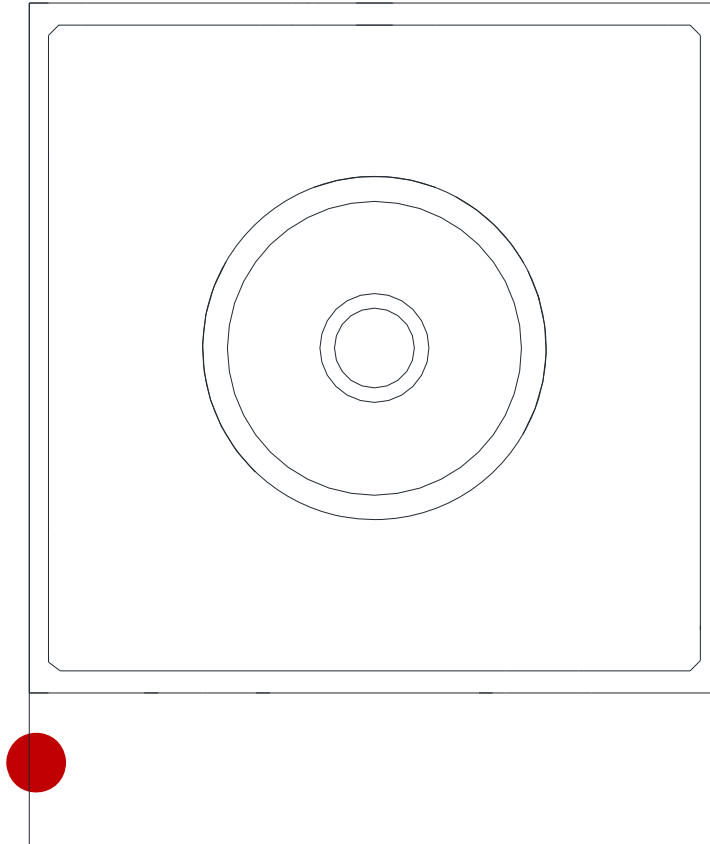
First floor level

※The repaired seismometer on the first floor is located approximately 50 cm to the south than it was originally

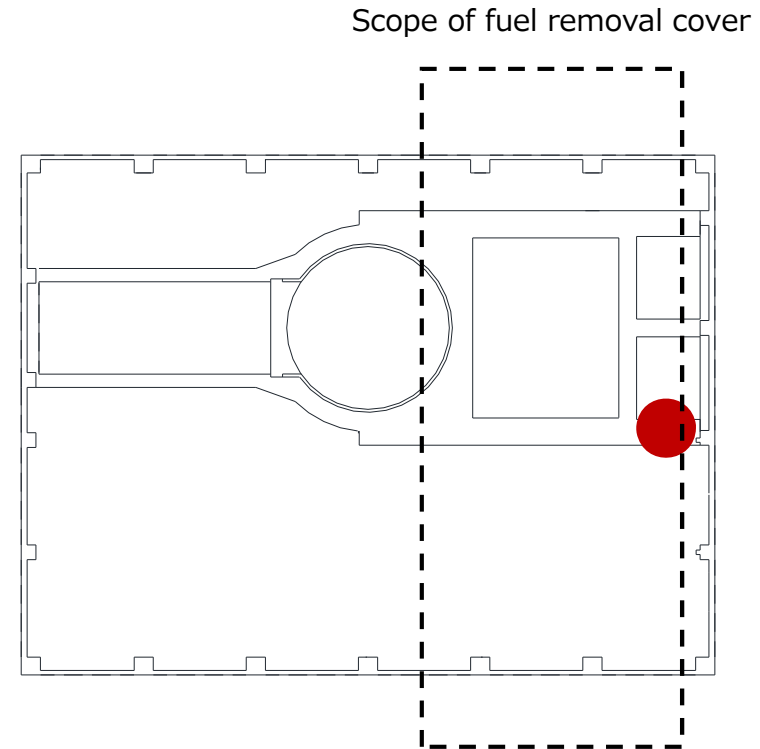
5<sup>th</sup> floor operating floor

※The repaired fifth floor seismometer is in the same location it was written

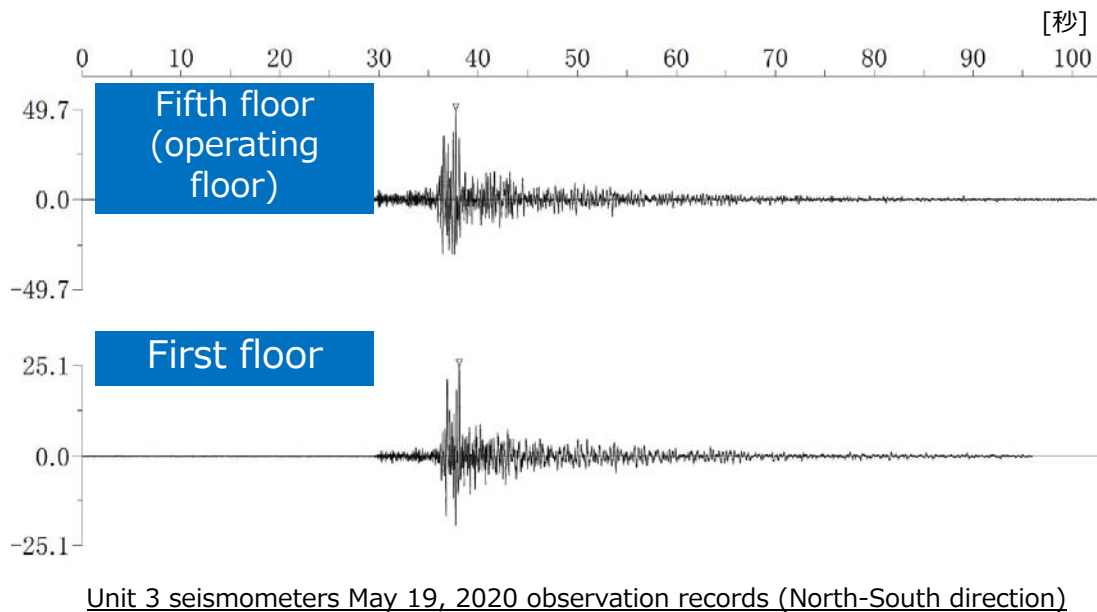
List of observation records for May 19, 2020

- The accelerations cannot be simply compared because the structure of the buildings and the seismometer installation locations differ, however the maximum acceleration seen at Unit 3 was not especially different from that seen at Units 5 and 6.
