Conditions at the Fukushima Daiichi Nuclear Power Station after the earthquake on March 20

Conditions after the earthquake

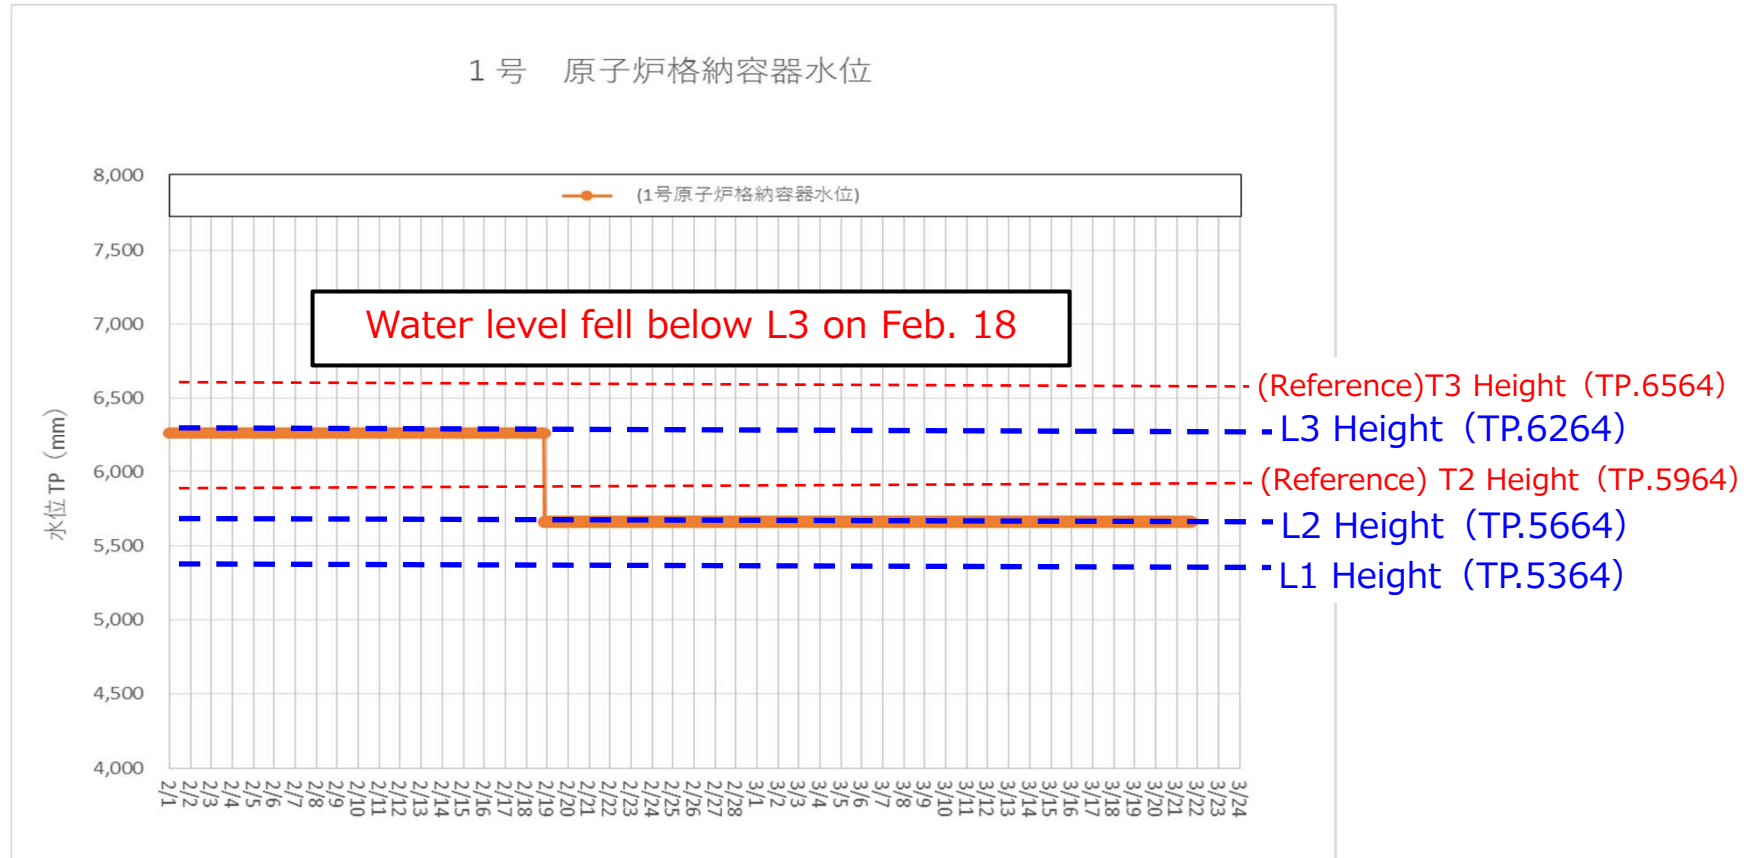
Water level inside the Unit 1 primary containment vessel

- As shown below, no significant changes have been seen with the water level inside the Unit 1 primary containment vessel.
- Current water level is between the installation locations of temperature gauge T2 (T.P.+5, 964mm) and water level gauge L2 (T.P.+5, 664mm) (The bottom of the primary containment vessel is at T.P.+4, 744mm)
- * When the earthquake occurred, the contact point of the L2 water level gauge inside the Unit 1 primary containment vessel temporarily shifted (for several seconds), but immediately returned to its original location. This was a temporary event and did not indicate a drop in primary containment vessel water level, but rather movement of the water surface caused by the earthquake.

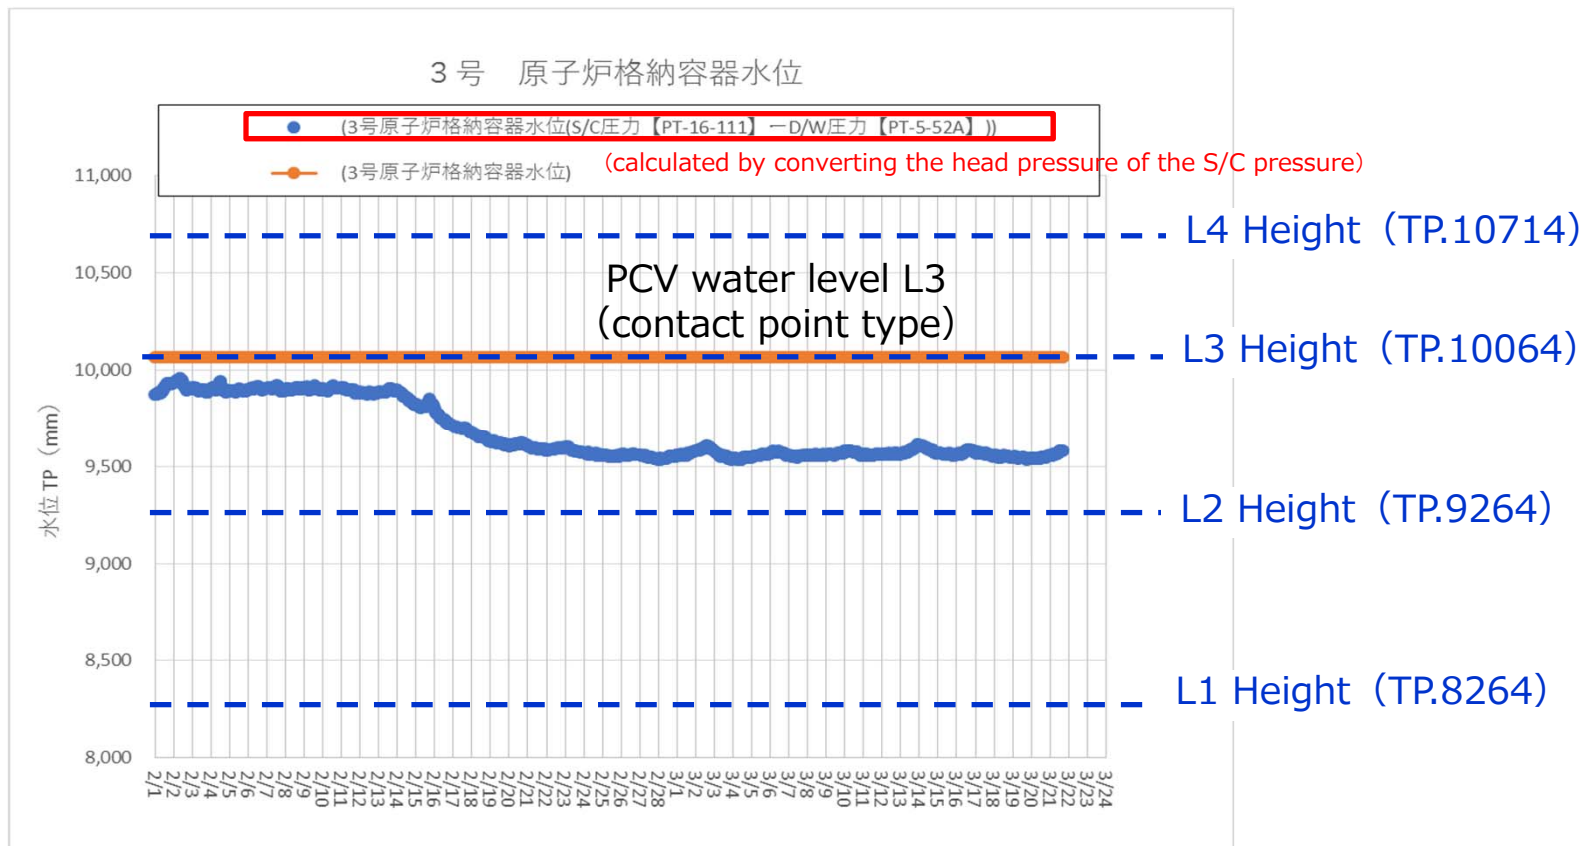
Water level inside the Unit 3 primary containment vessel

- As shown below, no significant changes have been seen with the water level inside the Unit 3 primary containment vessel.
- Current water level is between the installation locations of water level gauge L3 (T.P.+10, 064mm) and water level gauge L2 (T.P.+9, 264mm) (The bottom of the primary containment vessel is at T.P.+4, 044mm)
- * Primary containment vessel water level (calculated by converting the head pressure of the pressure in the pressure suppression chamber) was at T.P.+9, 553mm after the earthquake (9 PM, March 20) and has not fluctuated significantly compared to prior to the earthquake (4 PM on the same day:T.P.+9, 542mm). (Data fluctuation caused by the impact of atmospheric pressure, etc.)

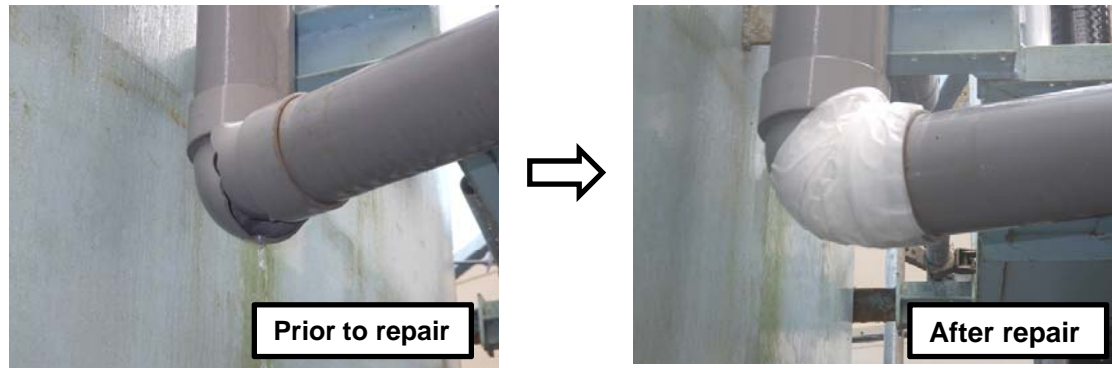
ODamage to rain gutters installed on tanks in the Unit 5/6 tank area F

- Date of occurrence (Time discovered): Around 1:43 AM, March 21
- Overview: Damage was found to one of the rain gutters on tank K4 in tank area F
- Handling: The pipe was temporarily repaired at 11 AM on March 21. A permanent repair will be made in the future.

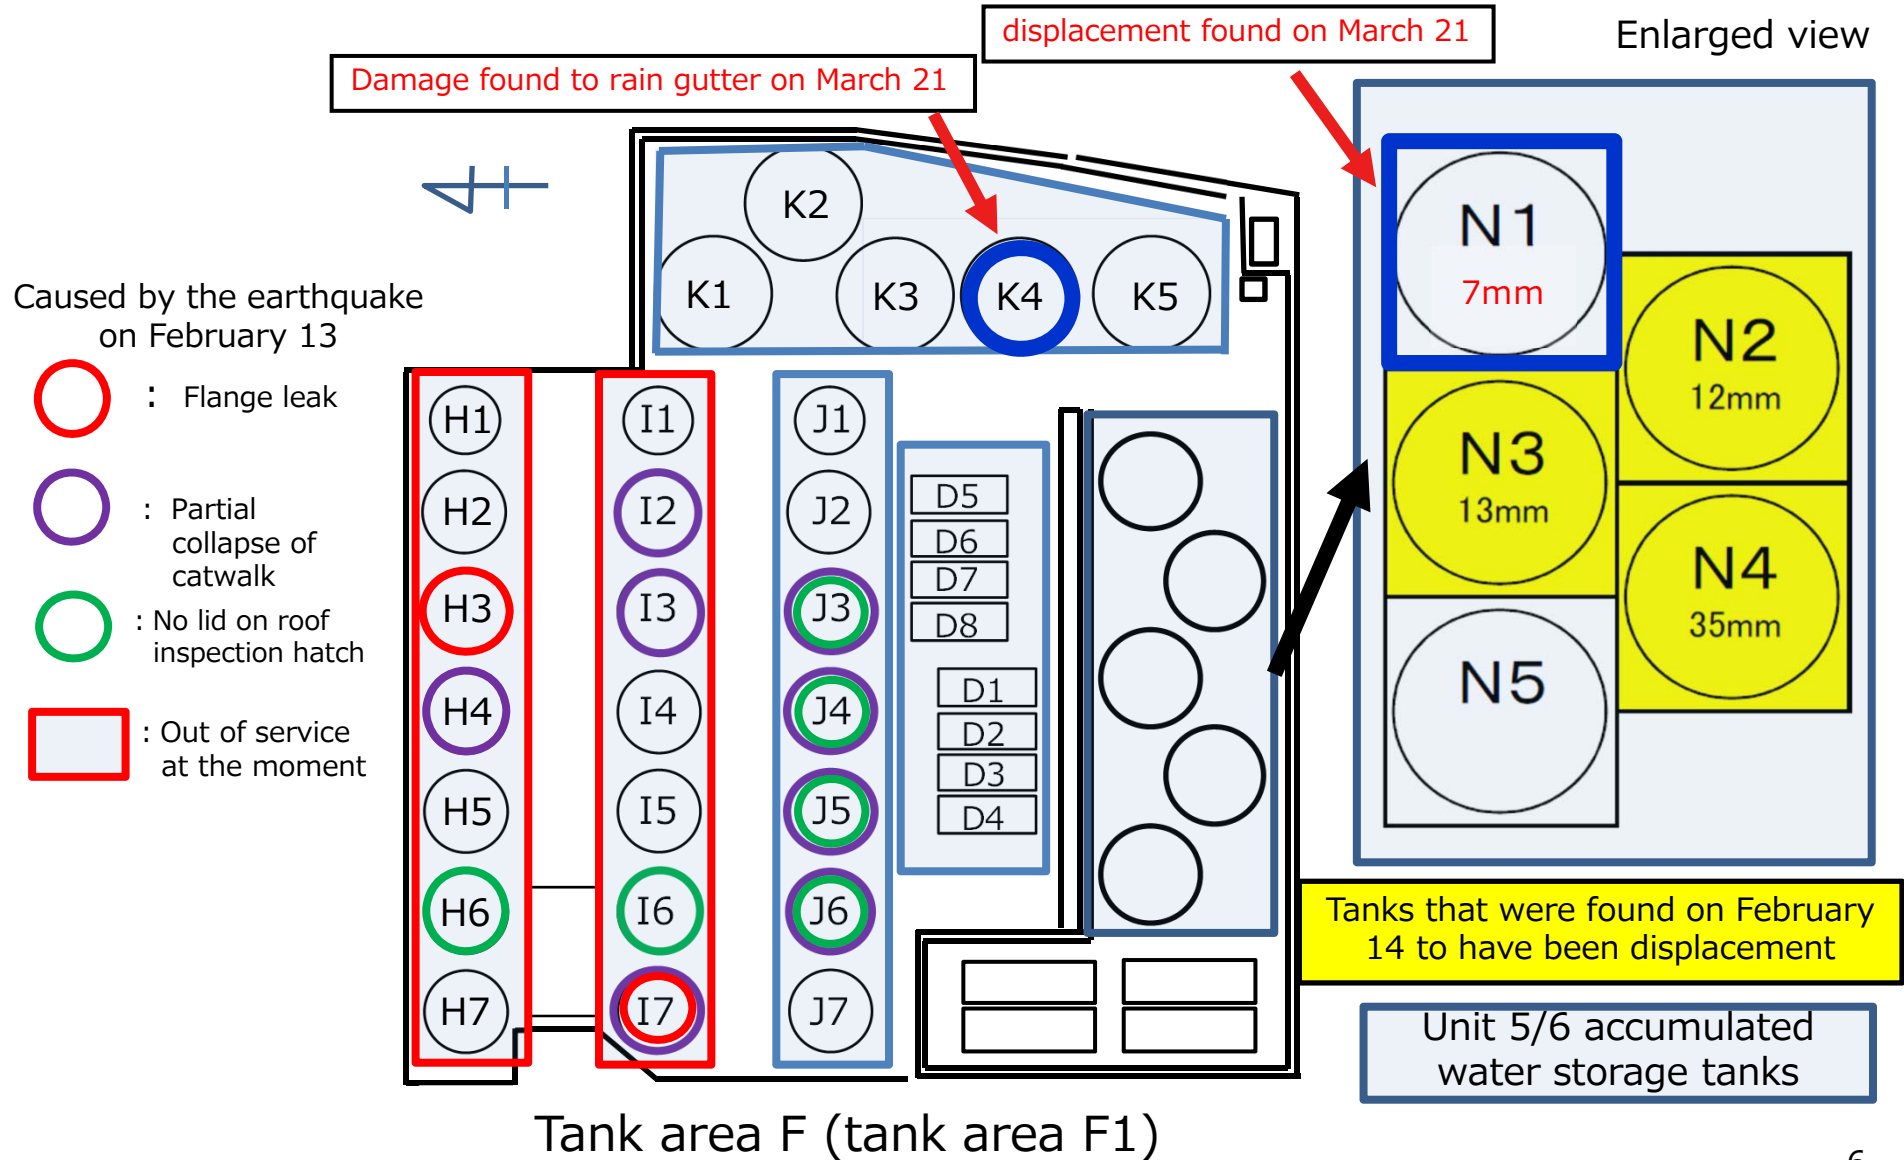
Tank area F tank diagram

O7mm displacement found at one of the tanks in the Unit 5/6 tank area F

- Date of occurrence (Time discovered): Around 10:30 AM, March 21
- Overview: The N1 tank in tank area F was found to have been displaced slightly. Although the detailed inspection discovered slight displacement of one tank in the tank area F (7mm), there has been no impact on function. (Refer to tank position diagram on the next page)

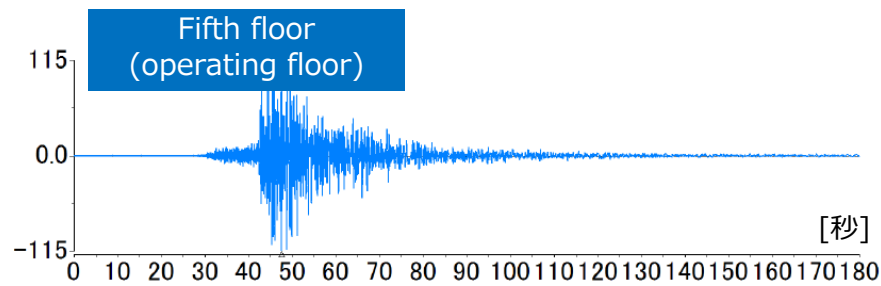
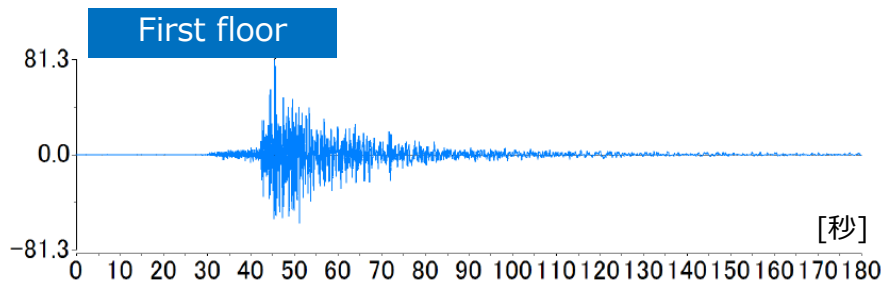
Unit 3 seismometer data

- [Time/Date] 6:09 PM, March 20, 2021 [Location of epicenter] Off the coast of Miyagi Prefecture [Magnitude] 6.9
- The maximum accelerations recorded by each seismometer for the earthquake mentioned above are as follows:
 - The accelerations cannot be simply compared because the structure of the buildings and the seismometer installation locations differ, however the maximum acceleration seen at Unit 3 was not especially different from that seen at Units 5 and 6.

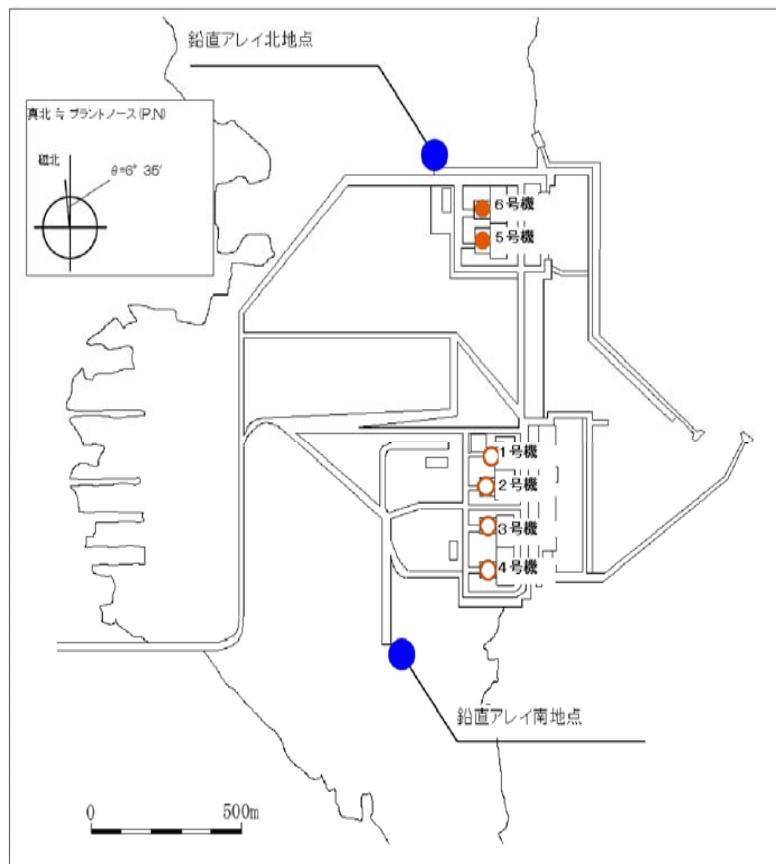
図1 福島第一における地震観測 (全体)

- Seismometers installed on the Unit 6 foundation plate are used for power station operation (for notifying/publicly announcing data to related departments, and inspections conducted in accordance with post-earthquake classifications), and for preliminary announcement of maximum acceleration.
- The other seismometers at Units 5 and 6 are used as backups and for other types of analyses. If the seismometer on the Unit 6 foundation plate is undergoing inspection, the seismometer on the Unit 5 foundation plate is used as a substitute to be able to quickly announce observation values.
- Observations taken with free foundation seismometers are used to determine standard seismic motion.

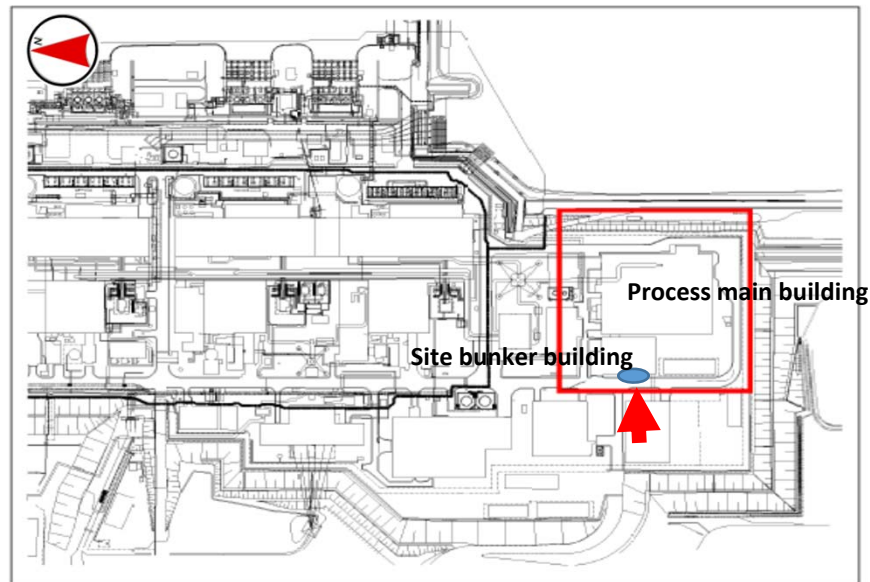
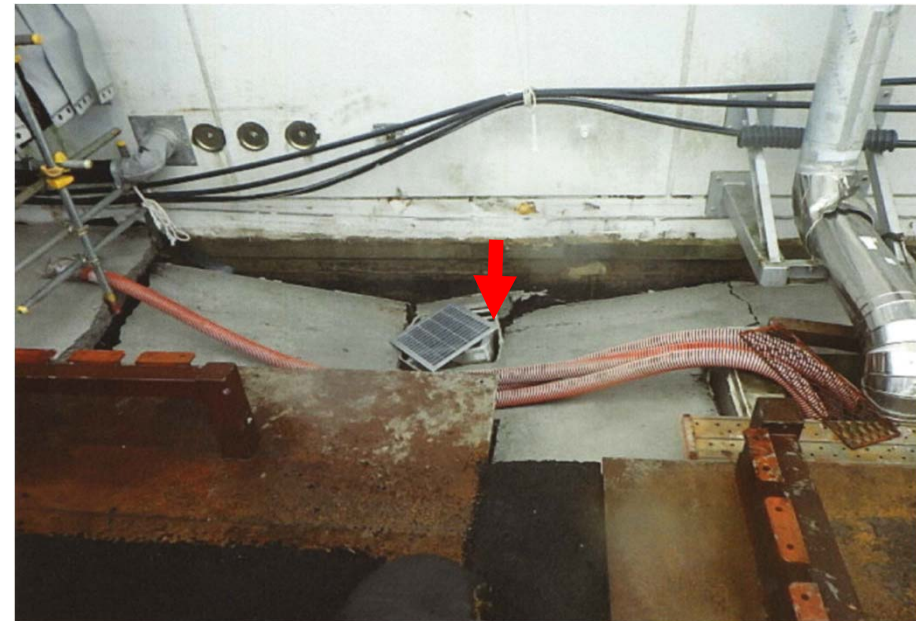
Substance found on the west side of the site bunker building

Date of occurrence (time discovered): Around 11 AM, March 21

Overview: During a field patrol, ground subsistence was found near the west side of the site bunker building. Slight subsidence was found after the earthquake on February 13, but the subsidence that occurred after this earthquake resulted in fractures to the concrete surfacing around the building. No abnormalities were found with pipes in the vicinity and the aforementioned fracture will be repaired in future. The aforementioned area was also made off-limits for safety reasons.
