# Conditions at the Fukushima Daiichi Nuclear Power Station after the earthquake on March 20 (Continued report)

# Conditions after the earthquake (Continued report)

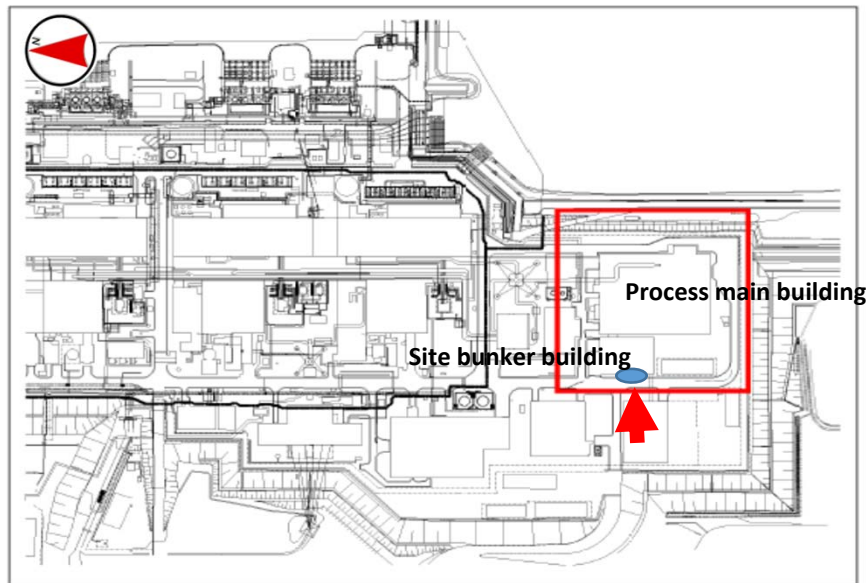
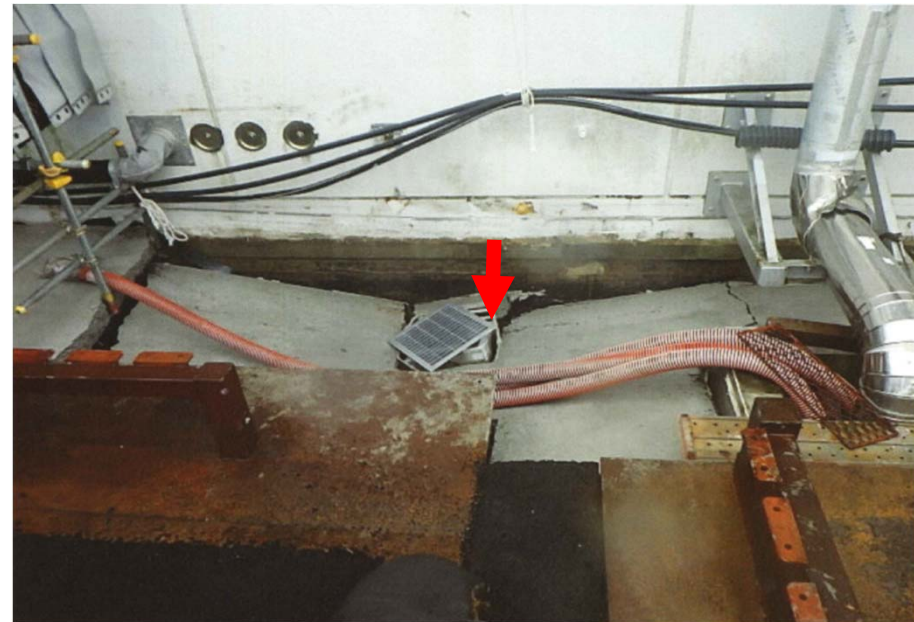
## Subsidence on the west side of the site bunker building

Overview: A field patrol noticed ground subsidence near the site bunker building on the west side. Slight subsidence was found after the earthquake on February 13, but the subsidence that occurred after this earthquake resulted in fractures to the concrete surfacing around the building. No abnormalities were found with pipes in the vicinity and the aforementioned fracture will be repaired in future. The aforementioned area was also made off-limits for safety reasons.

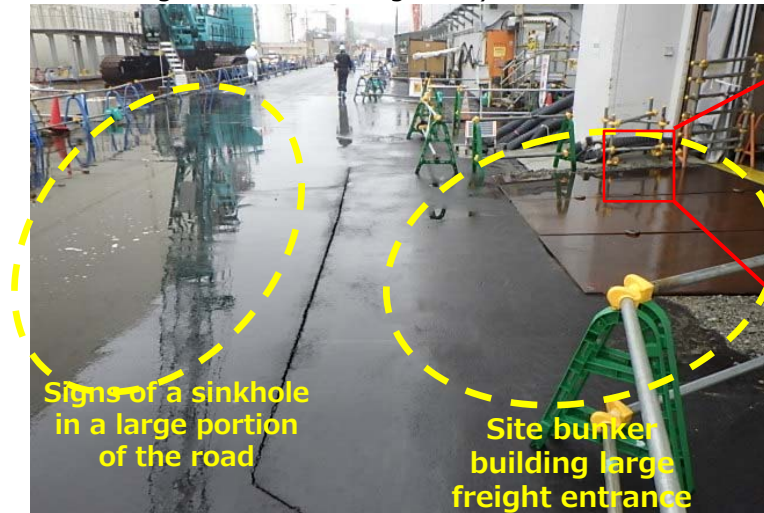
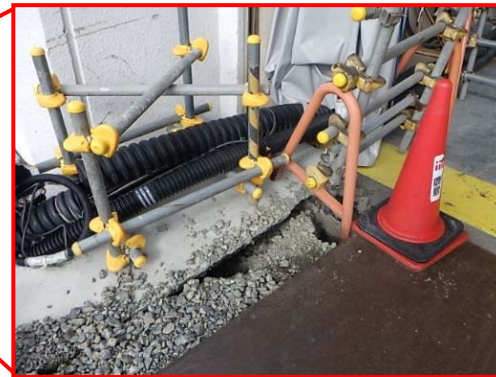
- The following changes have been seen in conjunction with the earthquakes on February 13 and March 20, and rainfall thereafter.
- Rainfall has widened the hole underneath the steel plates in front of the site bunker building's large freight entrance, and will be repaired starting on March 29.
- Other locations will also be repaired after conducting a detailed examination of the conditions (at current time these conditions are not hindering decommissioning work)

Hole underneath steel plates

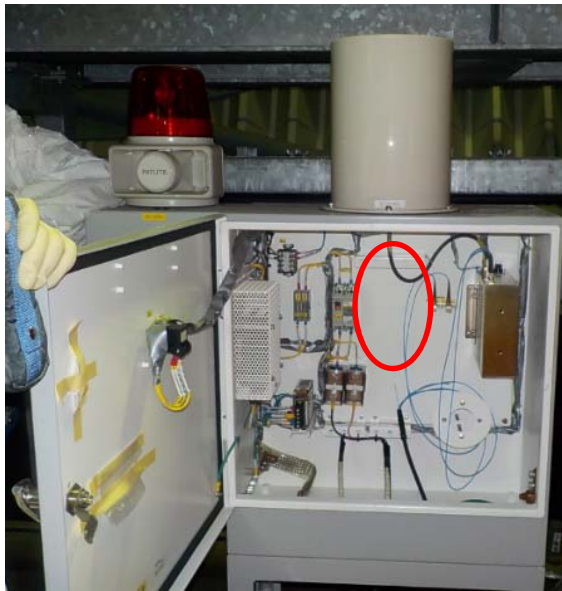
On March 21, a field inspection of the monitor confirmed that the monitor was fine and that there was a problem with transmission. On March 22, a field inspection of the detector found that a fuse for the fiber-optic transmitter for the detector on the aforementioned monitor had blown.

①Area radiation monitor detector box  
(Photograph taken prior to the earthquake, the aforementioned fuse is located in the area of the red circle)

The aforementioned fuse was replaced on the same day and function was restored to the aforementioned monitor.

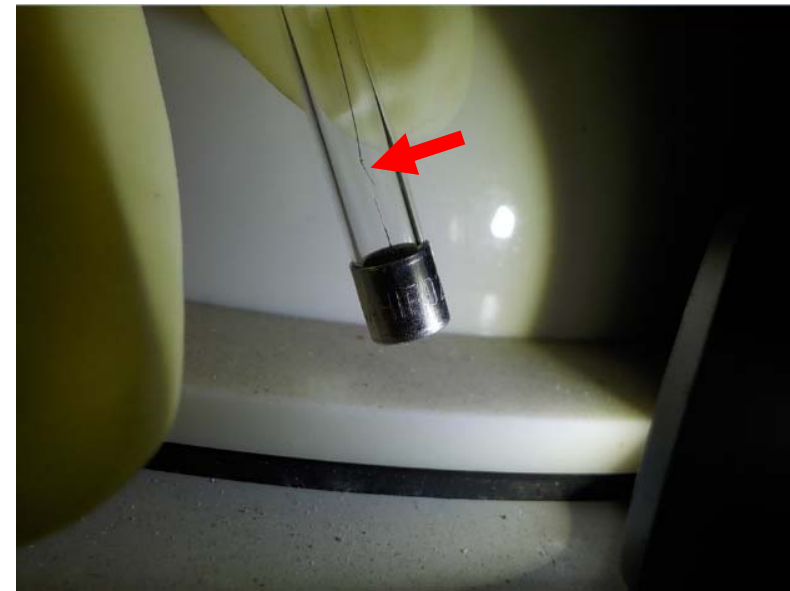
②Aforementioned blown fuse  
(arrow indicates severed element)
