## “High Alarm” from Plastic Scintillation Fiber monitor (PSF monitor) monitoring the wharf drainage channel at the Fukushima Daiichi Nuclear Power Station (Continued report)

# Containers on the east side of the old training building

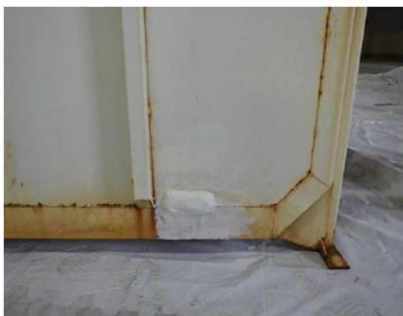
- Examination of the inside of containers found damp conditions and some rust on the bottom surface.
  - Examination of corrosion on the outside of the containers at the bottom found that sealant had been applied to the containers to prevent leaks, and a sealant-like material was found on the inside of the containers as well.

Figure 1. Corrosion repair

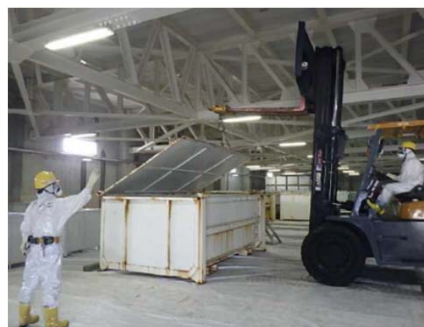
- The lids of containers on which corrosion was found were opened on March 25 and the contents at the top of the containers were examined. Waste generated during work immediately following the disaster (fabric and paper) were found to be wrapped in plastic along with other waste such as covering tarps and PVC piping, etc., and a dose of 10mSv/h was found for the equivalent dose rate of 70 $\mu$ m (gamma + beta).

Figure 2. Opening the lids

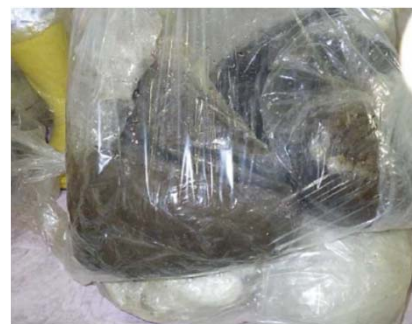
- In the aforementioned container, adsorbents, fabric and paper waste, rubber mats, covering tarps, and PVC piping, etc., has been sorted and is being stored separately in plastic bags, and adsorbents contain moisture. Furthermore, at current time no damage, such as holes, etc., has been found to the plastic bags.

Figure 3. Container contents (adsorbents containing moisture)

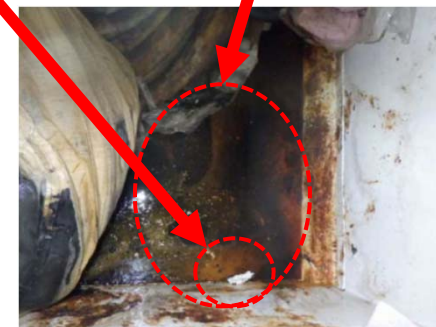
Figure 4. Inside of the container

Examining a portion of the bottom of the container (rust and dampness)

Sealant (sealant has been applied from the outside of the container)

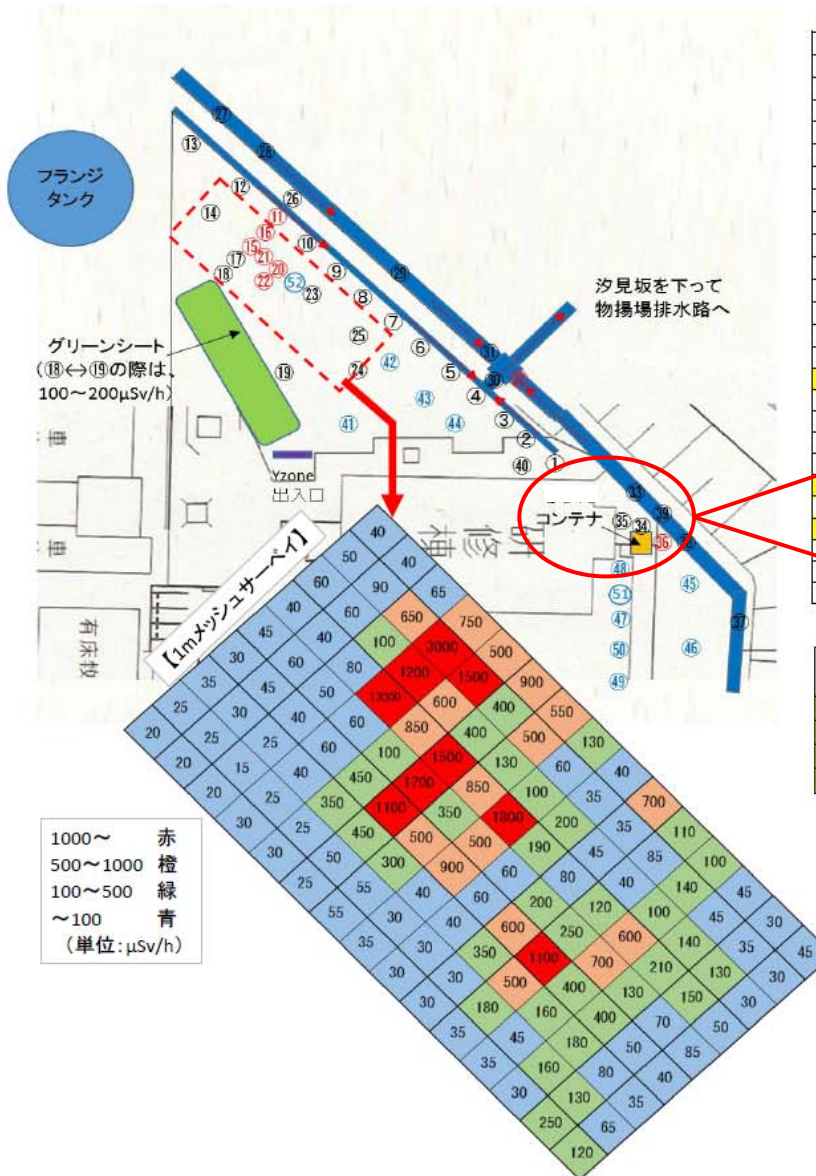
[Reference] Four containers located on the east side of the old training building

地点	1cm線量当量率	70μ線量当量率	地表面
①	25	40	鉄板
②	20	120	コンクリ+土
③	20	30	コンクリ+土
④	15	100	コンクリ+土
⑤	20	50	コンクリ+土
⑥	40	150	草
⑦	10	70	木
⑧	10	35	コンクリ
⑨	10	350	コンクリ+土
⑩	10	250	コンクリ+土
⑪	10	1,500	コンクリ+土
⑫	10	30	コンクリ
⑬	10	60	コンクリ
⑭	10	45	草
⑮	17	13,000	コンクリ+土
⑯	10	1,500	コンクリ+土
⑰	15	20	コンクリ
⑱	60	70	シート敷
⑲	60	400	マンホール蓋
⑳	18	4,500	コンクリ+土
㉑	12	850	コンクリ+土
㉒	17	3,000	コンクリ+土
㉓	20	1,200	コンクリ+土
㉔	25	200	コンクリ
㉕	15	240	コンクリ

地点	1cm線量当量率	70μ線量当量率	地表面
⑳	-	300	細い側溝内
㉑	-	100	側溝内
㉒	-	120	側溝内
㉓	-	100	側溝内
㉔	-	200	側溝内
㉕	-	120	側溝内
㉖	-	1,000	側溝内
㉗	-	250	側溝内
㉘	-	300	コンテナ際
㉙	-	700	側溝内
㉚	-	2,000	コンテナ際
㉛	-	85	側溝内
㉜	-	180	側溝内
㉝	-	250	側溝内
㉞	-	200	黒い囲いの下
㉟	10	15	コンクリ
㊱	8	170	コンクリ+砂
㊲	7	55	コンクリ
㊳	10	25	コンクリ
㊴	13	40	コンクリ+砂
㊵	15	20	コンクリ
㊶	140	1,100	側溝内
㊷	20	110	側溝内
㊸	-	90	側溝内
㊹	-	300	側溝内
㊺	-	2,300	側溝内
㊻	25	9,000	コンクリ+土

地点	70μ線量当量率 [μSv/h]	
	除去前	除去後
⑮	13,000	6,500
⑳	4,500	900
㉒	3,000	800
㉚	9,000	1,000

Surface dose rate in this area was found to be a maximum of 1.5 mSv/hour for both 70μm equivalent dose (gamma + beta) and 1cm equivalent dose rate. Air dose rate 1m away from the aforementioned locations was found to be a maximum of 0.25mSv/h for both 70μm equivalent dose (gamma + beta) and 1cm equivalent dose rate.

- We will quickly inspect the contents of these containers and how they came to be stored in the aforementioned area.
- As a provisional countermeasure, sandbags will be placed around the aforementioned four containers and inspection of the contents of these containers will be quickly conducted after which they will be relocated indoors upon the completion of preparations.

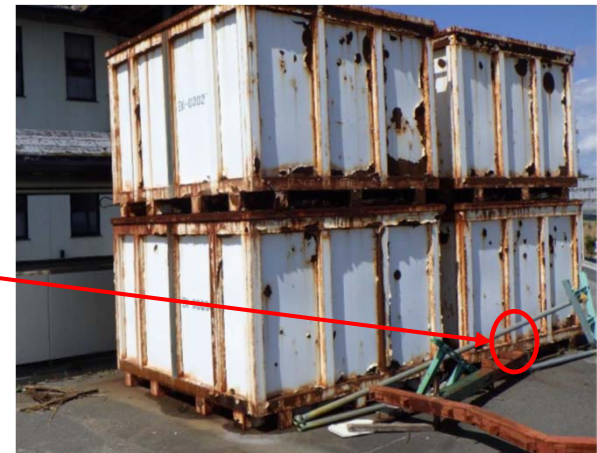
Containers located on the east side of the old training building 4

- Although corrosion was found on the outside of the aforementioned containers at the bottom, at current time no abnormalities, such as leaks, etc., have been found.
