- In light of the damage sustained to the high integrity container (HIC) exhaust filters in multi-nuclide removal equipment (ALPS), inspections of the exhaust filters used in ALPS (Additionally installed ALPS: 18 locations; existing ALPS: 28 locations; high-performance ALPS: 5 locations) were started on September 17.
- Inspections for the additionally installed ALPS were completed by September 20. And filters in 4 out of the 18 locations were found to be damaged.
- Inspections of 11 out of the 28 locations have been completed for existing ALPS as of September 20 and exhaust filters in 1 location has been found to be damaged.

Exhaust filter inspection results for ALPS facilities

(Reference) Inspection of existing ALPS exhaust filters given the damage to the HIC exhaust filters (1/3)

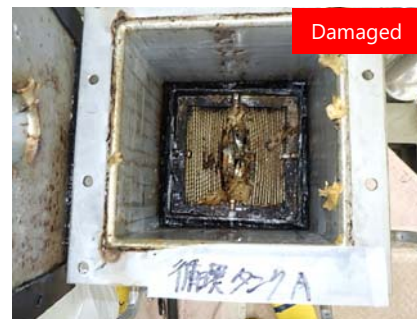
Existing ALPS circulation tank A

Damage was observed in a total of 4 locations: in 3 locations in the circulation tank (A, B, C) and in the carbonate soda storage tank

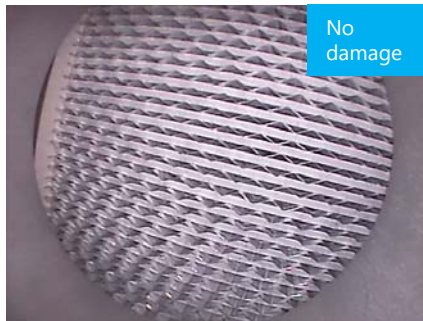
High-performance ALPS feed tank A

No damage

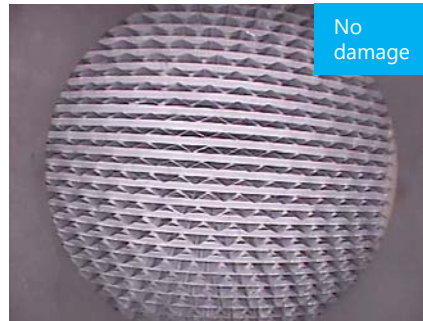
High-performance ALPS feed tank B

No damage

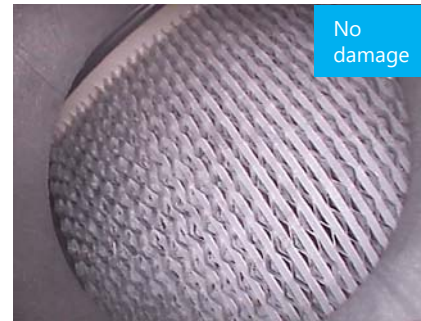
High-performance ALPS treated water tank A

No damage

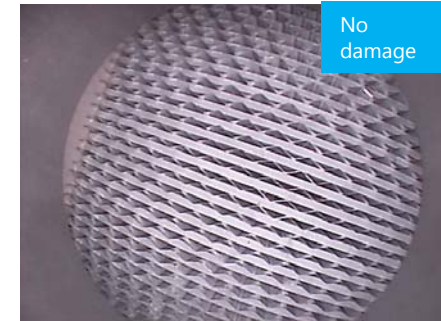
High-performance ALPS treated water tank B

No damage

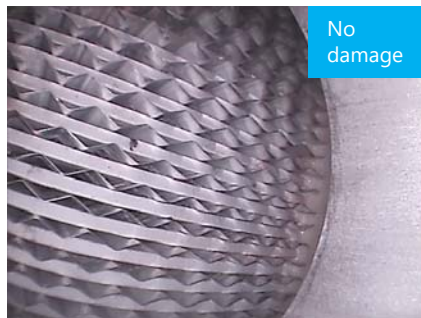
High-performance ALPS sampling tank

No damage
