Status of Investigation into the Rise in
Temperature of Temperature Measuring Tube 150-
7S for the Land-Side Impermeable Wall (frozen-
soil wall)

November 25, 2021

Tokyo Electric Power Company
Holdings, Inc.

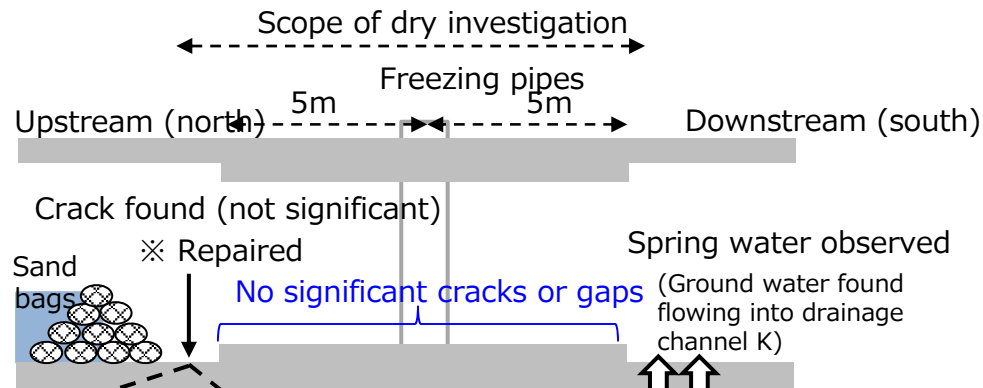
- From November 1, the reinforced section of drainage channel K was allowed to dry. One crack on the upstream side of the reinforced section was found along with spring water emanating from the channel bottom on the downstream side of the reinforced section. (The inside of drainage channel K was checked as a result of the hypothesis drawn in October)
- According to our hypothesis in October, it was thought that the rise in temperature of temperature measurement tube 150-7S was being caused by water leaking from drainage channel K, however when spring water was found inside drainage channel K, it indicated the possibility that groundwater may be flowing from around temperature measurement tube 150-7S towards drainage channel K, so we excavated shallow areas both inside and outside of the frozen soil wall around temperature measurement tube 150-7S.

Crack (Length: Approx. 1.0m, Width: Approx. 5.0mm)

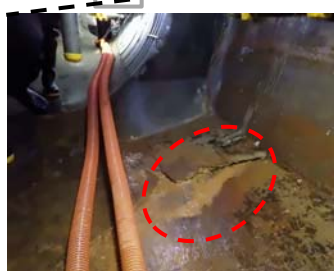
Spring water location (Bottom plate)

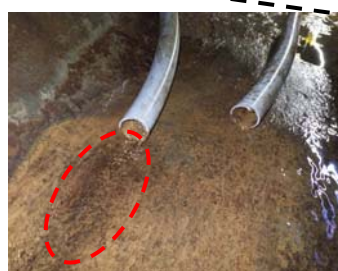
Spring water location (Water conveyance pipe)

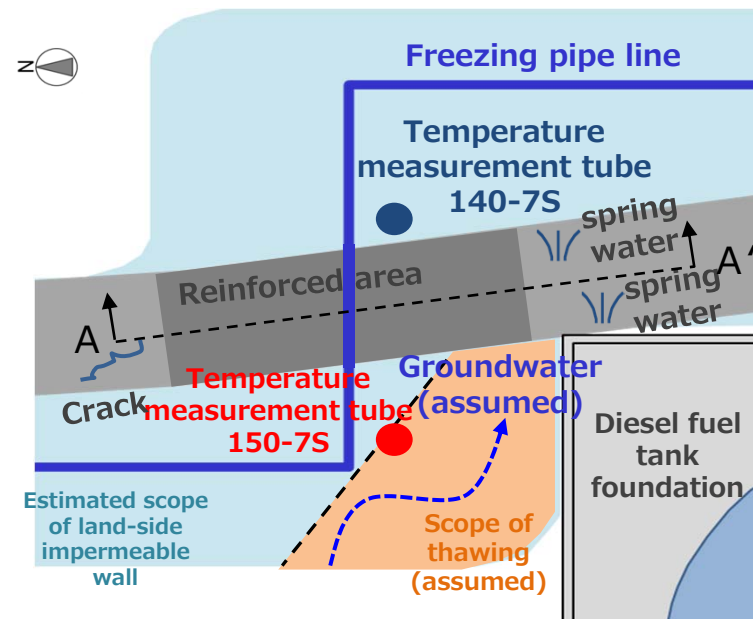
Estimated scope of thawing of land-side impermeable wall and diagram of the surrounding area

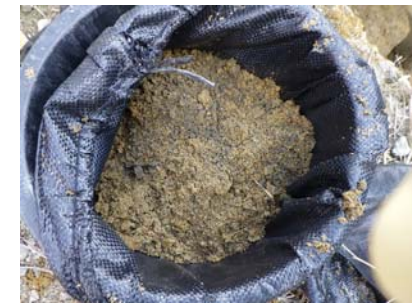
Excavated soil (around G.L.-2.6m)
 11/10 : Excavation of surface layer commences
 11/11 : Excavated to G.L.-1m~2m
 11/12 : Excavated to G.L.-2.8m

- No groundwater was found in the excavation area inside the land-side impermeable wall, so it was confirmed that water levels inside and outside the wall are being maintained.
- Subterranean temperatures deeper than around G.L.-2.70m were found to be below 0°C, and fixed point temperature readings confirmed that temperatures are being maintained below 0°C
- In light of the above, we believe that the land-side impermeable wall is functioning normally.

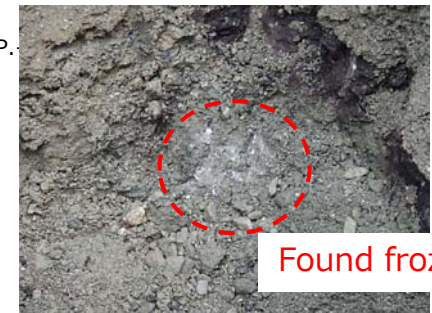
Found frozen

Excavated soil (Solidified) (Measurement point① Near G.L.-1.3m)

- Measurement point①G.L.-1.30m found to be frozen (solid)
- Subterranean temperature at around Measurement point ②G.L.-1.50m Confirmed to be below 0°C
- Groundwater surface found at around Measurement points ③, ④, ⑤G.L.-2.50m
- The land-side impermeable wall is functioning around temperature measurement tube 160-7S, but some shallow areas outside of the land-side impermeable wall near the diesel fuel tank foundation are not frozen

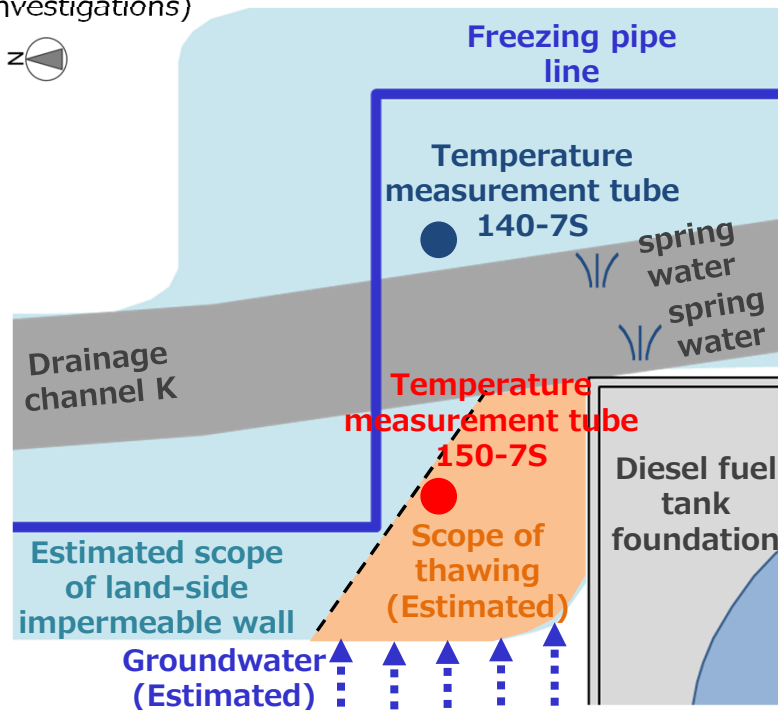
- Since spring water was found during the visual inspection of drainage channel K, it is assumed that the rise in temperature measured by temperature measurement tube 150-7S was caused by the thawing of a portion of the frozen wall caused by ground water flowing from the land-side impermeable wall to the downstream side of drainage channel K.
- The area outside of temperature measurement tube 150-7S shall be waterproofed to see if the flow of groundwater can be stopped and to measure subsequent changes in temperatures measured by temperature measurement tube 150-7S as well as changes in the amount of spring water flowing into drainage channel K. (Waterproofing has been given priority since the area is very narrow and it would be difficult to simultaneously implement groundwater flow direction investigations)

Estimated scope of thawing of the land-side impermeable wall

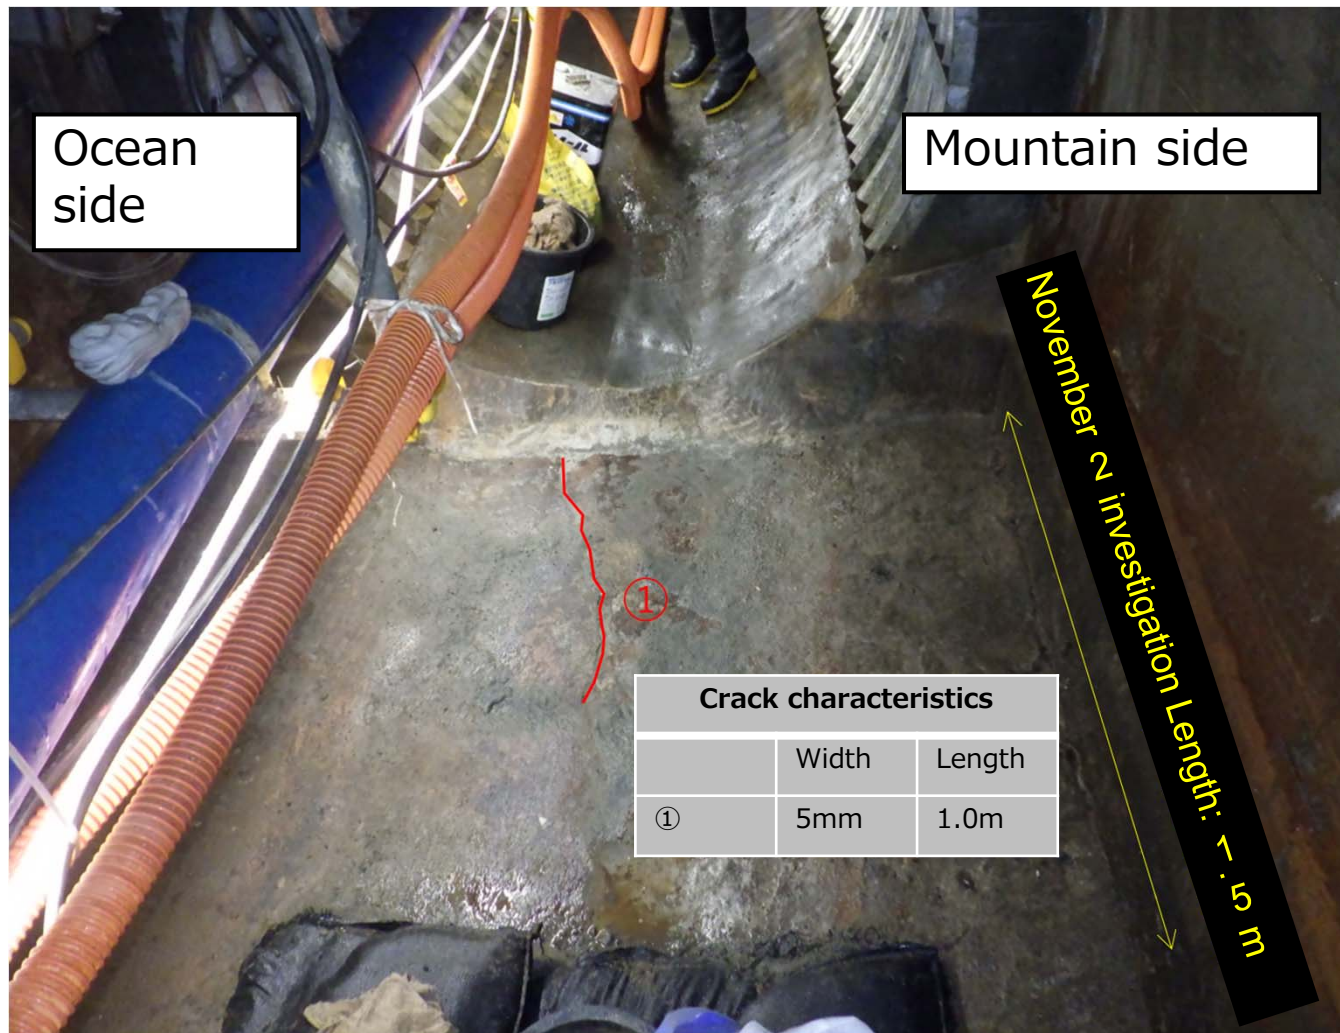
Results of crack investigation in dried out section of drainage channel K

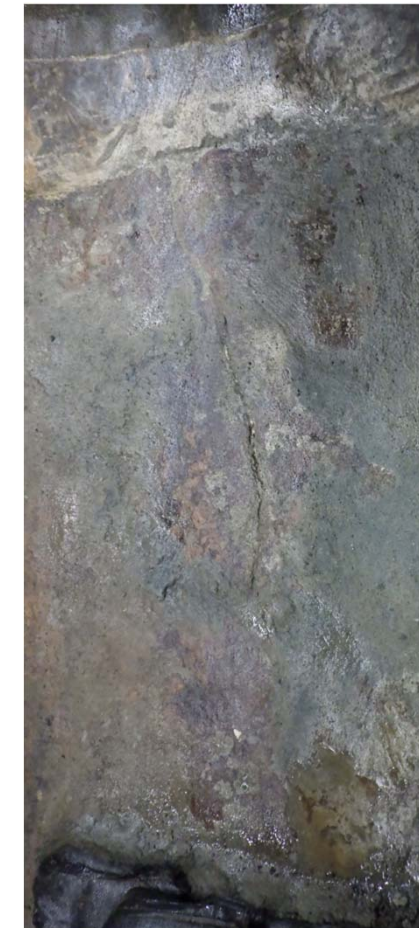
Enlarged photo of crack

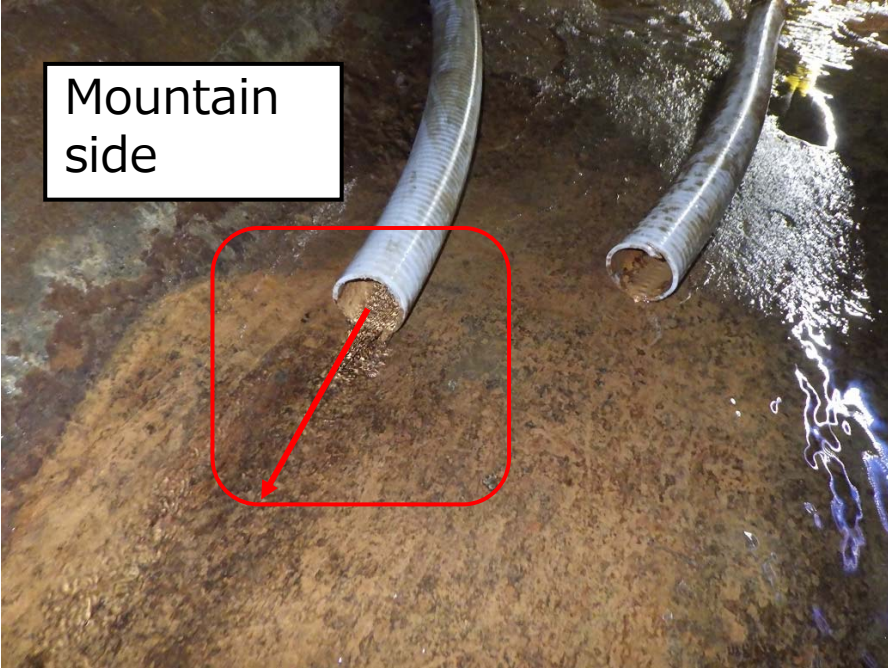
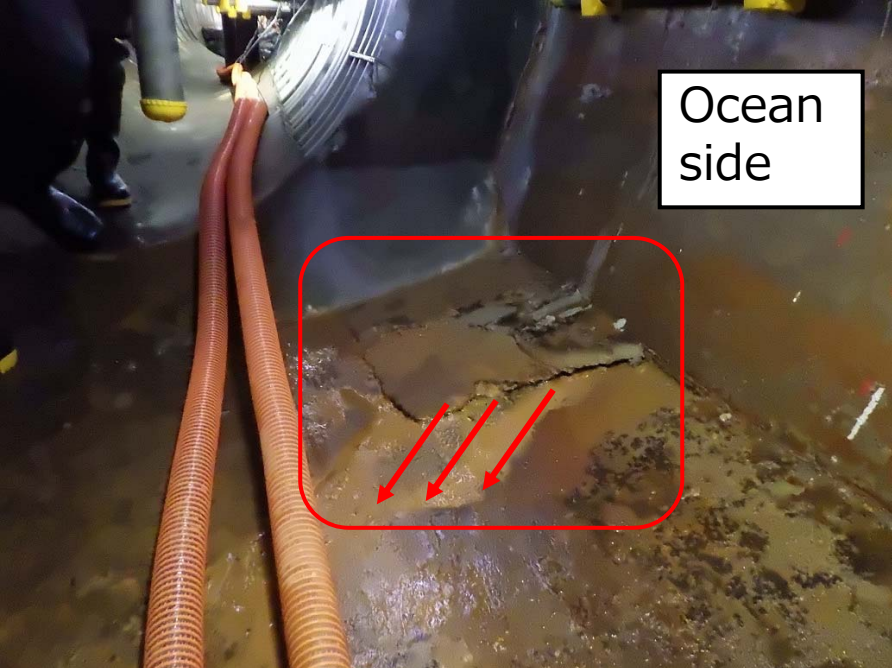
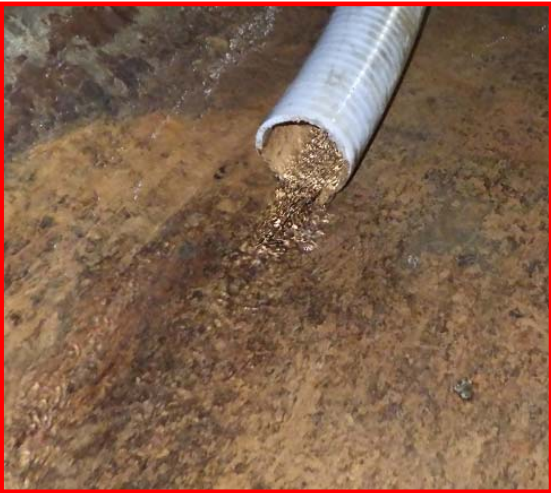
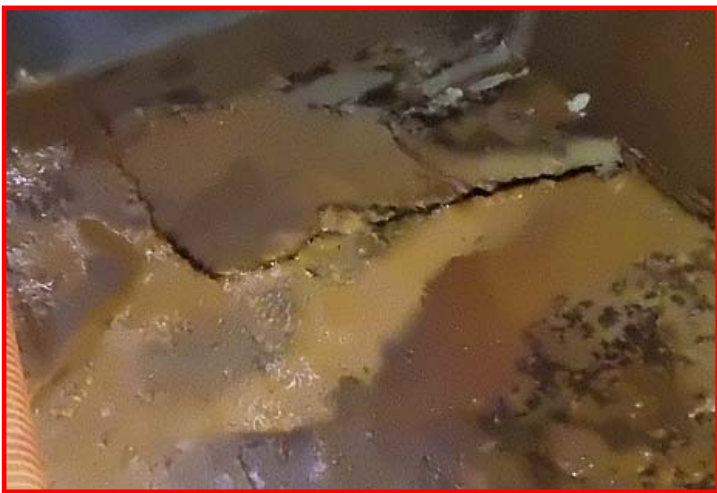
(Reference) Drainage channel K reinforced area downstream investigation (two locations of spring water found)

Spring water locations
