# Implementation Status of the Fukushima Daiichi Nuclear Power Station Unit 1 Primary Containment Vessel Internal Investigation (Preliminary report)

< Reference Material >  
February 8, 2022  
Tokyo Electric Power Company Holdings,  
Inc.  
Fukushima Daiichi D&D Engineering  
Company

# Photos taken during the PCV internal investigation on February 8

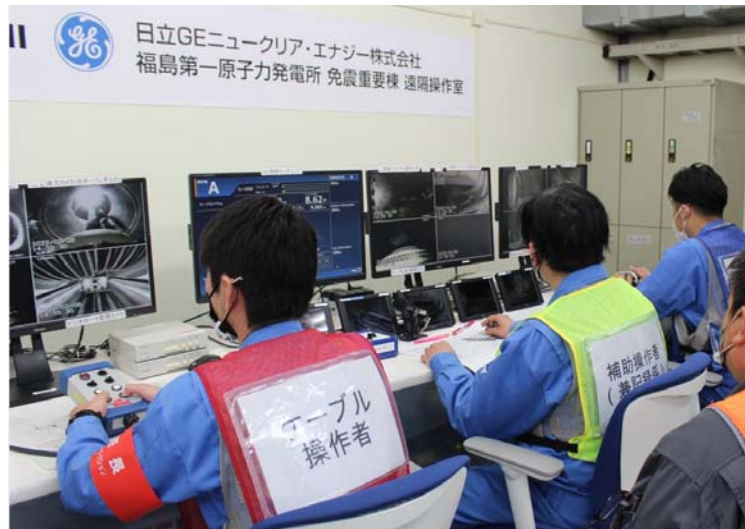
Photo 1. Work in the remote operations room

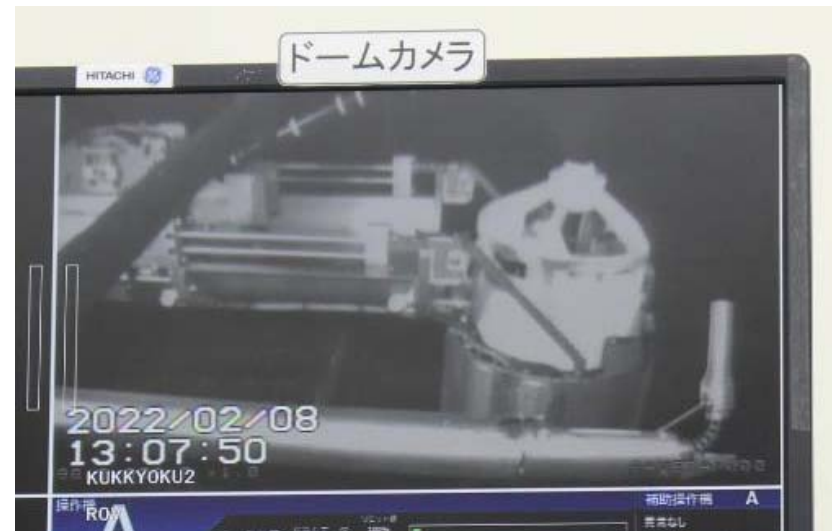
Photo 2. Lowering the submersible ROV

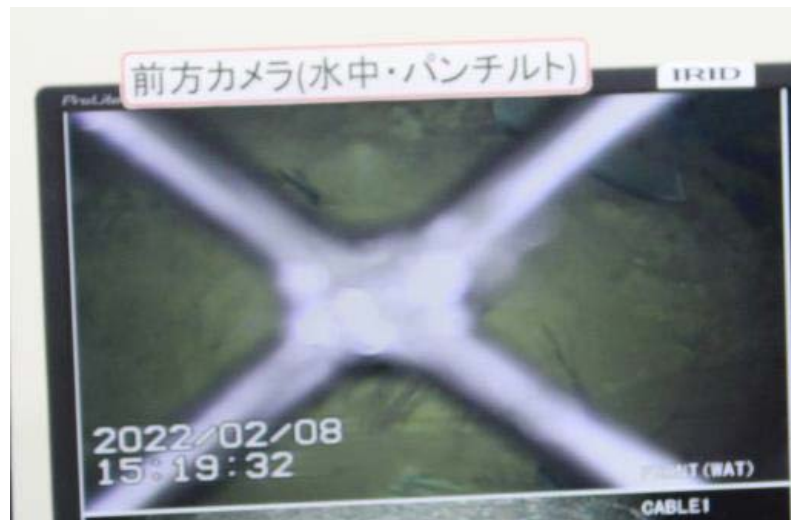
Photo 3. ROV arrives at the surface of the water at the bottom of the PCV

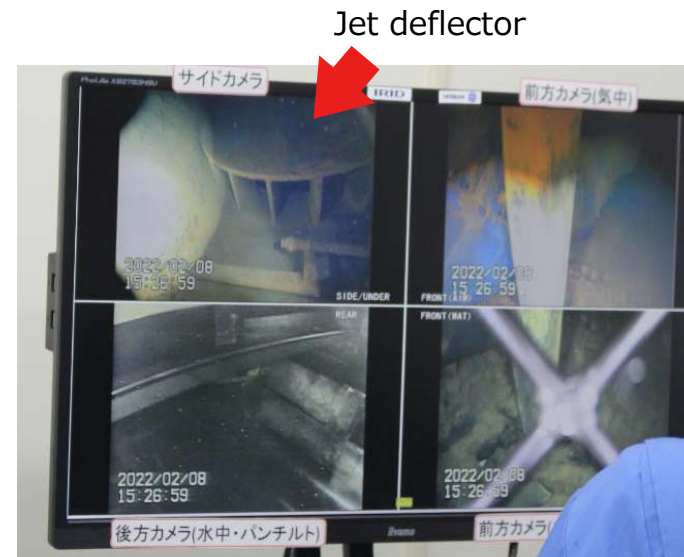
Photo 4. Photos from underneath the water at the bottom of the PCV

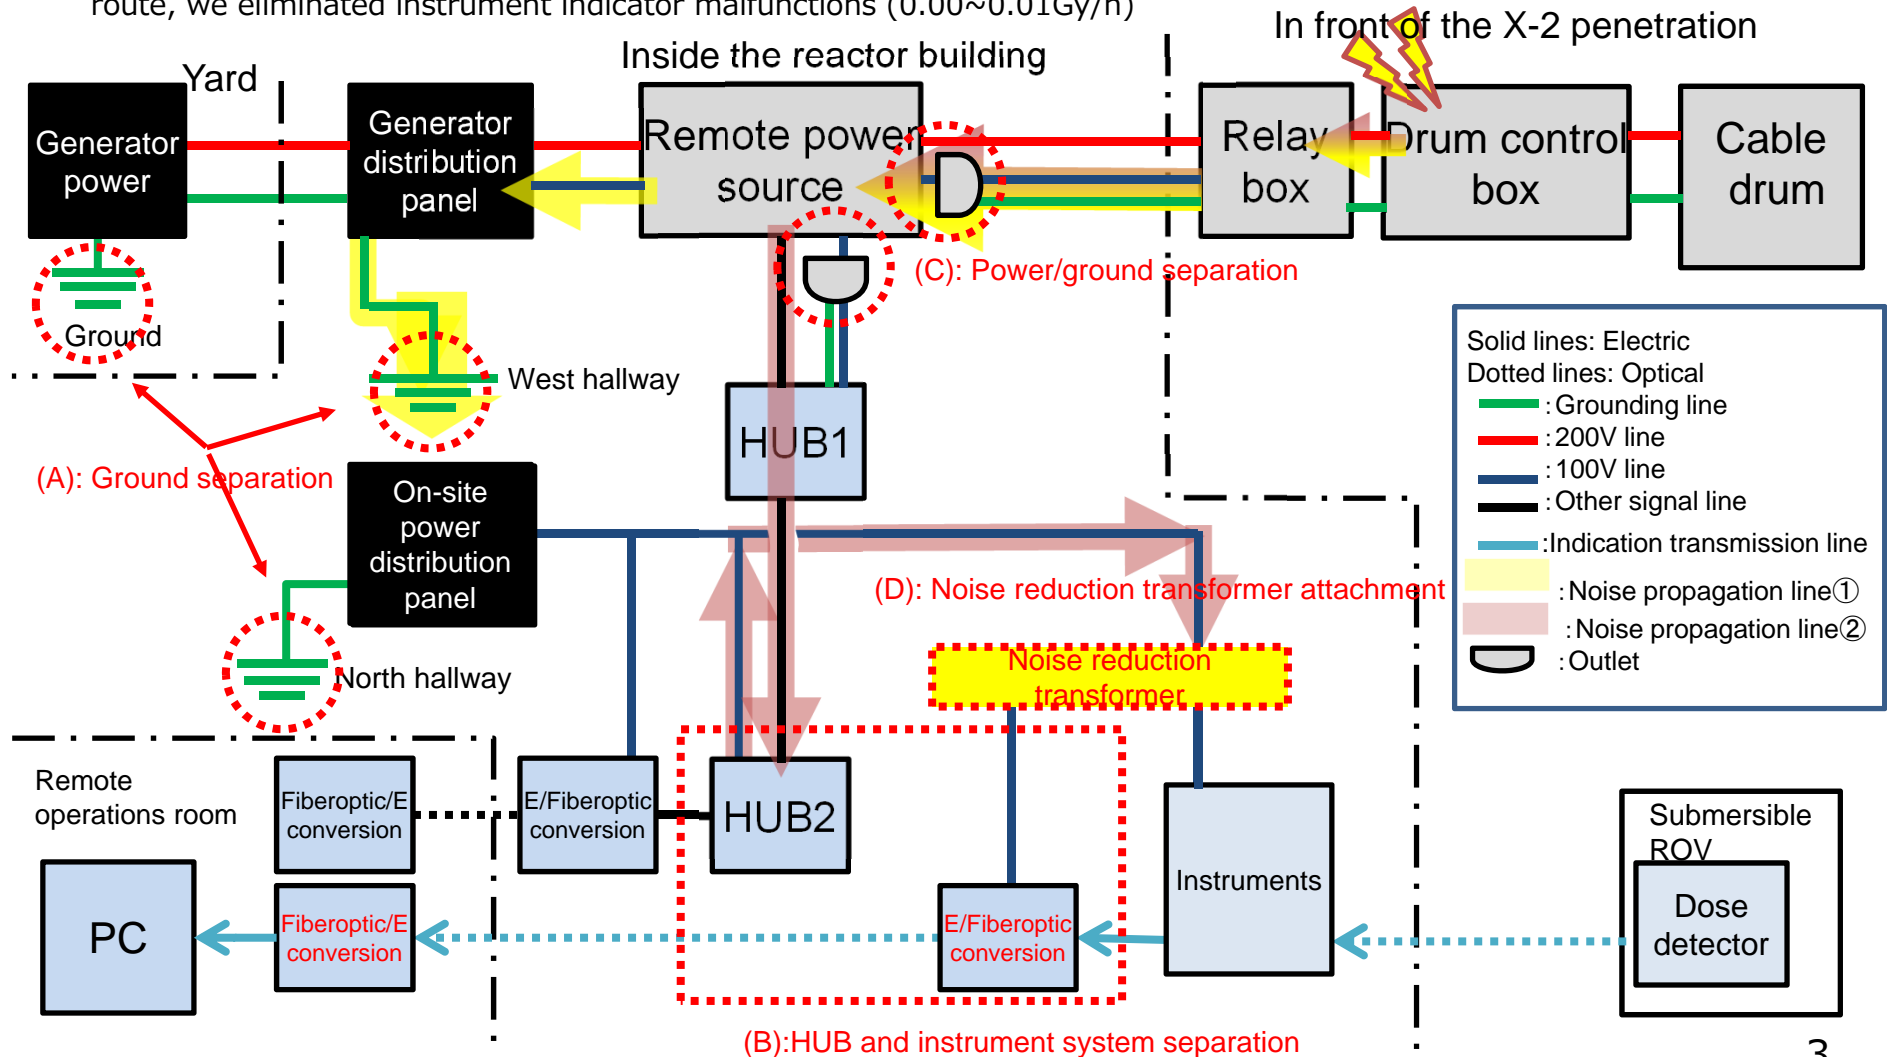
# 【Reference】 Causes and countermeasures for the nonconformities found during preparations on January 12 (1/2)

- From the results of additional investigations we have hypothesized that noise originating from the drum control box propagated as follows and affected the instruments. (①: Noise propagating from the south grounding line, ②: Noise propagating from the HUB)
- By implementing the countermeasures (A)~(D) shown in the diagram below and cutting off each noise propagation route, we eliminated instrument indicator malfunctions (0.00~0.01Gy/h)

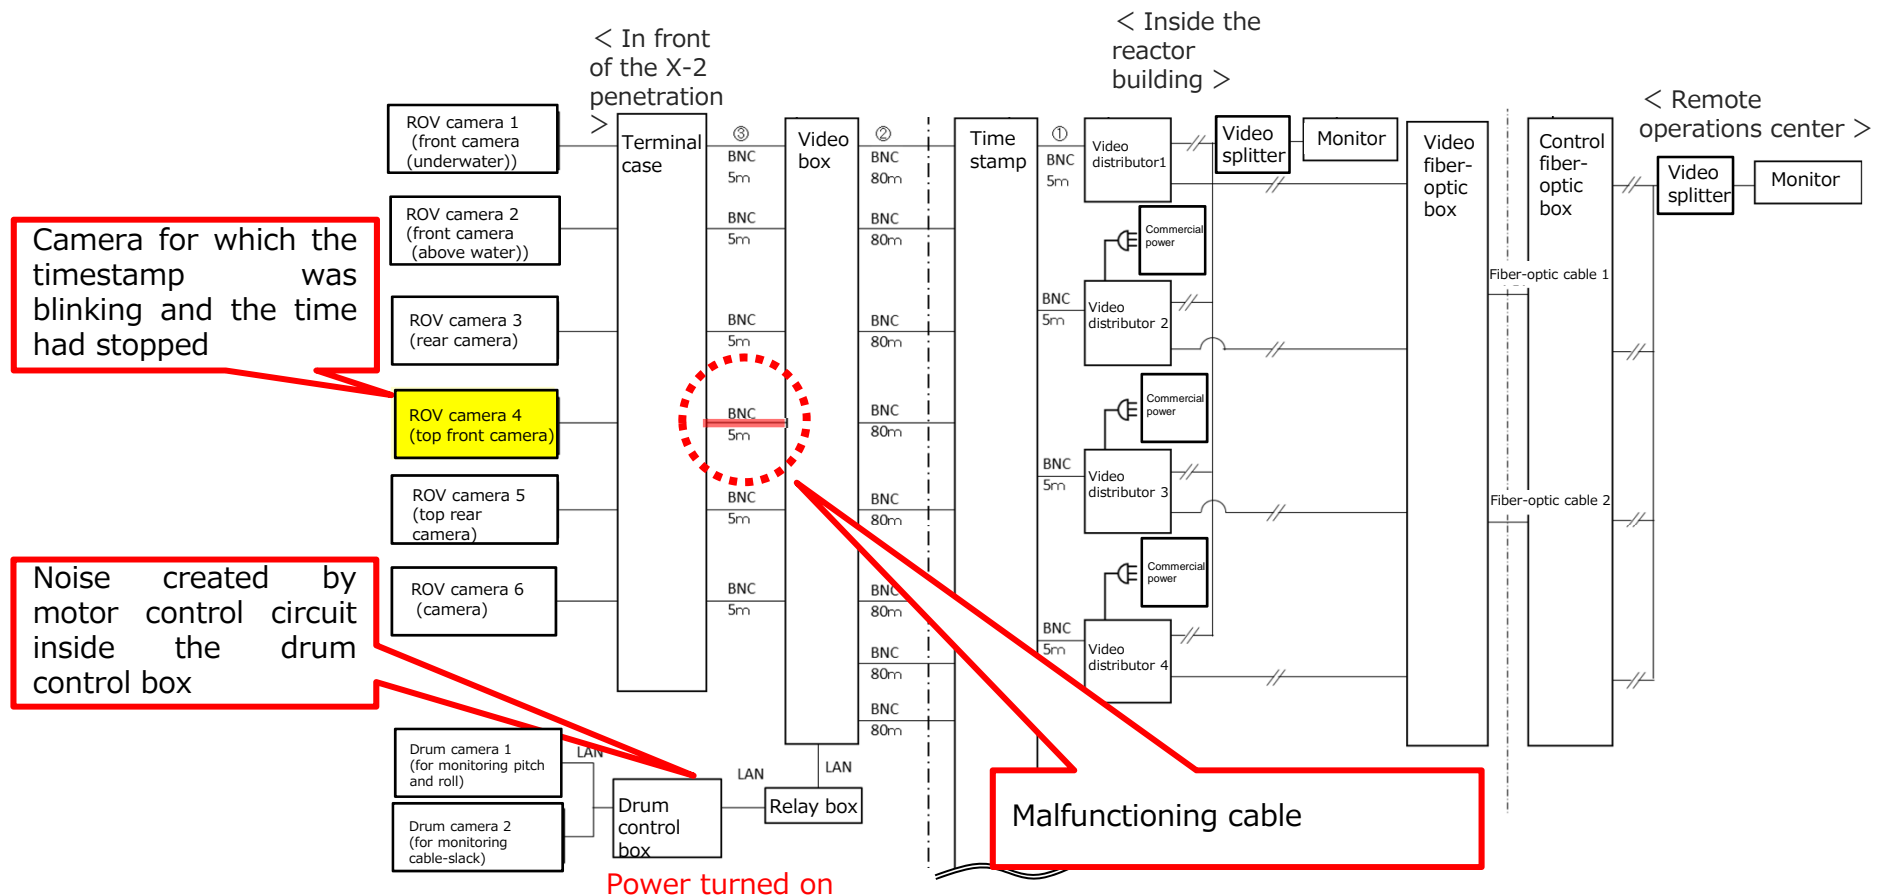
# 【Reference】 Causes and countermeasures for the nonconformities found during preparations on January 12 (2/2)

Tension from the outside was put on **one of the camera communication cables** thereby causing signal interruption and affecting the timestamp display.

The malfunctioning cable was replaced with a longer cable to avoid the cable from being put under tension from the outside. During reproducibility tests thereafter, no abnormalities were found with the timestamp display.
