Implementation Status of the Fukushima Daiichi Nuclear Power Station Unit 1 Primary Containment Vessel Internal Investigation (As of February 9)

< Reference Material >
February 9, 2022
Tokyo Electric Power Company Holdings,
Inc.
Fukushima Daiichi D&D Engineering
Company

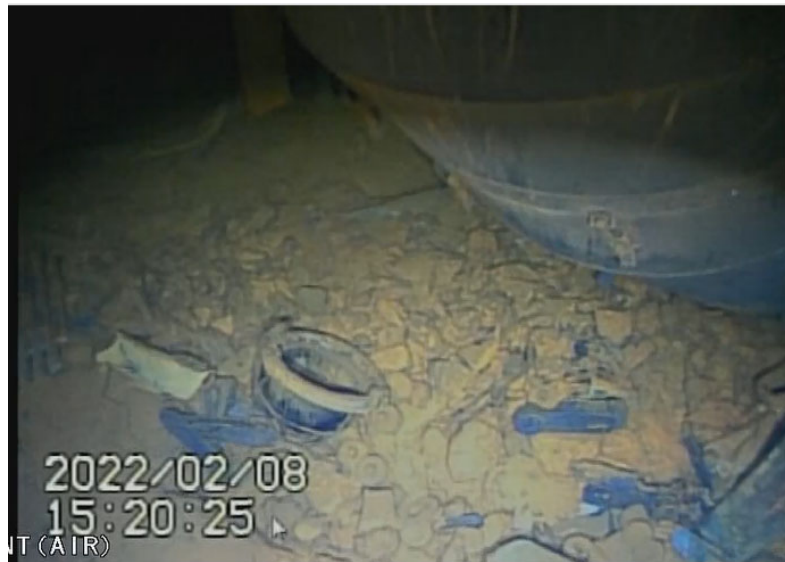
Area directly below where the submersible ROV was inserted

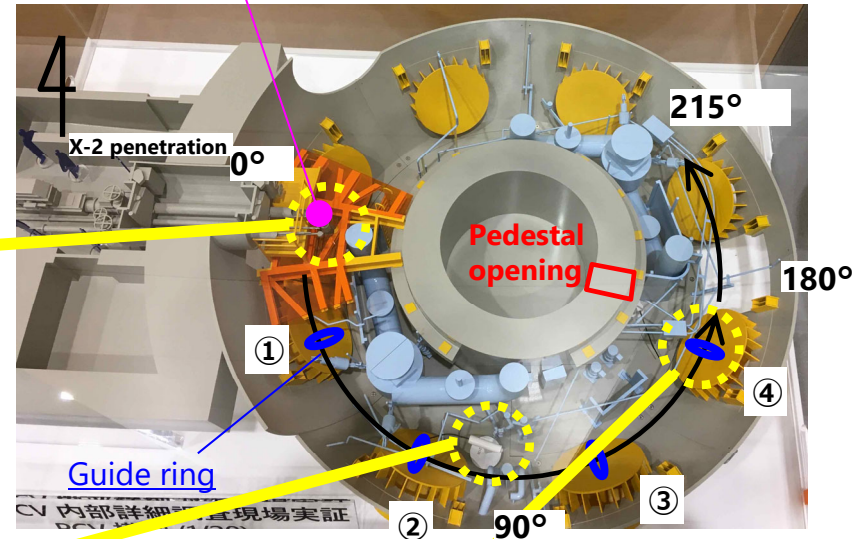
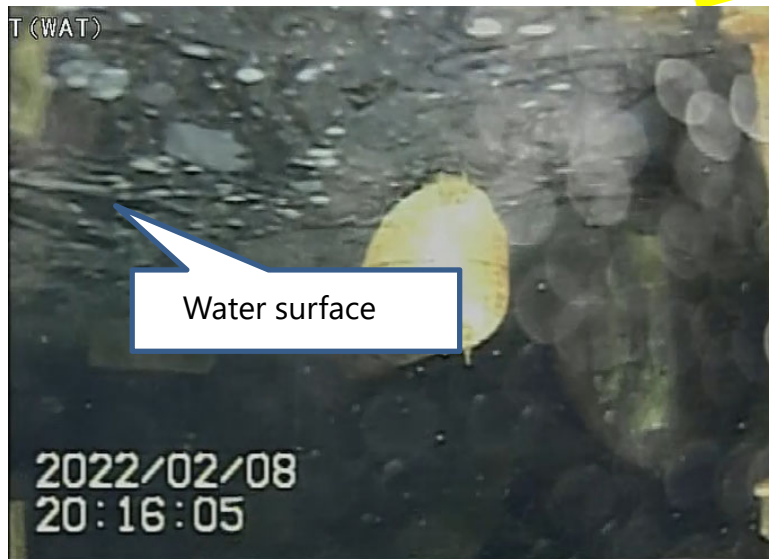
Floating matter on the surface of the water

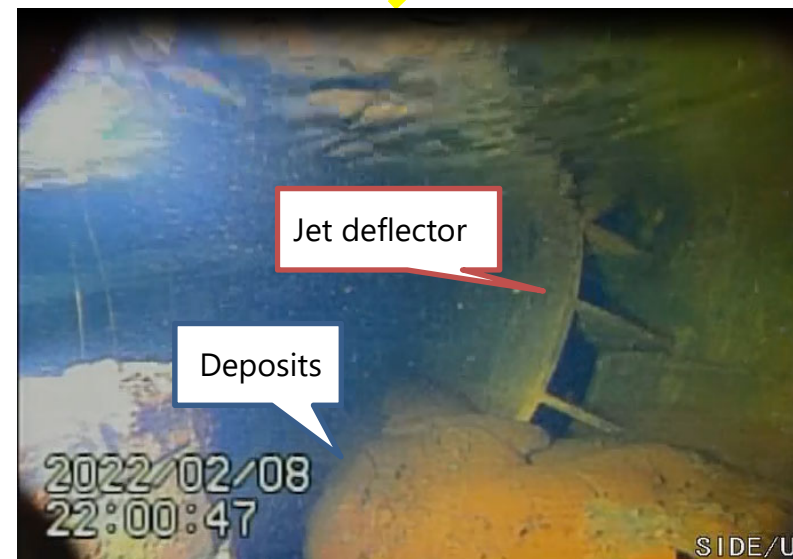
- What appears to be deposits at the bottom of the PCV, parts of gratings likely severed when building the access route, steel scraps, parts of reactor recirculating system pipes and conduits were identified while installing the guide rings (Referred to slide 5). Detailed investigations will be conducted in future investigations using the information gathered in this investigation.

Deposits near the 4th jet deflector

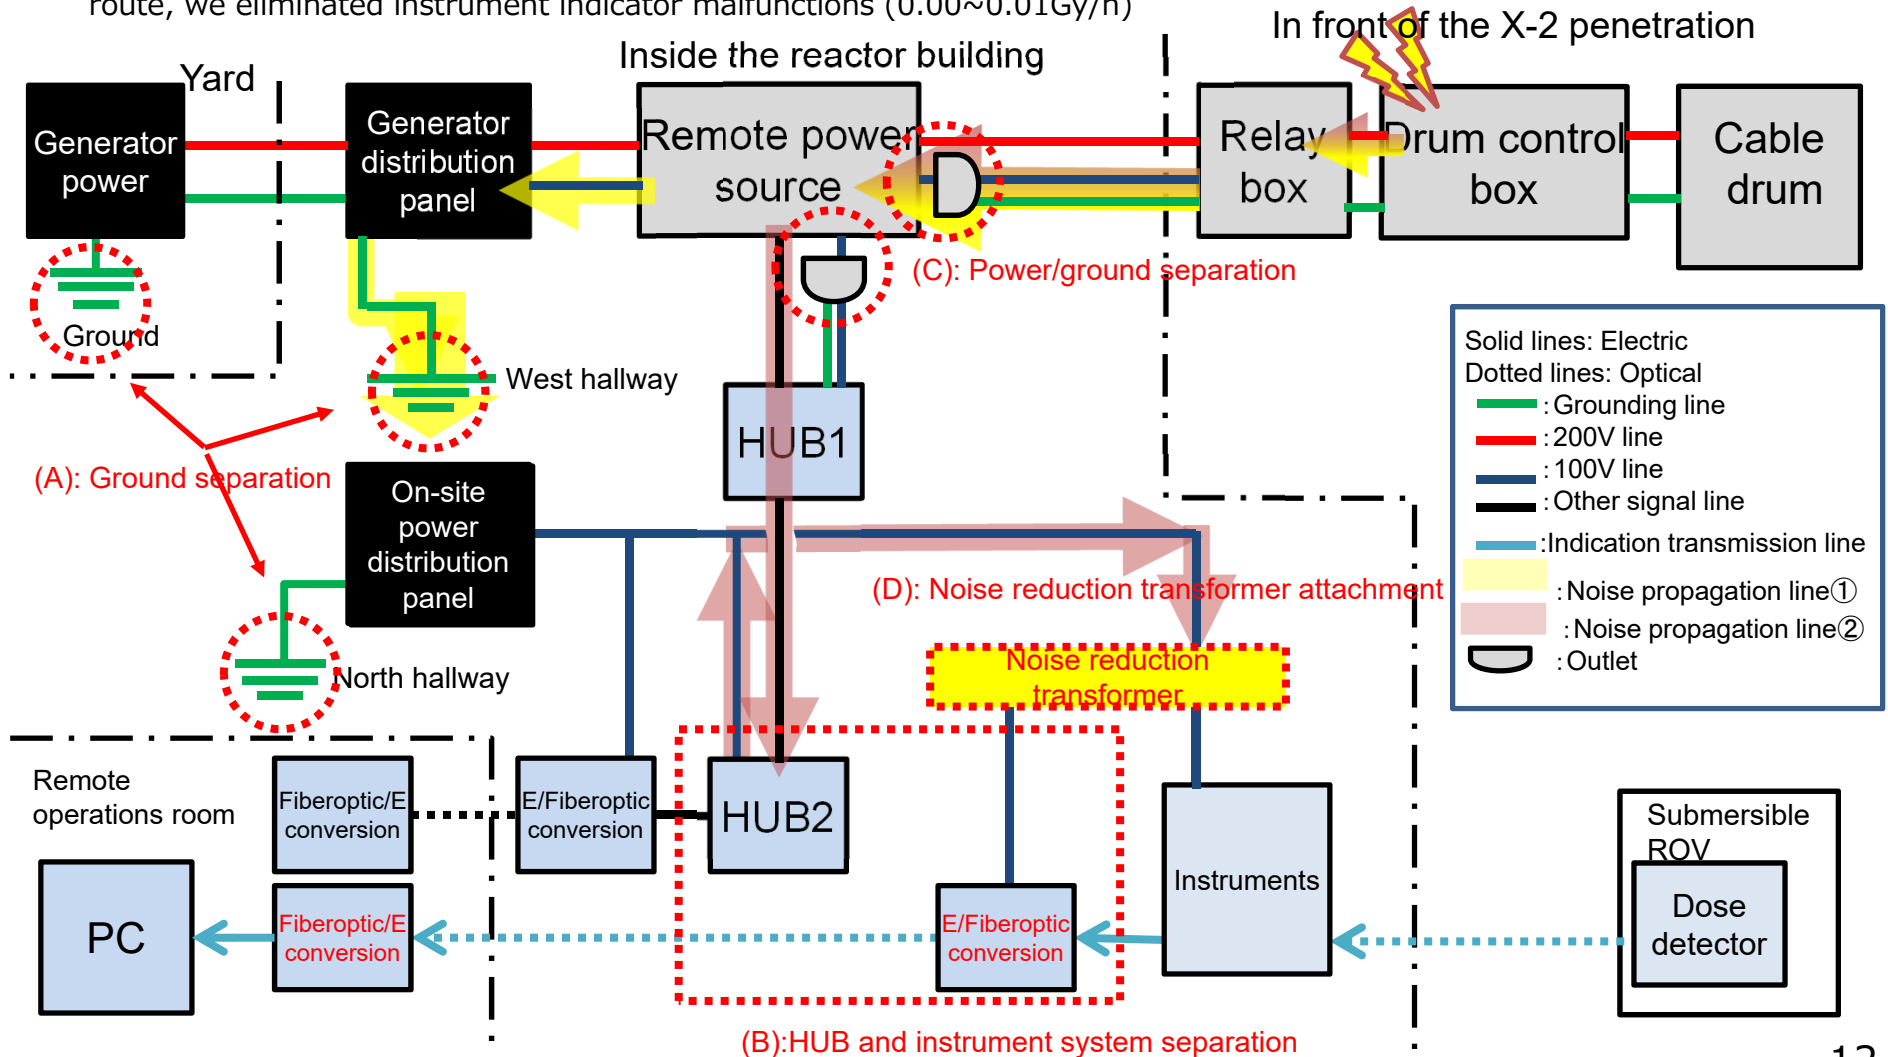
【Reference】 Causes and countermeasures for the nonconformities found during preparations on January 12 (1/2)

- From the results of additional investigations we have hypothesized that noise originating from the drum control box propagated as follows and affected the instruments. (①: Noise propagating from the south grounding line, ②: Noise propagating from the HUB)
- By implementing the countermeasures (A)~(D) shown in the diagram below and cutting off each noise propagation route, we eliminated instrument indicator malfunctions (0.00~0.01Gy/h)

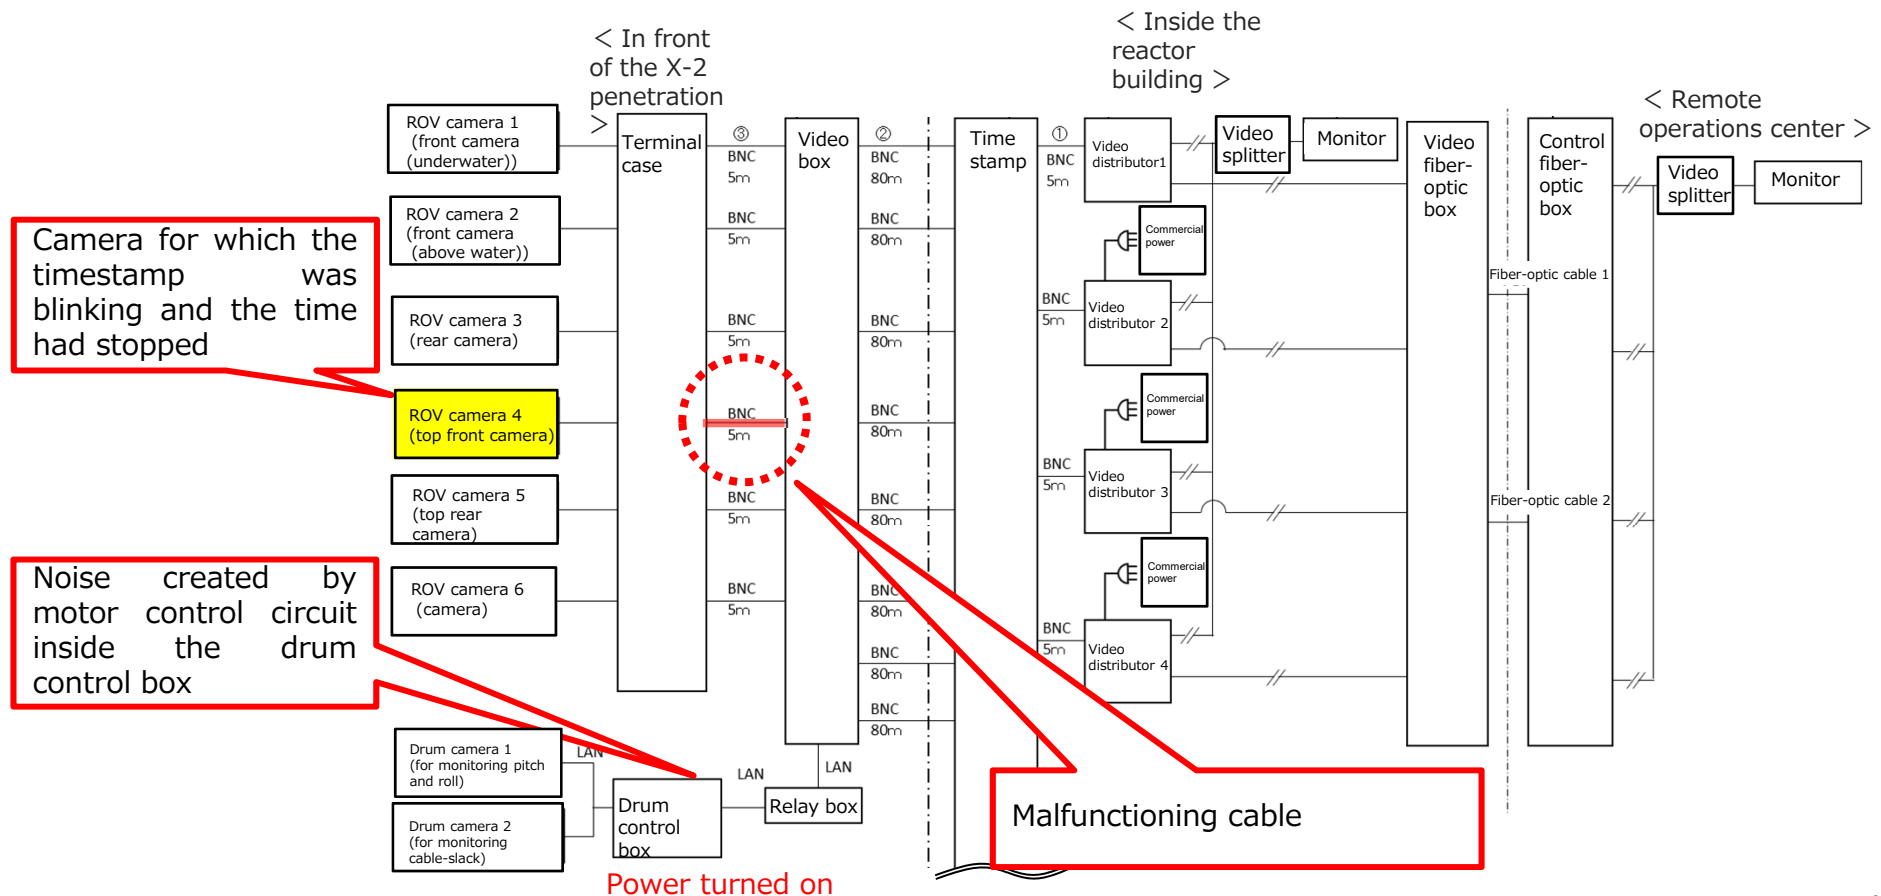
【Reference】 Causes and countermeasures for the nonconformities found during preparations on January 12 (2/2)

Tension from the outside was put on **one of the camera communication cables** thereby causing signal interruption and affecting the timestamp display.

The malfunctioning cable was replaced with a longer cable to avoid the cable from being put under tension from the outside. During reproducibility tests thereafter, no abnormalities were found with the timestamp display.
