# Implementation Status of the Fukushima Daiichi Nuclear Power Station Unit 1 Primary Containment Vessel Internal Investigation (As of February 10)

# Guide ring ④ installation and conditions to the east-northeast of the PCV (215°) (Photos taken from investigation on February 9)

# Conditions around the pedestal opening (From investigation on February 9)

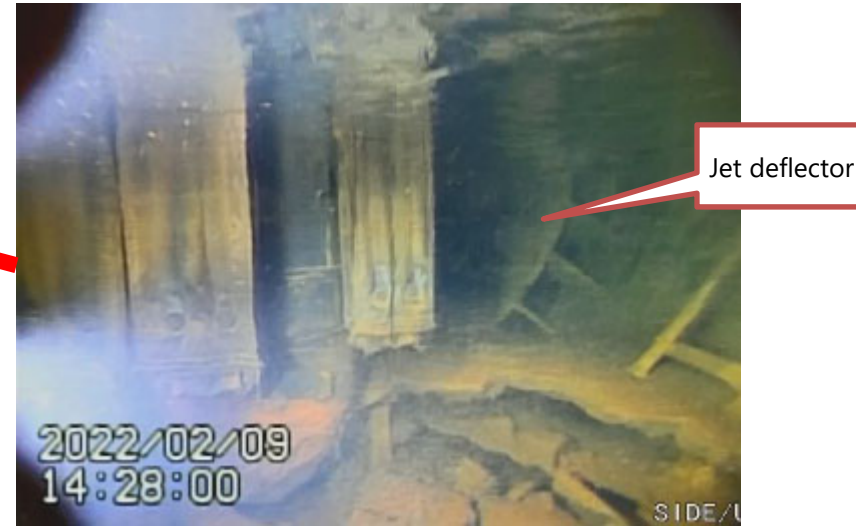
- Furthermore, after guide rings installation on February 9, an investigation of the area to the east-northeast of the PCV (215°) was conducted to obtain information that will contribute to future investigations. During this investigation deposits were found near the jet deflectors in the aforementioned area. (Referred to slide 4)

Conditions to the east-northeast of the PCV (bird's-eye view)

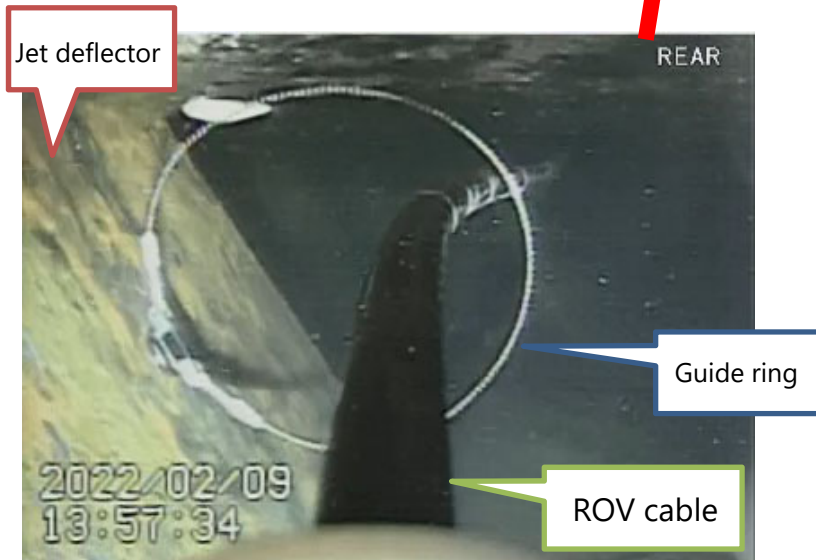
Guide ring ④ installation (Installation completed at 1:50 PM on February 9)

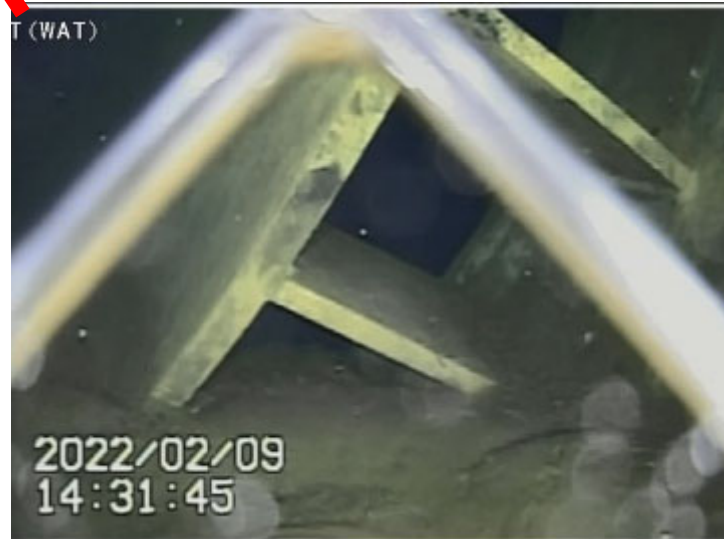
Conditions to the east-northeast of the PCV (close-up)

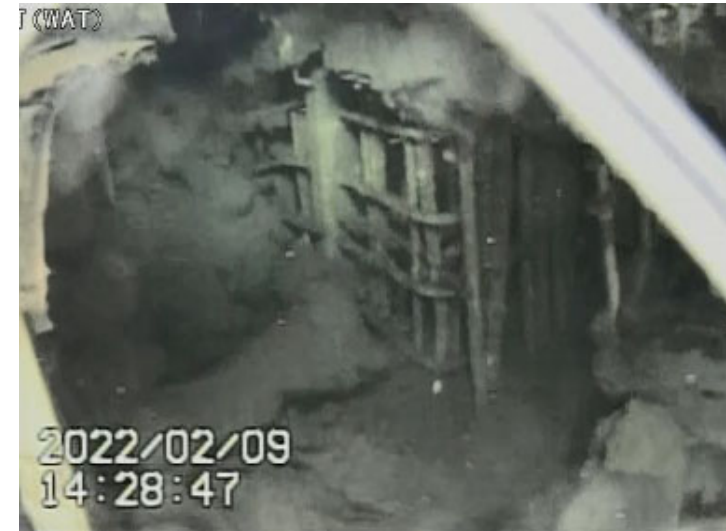
- 
- Conditions around the pedestal opening were also investigated. When the conditions in the area from around the opening to inside the pedestal opening were investigated, clumps of deposits were found, but it could not be determined if these deposits are core internals or fuel debris. Furthermore, objects that are thought to be rebar were also found around the opening. (Referred to slide 5)

A. Near the pedestal opening

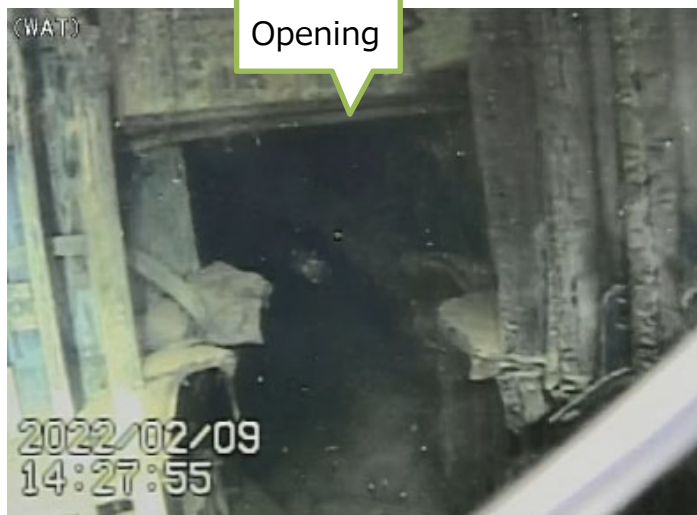
B. Bird's-eye view of the pedestal opening

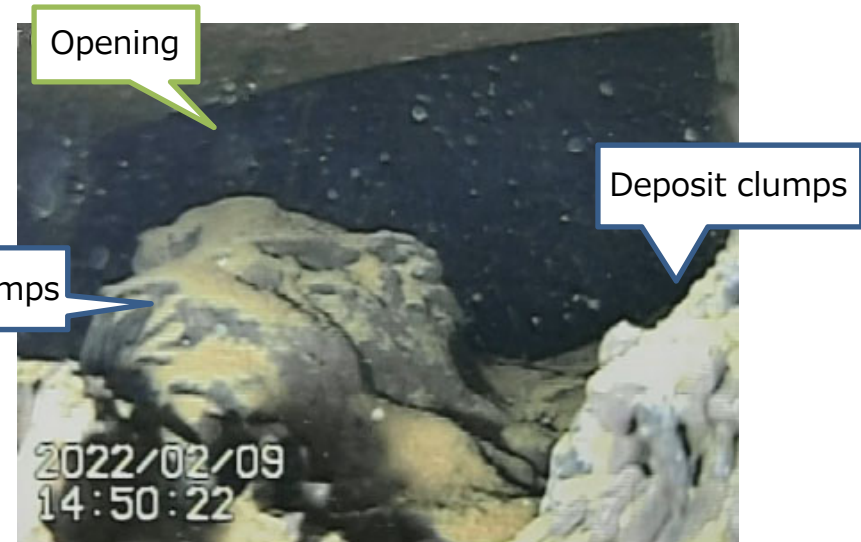
C. Inside the pedestal opening

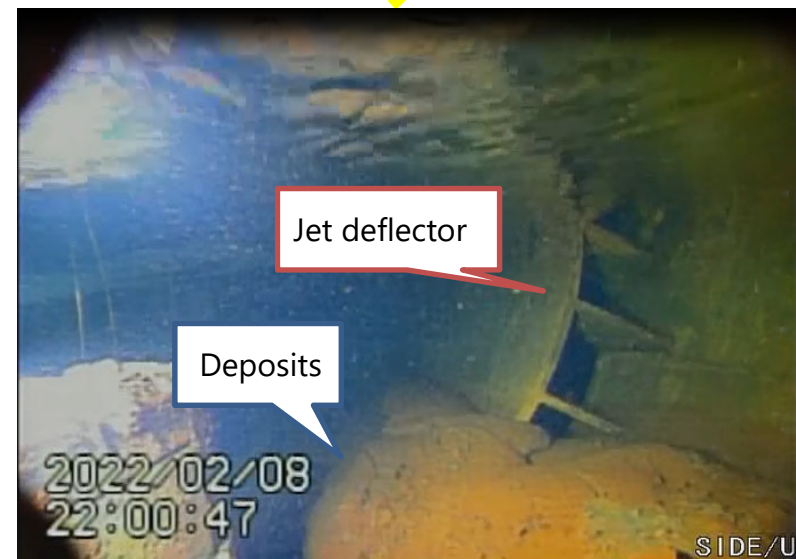
Deposits near the 4<sup>th</sup> jet deflector

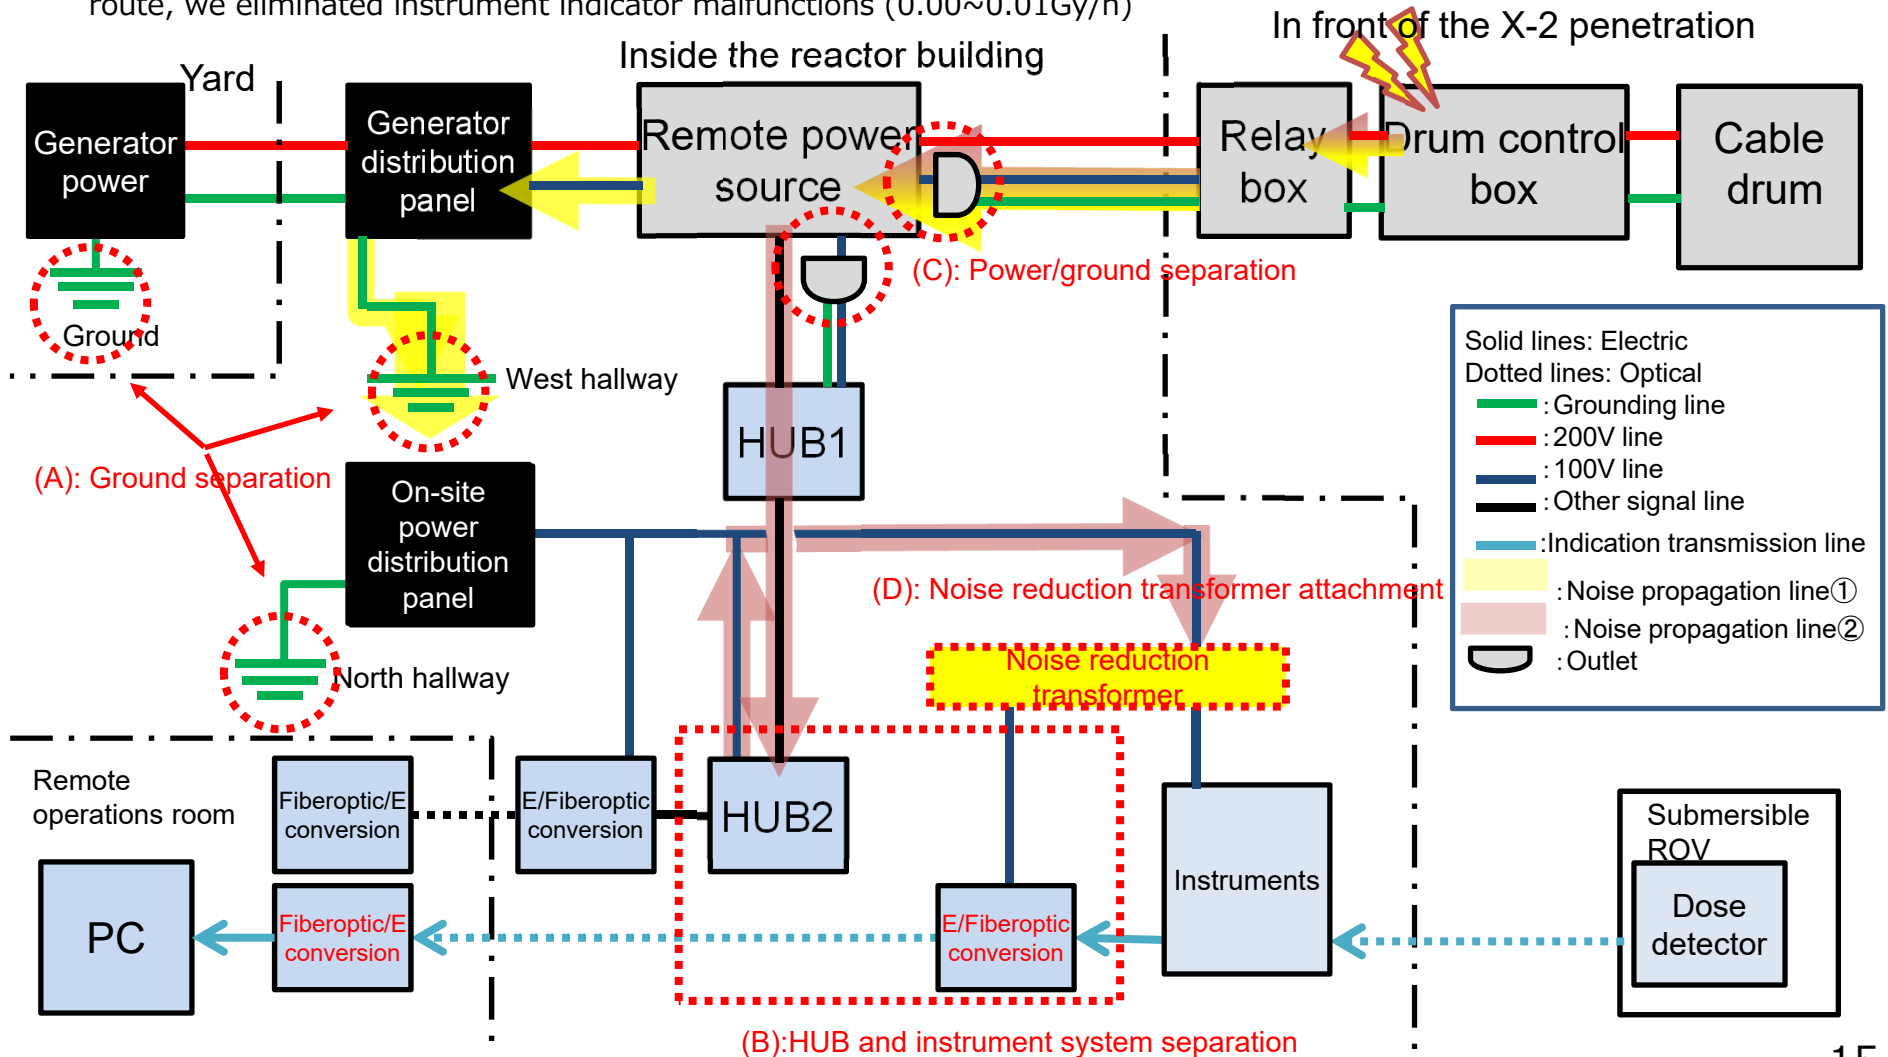
- From the results of additional investigations we have hypothesized that noise originating from the drum control box propagated as follows and affected the instruments. (①: Noise propagating from the south grounding line, ②: Noise propagating from the HUB)
- By implementing the countermeasures (A)~(D) shown in the diagram below and cutting off each noise propagation route, we eliminated instrument indicator malfunctions (0.00~0.01Gy/h)
