Conditions at the Fukushima Daiichi Nuclear Power Station after the Earthquake of March 16

< Reference document >
M a r c h 1 7 , 2 0 2 2
Tokyo Electric Power Company Holdings, Inc.
Fukushima Daiichi Decontamination &
Decommissioning Engineering Company

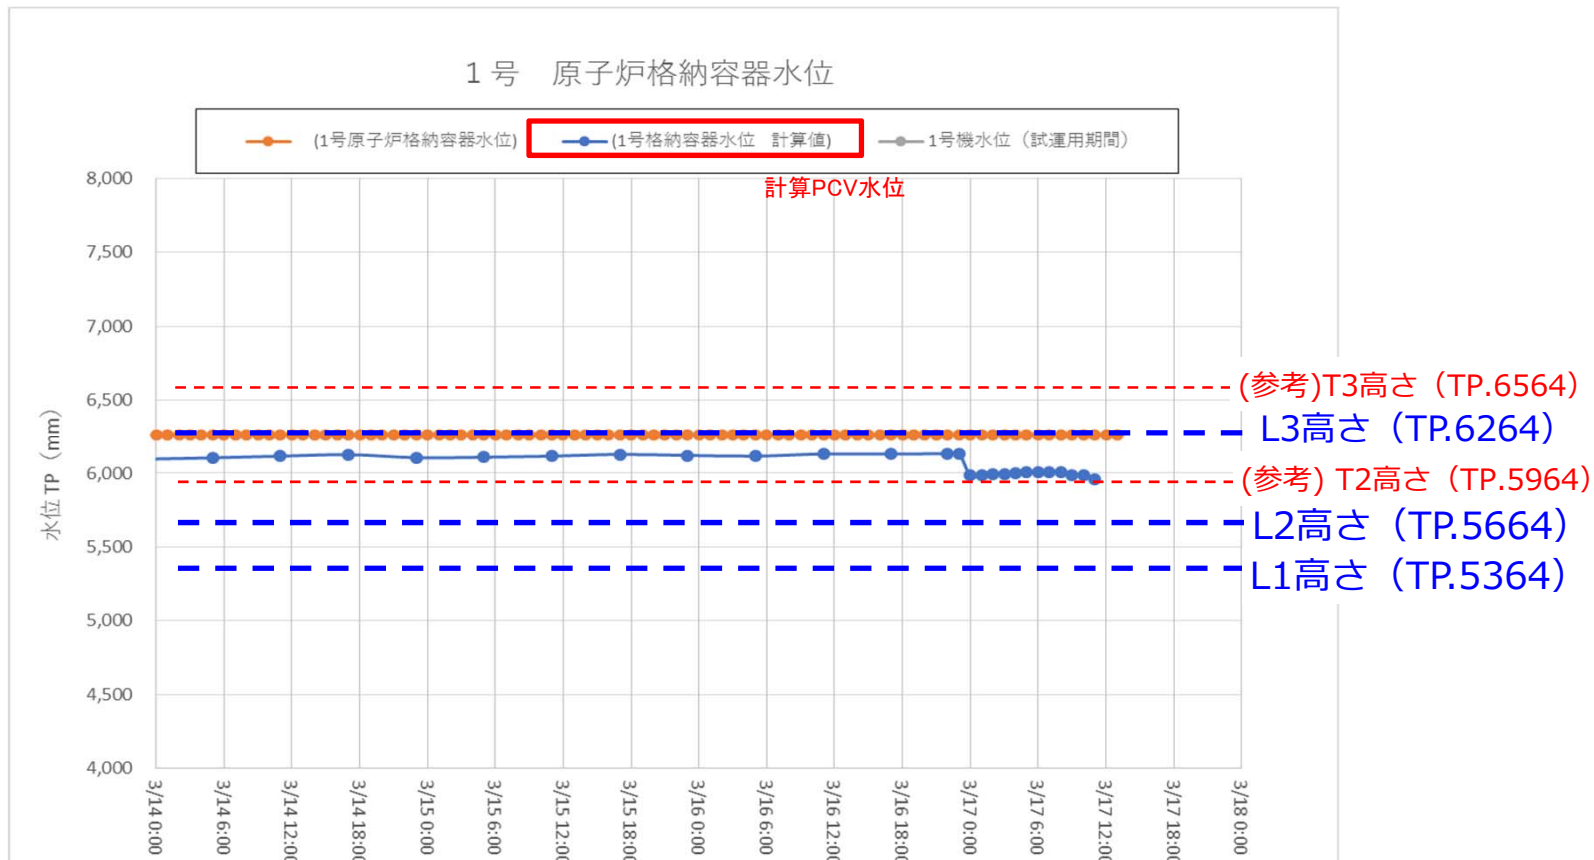
Water level inside the Unit 1 primary containment vessel

○Although the water level inside the Unit 1 primary containment vessel had temporarily decreased as follows, no significant changes have been confirmed. Fluctuations in the water level will continue to be closely observed.

○The current water level is close to the position of water gauge L3 (T.P.+6,264mm).
(Primary containment vessel bottom is T.P.+4,744mm)

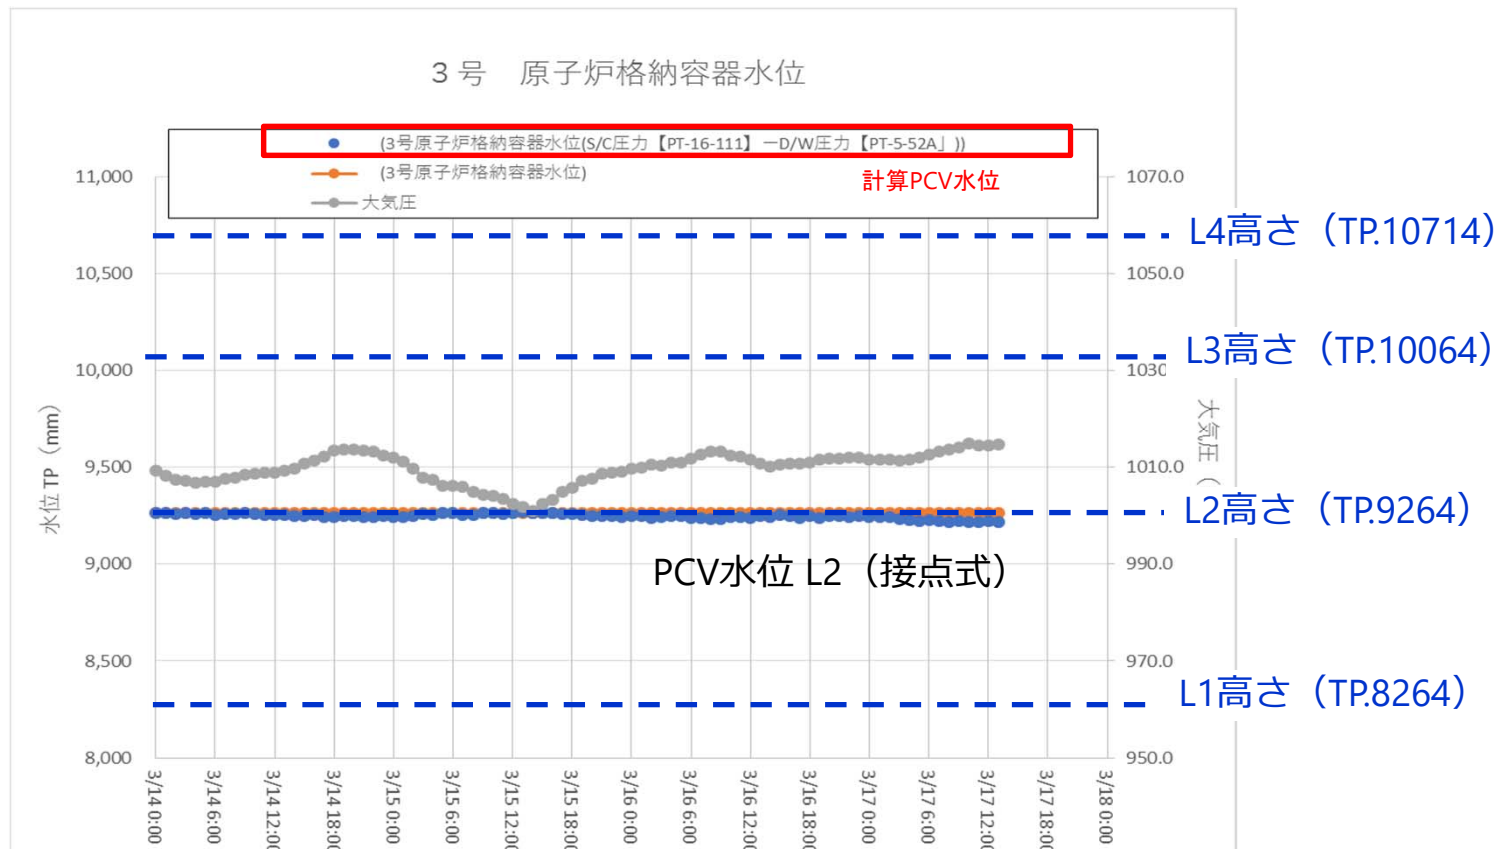
Water level inside the Unit 3 primary containment vessel

- No significant changes have been confirmed regarding the water level inside the Unit 3 primary containment vessel, as follows.
- The current water level is close to the position of water gauge L2 (T.P.+9,264mm).
(Primary containment vessel bottom is T.P.+4,044mm)

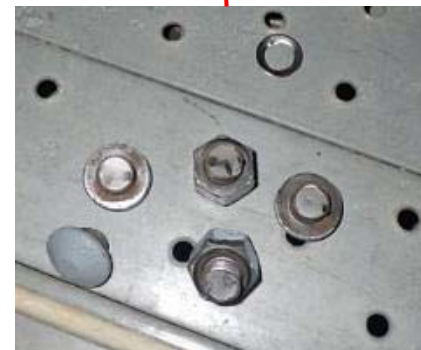
Description: TEPCO employees found a steel auxiliary member used for exterior wall installation had fallen. It is speculated that the member had fallen due to bolts at the joint rupturing. No significant corrosion was found on the bolts.

Bolts at the joint ruptured
