Conditions at the Fukushima Daiichi Nuclear Power Station after the Earthquake of March 16 (Update 2)

< Reference document >
M a r c h 2 2 , 2 0 2 2
Tokyo Electric Power Company Holdings, Inc.
Fukushima Daiichi Decontamination &
Decommissioning Engineering Company

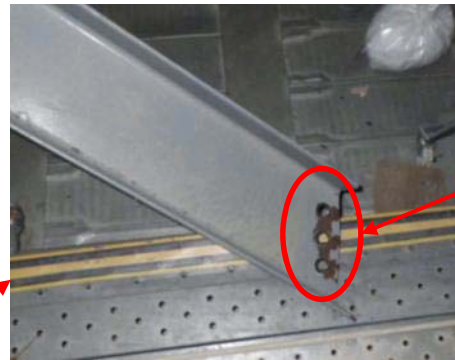
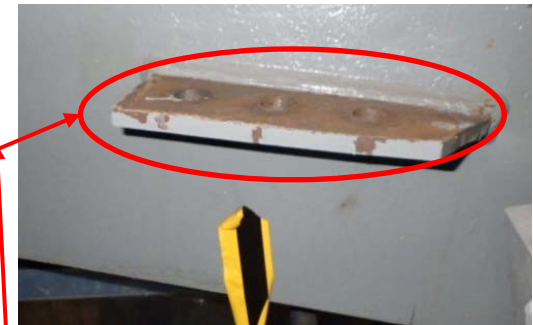
Bolts at the joint ruptured

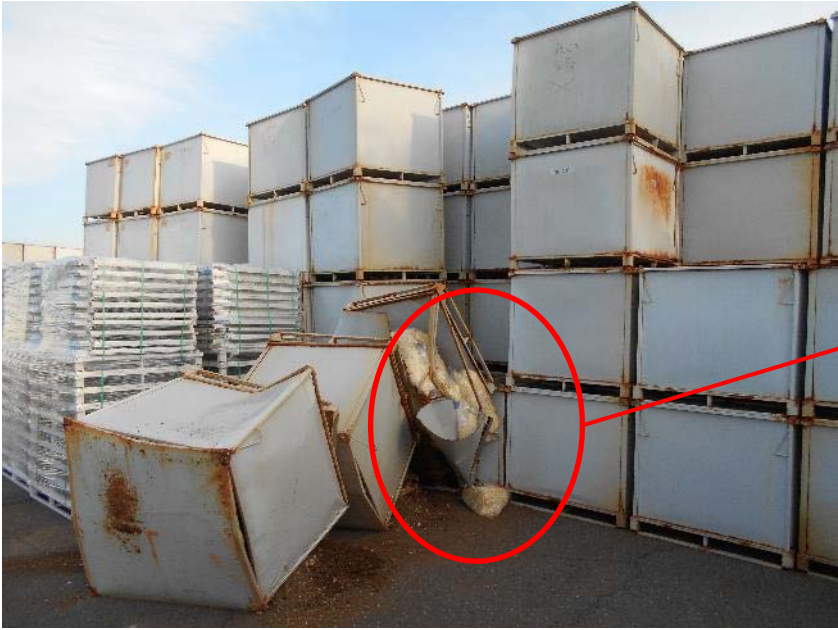
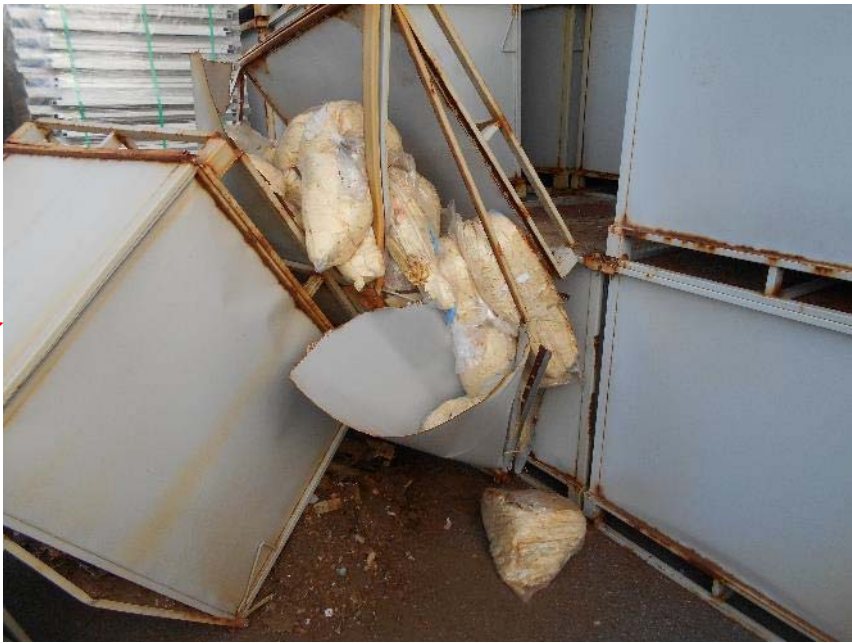
State of containers

- A thorough examination of the contents of six containers in temporary storage area A that were toppled has found that four containers were filled with used protective clothing, and two containers were filled with metal scrap. The toppled containers have been set upright.

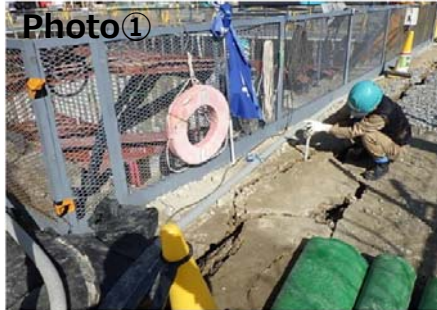
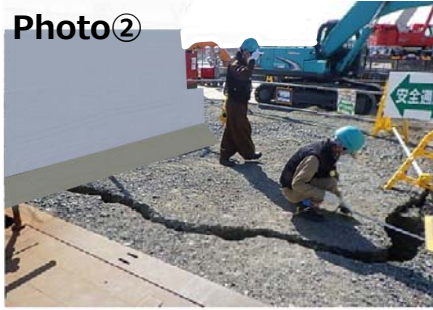
① Unit 5/6 seawall yard

Ground cracks and subsidence have been found in the Unit 5/6 seawall yard. Environmental improvements are underway in the aforementioned yard in preparation for the construction of facilities to dilute and discharge ALPS treated water, but the cracks and subsidence have had no impact on the shafts currently being constructed.

Surface cracks/ground subsidence

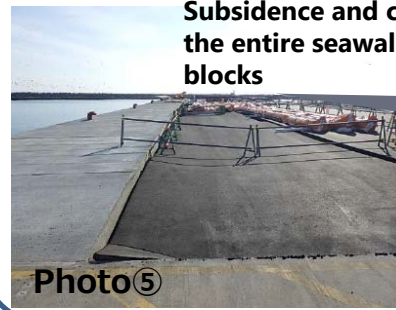
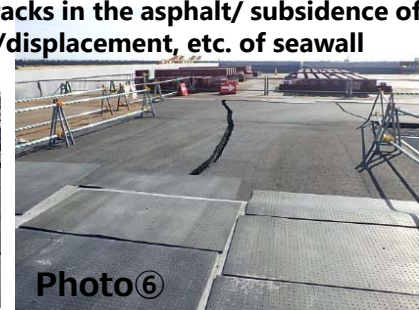
③ : New port yard

Subsidence and cracks have been found in the asphalt throughout the entire new port yard, and subsidence of the entire seawall, and the displacement, etc. of seawall blocks has been found. Vehicles cannot currently access the area so emergency repairs are to be made.

Subsidence and cracks in the asphalt/ subsidence of the entire seawall/displacement, etc. of seawall blocks

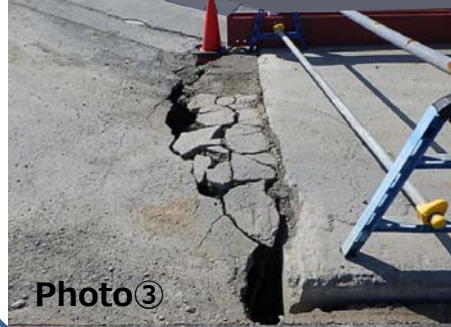
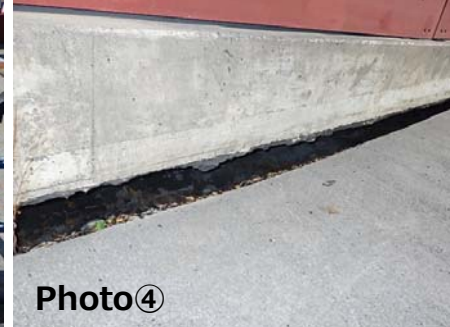
Subsidence has been found in the road leading from the Unit 5/6 gate to the ocean side area that is 2.5m above sea level. The subsidence has rendered that part of the road impassable vehicles so emergency repairs are to be made.

② : Unit 5 south side ramp Road subsidence/ground subsidence, etc.

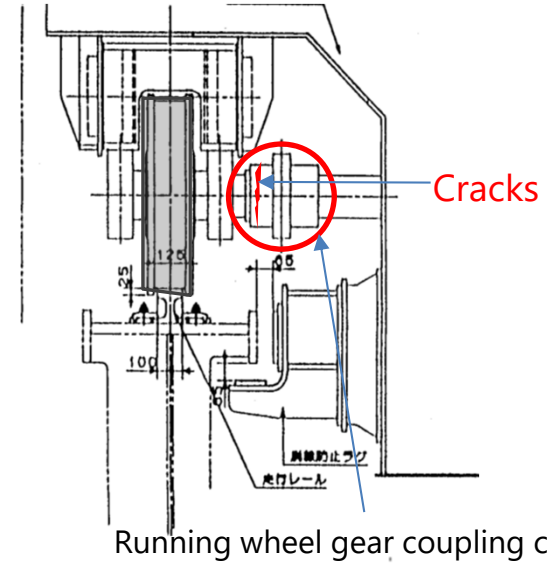
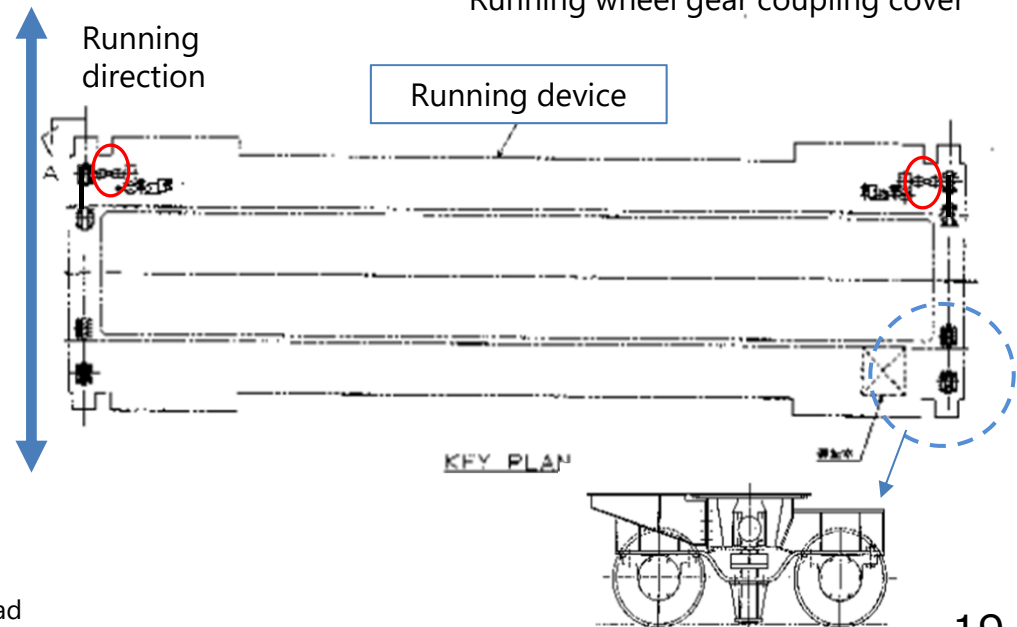
Ceiling crane in the cask loading/unloading area

- An operations check of the ceiling crane (currently undergoing inspection) in the common auxiliary operations building cask unloading/loading area found that the ceiling crane does not run back and forth, in addition to the following.

A visual inspection has found two cracks in the gear coupling covers for the running wheels.
