Location of the detailed visual inspection of the perimeter of the pedestal and inspection schedule

Conditions around the pedestal opening (foundation) (from investigation on May 19 ①)

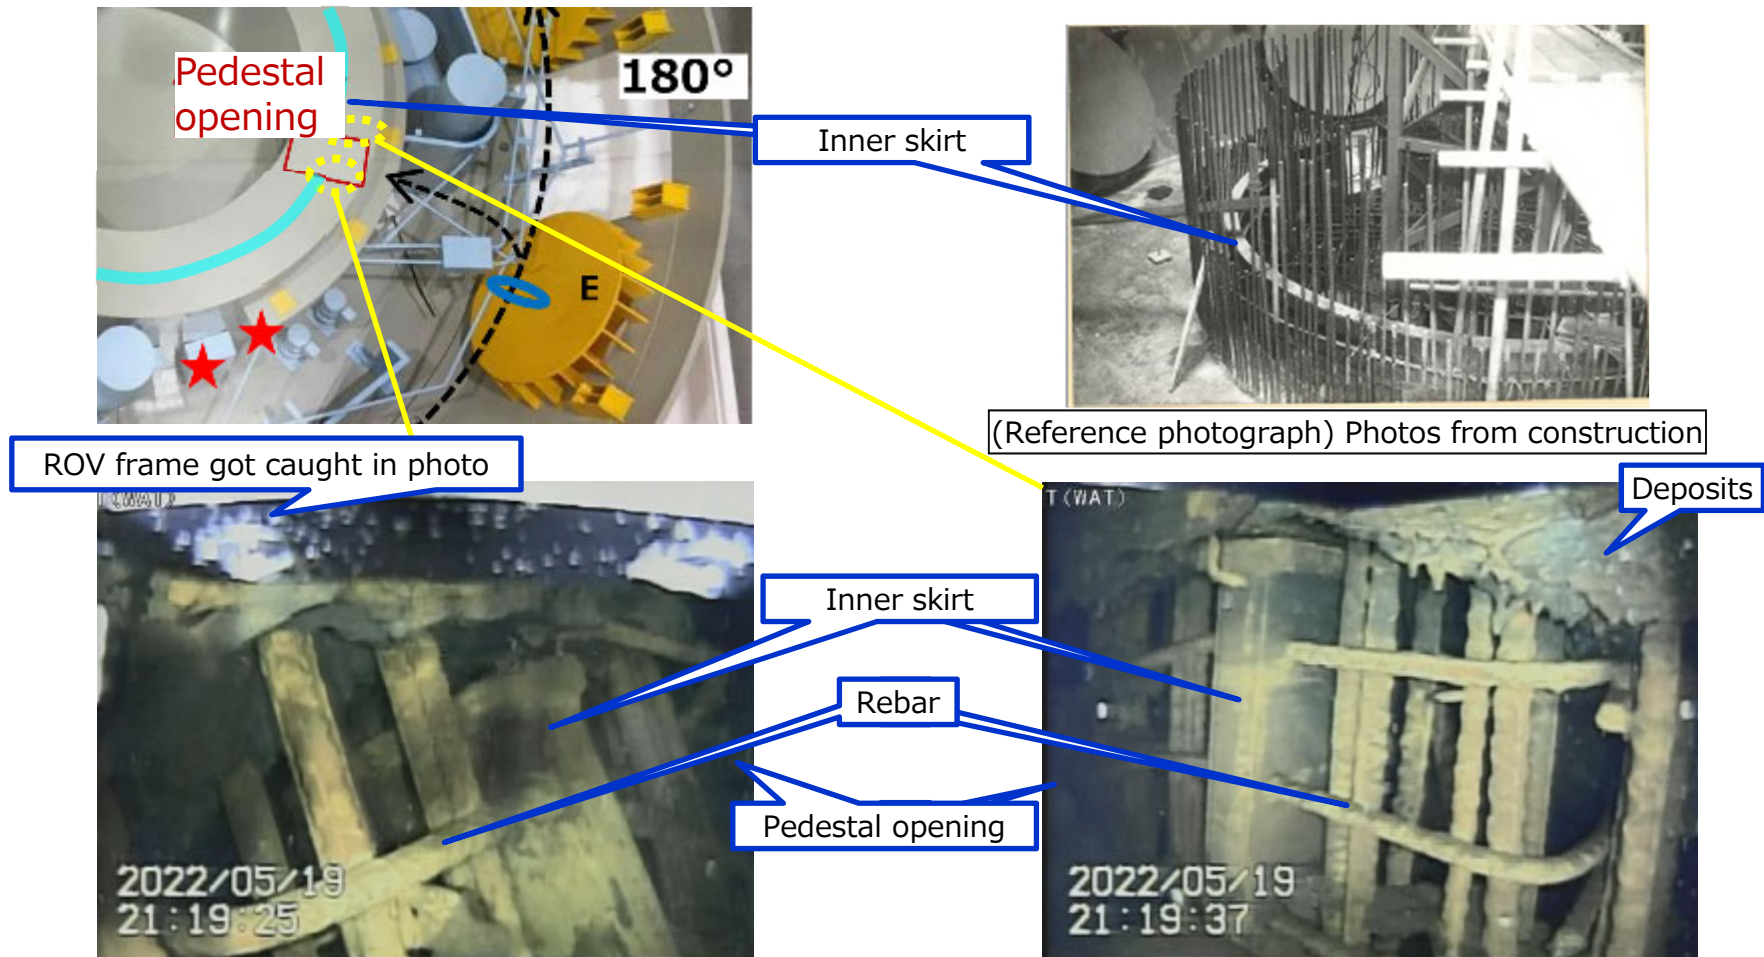
- ✓ Close up photos of the rebar-like objects were compared with photos taken at the time of construction and it was determined that the objects are indeed rebar from the pedestal. The inner skirt ※ was also observed

Photo 1. Conditions at the pedestal opening (left side foundation)

Photo 2. Conditions at the pedestal opening (right side foundation)
Source: International Research Institute for Nuclear Decommissioning (IRID)

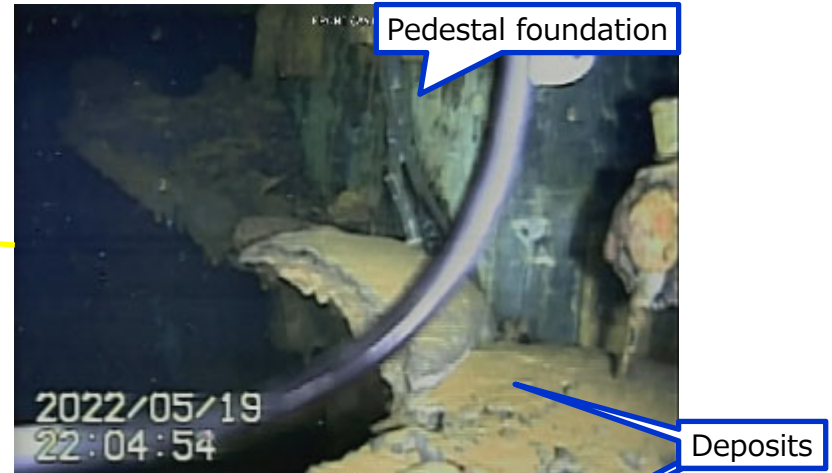
Photo 1. Conditions above the deposits at the opening of the pedestal (right side foundation)

- ✓ Pedestal rebar was found at the bottom the deposits
- ✓ At the top of the deposits we found the pedestal foundation intact

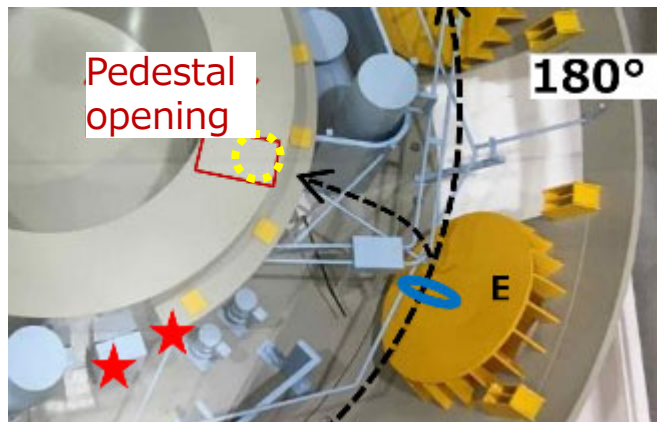
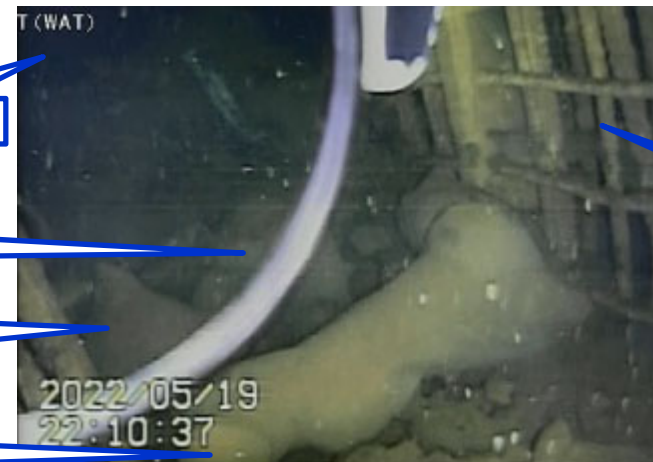
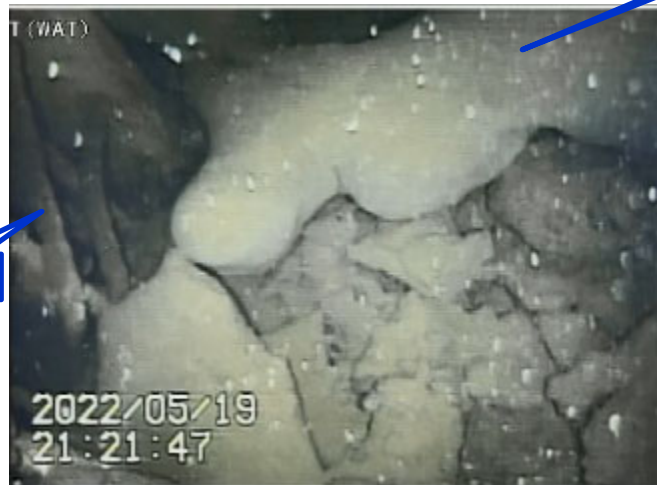
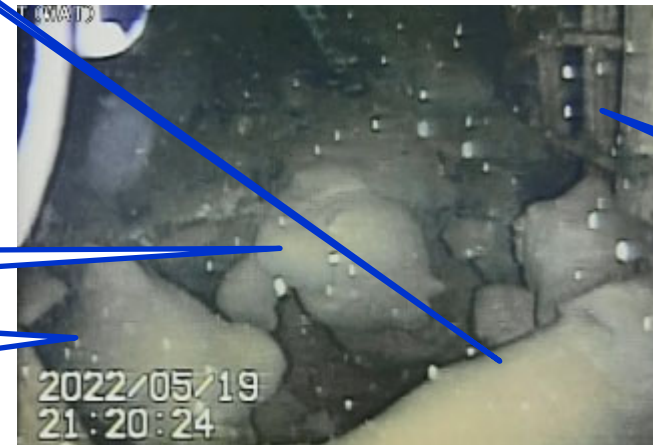
- ✓ Several clump-like deposits were found

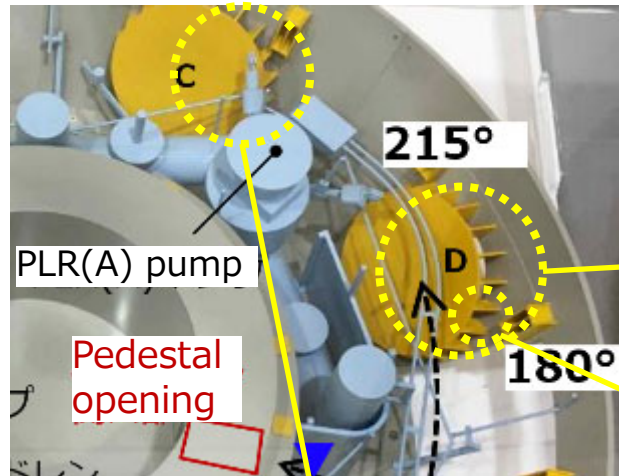
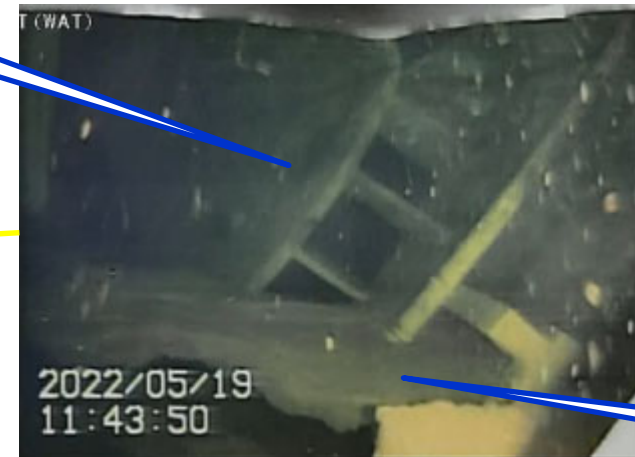
Photo 1. Looking down on jet deflector (D)

- ✓ Deposits were found around Jets deflector (D) and behind it (pressure suppression chamber side)
- ✓ Deposits were found around Jets deflector (C)

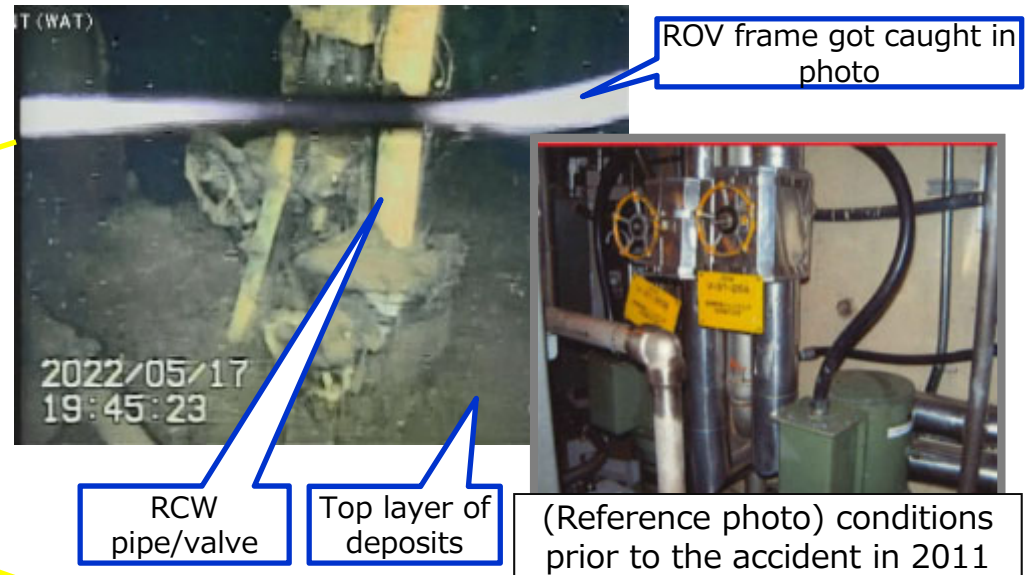
Photo 1. Conditions near the equipment drain sump pump

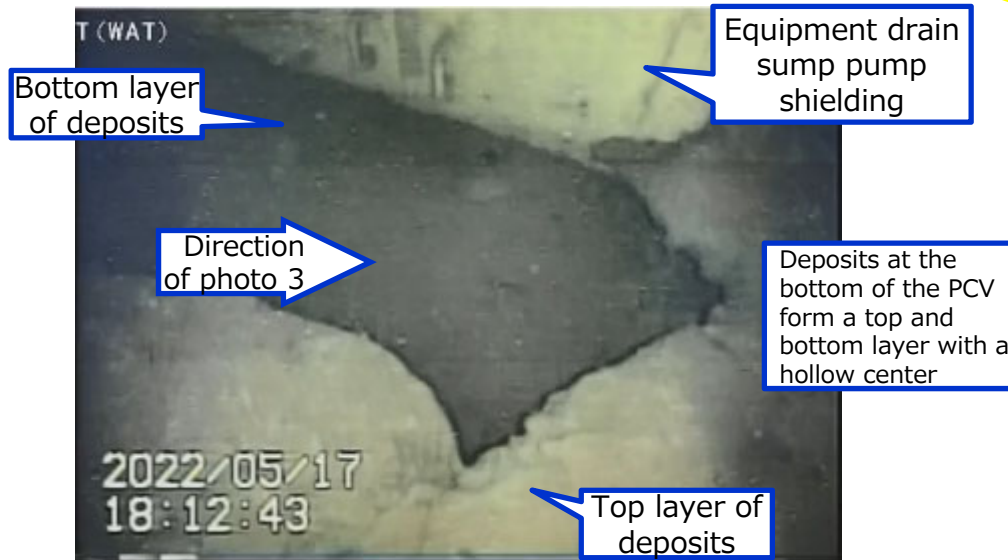
Photo 2. Deposits at the bottom of the PCV

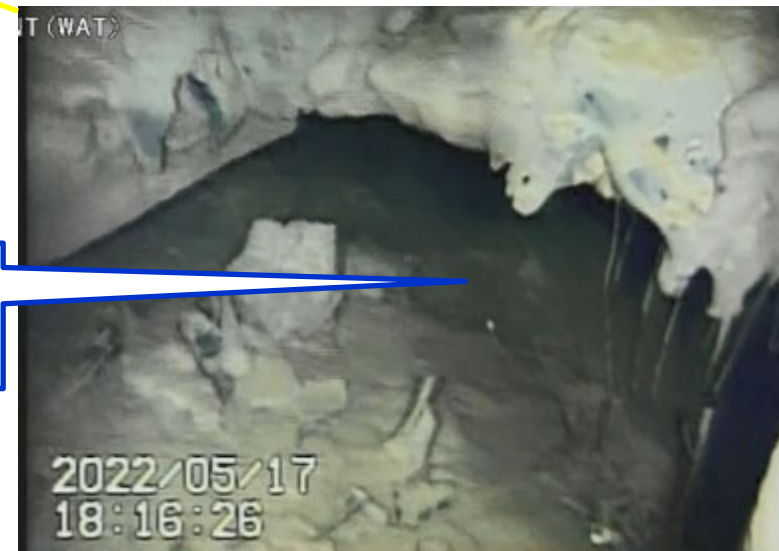
Photo 3. Deposits at the bottom of the PCV
 (hollow area)

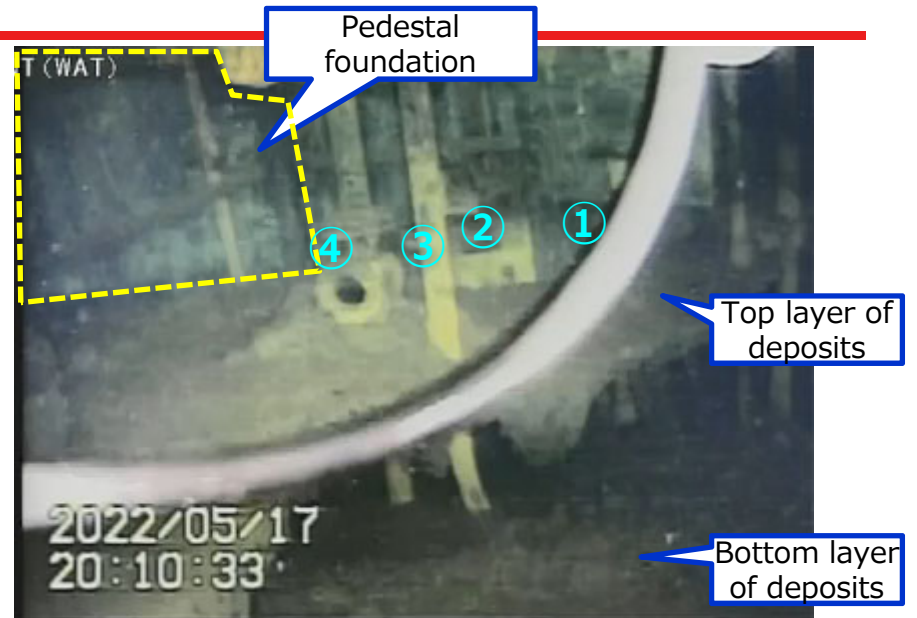
Photo 1. Conditions at top of pedestal foundation

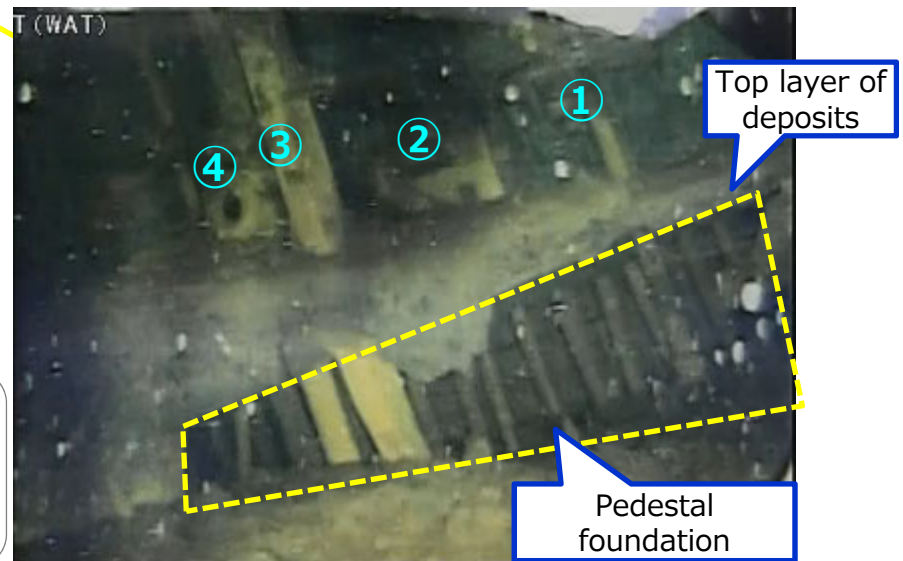
Photo 2. Conditions at bottom of pedestal foundation

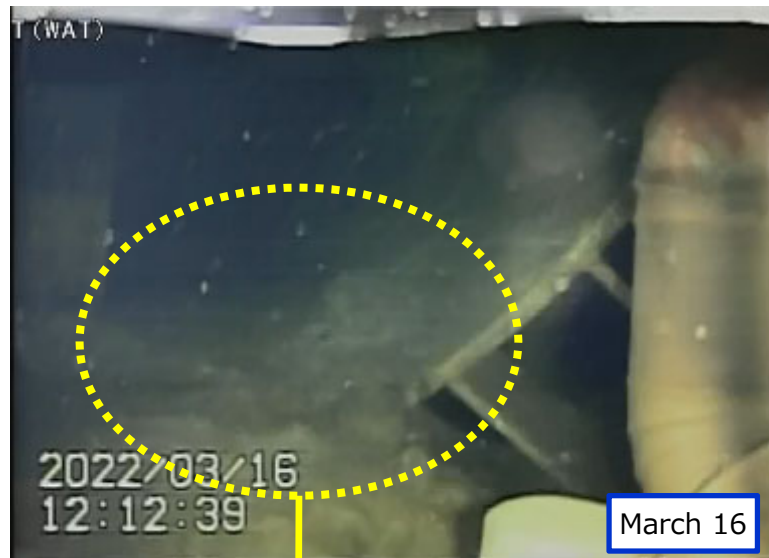
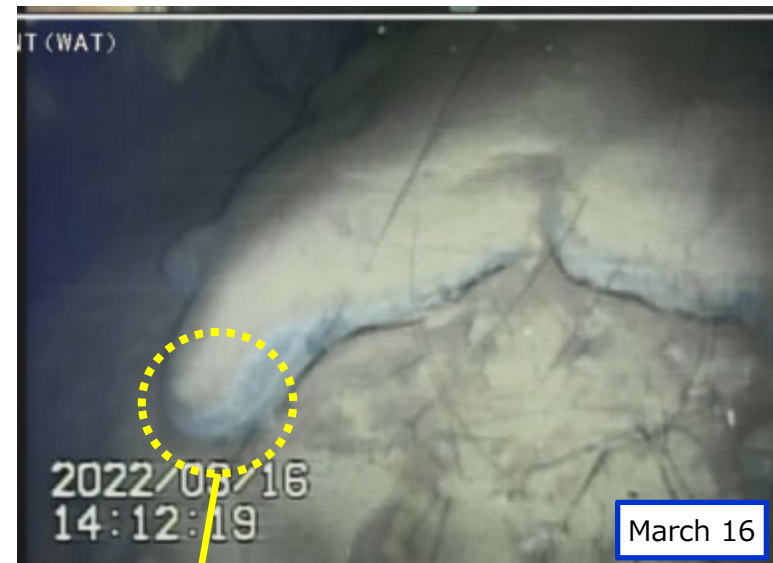
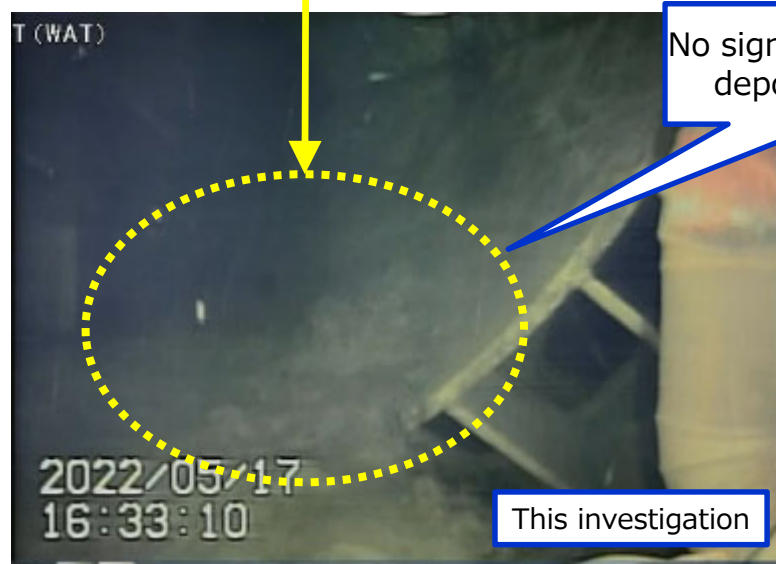
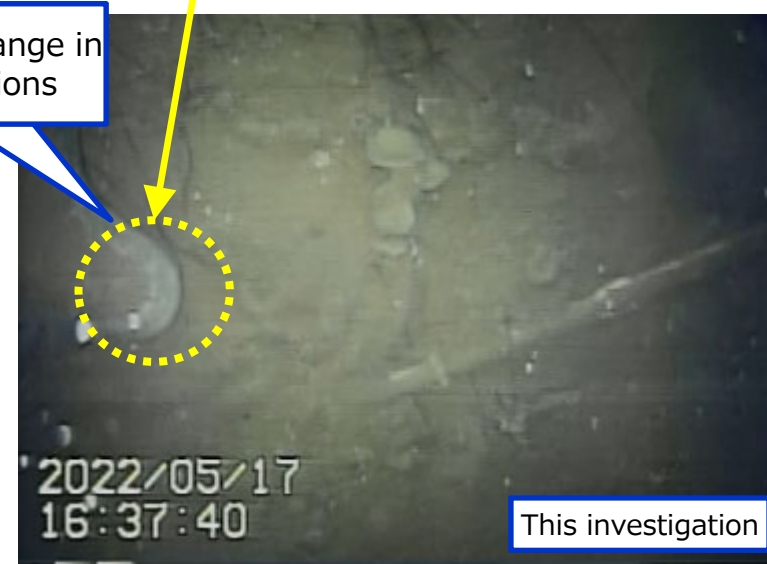
No significant change in deposit conditions

Photo 1. Looking down on jet deflector (F)

Photo 2. Conditions around jet deflector (F)

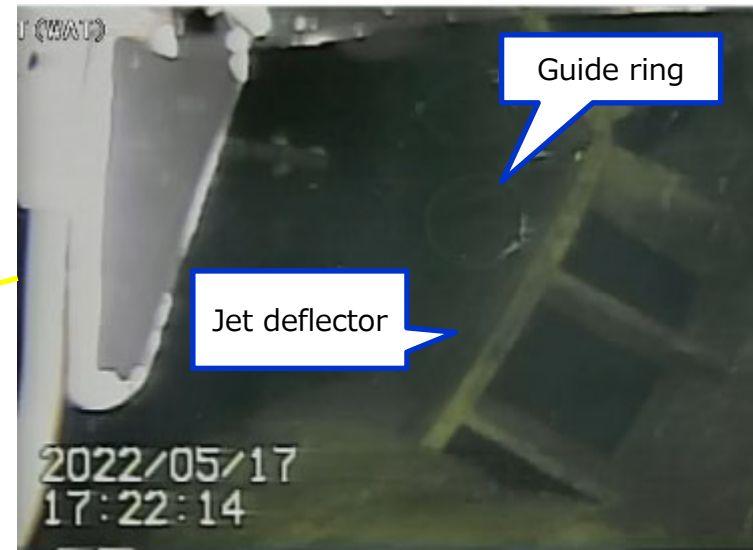
Photo 1. Looking down on jet deflector (E)

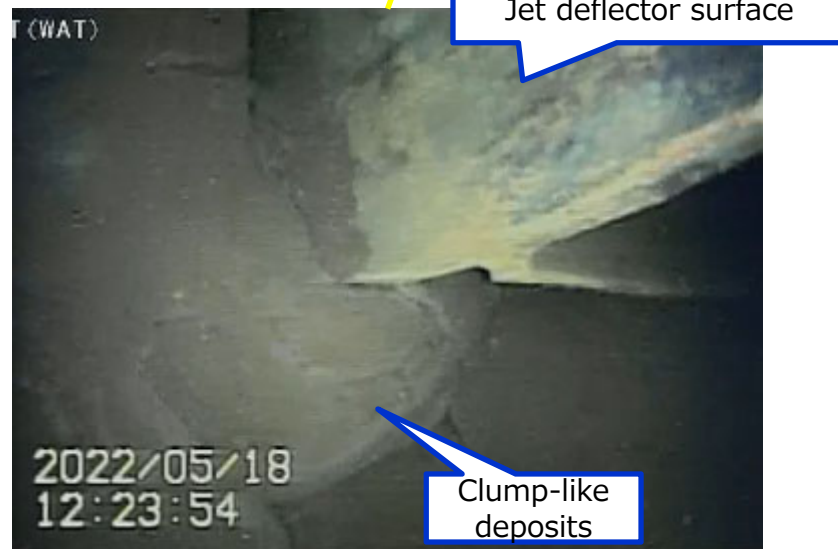
Photo 2. Conditions at the bottom front of jet deflector (E)

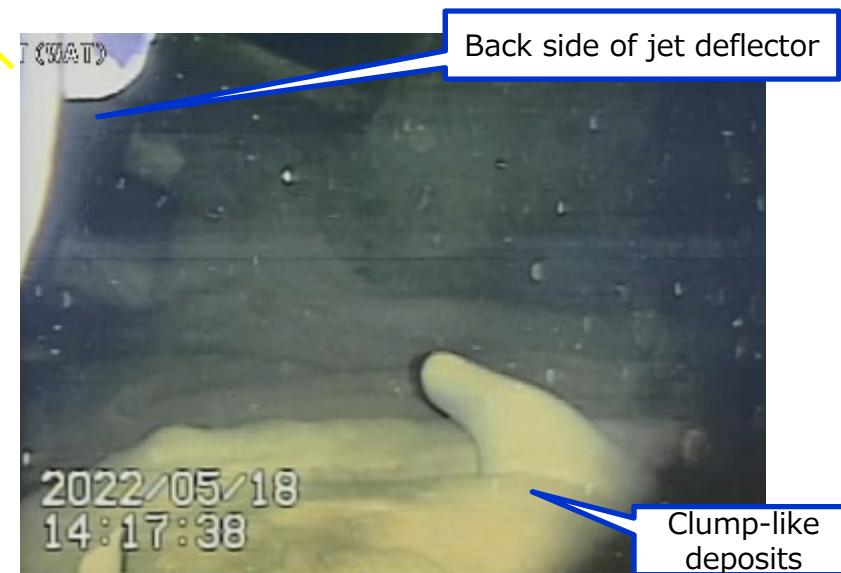
Photo 3. Conditions at the back of jet deflector (E)

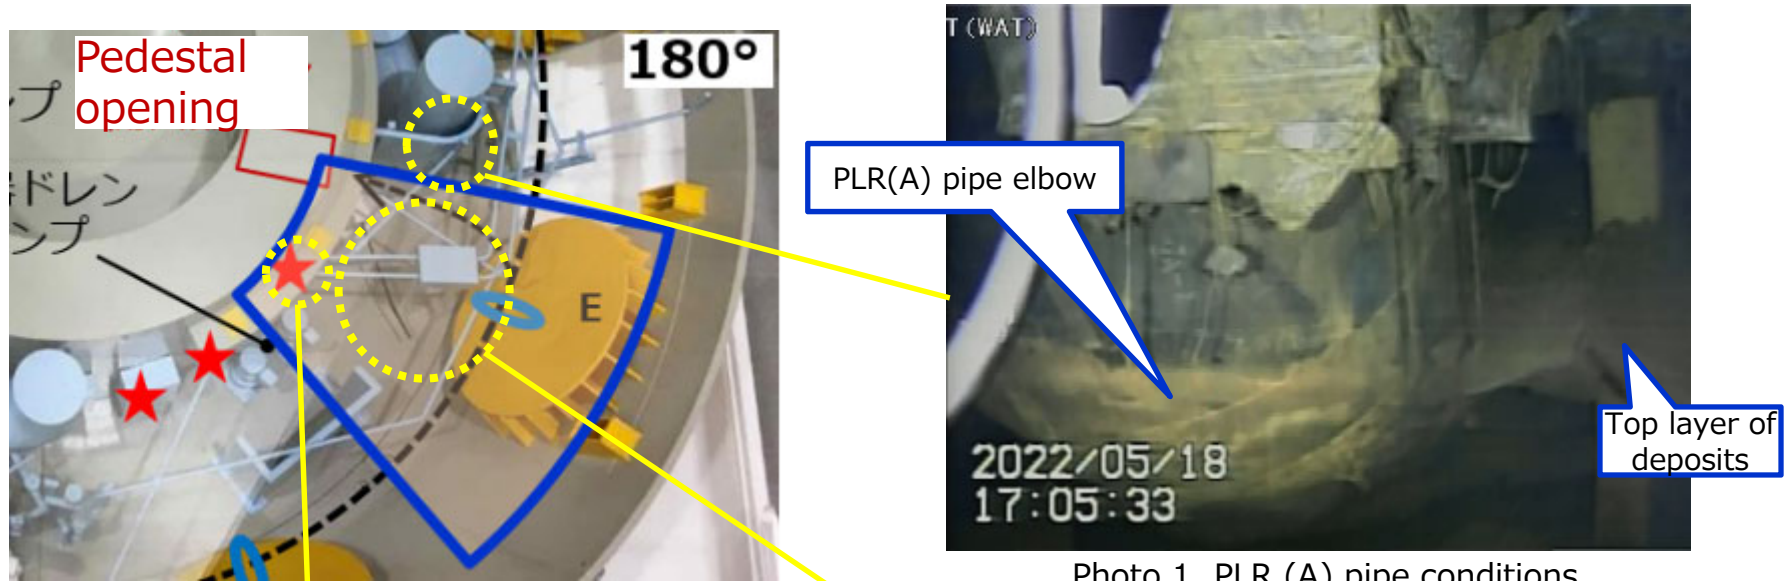
Photo 1. PLR (A) pipe conditions

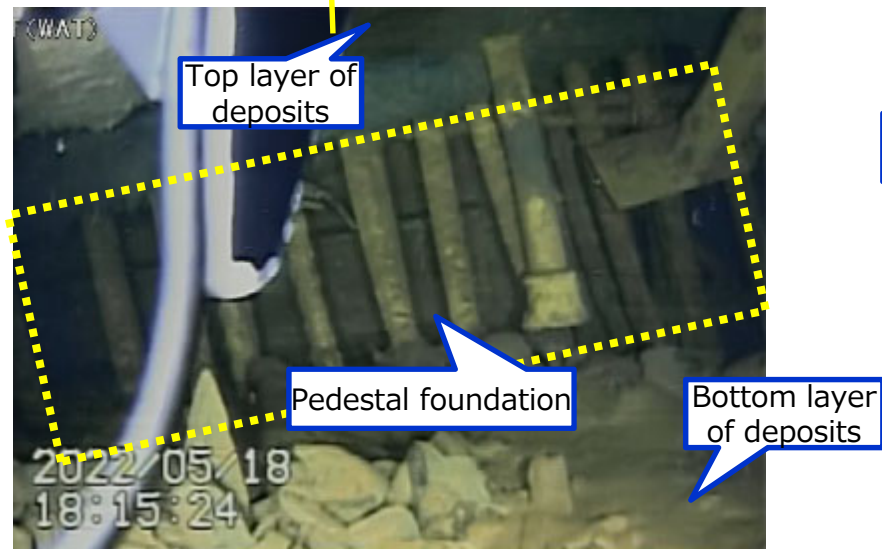
Photo 2. Conditions around the pedestal foundation

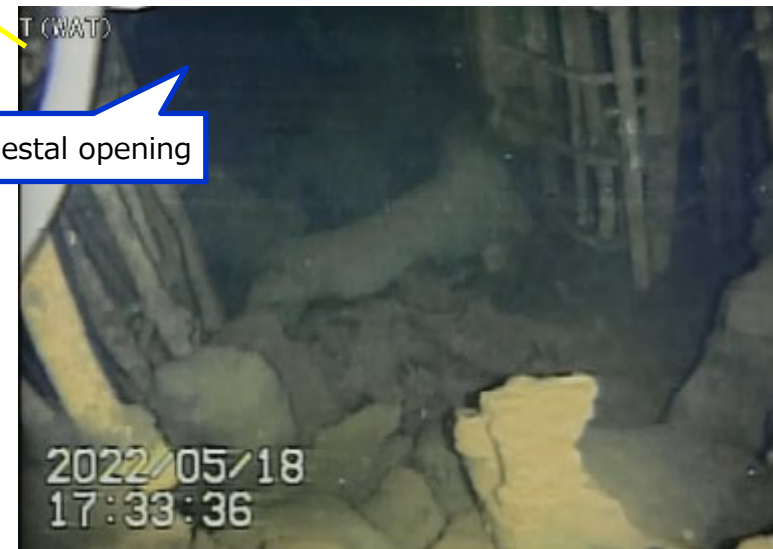
Photo 3. Deposits in front of the pedestal opening
