Status of Unit 1 PCV internal investigation

May 26, 2022

International Research Institute for Nuclear Decommissioning
Tokyo Electric Power Company Holdings, Inc.

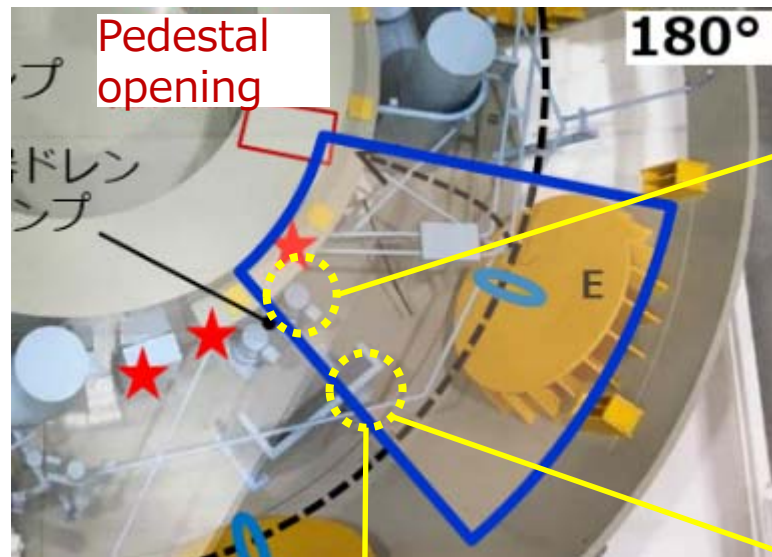
Photo 1. Conditions near the equipment drain sump pump

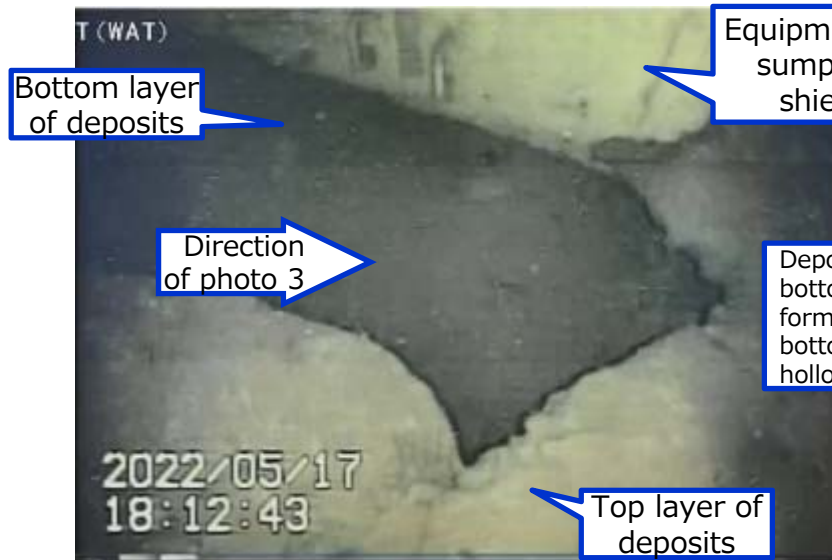
Photo 2. Deposits at the bottom of the PCV

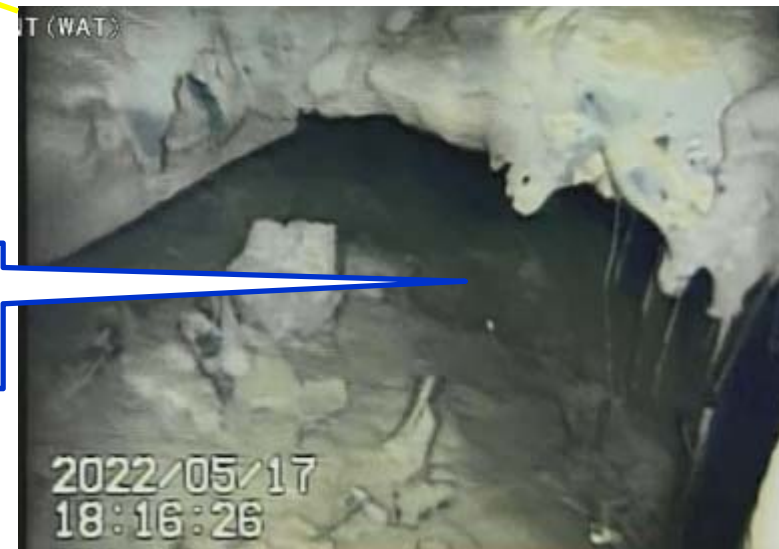
Photo 3. Deposits at the bottom of the PCV (hollow area)

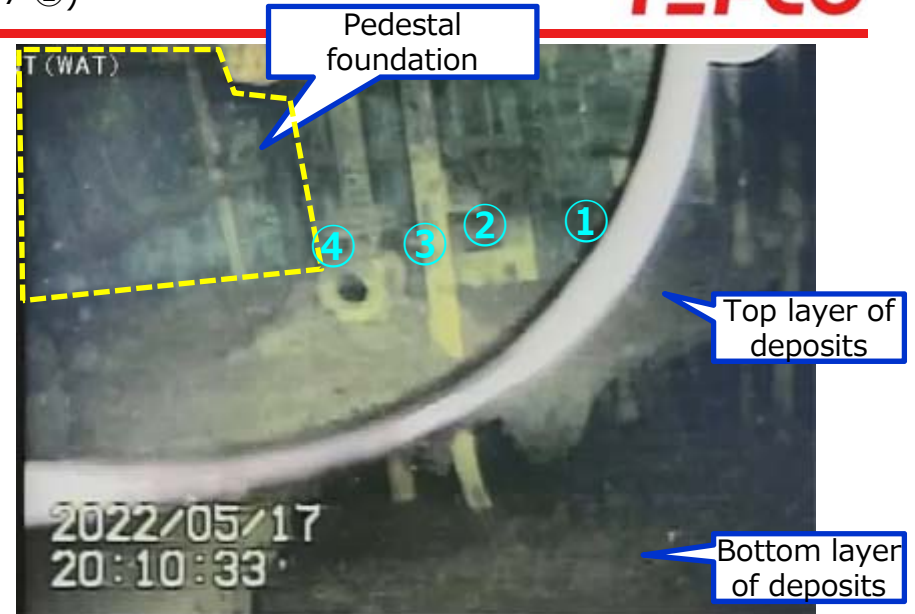
Photo 1. Conditions at top of pedestal foundation

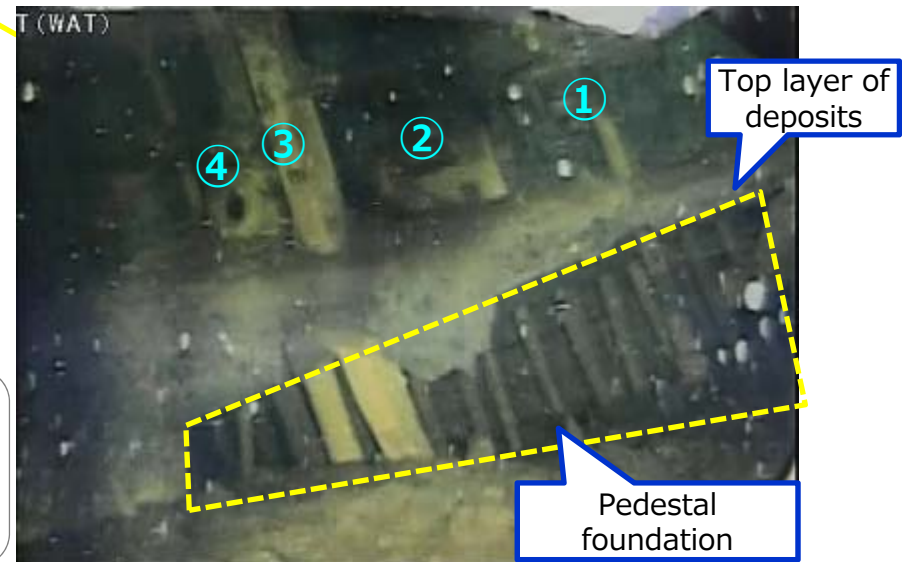
Photo 2. Conditions at bottom of pedestal foundation

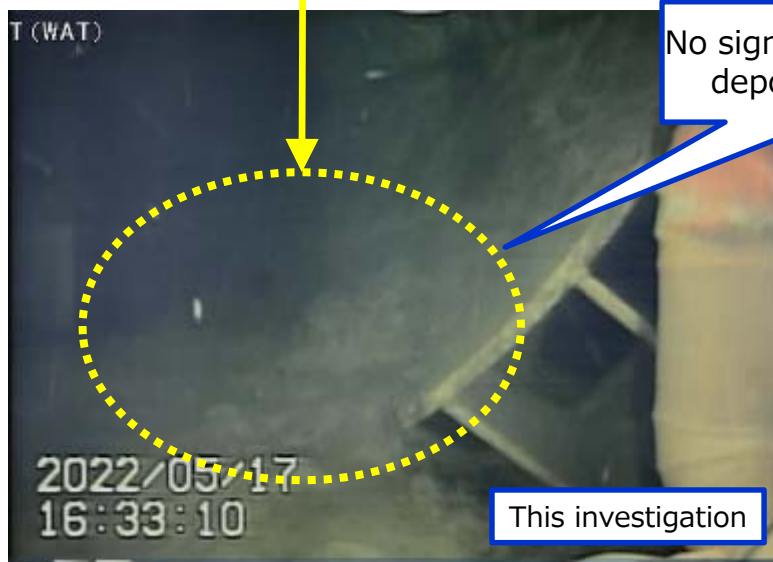
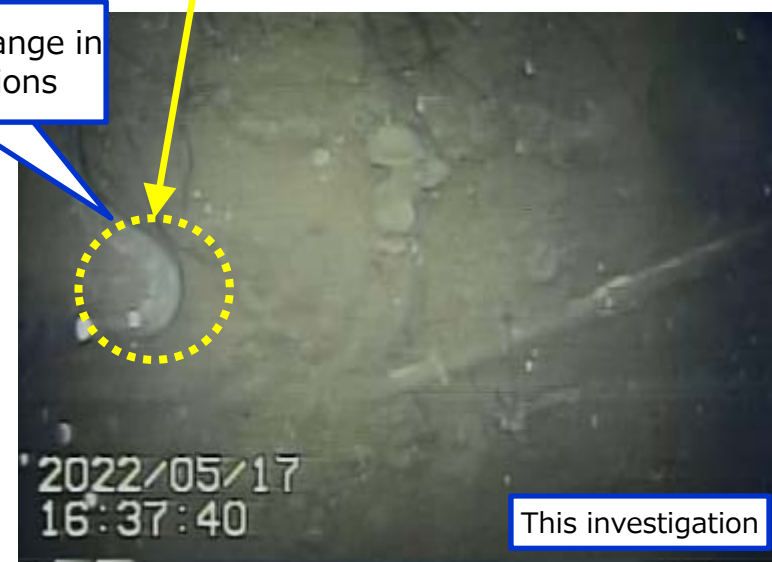
No significant change in deposit conditions

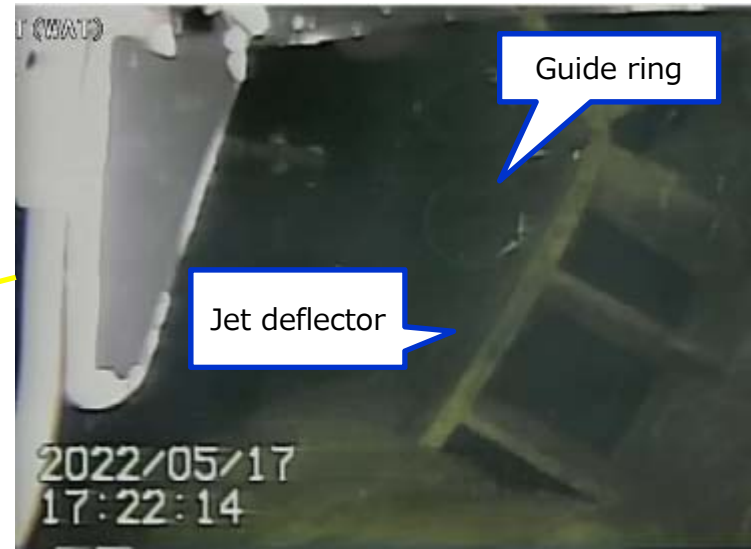
Photo 1. Looking down on jet deflector (E)

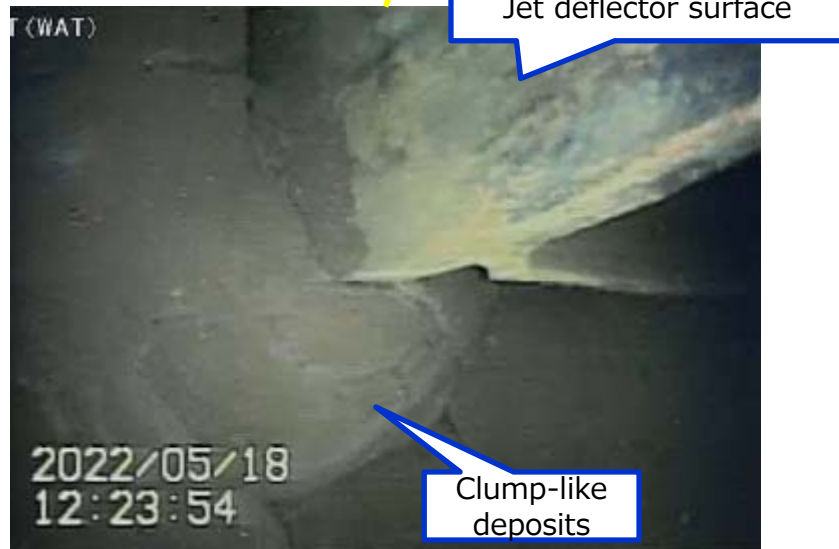
Photo 2. Conditions at the bottom front of jet deflector (E)

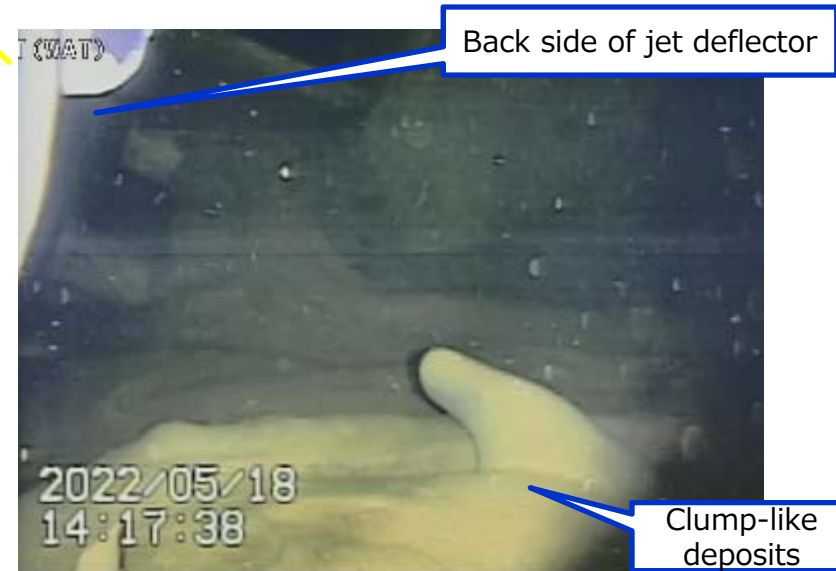
Photo 3. Conditions at the back of jet deflector (E)

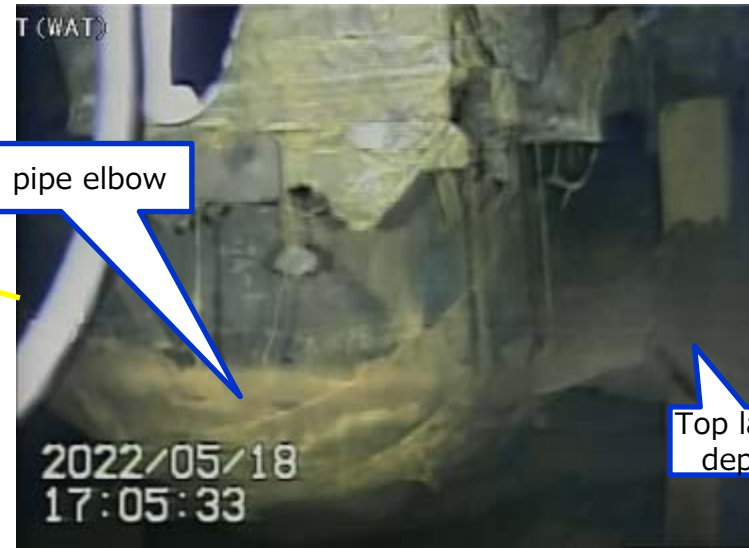
Photo 1. PLR (A) pipe conditions

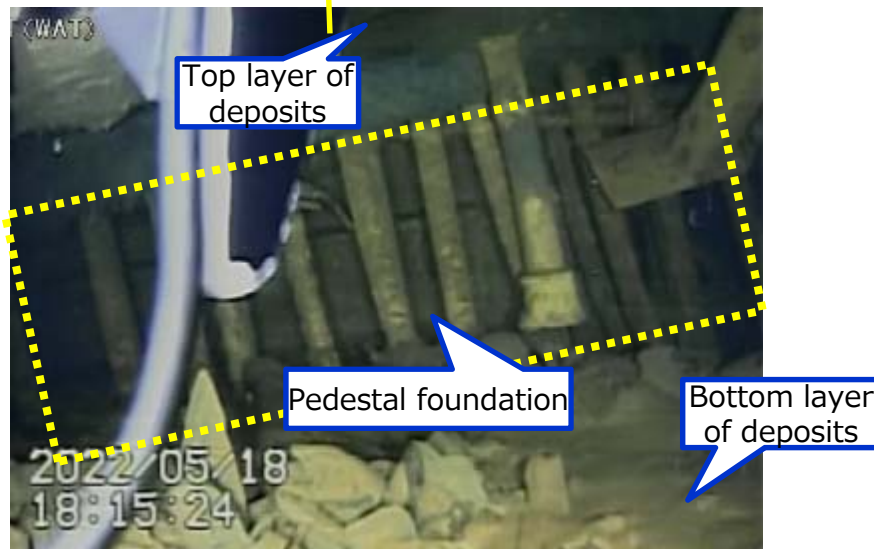
Photo 2. Conditions around the pedestal foundation

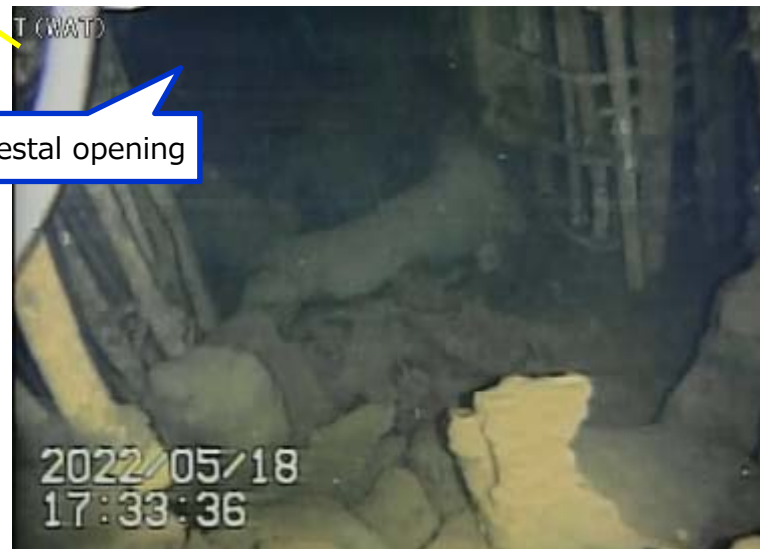
Photo 3. Deposits in front of the pedestal opening

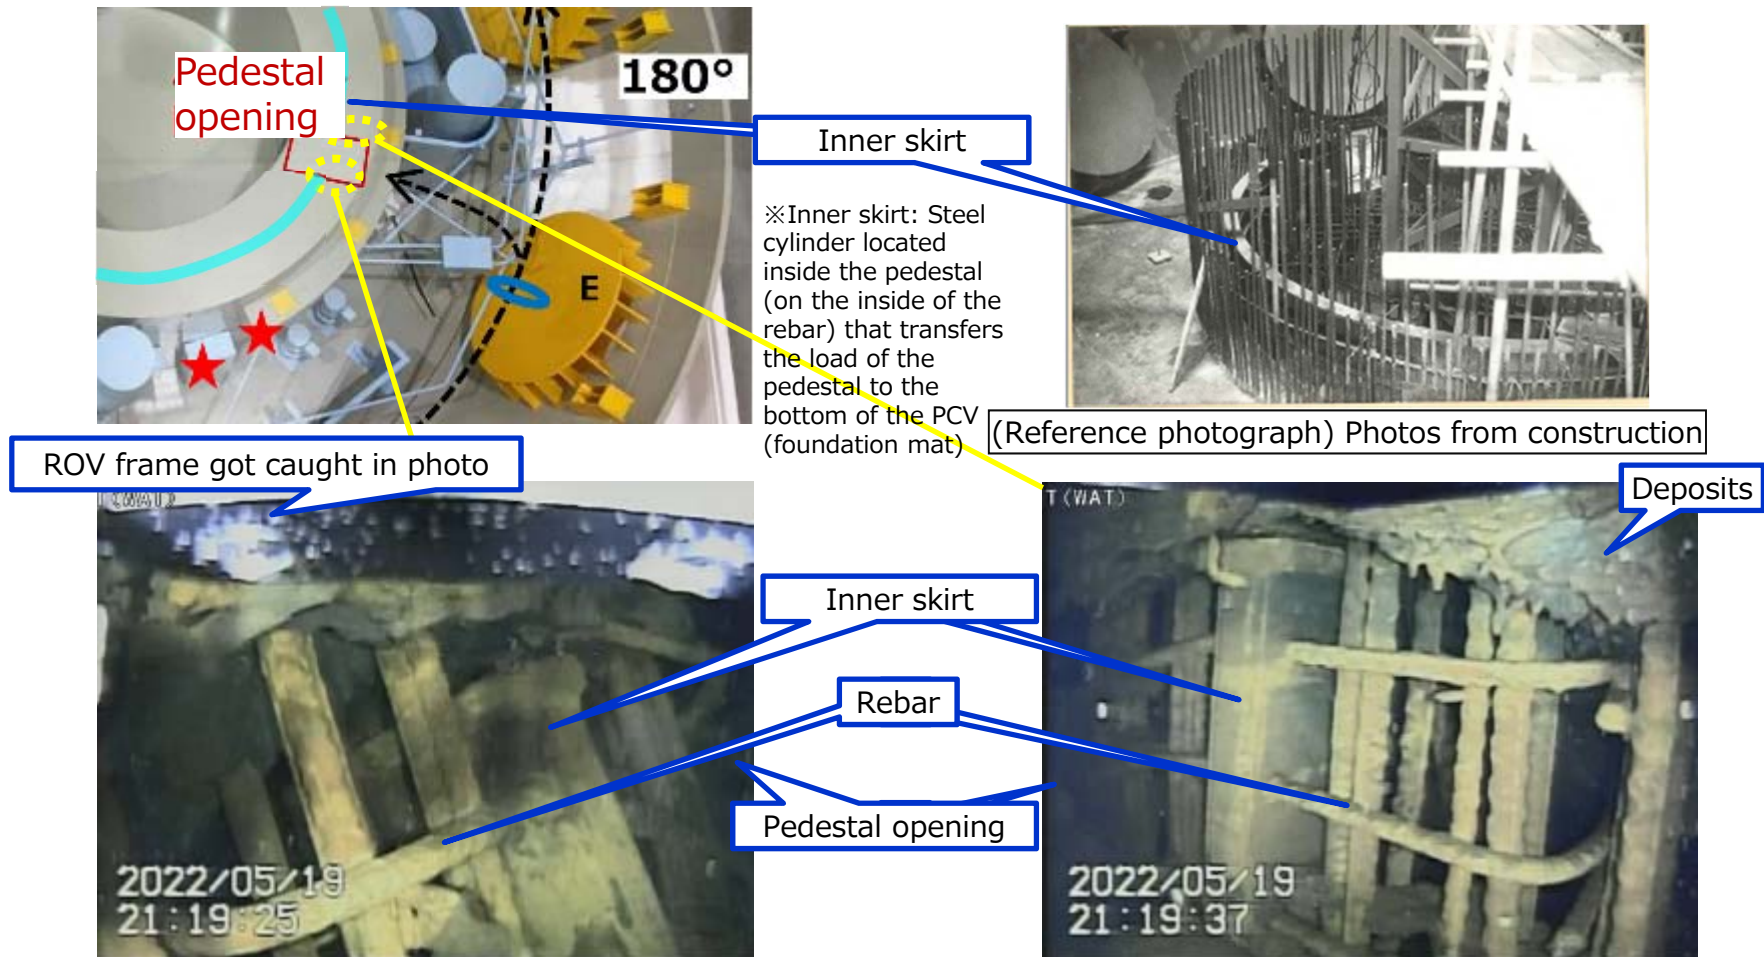
- ✓ Close up photos of the rebar-like objects were compared with photos taken at the time of construction and it was determined that the objects are indeed rebar from the pedestal. The inner skirt* was also observed
- ✓ A post-accident (FY2016) assessment of the seismic resistance of the Unit 1 reactor pressure vessel and primary containment vessel confirmed that even though part of the pedestal is damaged, it is adequately supported
- ✓ In light of the results of this investigation, we shall acquire more data going forward and conduct another assessment

Photo 1. Conditions at the pedestal opening (left side foundation)

Photo 2. Conditions at the pedestal opening (right side foundation)
Source: International Research Institute for Nuclear Decommissioning (IRID)

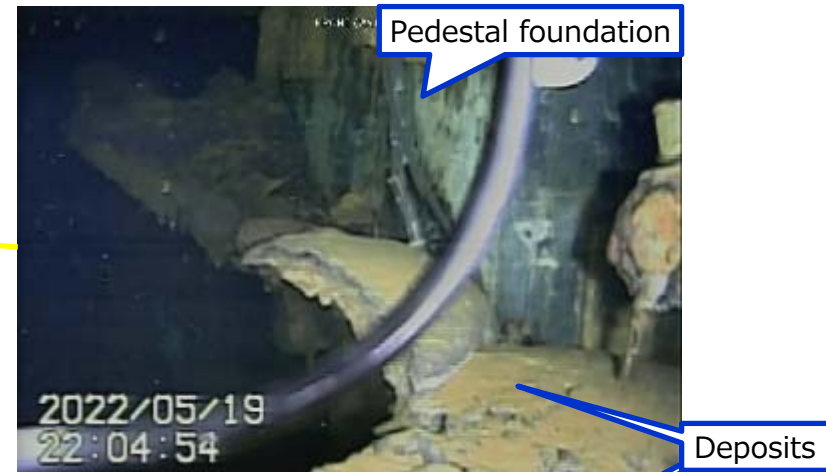
- ✓ Pedestal rebar was found at the bottom the deposits
- ✓ At the top of the deposits we found the pedestal foundation intact

Photo 1. Conditions above the deposits at the opening of the pedestal (right side foundation)

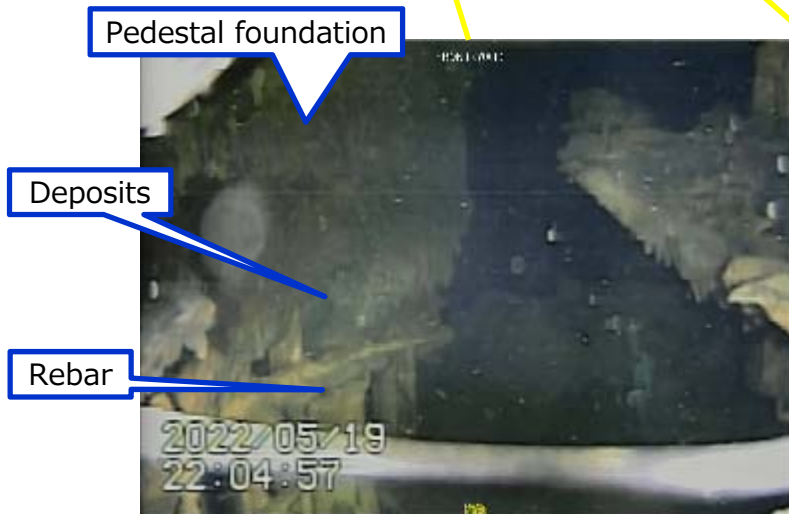
Photo 2. Conditions above and below the deposits at the pedestal opening (left side foundation)

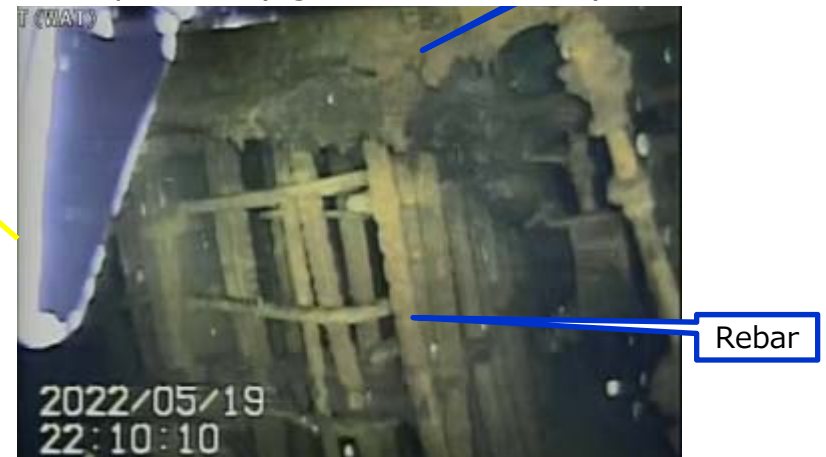
Photo 3. Conditions at the bottom of the deposits at the pedestal opening (right side foundation)

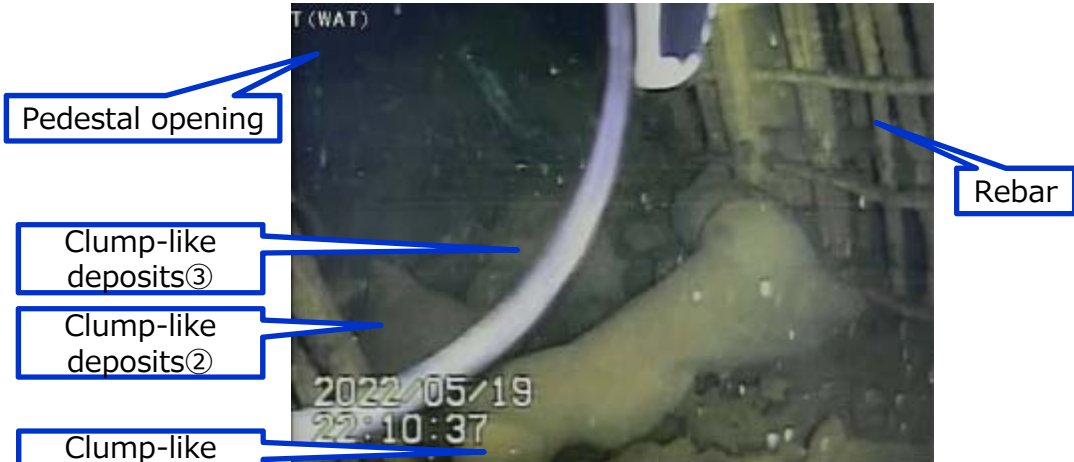
✓ Several clump-like deposits were found

Photo 1. Looking down on the pedestal opening (inside nearest to the ROV)

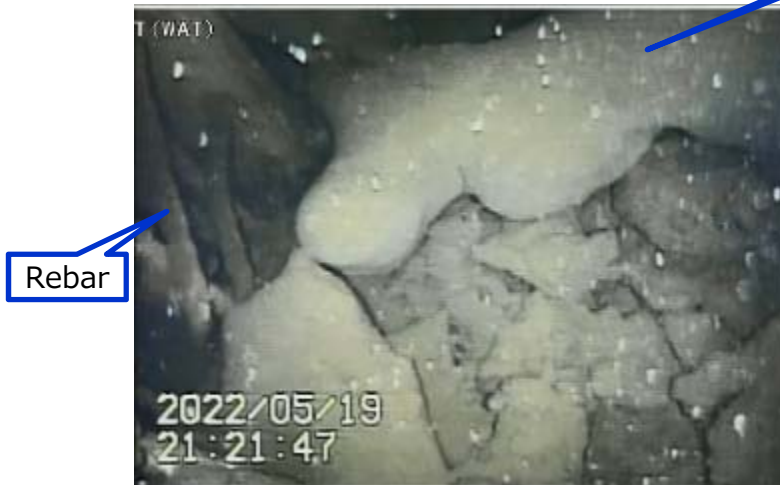
Photo 2. Conditions at the pedestal opening (inside nearest to the ROV)

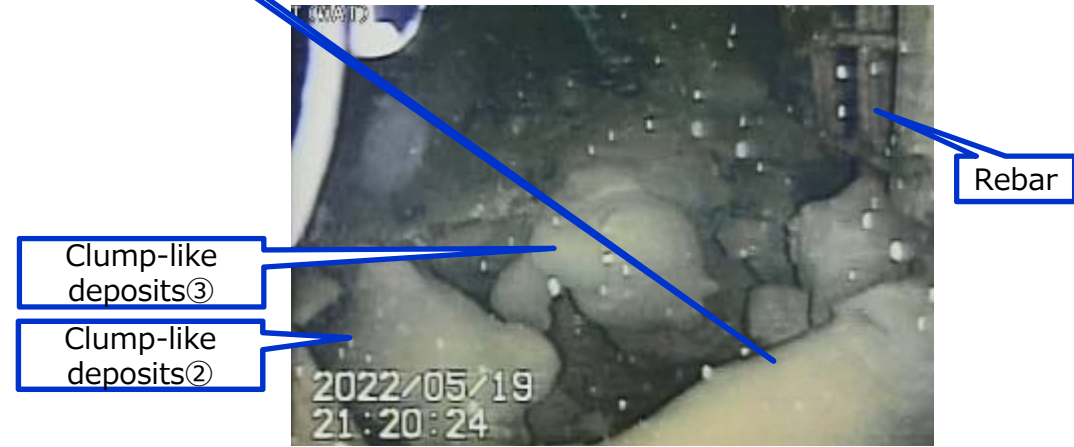
Photo 3. Conditions at the pedestal opening (inside nearest to the ROV)

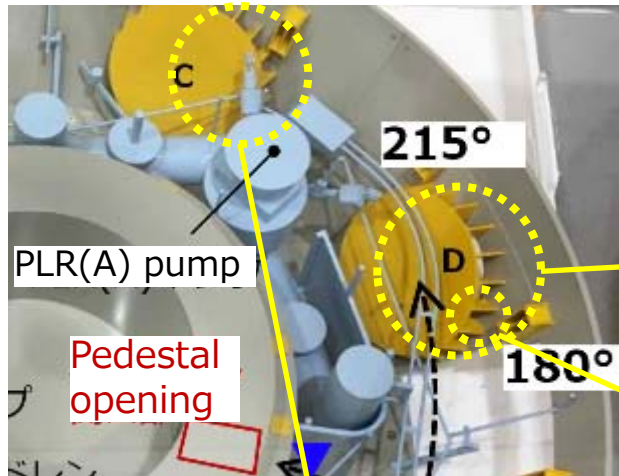
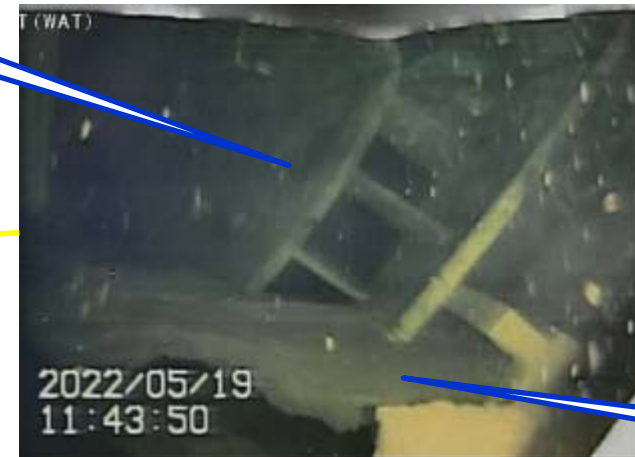
- ✓ Deposits were found around Jets deflector (D) and behind it (pressure suppression chamber side)
- ✓ Deposits were found around Jets deflector (C)

Photo 1. Looking down on jet deflector (D)

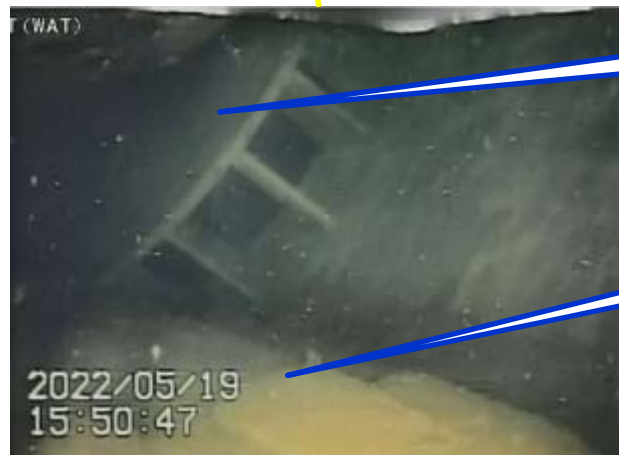
Photo 2. Looking down on jet deflector (C)

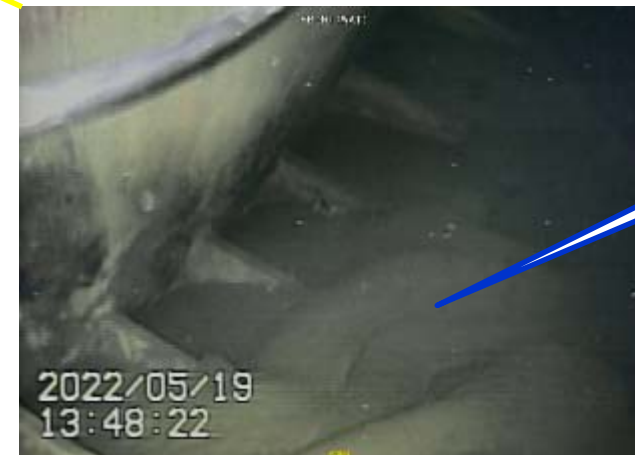
Photo 3. Conditions at the back of jet deflector (D)

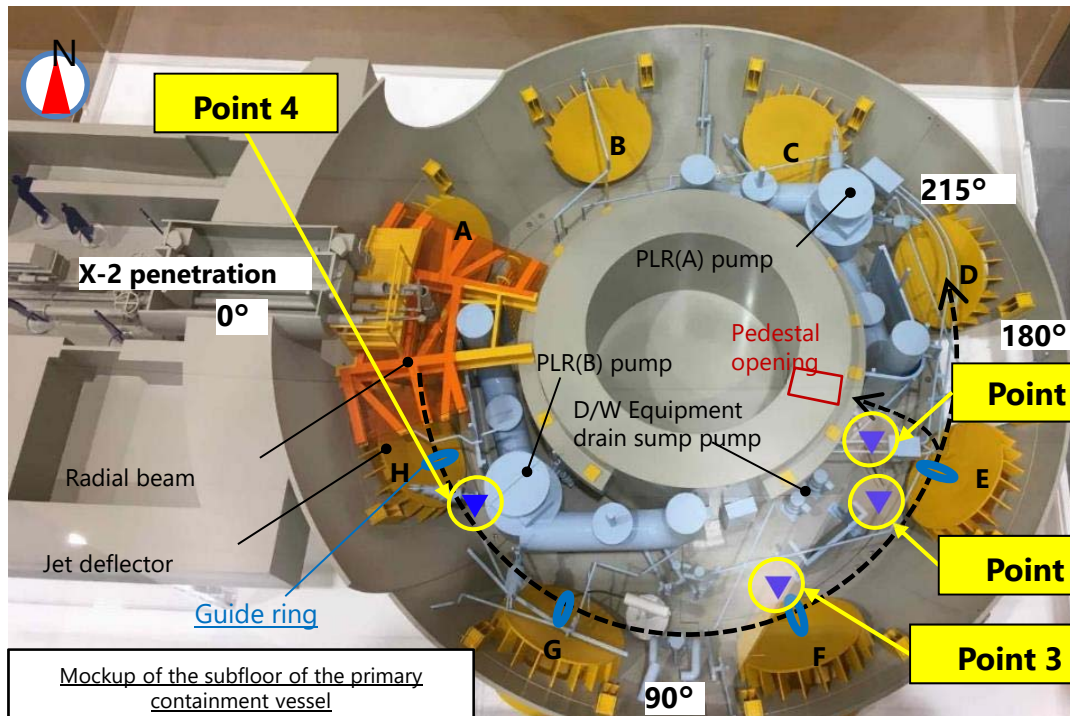
- Thermal neutron flux was observed at all measurement points.
- Since a lot of thermal neutron flux was observed near the pedestal opening, fuel debris is assumed to be the origin.
- Going forward, the next rover to be used, ROV-C (deposit thickness measurement), will measure the height and thickness of deposits after which ROV-D (fuel debris detection) will be used to look for the presence of fuel debris in the deposits.

Measurement point	Point 1	Point 2	Point 3	Point 4
Thermal neutron flux[cm^2/s]	48.0	29.1	50.2	5.8
