Response to the Body Contamination That Occurred during the Cleaning of Additionally Installed ALPS Pipes

November 16, 2023

Tokyo Electric Power Company Holdings, Inc.

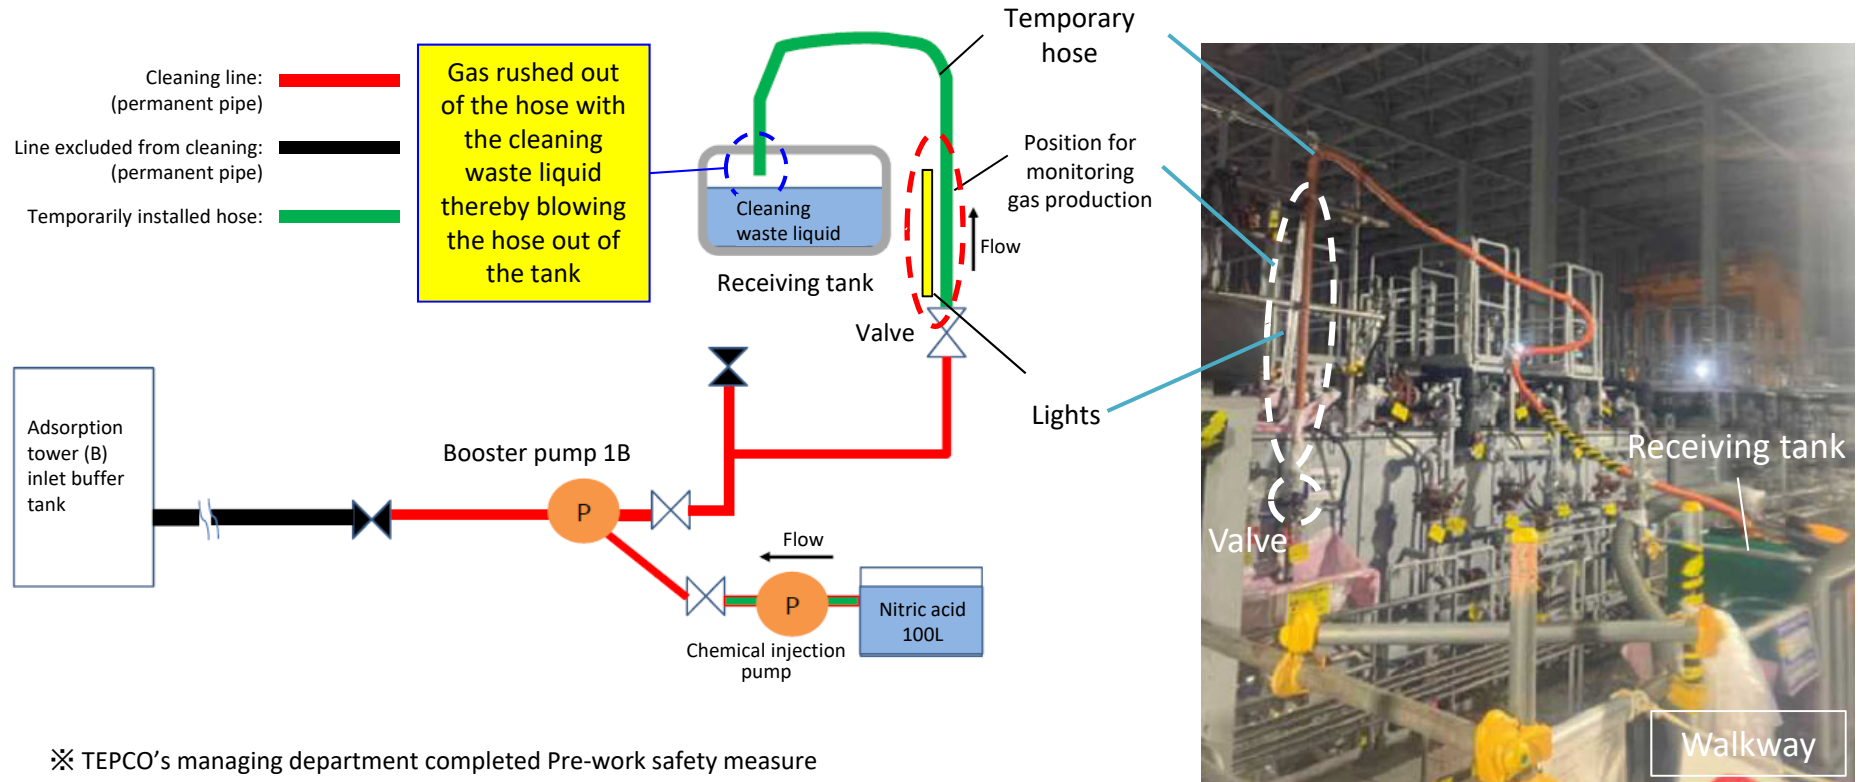
Photograph of adsorption tower (B) from the walkway

- On October 24 and 25[※], Toshiba Energy Systems was cleaning the carbonate that accumulates in the cross-filter outlet pipe (B) in conjunction with the operation of additionally installed ALPS, by dissolving it with nitric acid.

- Gas produced through the chemical reaction of carbonate that had accumulated inside the pipes together with the cleaning agent (nitric acid) rushed out of the hose that was leading into the receiving tank causing it to blow out of the tank and splash cleaning waste liquid onto two workers (A,B) that were working nearby thereby contaminating them.
- It is assumed that the two workers (D,E) that cleaned up the splashed cleaning waste liquid were contaminated either during the cleaning process or when they removed their PPE (anorak suit).

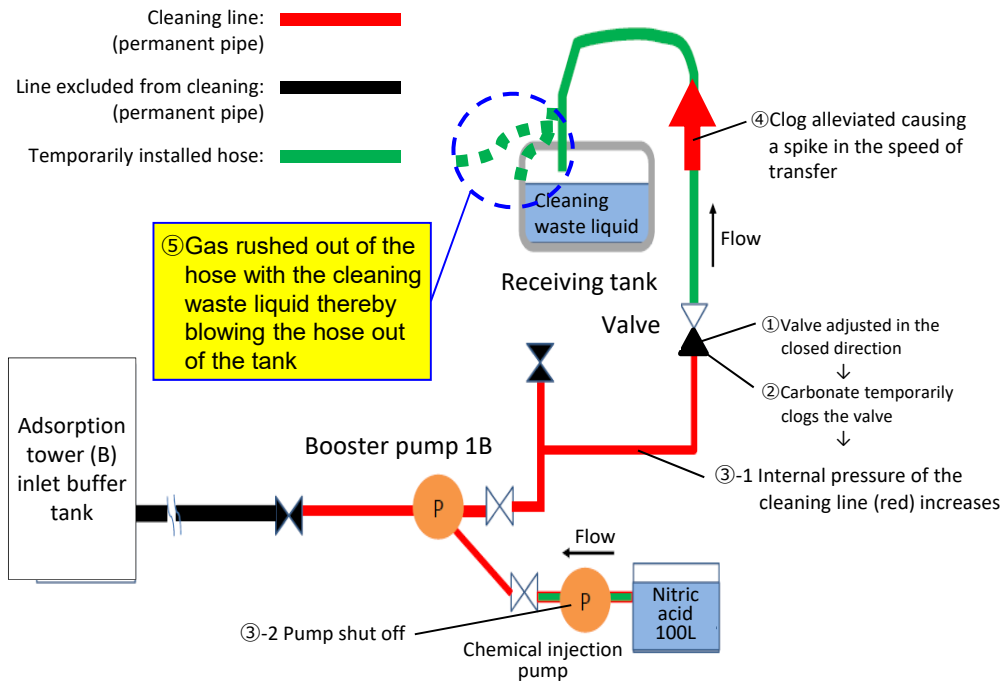
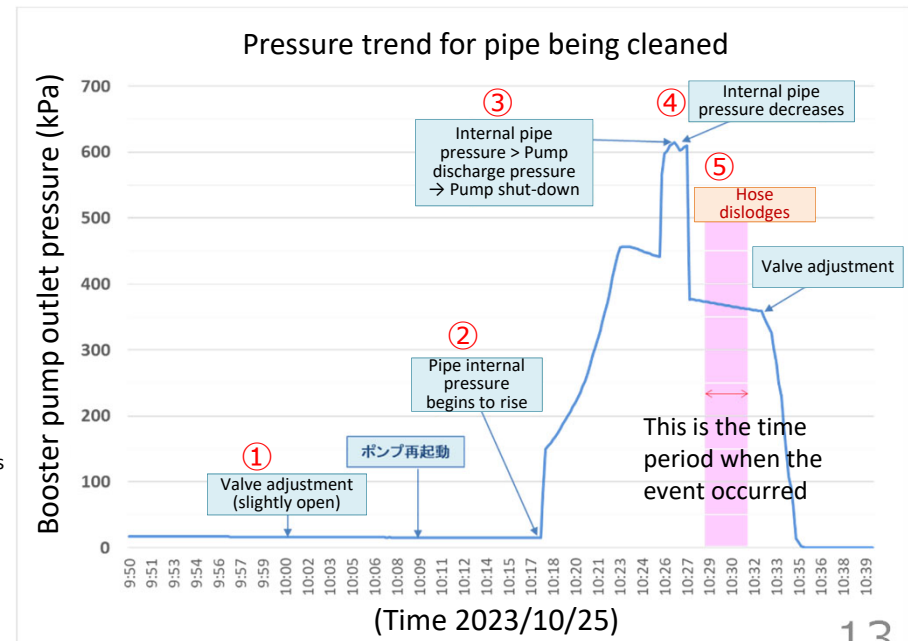
[Reference] Cause ① (Clogging of the pipe due to valve adjustment)

- ① Upon fearing an increase in the amount of cleaning waste liquid that was being expelled into the receiving tank, Toshiba's design manager on site adjusted (in the closed direction) the opening of the valve (the connection point between the permanent pipe and the temporary hose) which had not been planned, in order to expel only CO2 gas into the receiving tank.

- ② Thereafter, it is assumed that carbonate broke off from the inside wall of the pipe due to dissolution by the nitric acid, and temporarily clogged the valve.

- ③ The internal pressure between the pump and the aforementioned valve (permanent pipe of the cleaning line) increased, thereby preventing the injection of nitric acid, causing the pump to shut off.

- ④ As the carbonate dissolved, the clog was alleviated and liquid allowed to flow, which decreased the internal pressure of the pipe causing the speed of transfer of the cleaning waste liquid downstream from the valve (temporary hose) to spike.

- ⑤ Gas and cleaning waste liquid rushed out of the hose, thereby causing a reactive force that dislodged the hose.

- Adjustment of the aforementioned valve during the cleaning of pipes will be prohibited using chain locks and display tags, etc.
- In the event of any unexpected or non-routine incidents, operations will be temporarily suspended, and a response strategy, including risk assessment, will be discussed

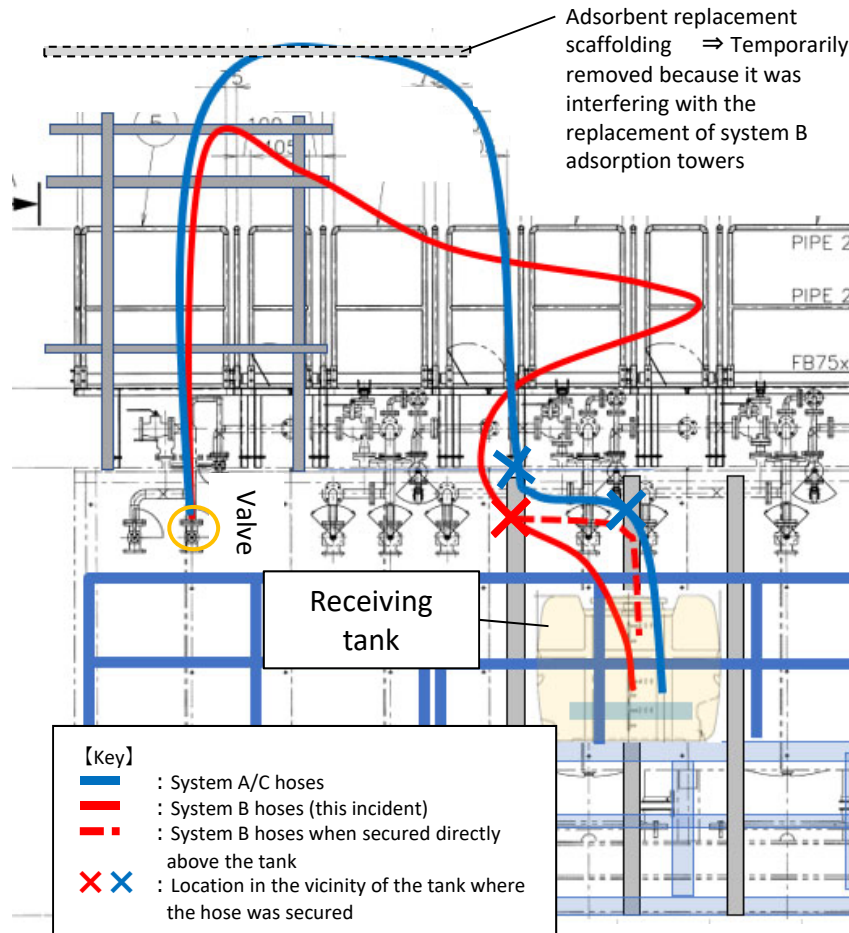
Change in the location where the hose is secured

- When systems A and C were cleaned in the past, it was possible to bring the hose high up from the valve outlet, allowing a simple hose layout (blue line in the diagram).

- For system B, there were no high structures in the vicinity to secure the hose to, as observed when systems A and C were cleaned. In order to minimize any reverse slope, the hose had to be laid out in a complicated matter (red line in the diagram).

- In this case, concerns arose regarding the securing of the hose directly above the tank (red dotted line) which could lead to a shallow insertion depth into the tank, causing an increased separation between the hose tip and the liquid surface. Consequently, this arrangement would hinder the adjustment of the hose end height according to the liquid level and dust dispersion during waste cleaning liquid discharge.

- Therefore, compared to the cleaning of systems A and C, when system B was cleaned, the hose was secured at a location far from the tank thereby making it easier for the end of the hose to jump out of the tank.

- Since there were no details on where the hose should be secured in the manual, and there were no signs of the hose jumping out of the tank when systems A and C were cleaned, the primary contractor work manager decided that there would be no problem with securing the hose in the location marked by the ×.

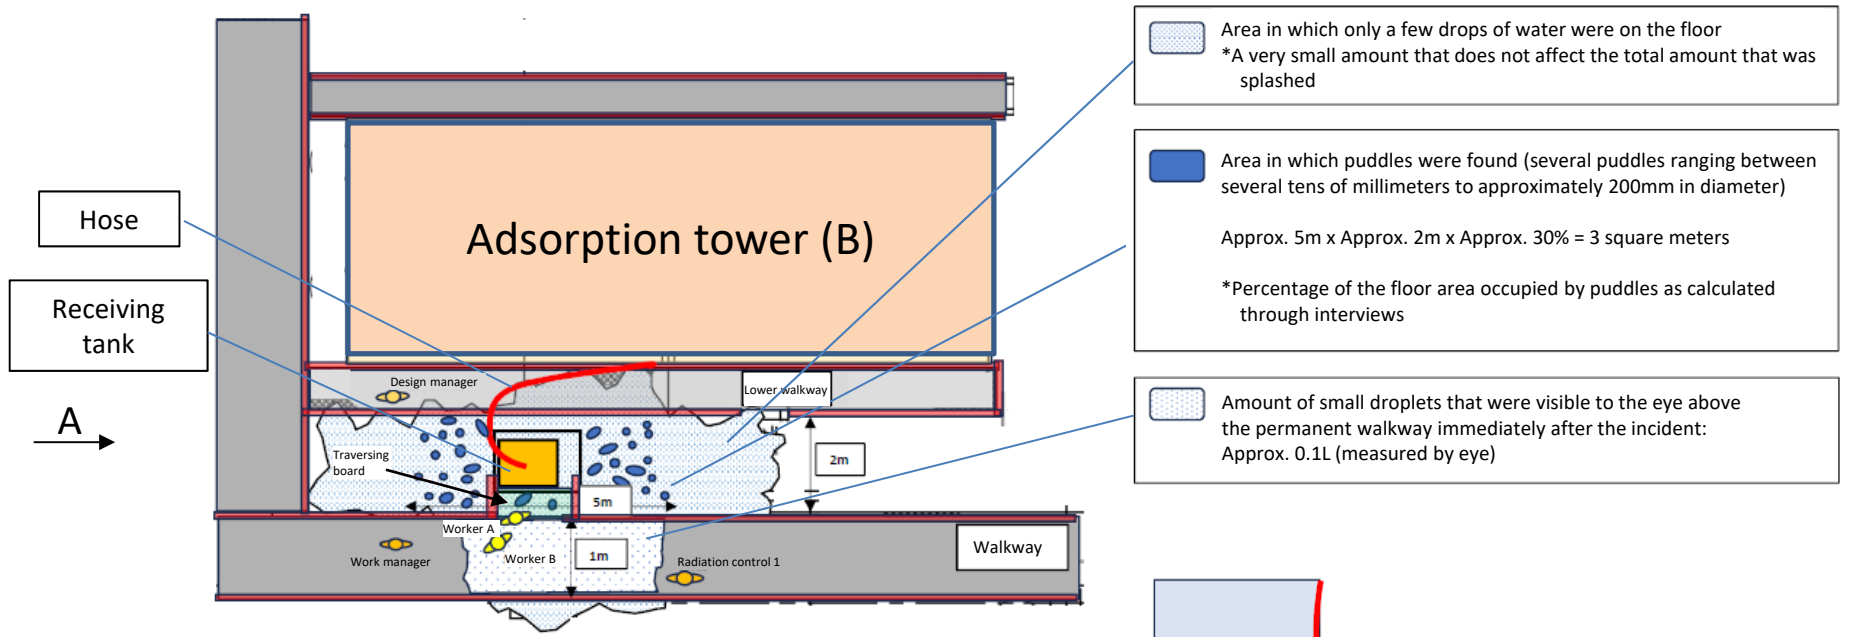
- Interviews with workers in the area and workers that were involved in decontaminating the area have indicated that several liters of water had splashed, including the water that splashed on workers.

Water splashed on the floor
