External view of X-6 penetration

<Reference> About the deposit removal equipment

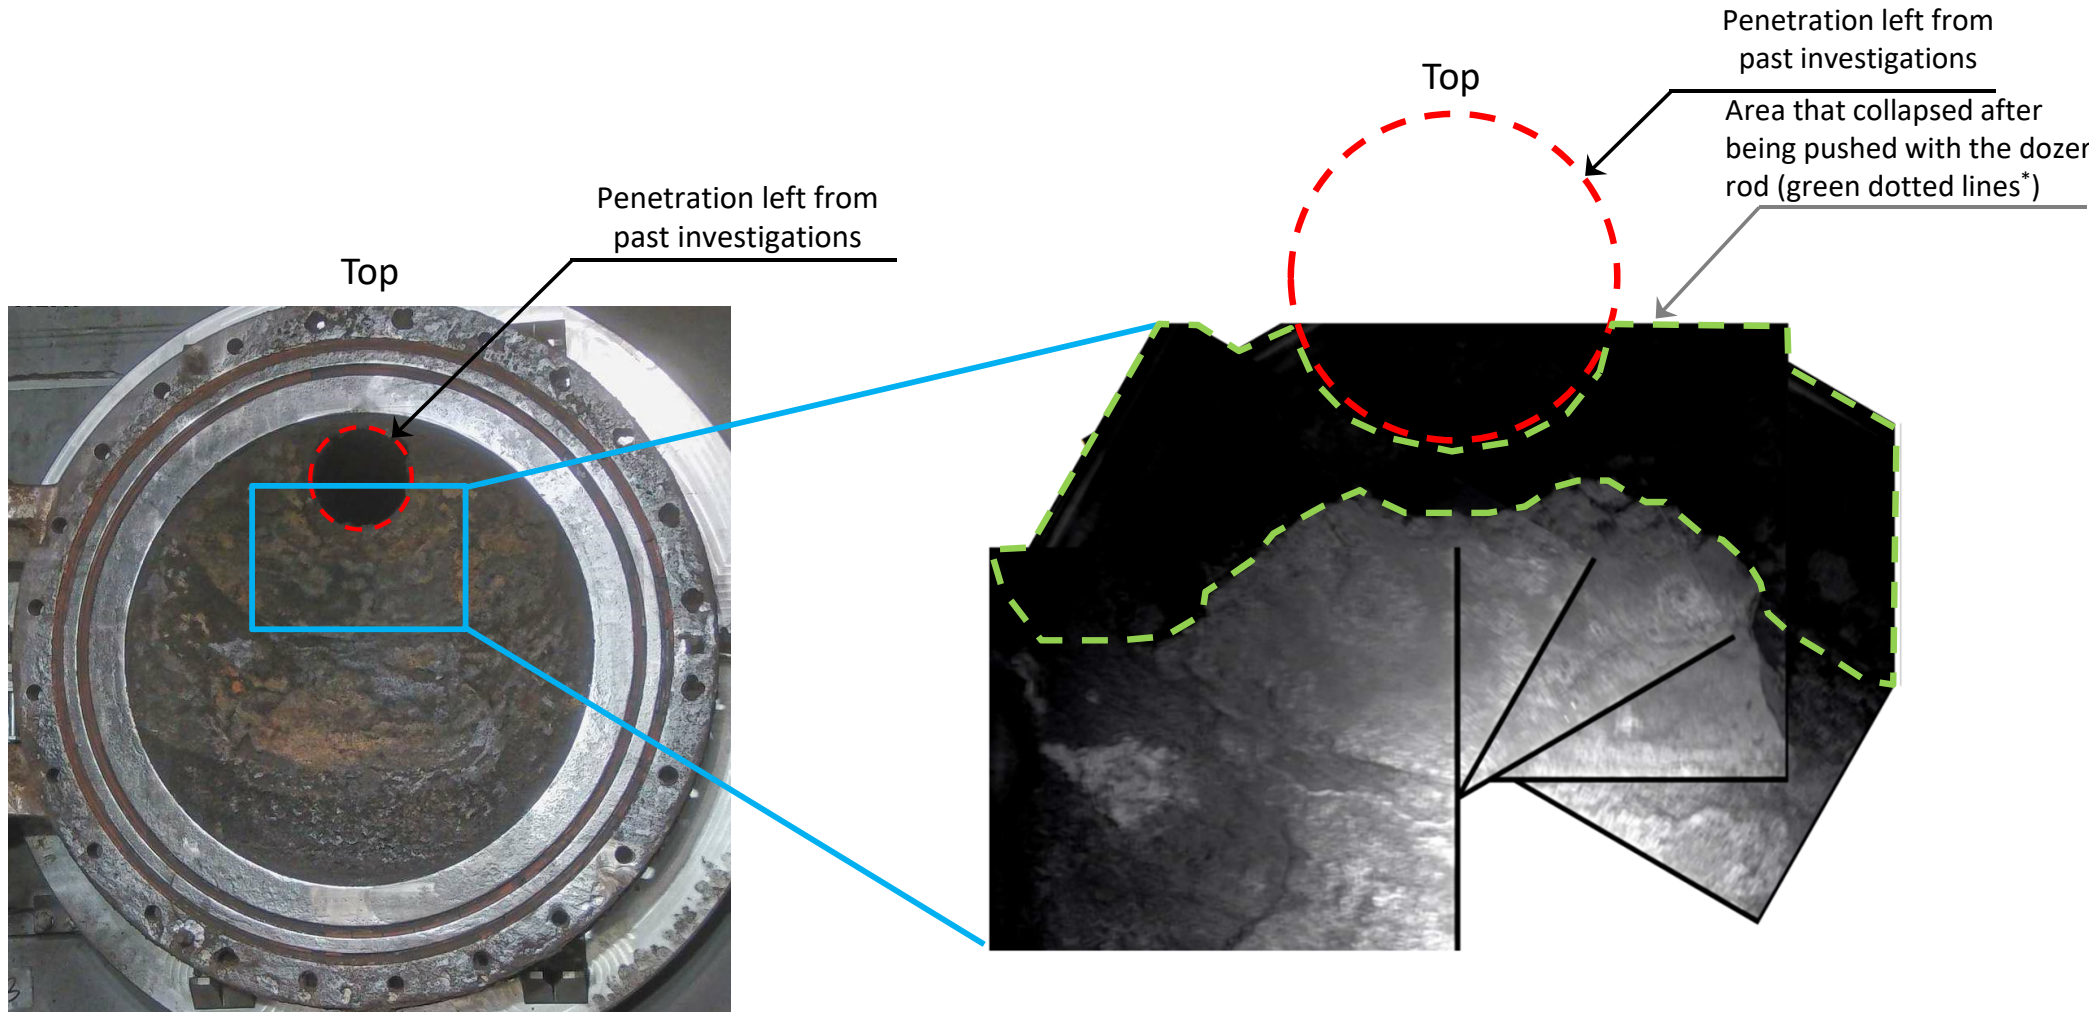
Collapsed deposit near the penetration that remained from past investigations (as of the end of work on January 10)

*This is a photo of only a portion of the deposit that was collapsed on January 10 after being pushed with the dozer rod. The entire scope of collapse is not shown here.
