Fukushima Daiichi Nuclear Power Station

Water leak from the east side wall of the high-temperature incinerator building

< Reference document >
 February 7, 2024
 Tokyo Electric Power Company Holdings, Inc.
 Fukushima Daiichi Decontamination &
 Decommissioning Engineering Company

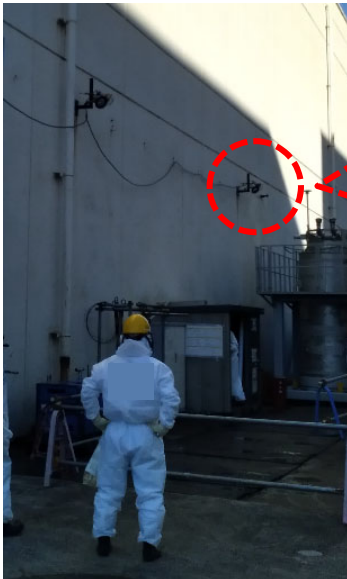
【Field conditions (external view of the building)】

- At around 8:53 AM on February 7, a contractor worker discovered water leaking from vent opening (to vent hydrogen generated inside the adsorption apparatus) from the #2 cesium adsorption apparatus (SARRY), which is located approximately 5m from the ground on the east side wall of the high-temperature incinerator building.

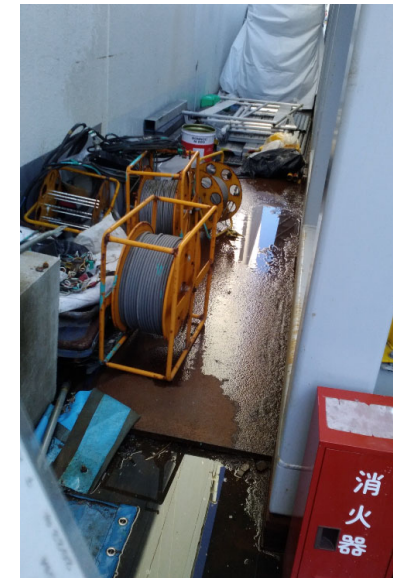
【Metal plates laid on the ground】

- During the same time period, filtrated water was being used to flush out SARRY, which was shut down, in preparation for a valve inspection. At around 9:10 AM, the master valve for the filtrated water was closed and around 9:16 AM it was confirmed that the leak had stopped. The leaked water consisted of system water and filtrated water, and resulting approximately 1mm deep puddle covered an area approximately 4m x 4m on the metal plates laid on the ground in this location. Since it is possible that the leaked water seeped into the ground through the gaps in the metal plates, as an emergency measure the aforementioned area has been cordoned off and the soil in this area will be collected going forward.
