Causes and Countermeasures for the Leak of Water Containing Radioactive Substances from the High Temperature Incinerator Building

February 15, 2024

TEPCO

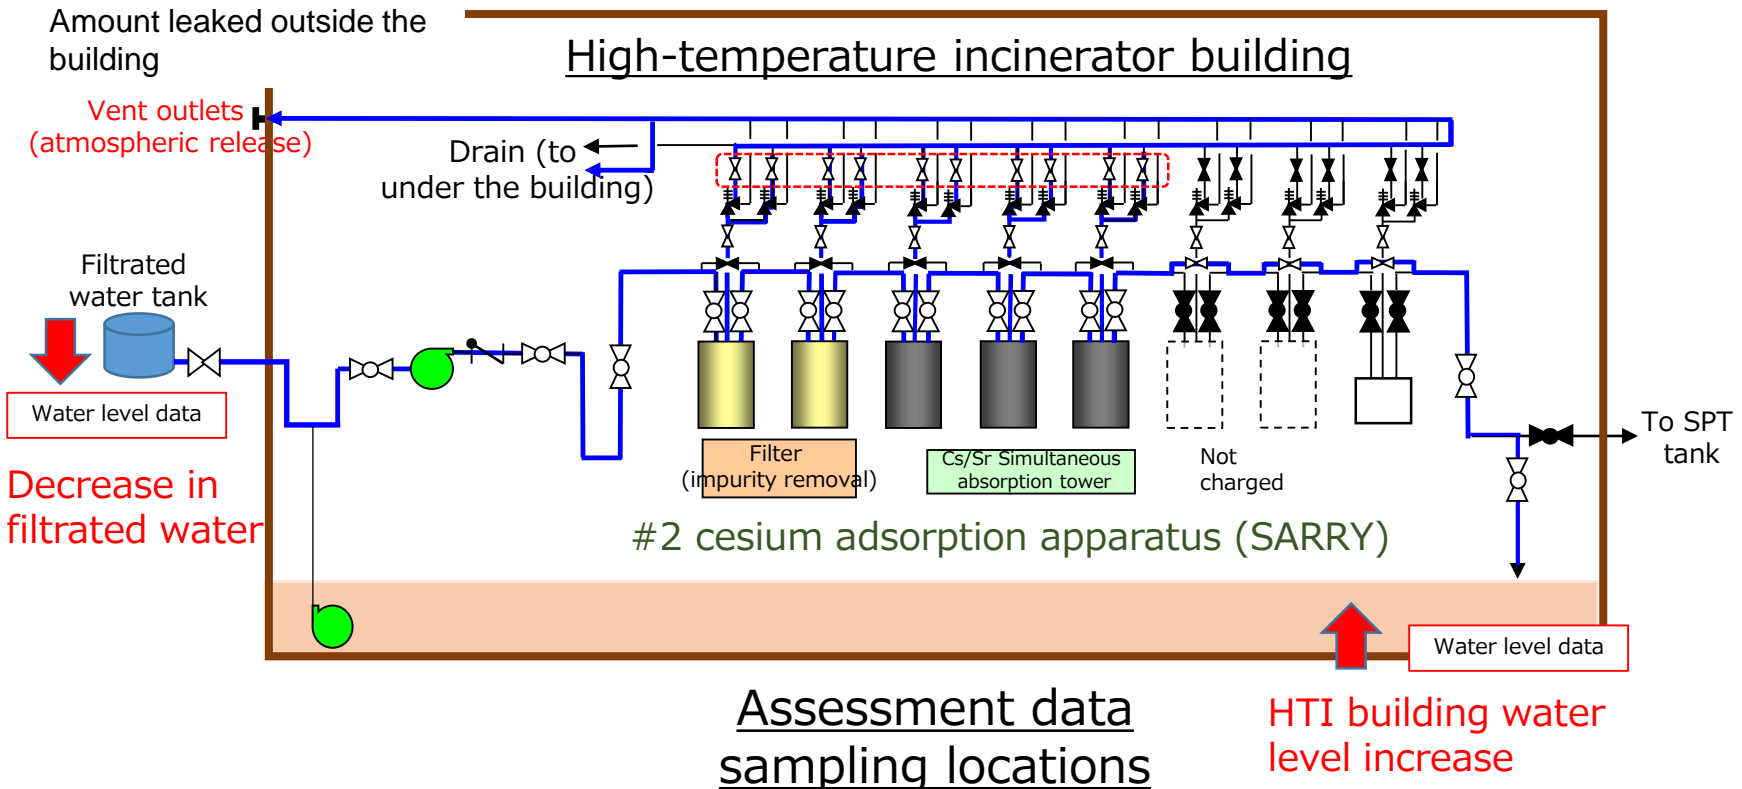
- Assessment overview
 - The amount of the leak was assessed from the water level decrease of filtrated water and the water level increase in the high temperature incinerator building. The amount of filtrated water used was closely investigated and the amount used for tasks other than the aforementioned task (approximately 4m³) was subtracted from the amount of decrease when the leak occurred as calculated during the simplified assessment (4 m³ subtracted from approximately 17.6m³ = 13.6m³).

- The amount of radioactivity was calculated from the radioactivity concentration of the system water and the amount of the leak. Design schematics were used to closely examine the amount of water inside the containers, such as the adsorption apparatus, etc., and subtract from the amount of system water used during the simplified assessment (reduced from approx. 9.12m³ to approx. 8.15m³)

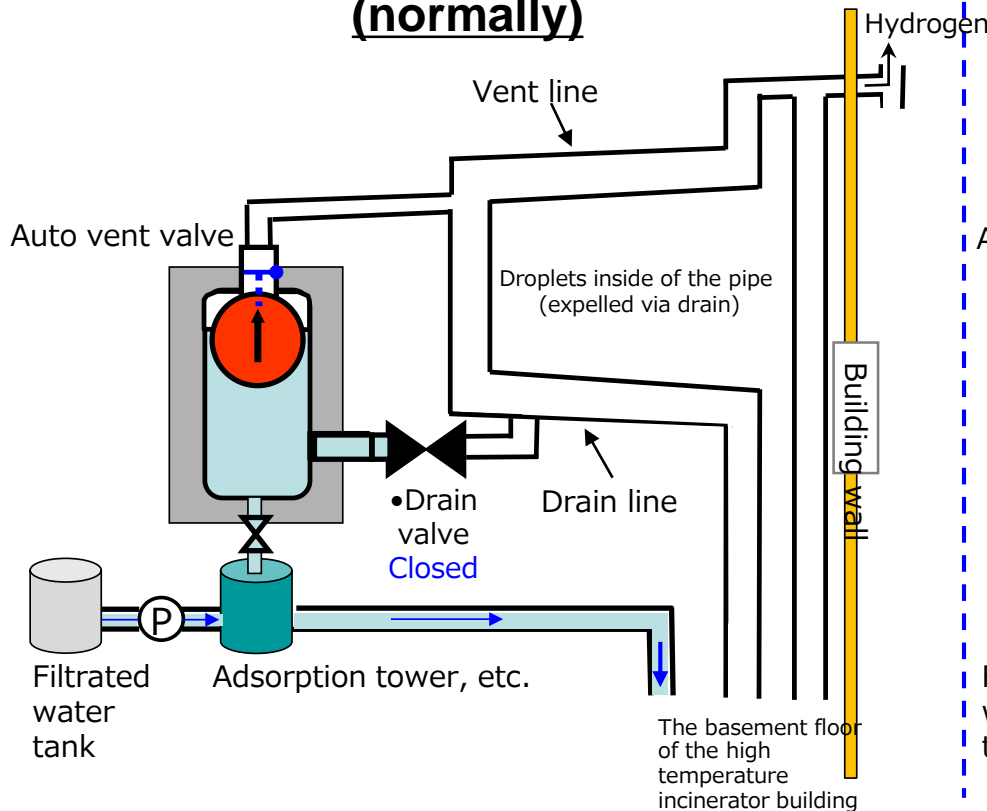
During dose reduction work (normally)

- Dose reduction work to reduce dose prior to valve inspection was implemented with the filter and adsorption tower drain valves (10 valves in total) open.
- Since the drain valves were open, system water flowed into the drain lines.
- After flowing through the drain lines, the system water that couldn't drain out to the basement floor of the high-temperature incinerator building and flowed back up the vent line and leaked outside the building through the vent outlet.

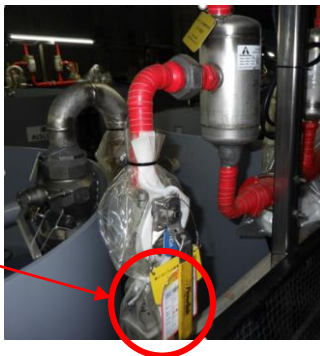
Valve open

- The worker checking the valves follow the procedures and employed methods for preventing human error (*1) while checking the valves, however the worker only checked to see if the valve numbers match the procedures and overlooked that the valves were "closed."

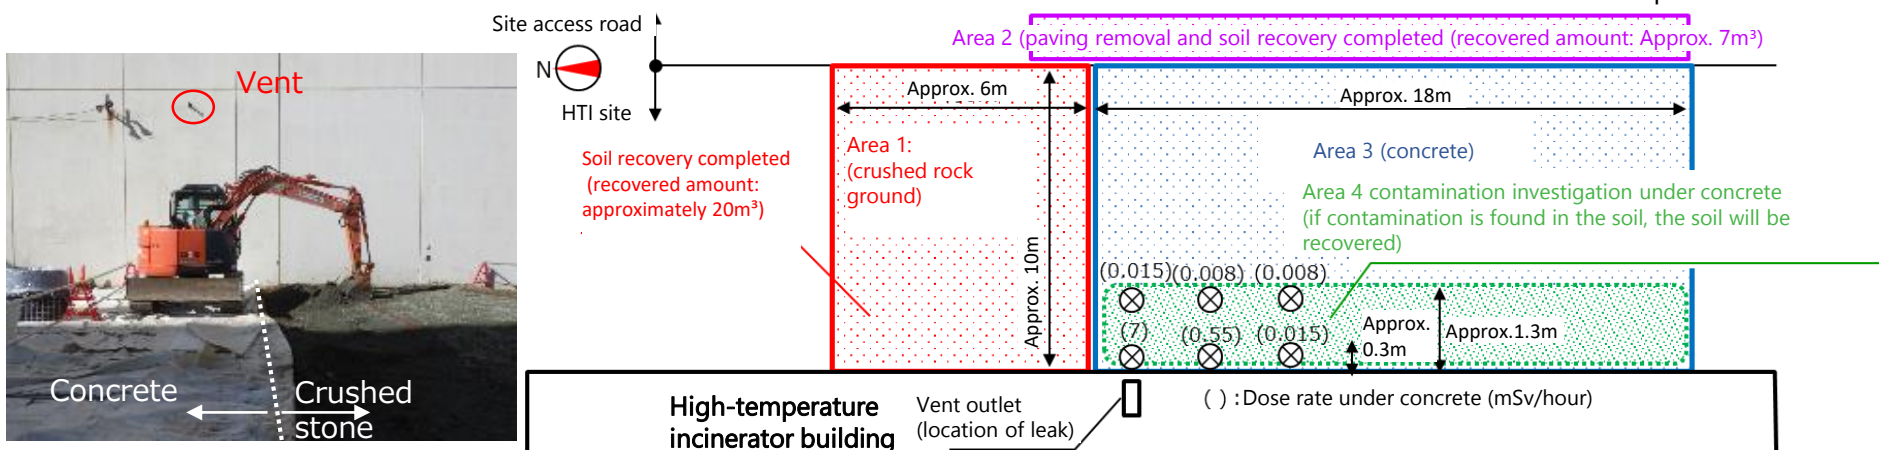
- ✓ Soil will be recovered until the ground surface dose rate※ is lowered to below 0.020mSv (equal to background in the surrounding area on average.)
 - The work in areas 1~3 has been completed thereby eliminating the highly urgent risk of dispersing radioactive substances.

- Core samples taken from underneath the concrete directly underneath leak area 4 revealed soil dose rate to be 7 mSv/hour, so contamination investigation of the ground underneath the concrete and soil recovery is being implemented. They shall continue until we confirmed that the ground surface dose rate* is below 0.020 mSv/hour on average.

- ✓ Soil recovery commenced on February 8. The work is carefully being conducted to avoid damaging buried equipment, prevent the dispersion of dust in conjunction with recovery work, and limit worker exposure (protective covers, etc., are being used to reduce the risk of dispersing leaked radioactive substances).
