Unit 1 PCV Internal Investigation (Non-submerged area)

February 29, 2024

Tokyo Electric Power Company Holdings, Inc.

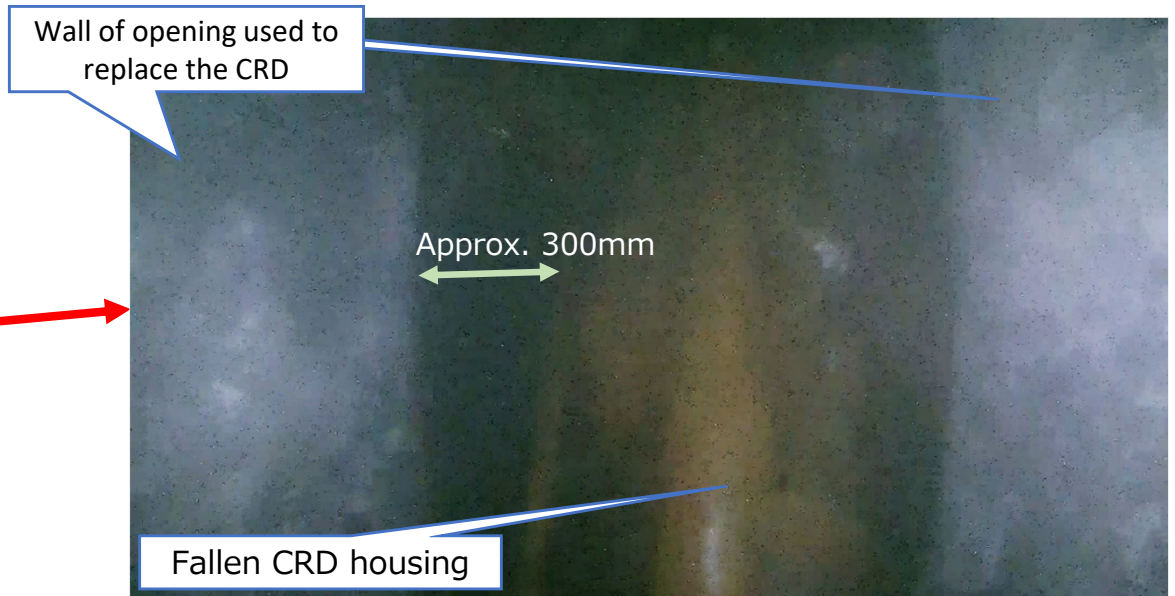
Photo 1. Condition of opening used to replace the CRD (after compensating for the flickering)

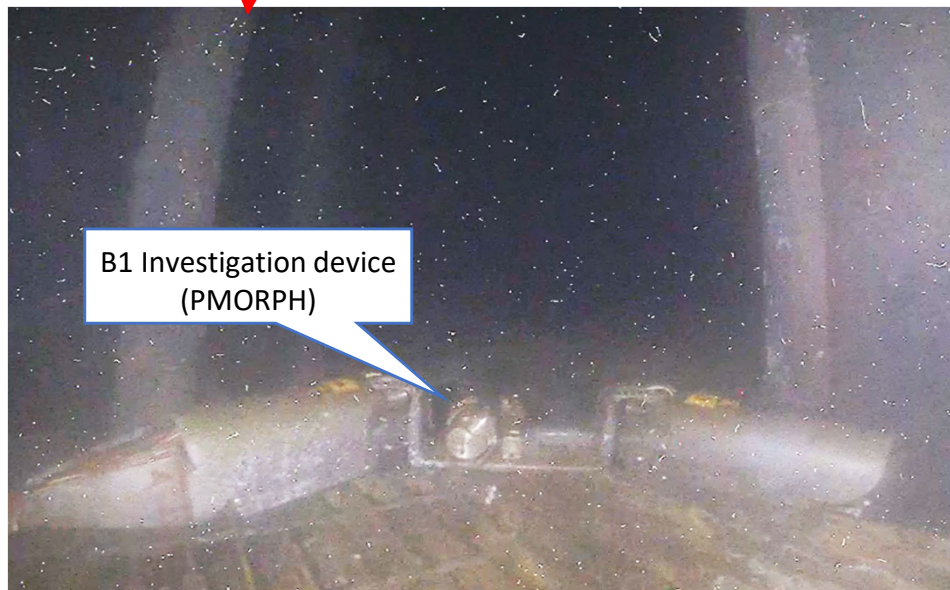
Photo 2. remains of B1 investigation device (PMORPH) on south side

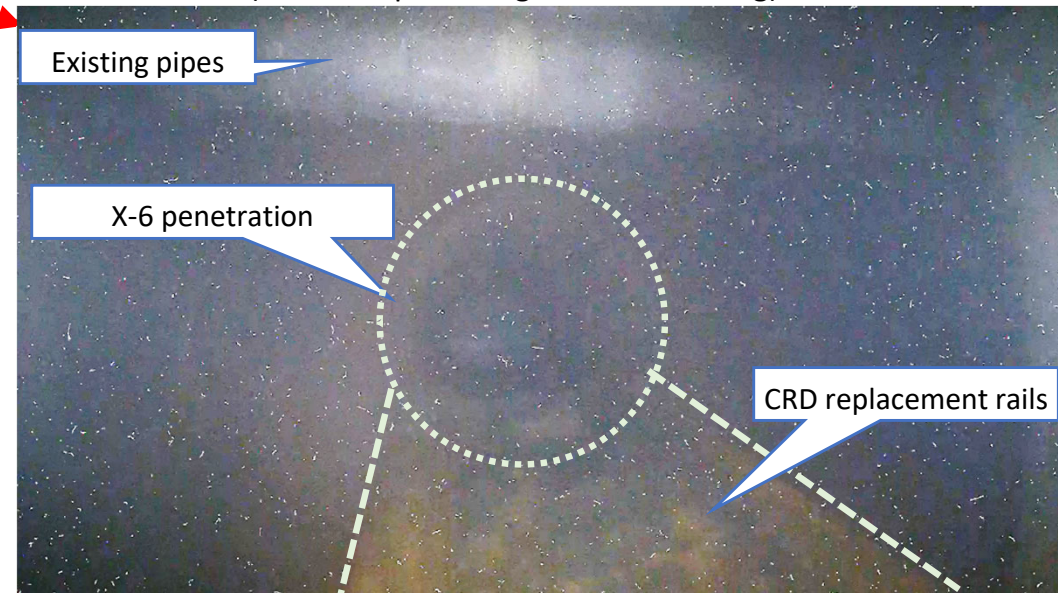
Photo 3. X-6 penetration condition

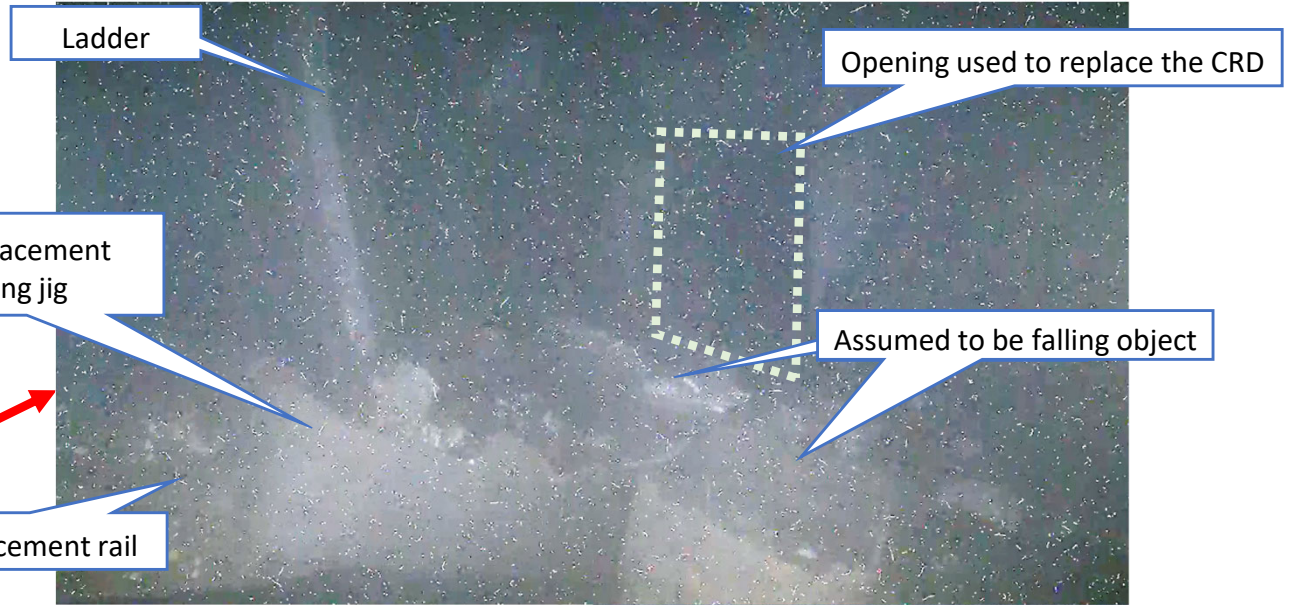
Photo 1. CRD replacement rails condition ①

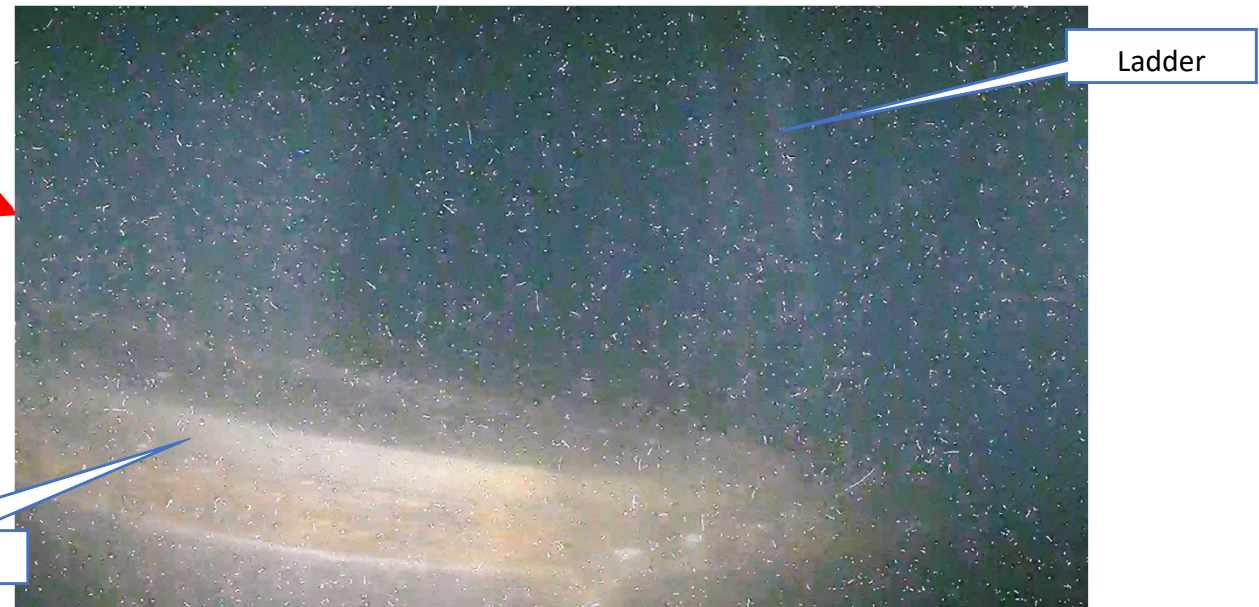
Photo 2. CRD replacement rail condition ②

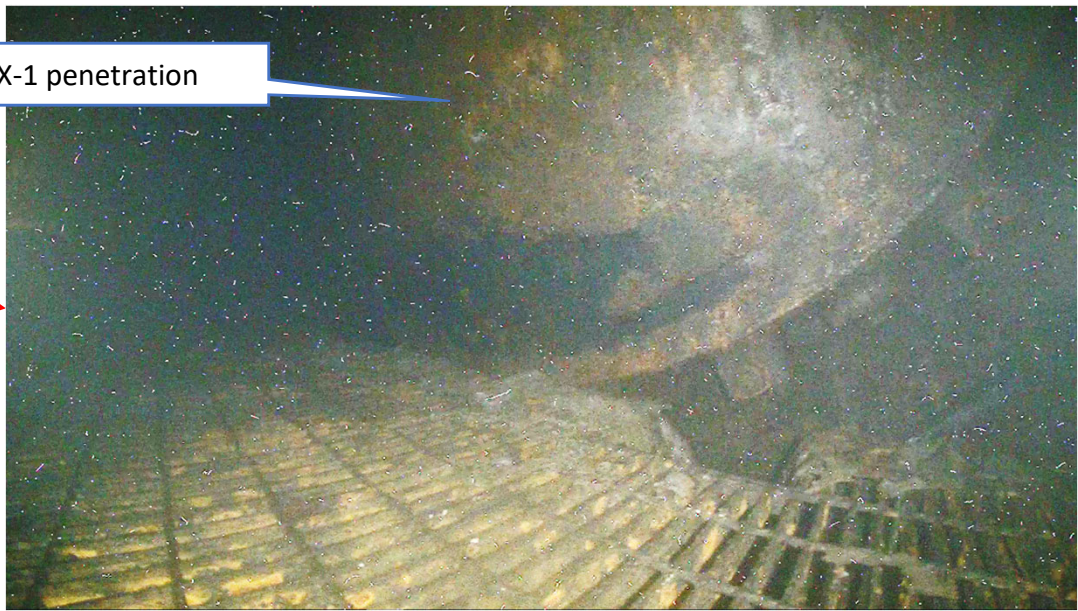
Photo 1. X-1 penetration condition

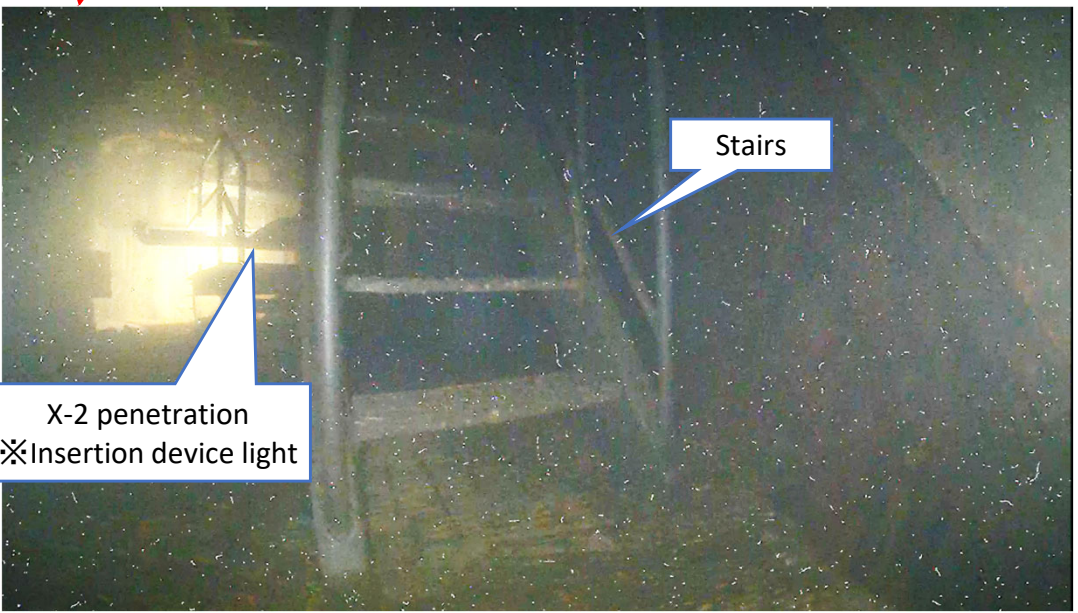
Photo 2. Condition of stairs

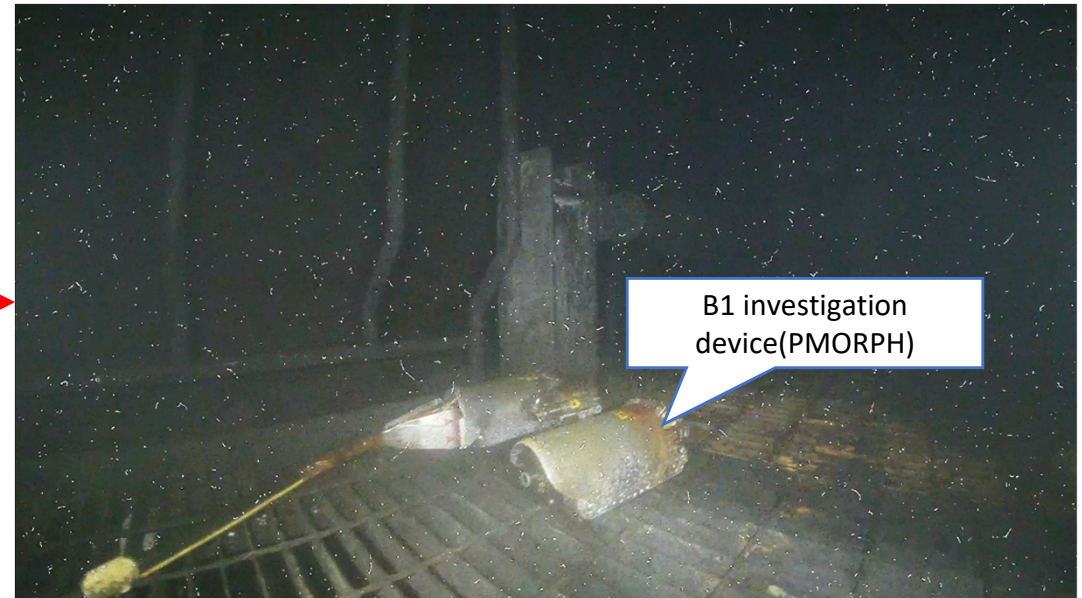
Photo 1. Remains of B1 investigation device (PMORPH) on north side

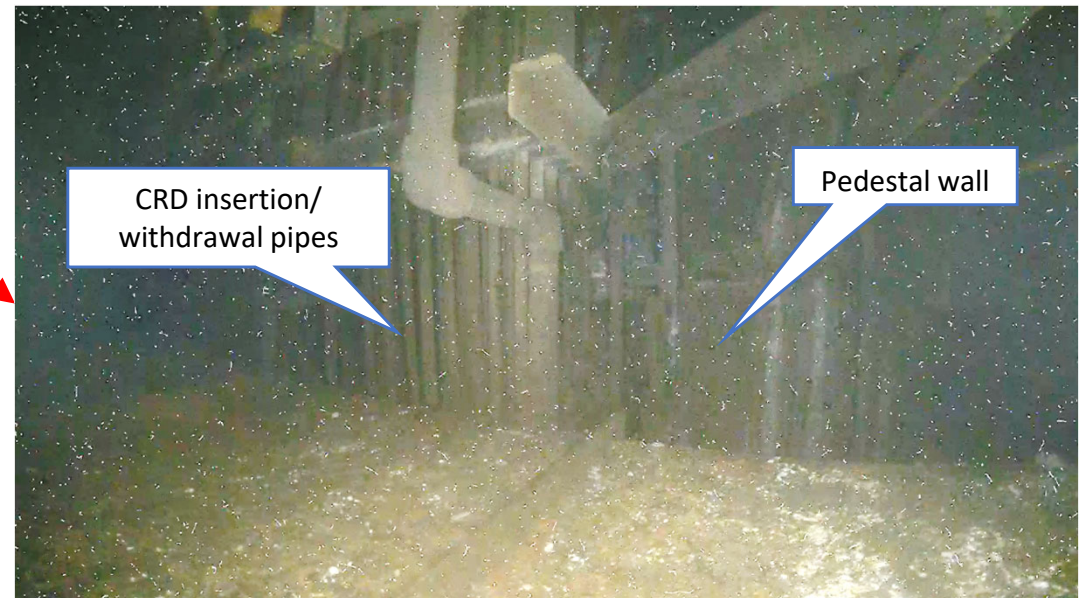
Photo 2. condition of CRD insertion/withdrawal pipes
