### Measures pertaining to the fish inside the port of Fukushima Daiichi Nuclear Power Station (completion of the replacement of the net to prevent fish from leaving at the east sea wall, etc.) Engineering Company

< Reference document> rch 4, Tokyo Electric Power Company Holdings, Inc. Fukushima Daiichi Decontamination & Decommissioning

## 2. Replacement for the net to prevent the fish from leaving at the east sea wall(1/2)

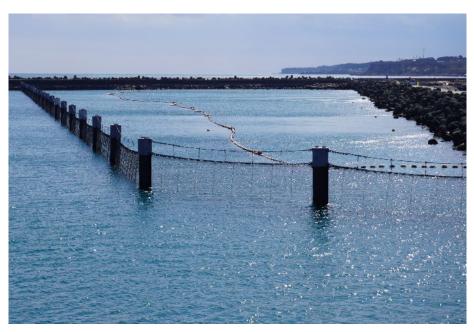
Figure 2-1. The net surrounds the east sea wall and the Units 1-4 intake open channel

- We <u>have replaced</u> the net to prevent the fish from leaving at the east sea wall <u>with steel pipe piles and a high durability net</u> (<u>made from polyester monofilament</u>), and we have <u>extended this net so that it surrounds the vicinity of the Units 1-4 intake open channel.</u>
- In addition to completing work fining the mesh of the nets to prevent the fish from leaving, we have been able to <u>further enhance</u> <u>measures to prevent the fish from leaving in the vicinity of the aforementioned open channel.</u>

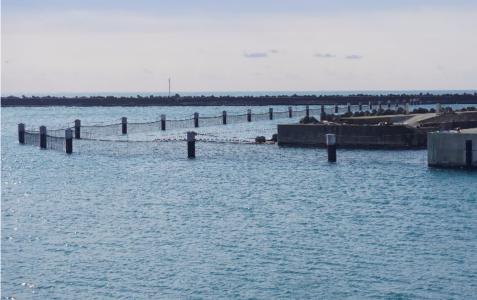
Figure 2-2. The net surrounds the outlet to the Units 1-4 intake open channel

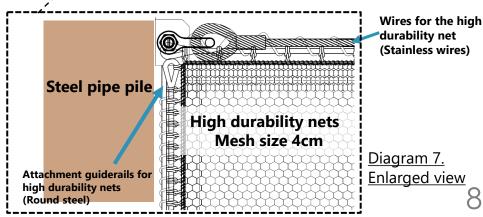
### Diagram 6. High durability net attachment method

- Wires for attaching high durability nets will be lifted with a 250ton crane barge and installed between the steel pipe piles.
- High durability nets will be lifted with a crane barge and bound to the wires and piles by a diver.
- During the construction work, gill nets keep placed at the port entrance and basket nets will be added near the breakwater.
