# Fukushima Daiichi Nuclear Power Station

## Unit 1 Primary Containment Vessel Internal Investigation (Non-submerged area)

### Causes and Countermeasures for Snake-like Robot Cable Issues

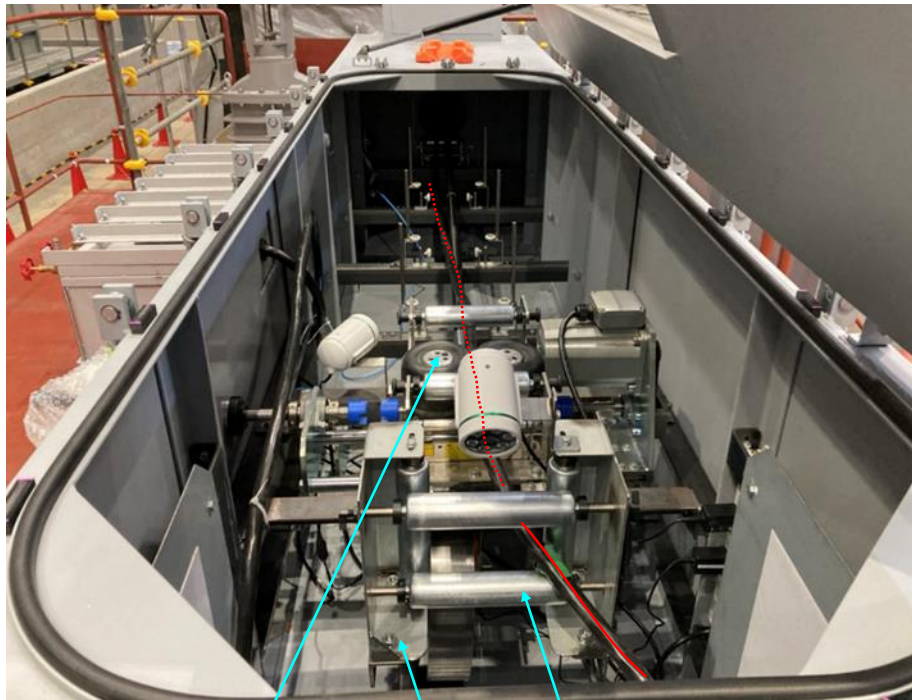
Normal conditions (photo taken during the mockup)

Cable winch

Cable guide roller

Guide roller installation bracket

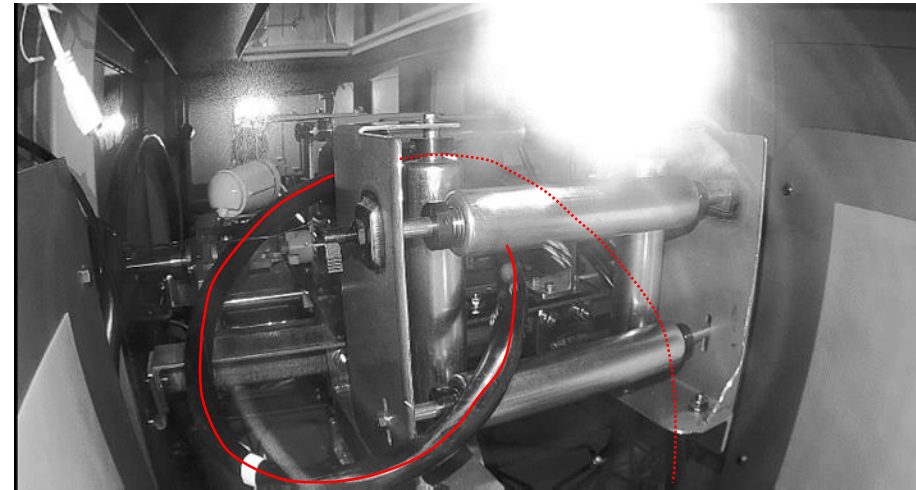
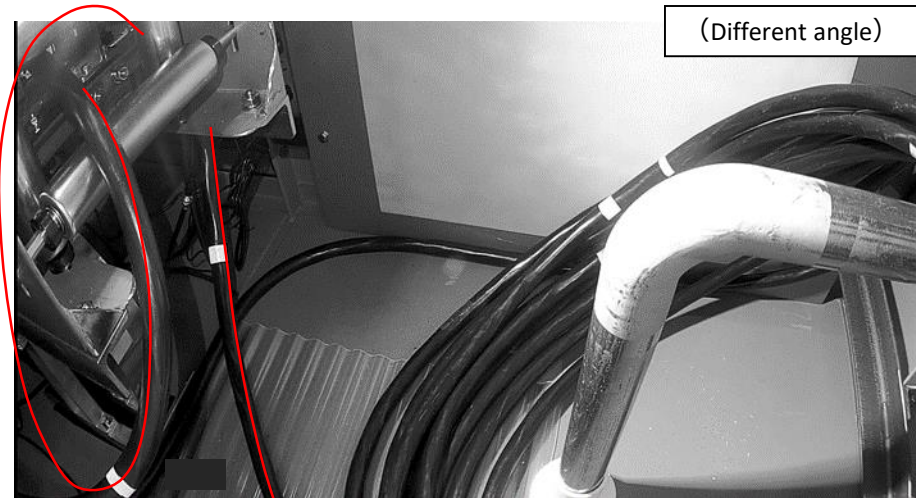
Conditions when event occurred

- Usually, cable is routed through guide roller to the cable winch.
- In this case, cable route was different from the normal route due to the flexure in the cable. As a result, cable was caught in the installation bracket for the guide roller, unable to be paid out.

(Different angle)

— : Cable route

① **Cable recoiling**

Since it is getting more probable that the cable will take a different route when paid out repeatedly, the cable will be recoiled to reduce the possibility of it taking a different cable route.

② **Restricting the range of mobility of the cable**

A guard panel will be installed to restrict the range of mobility of the cable to prevent it from getting caught up on, or wrapping around, the guide roller installation bracket even if the cable behave differently than normal.
