# Fukushima Daiichi Nuclear Power Station

## Unit 1 Primary Containment Vessel Internal Investigation (Non-Submerged Area)

### Status Inside the Pedestal

# Investigation Results on March 14 (Around the opening outside the pedestal)

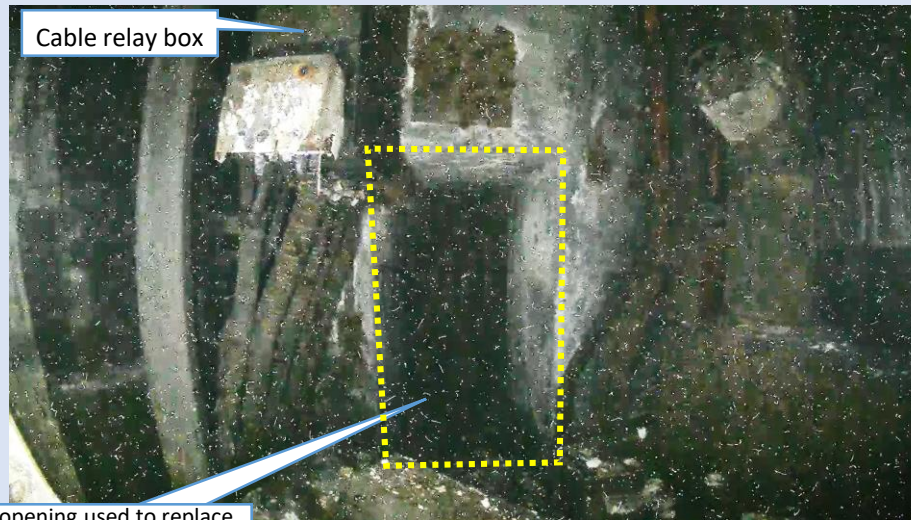
Photo ①: This is a picture of the opening used to replace the CRD taken from outside the pedestal. Although there are fallen objects in front of the opening, there is no substantial damage to the opening walls. The existing structures have experienced some discoloration due to aging, but they retain their original form for the most part.

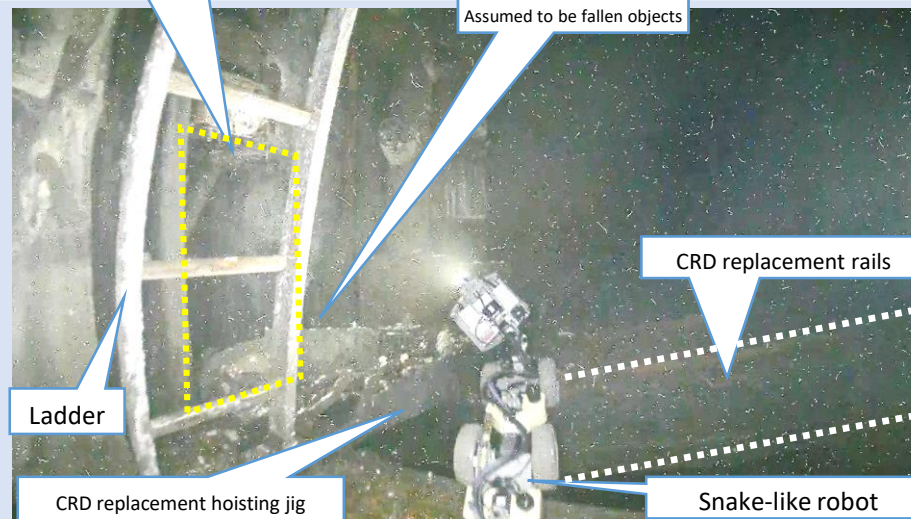
Photo ②: This photo gives a birds-eye view of the snake-like robot in front of the opening used to replace the CRD. Since no major obstructions were found in the vicinity of the CRD replacement rails during the February 28 investigation, the snake-like robot relayed radio signals from the location of the CRD replacement rails as planned.

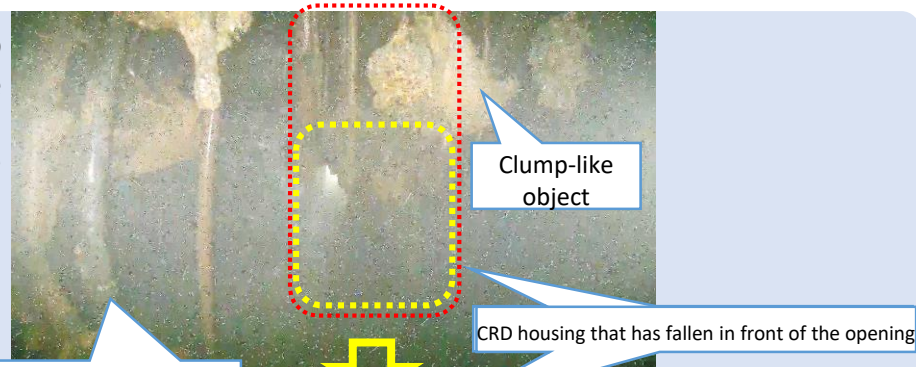
- Photo ①: This is a photo of the CRD housing that has fallen near the opening used to replace CRD taken from inside the pedestal. Icicle-like adhesions are seen at the top.

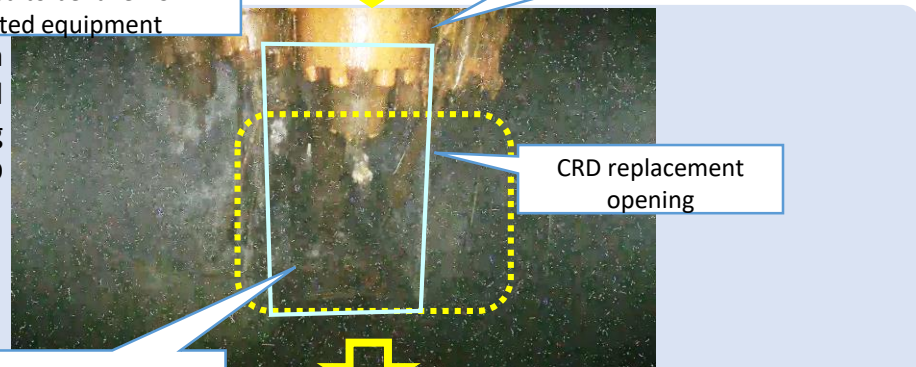
Assumed to be fallen CRD related equipment

- Photo ②: This is a photo of the area surrounded by the yellow dotted line in photo ①. The CRD housing fell with multiple pieces of CRD related equipment.

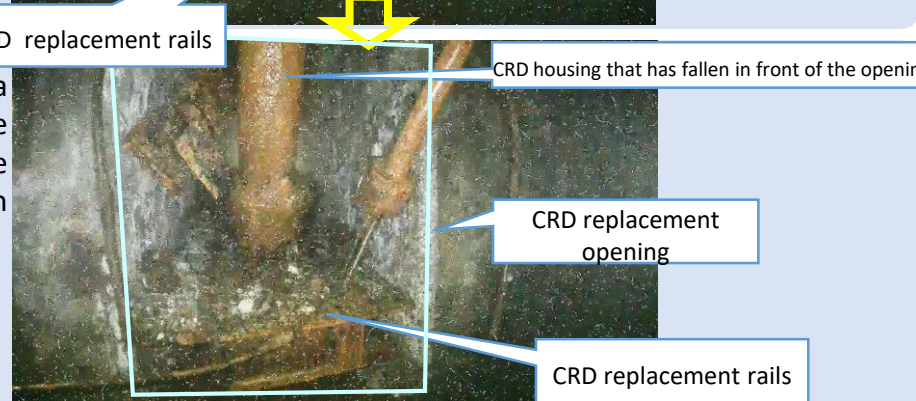
- Photo ③: This is a photo of the area surrounded by the yellow dotted line in photo ②. It appears that the bottom of the CRD housing fell on top of the CRD replacement rails.

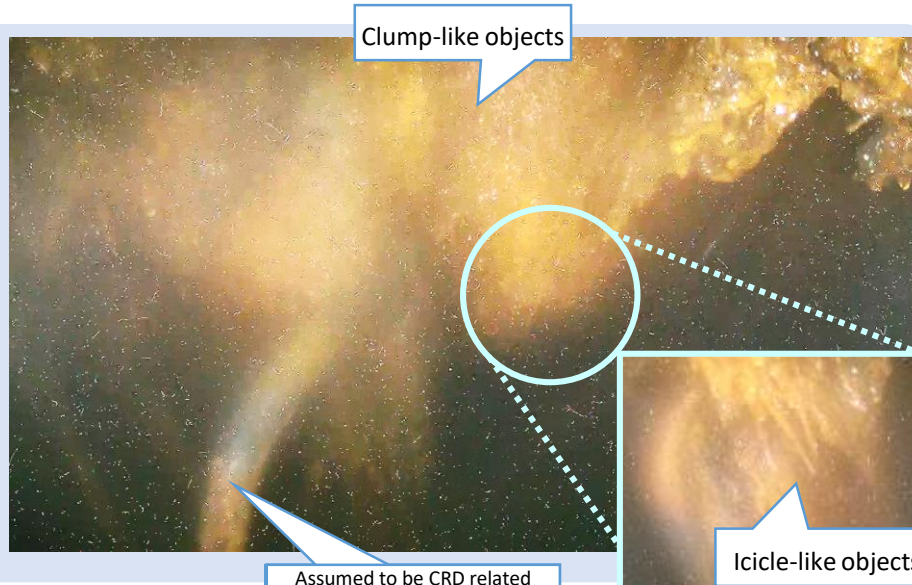
■ Photo ①: There are clump-like objects on top of the CRD housing that has fallen in the vicinity of the opening used to replace the CRD. Icicle-like objects are seen partly on the clump-like objects. Since they concentrate around the top, it is assumed that these objects migrated downward from above.

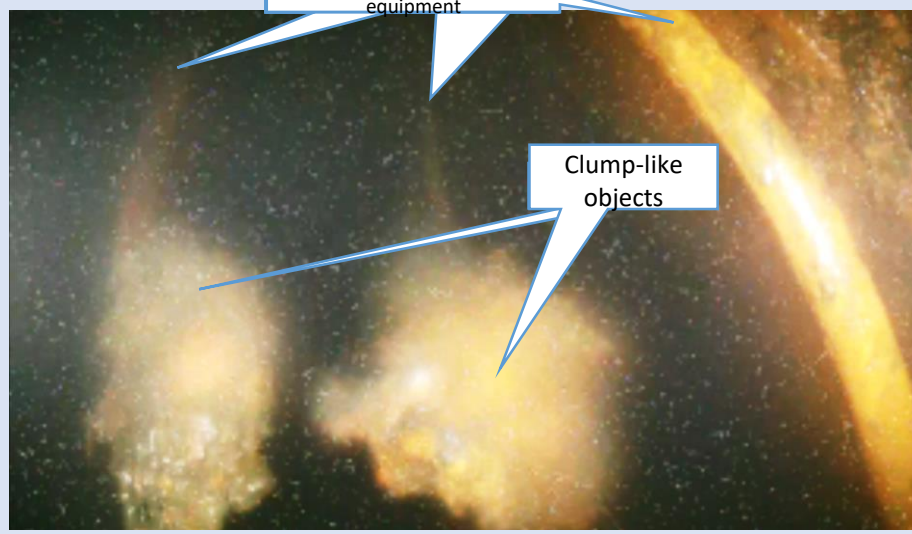
■ Photo ②: These are clump-like objects that are further inside the pedestal than the CRD housing that has fallen in the vicinity of the opening used to replace the CRD. They are hanging off of the CRD related equipment. As with photo ①, it is assumed that these objects migrated downward from above.

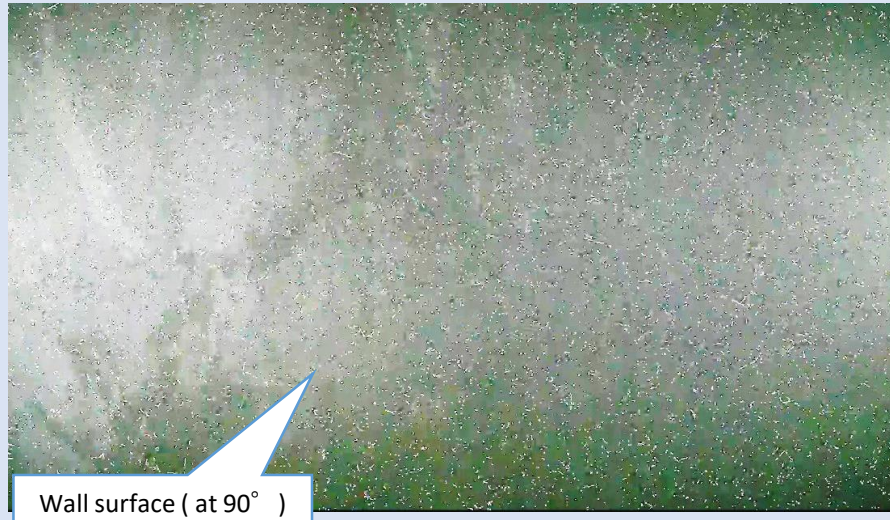
- Photo ①: This is a photo of the pedestal wall at 90° inside the pedestal. Although there is some discoloration, but no significant damage is observed, and the concrete is still present. No equipment are found since there had been no equipment installed on this wall prior to the disaster.

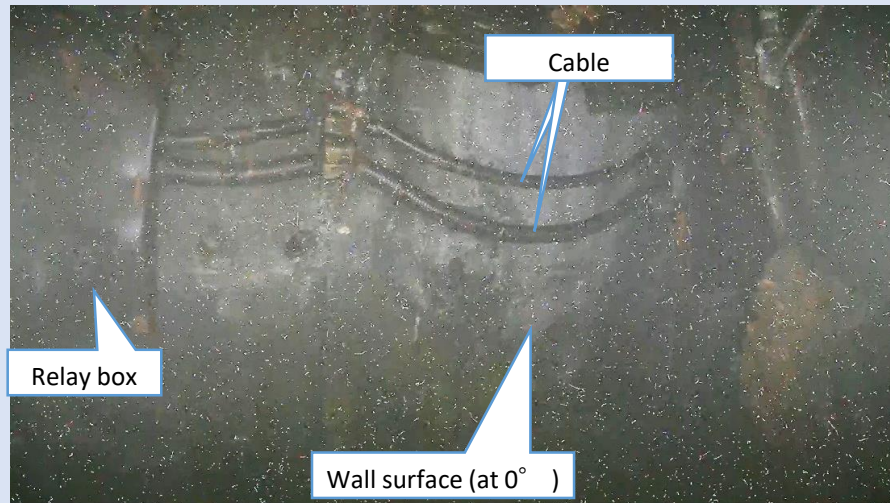
- Photo ②: This is a photo of the pedestal wall at 0° inside the pedestal. As with photo ①, there is some discoloration but no significant damage is observed, and the concrete is still present. Cable relay box, which is assumed to be discolored and deformed, are observed.

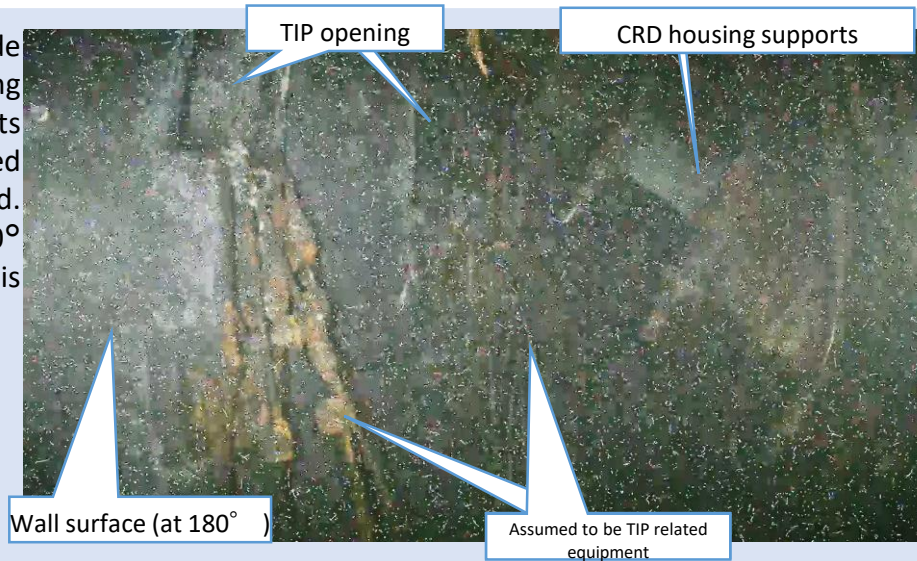
Photo ①: This is a photo of inside the pedestal at 180°. The existing TIP opening can be seen, and objects assumed to be TIP related equipment are hanging downward. Similarly with the pedestal wall at 0° and 90°, no significant damage is observed.

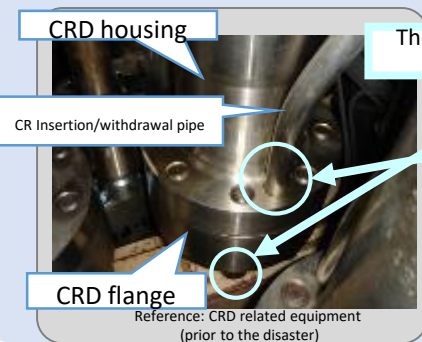
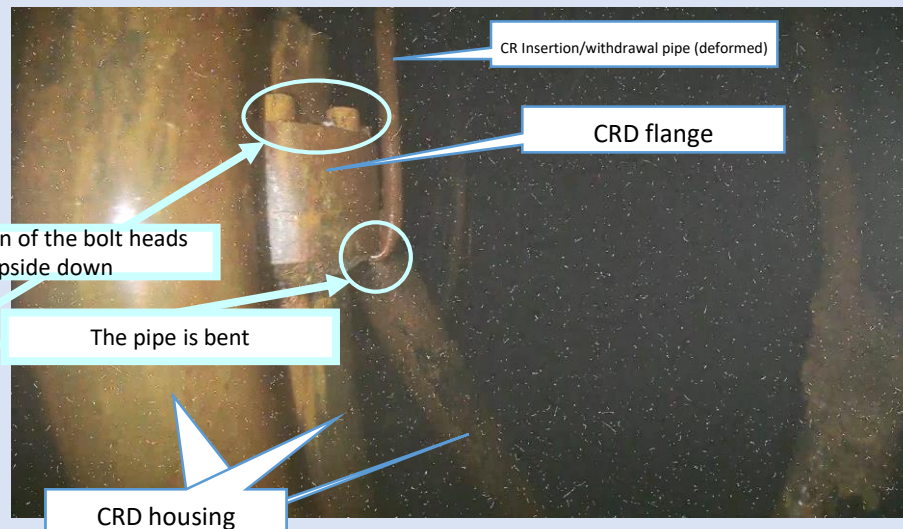
Photo ②: This photo shows the CRD housing that has been reversed from its original position. The insertion/withdrawal pipe is deformed.
