# Unit 1 PCV Internal Investigation (Non-submerged area)

March 28, 2024

Tokyo Electric Power Company Holdings, Inc.

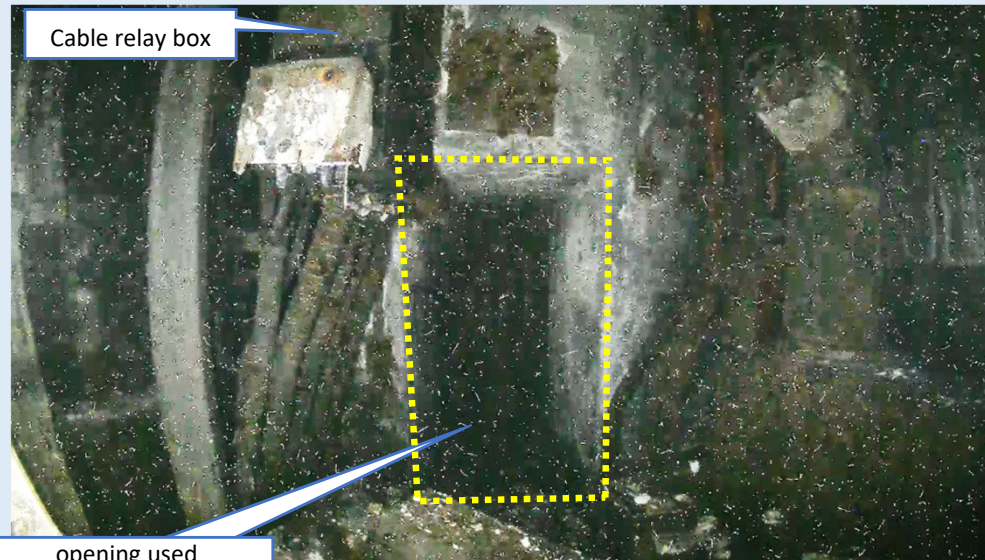
■ Photo ①: This is a picture of the opening used to replace the CRD taken from outside the pedestal. Although there are fallen objects in front of the opening, there is no substantial damage to the pedestal walls. The existing structures have experienced some discoloration due to aging, but they retain their original form for the most part.

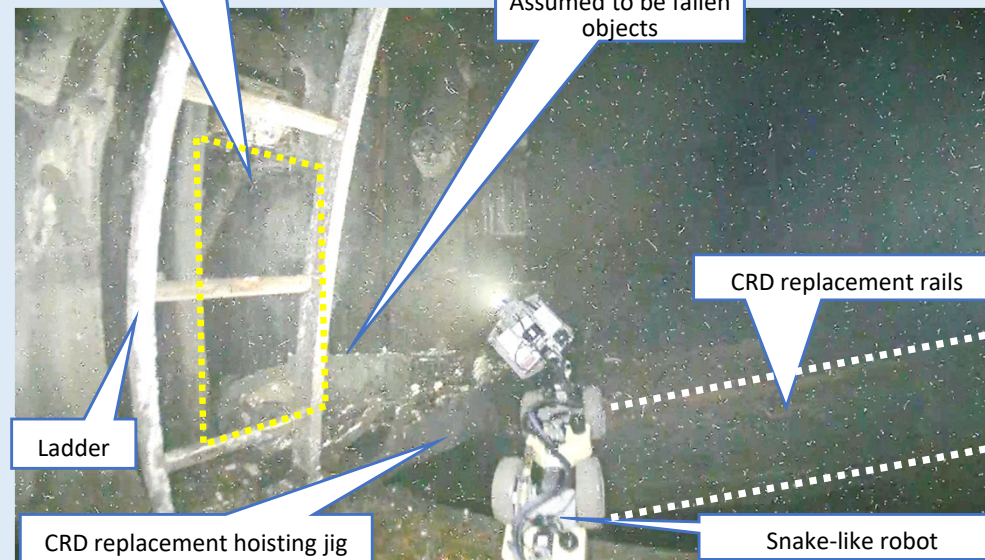
■ Photo ②: This photo gives a birds-eye view of the snake-like robot in front of the opening used to replace the CRD. Since no major obstructions were found in the vicinity of the CRD replacement rails during the February 28 investigation, the snake-like robot relayed radio signals from the location of the CRD replacement rails as planned.

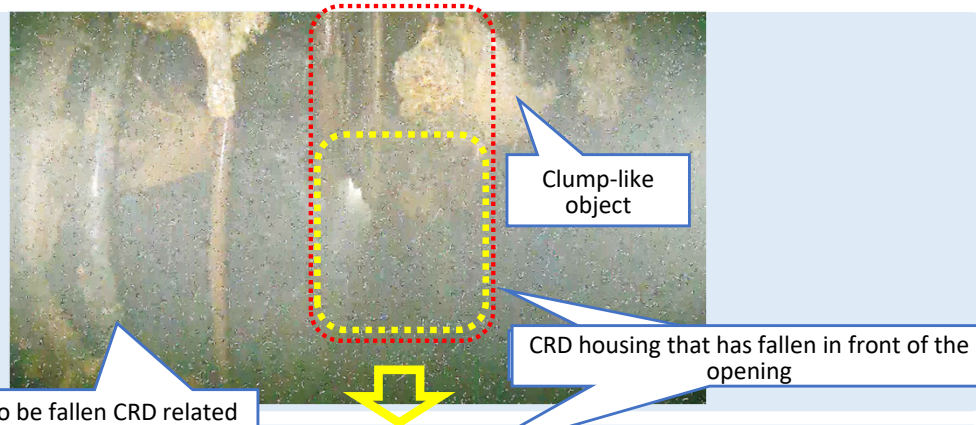
- Photo ①: This is a photo near the opening used to replace the CRD, taken from inside the pedestal. The area surrounded by red dotted line is the fallen CRD housing that has obstructed the opening.

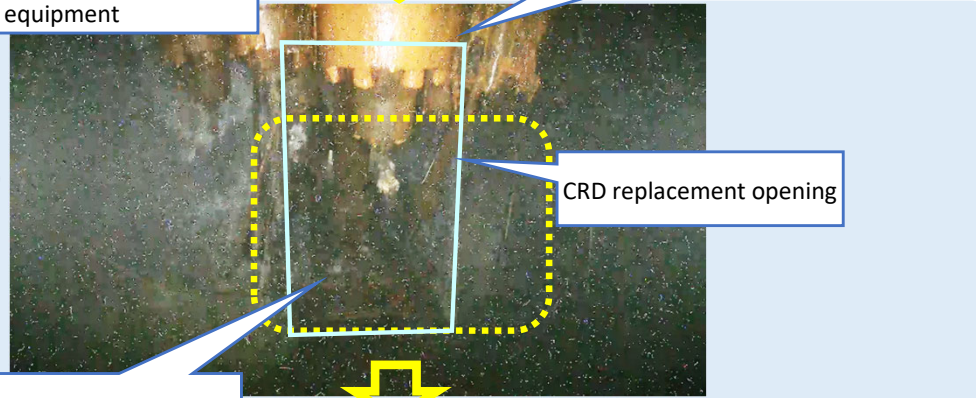
- Photo ②: This is a photo of the area surrounded by the yellow dotted line in photo ①. The CRD housing fell with multiple pieces of CRD related equipment.

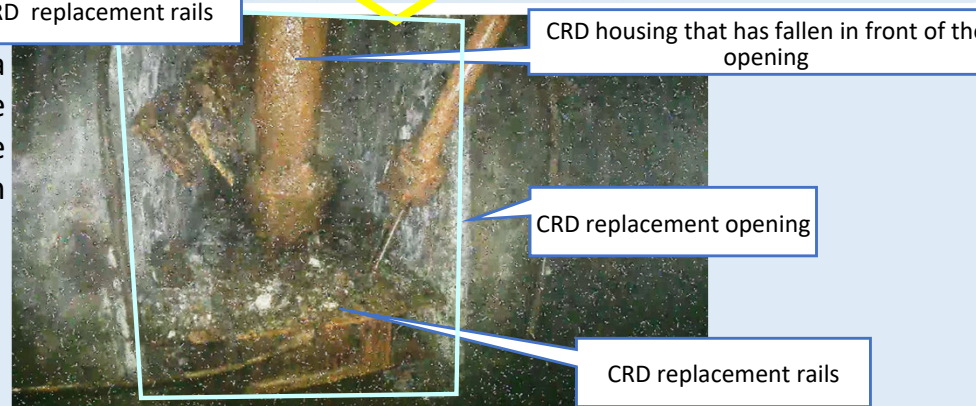
- Photo ③: This is a photo of the area surrounded by the yellow dotted line in photo ②. It appears that the bottom of the CRD housing fell on top of the CRD replacement rails.

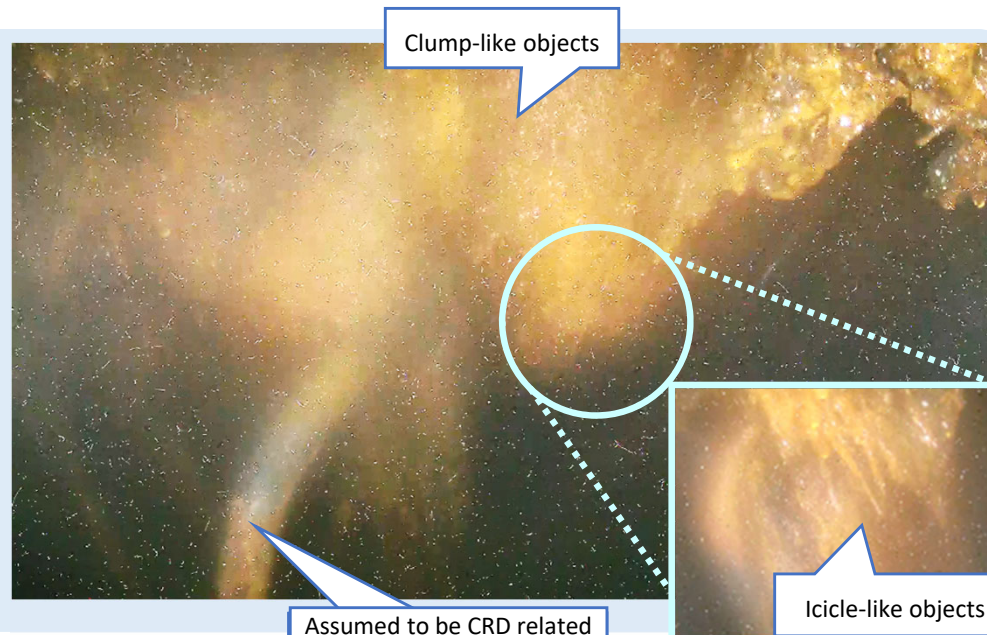
- Photo ①: There are clump-like objects on top of the CRD housing that has fallen in the vicinity of the opening used to replace the CRD. Icicle-like objects are seen partly on the clump-like objects. Since they concentrate around the top, it is assumed that these objects migrated downward from above.

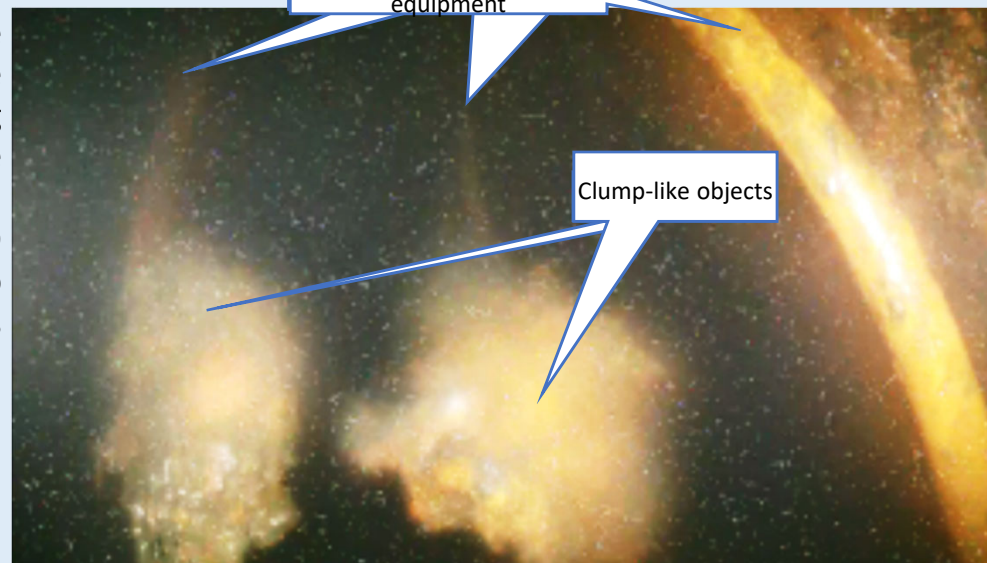
- Photo ②: These are clump-like objects that are further inside the pedestal than the CRD housing that has fallen in the vicinity of the opening used to replace the CRD. They are hanging off of the CRD related equipment. As with photo ①, it is assumed that these objects migrated downward from above.

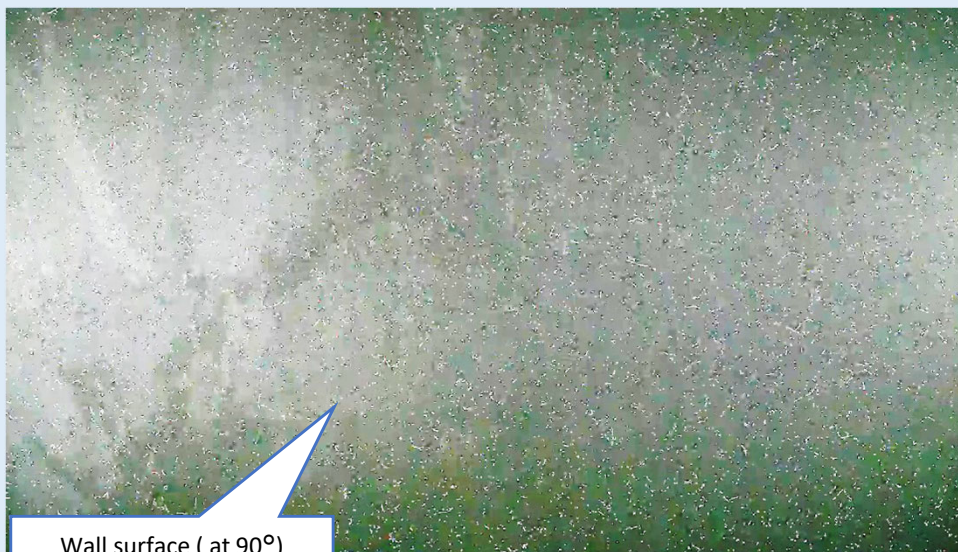
- Photo ①: This is a photo of the pedestal wall at 90° inside the pedestal. Although there is some discoloration, but no significant damage is observed, and the concrete is still present. No equipment is found since there had been no equipment installed on this wall prior to the disaster.

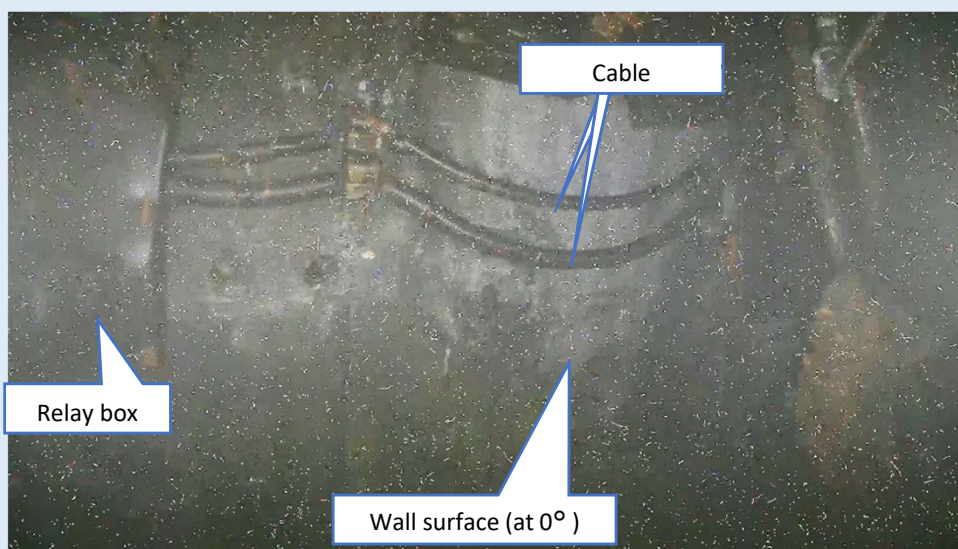
- Photo ②: This is a photo of the pedestal wall at 0° inside the pedestal. As with photo ①, there is some discoloration but no significant damage is observed, and the concrete is still present. Cable relay box, which is assumed to be discolored and deformed, are observed.

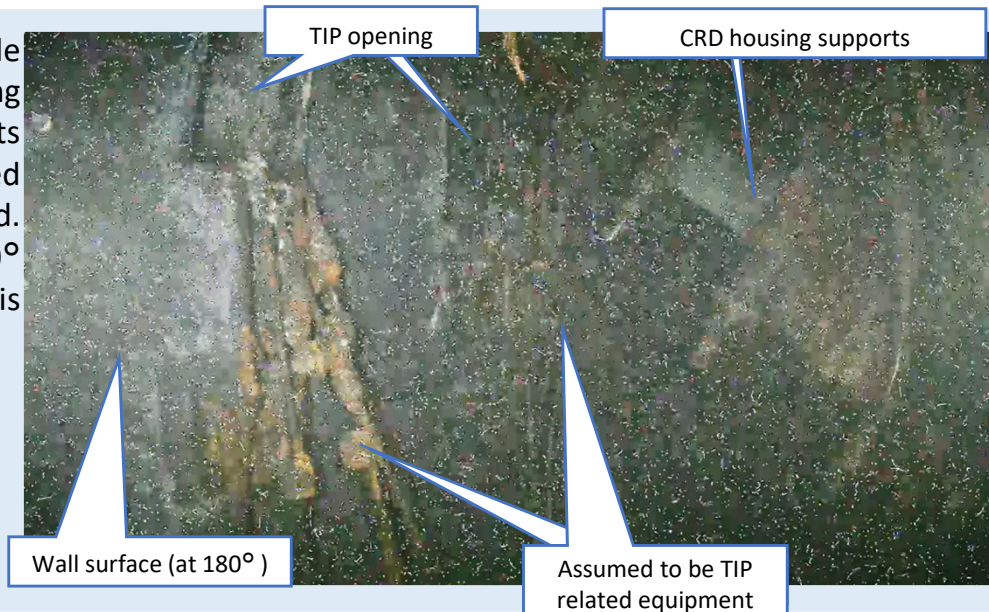
■ Photo ①: This is a photo of inside the pedestal at 180°. The existing TIP opening can be seen, and objects assumed to be TIP related equipment are hanging downward. Similarly with the pedestal wall at 0° and 90°, no significant damage is observed.

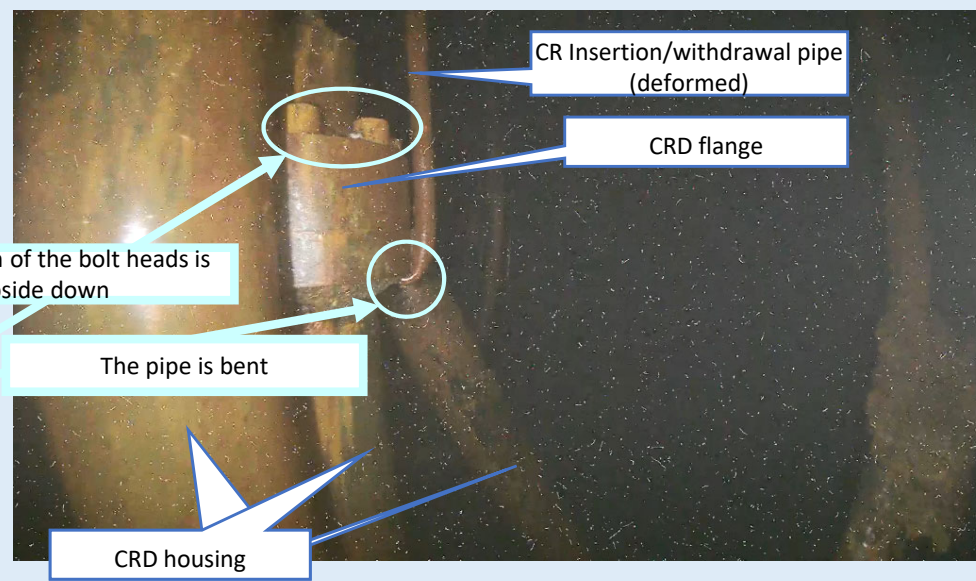
■ Photo ②: This photo shows the CRD housing that has been reversed from its original position. The insertion/withdrawal pipe is deformed.

The position of the bolt heads is upside down

The pipe is bent

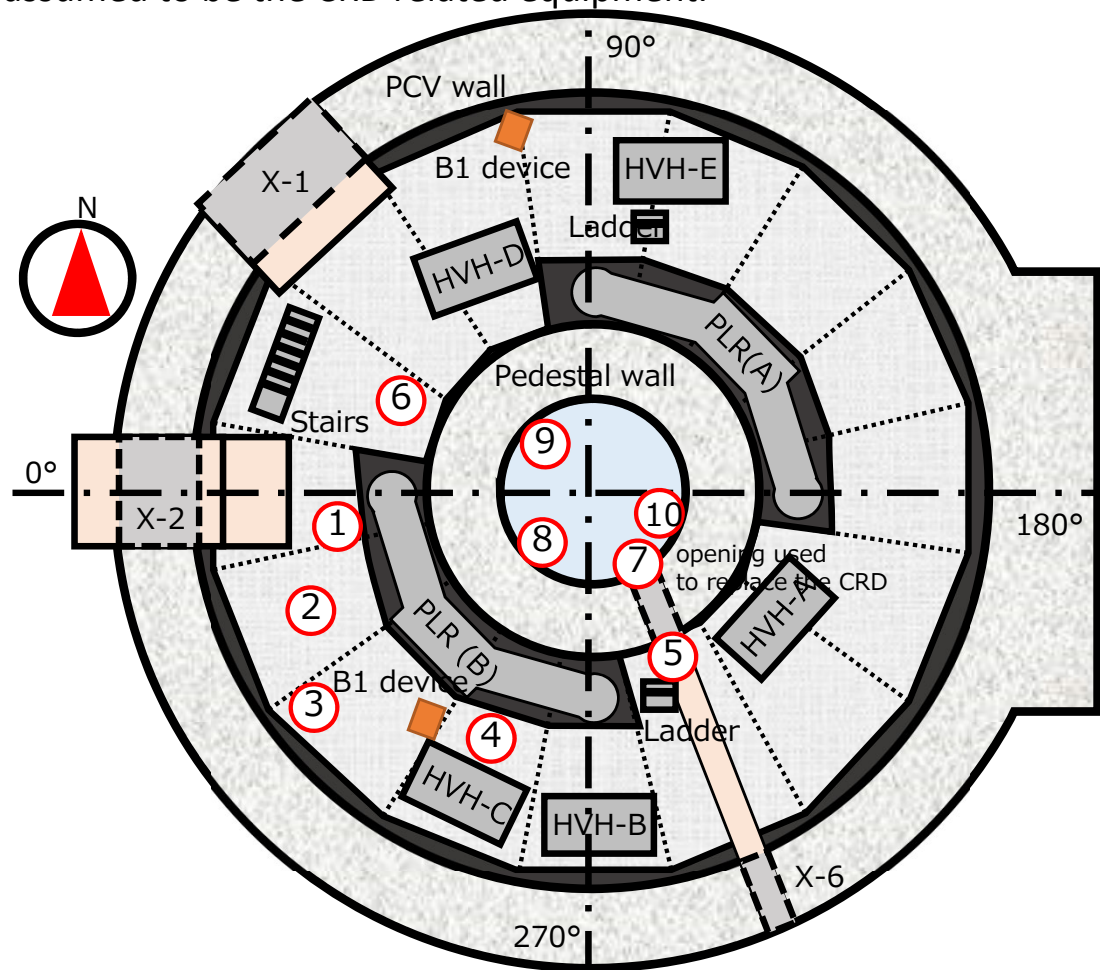
- We have observed fallen objects on the grating outside the pedestal, such as lead shielding mats, etc., that were seen in past investigations.
- There is a fallen object in front of the opening used to replace the CRD which is assumed to be the chain block used to hoist the CRD rails.
- Inside the pedestal, in addition to the vicinity of the opening used to replace the CRD, there are fallen structures on the wall side, which are assumed to be the CRD related equipment.

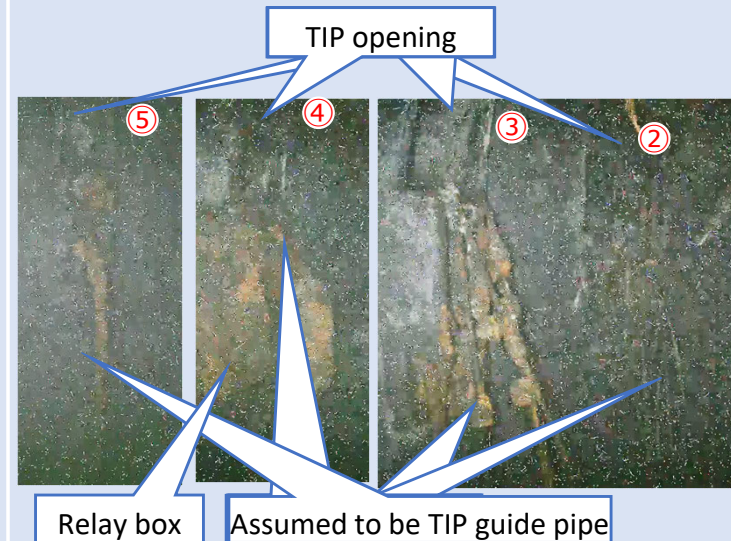
Condition of TIP opening (around 180°)

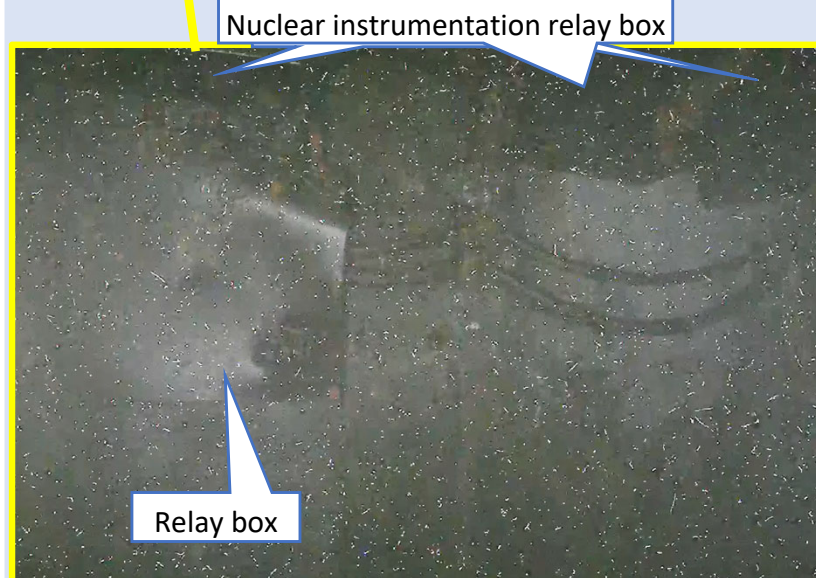
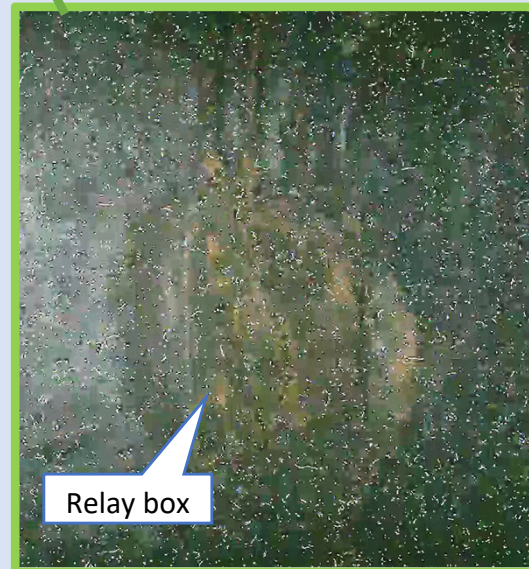
Condition of relay box inside the pedestal (left: around 0°, right: around 180°)

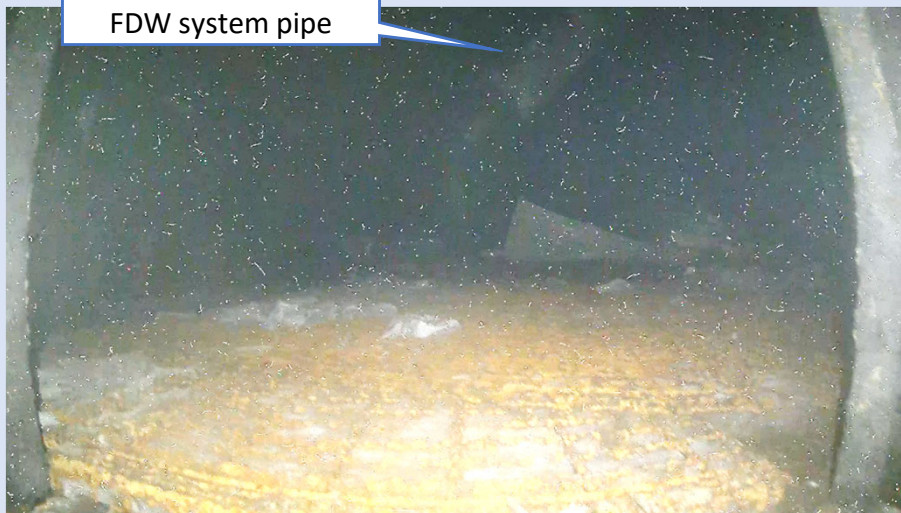
Condition of second floor

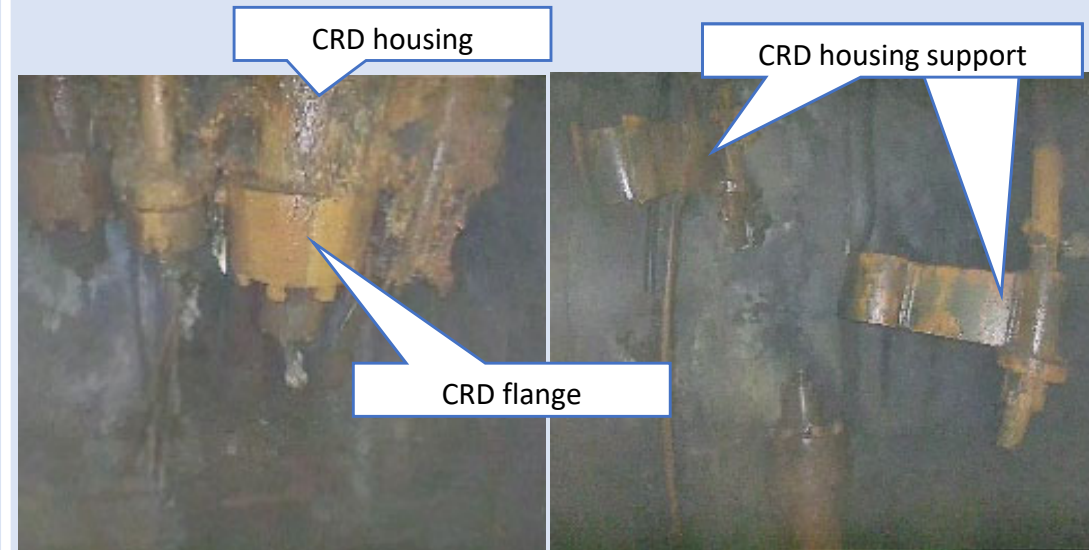
Conditions of the CRD related equipment  
(left: housing, right: support)

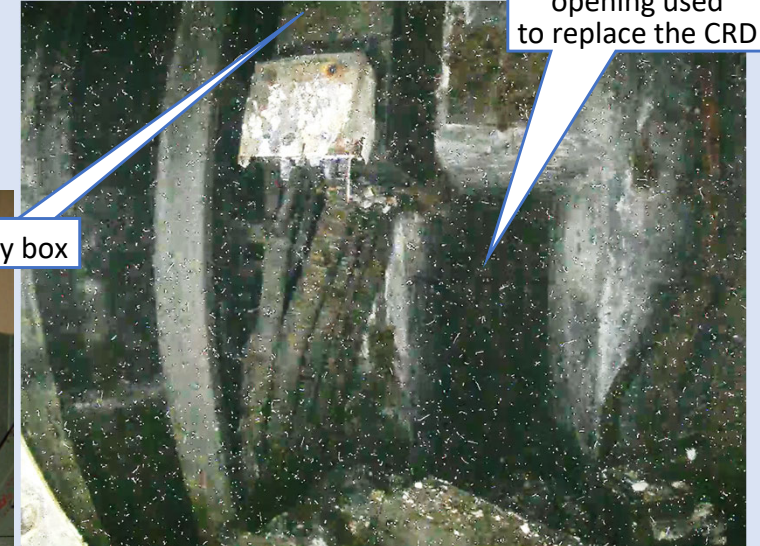
Condition in front of the opening used to replace the CRD (relay box)

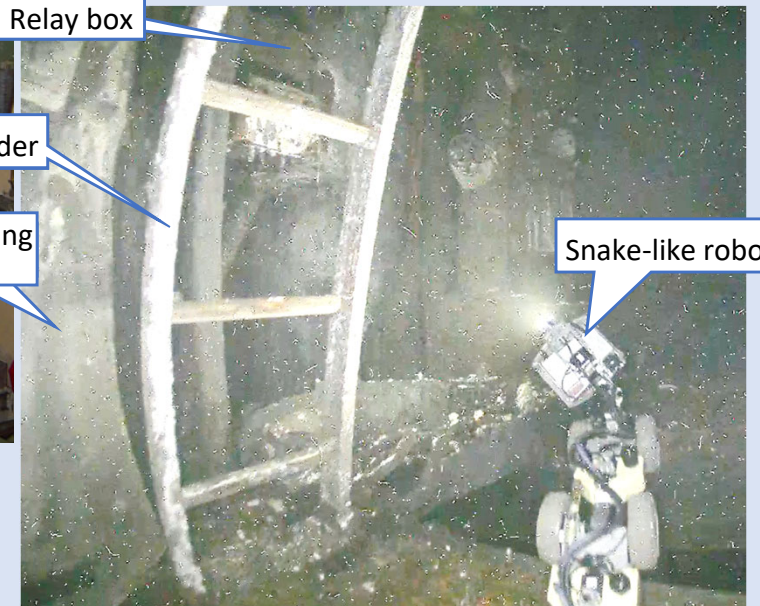
Condition in front of the opening used to replace the CRD (ladder)

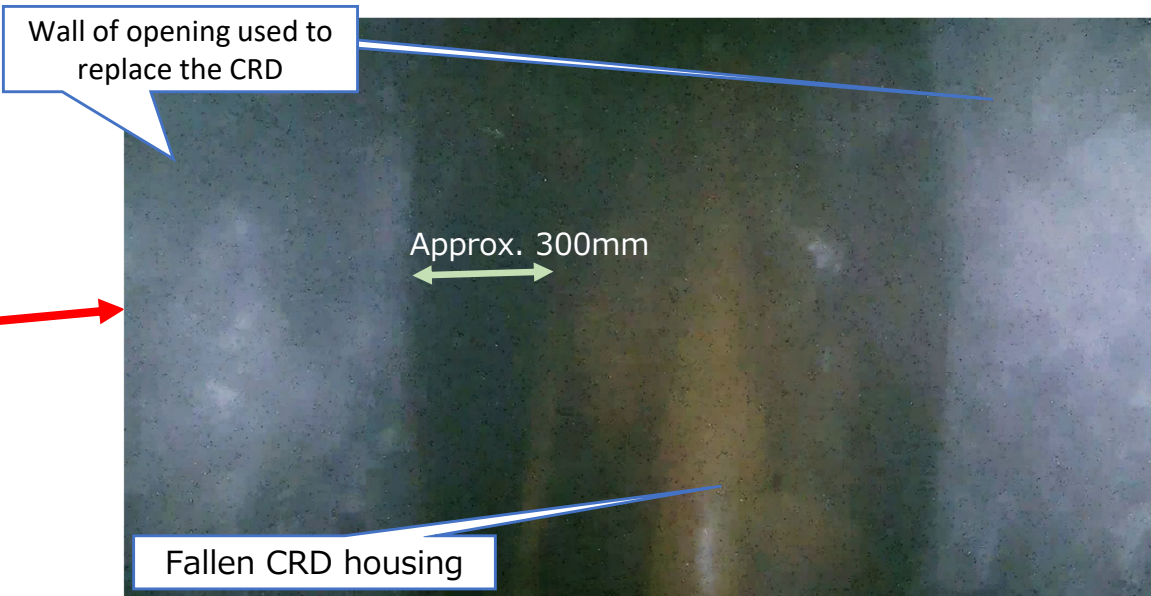
Photo 1. Condition of opening used to replace the CRD (after compensating for the flickering)

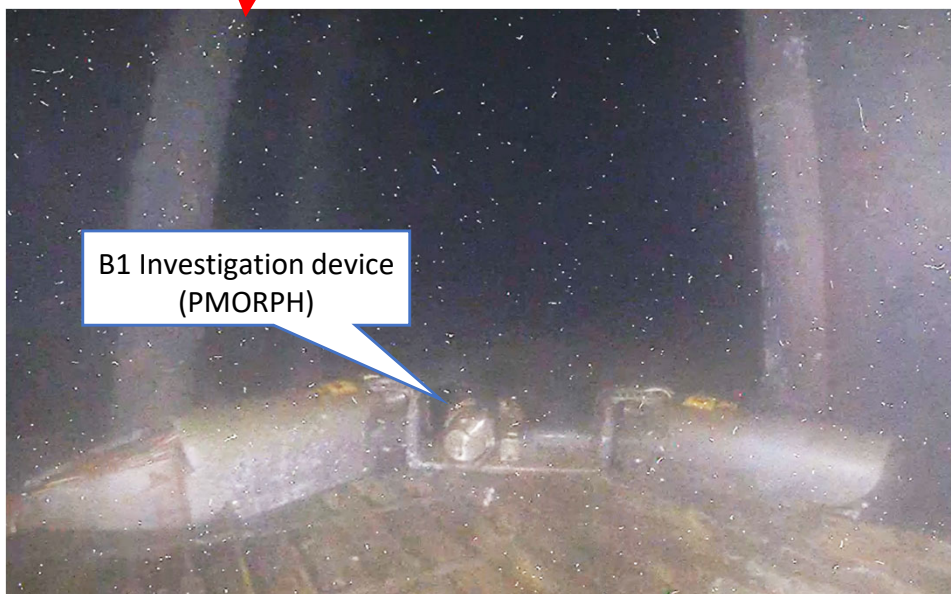
Photo 2. remains of B1 investigation device (PMORPH) on south side

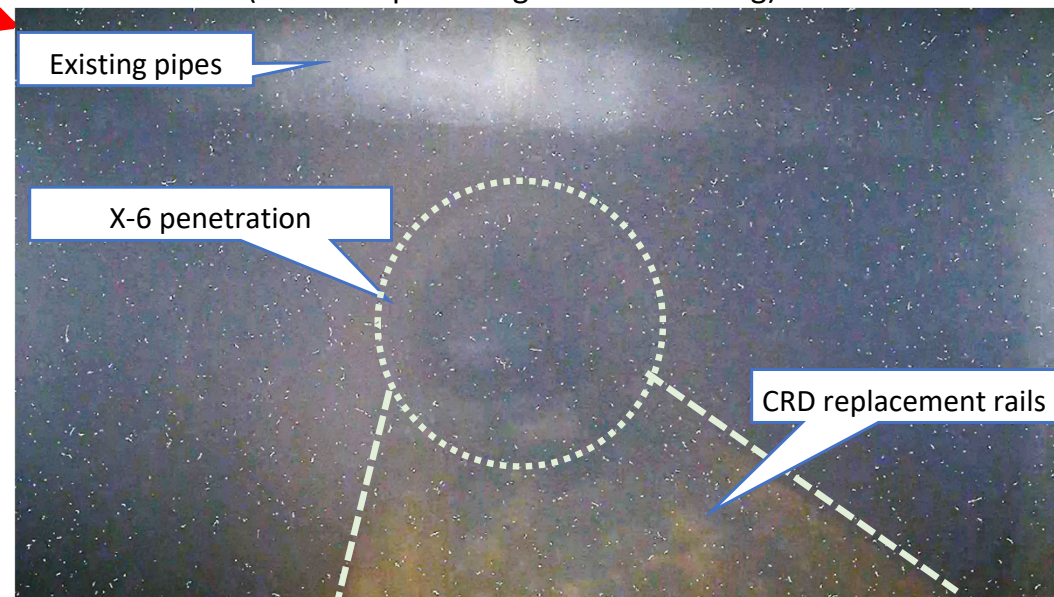
Photo 3. X-6 penetration condition

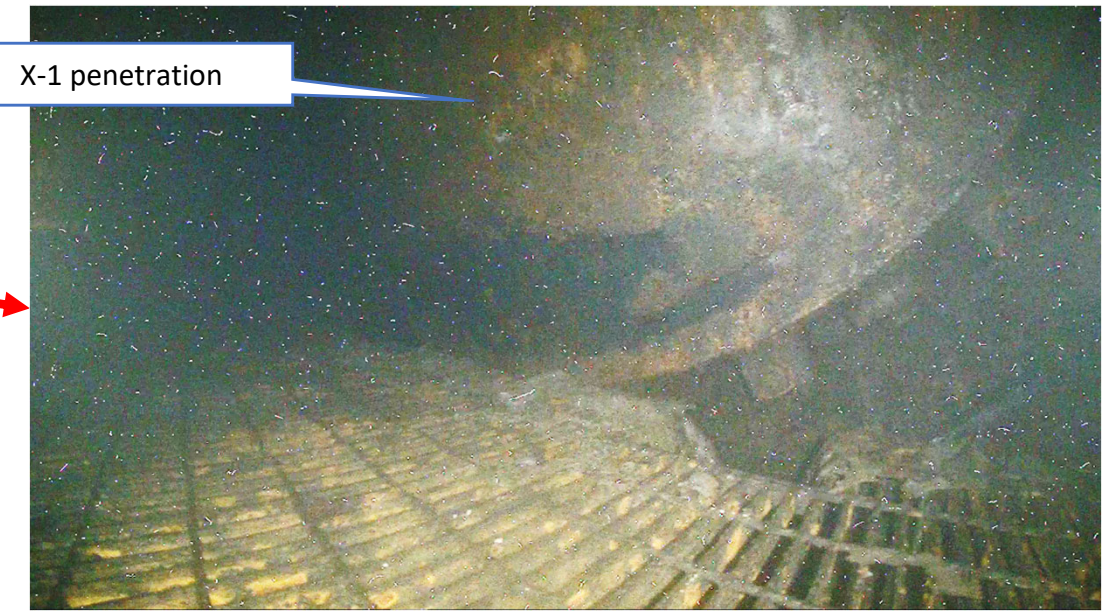
Photo 1. X-1 penetration condition

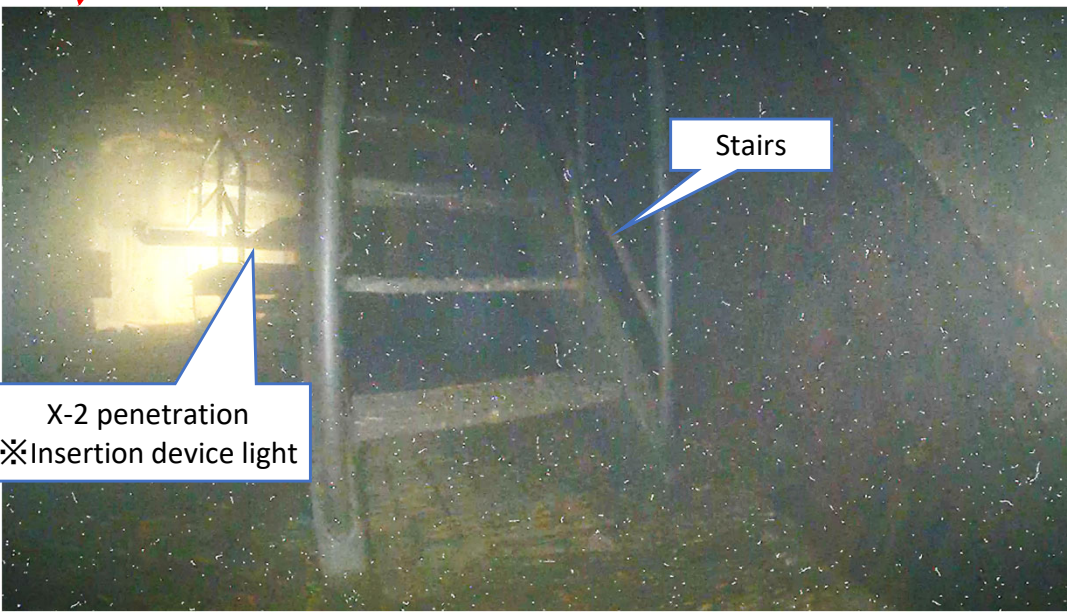
Photo 2. Condition of stairs

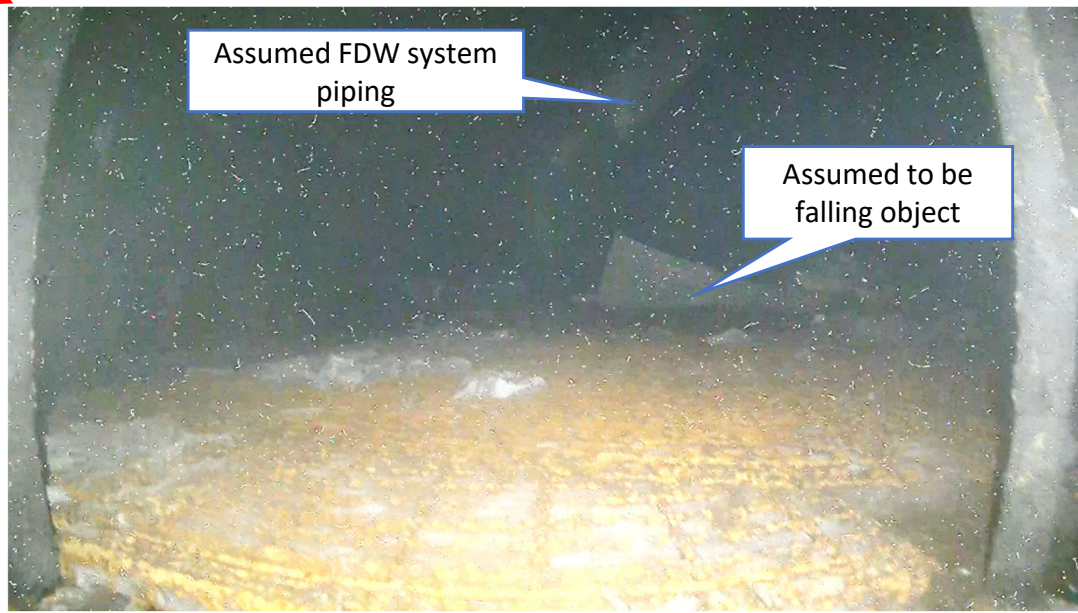
Assumed FDW system piping

Assumed to be falling object

Photo 3. 2FL condition

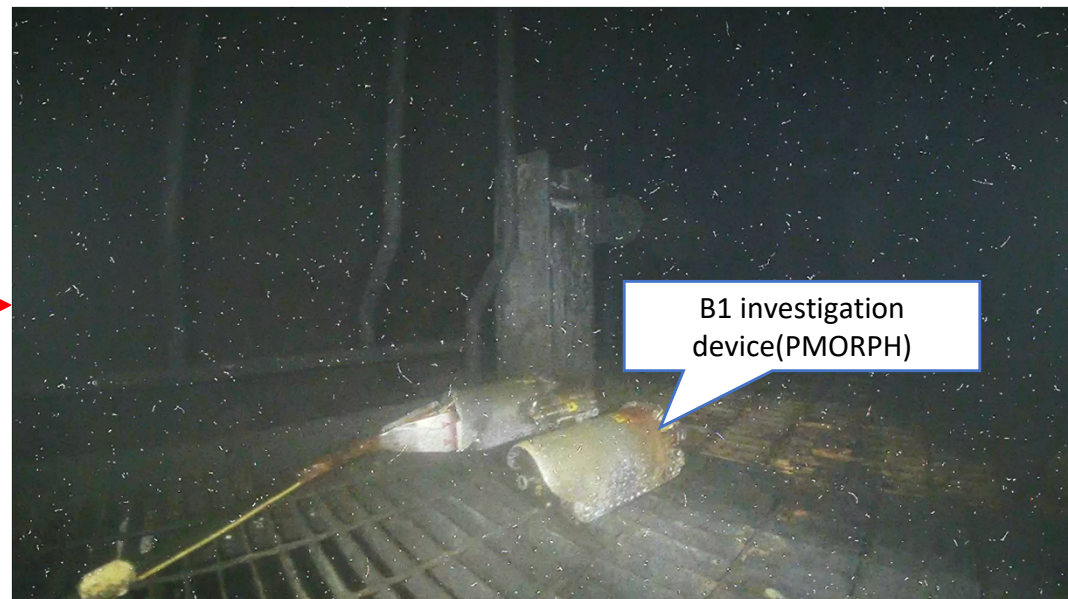
Photo 1. Remains of B1 investigation device (PMORPH) on north side

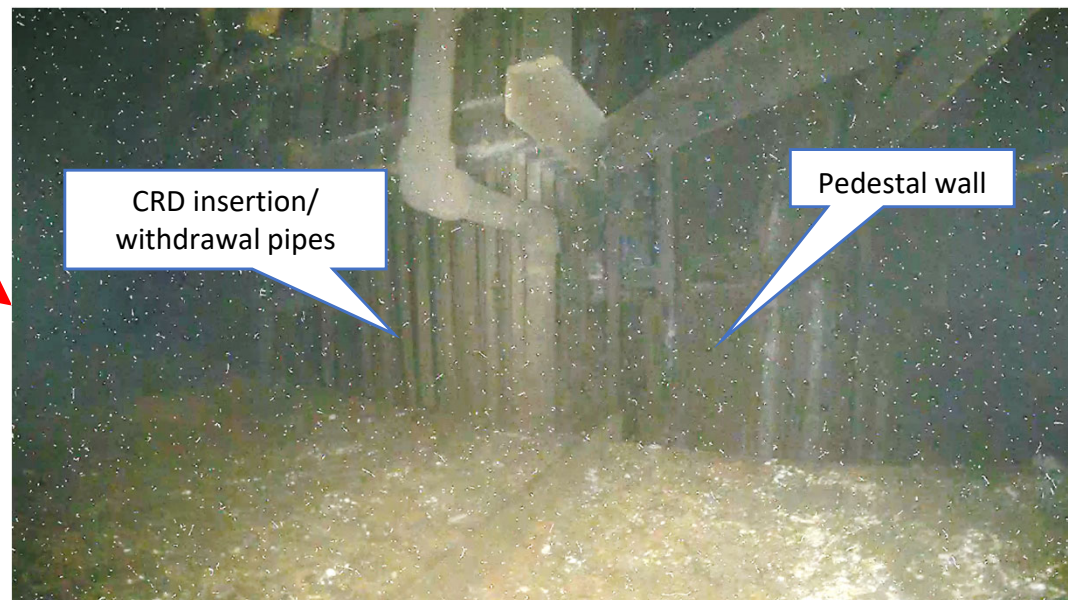
Photo 2. condition of CRD insertion/withdrawal pipes

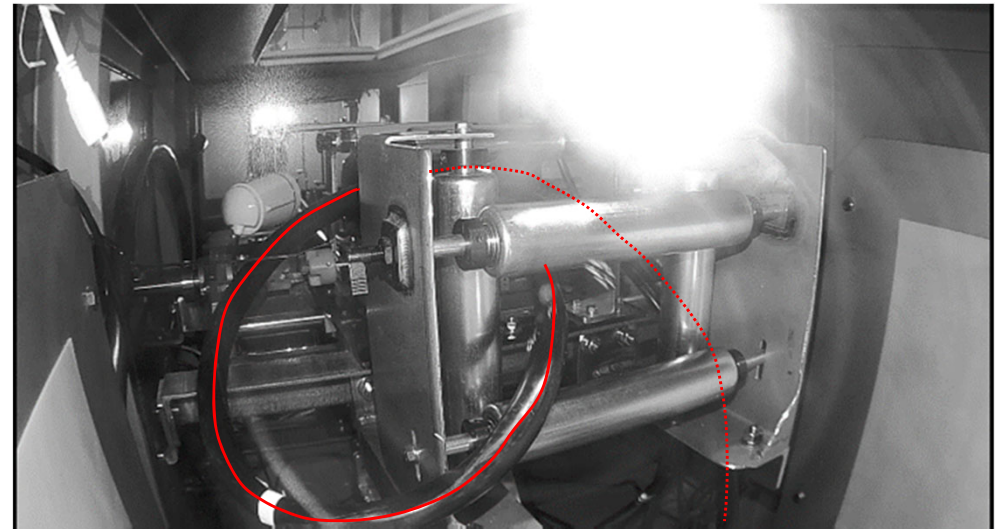
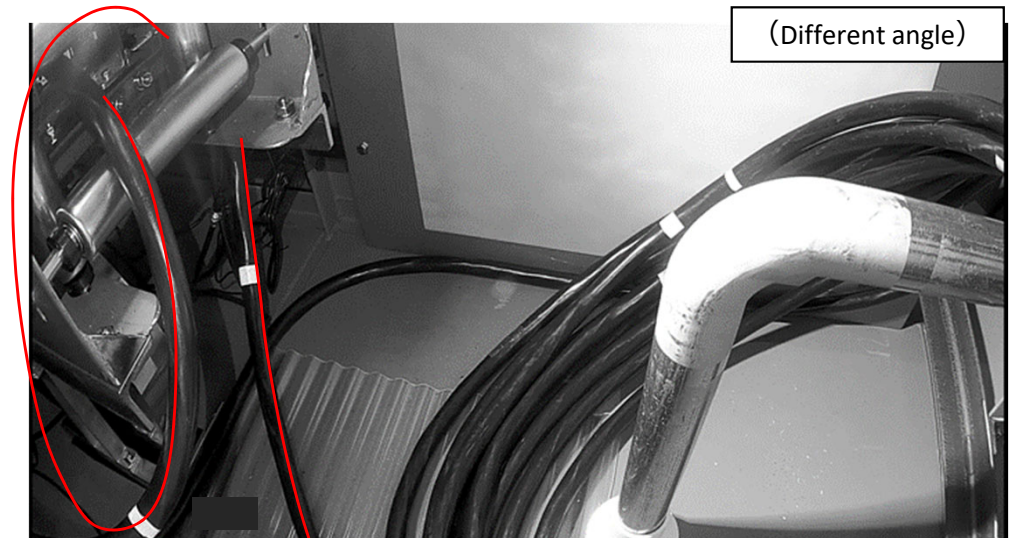
- Usually, cable is routed through guide roller to the cable winch.
- In this case, cable route was different from the normal route due to the flexure in the cable. As a result, cable was caught in the installation bracket for the guide roller, unable to be paid out.

Conditions when event occurred

① **Cable recoiling**

Since it is getting more probable that the cable will take a different route when paid out repeatedly, the cable will be recoiled to reduce the possibility of it taking a different cable route.

② **Restricting the range of mobility of the cable**

A guard panel will be installed to restrict the range of mobility of the cable to prevent it from getting caught up on, or wrapping around, the guide roller installation bracket even if the cable behave differently than normal.
