# Fukushima Daiichi Nuclear Power Station

## K4 Area Tank Group E Internal Inspection Implementation Status

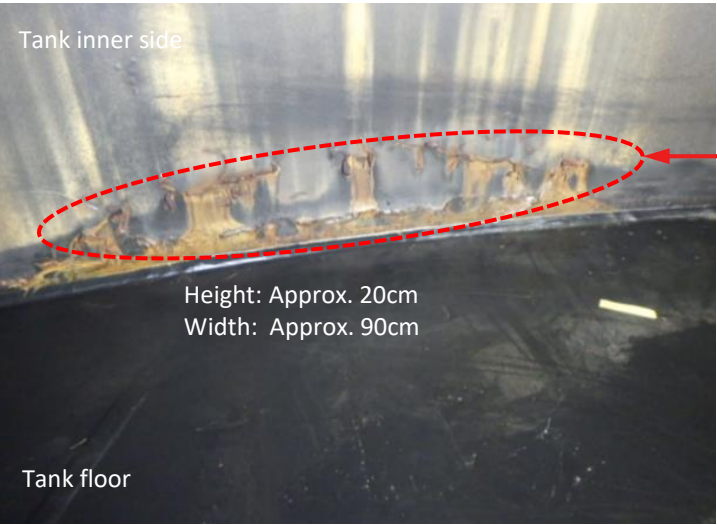
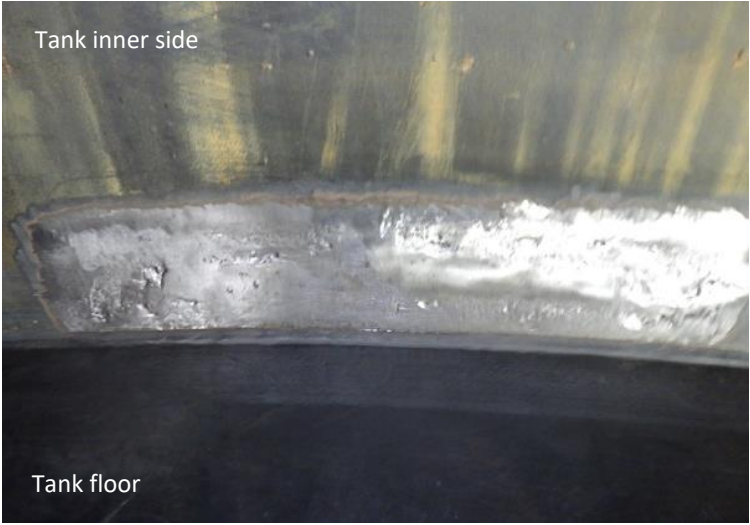
# K4 Area Tank Group E Internal Inspection Implementation Status (E1 tank)

- As a result of the internal inspection, we found localized corrosion and flaking paint in tanks E1, E2 and E5.
- The discovered corrosion was localized and was most likely caused by water (ALPS treated water) that seeped in between the flaking paint and the tank base metal.

After grinding away the paint

- The corrosion is not of a nature that would impact the structural integrity of the tank, and there is no risk of leakage when storing ALPS treated water. The aforementioned locations will be repaired prior to using the tanks again to store ALPS treated water.

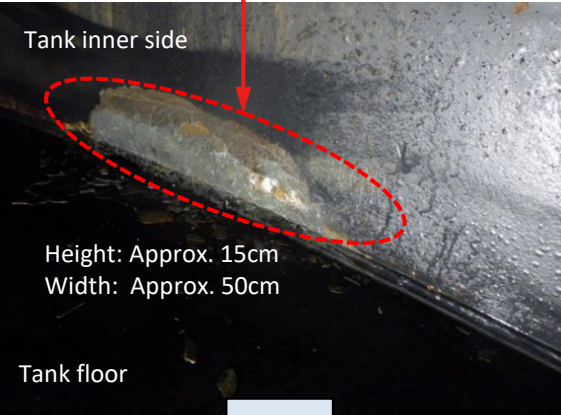
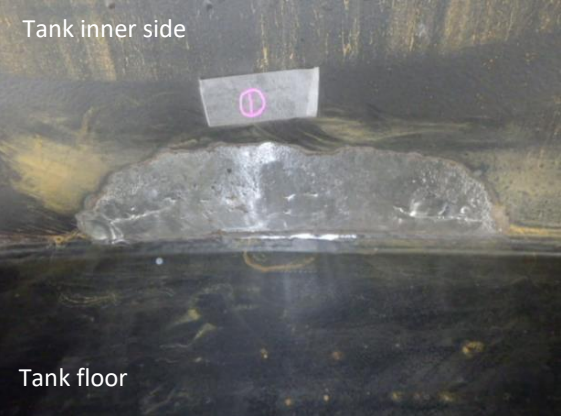
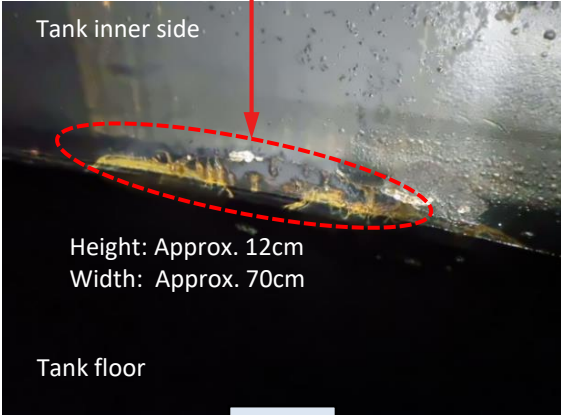
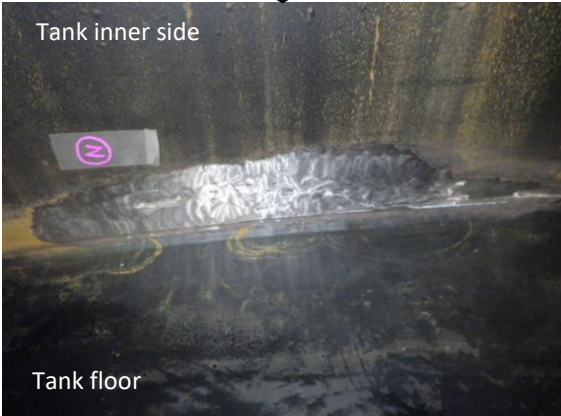
# K4 Area Tank Group E Internal Inspection Implementation Status (E2 tank)

Location where paint was flaking

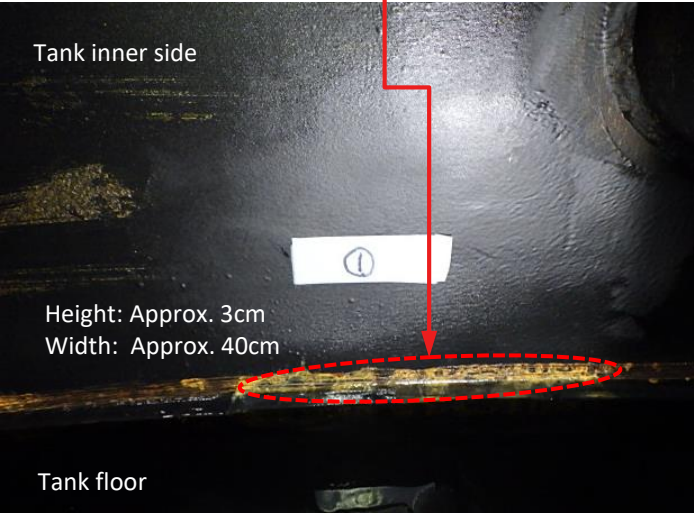
Location where rust was found

\*This area will be repainted because minor rust was found on the surface

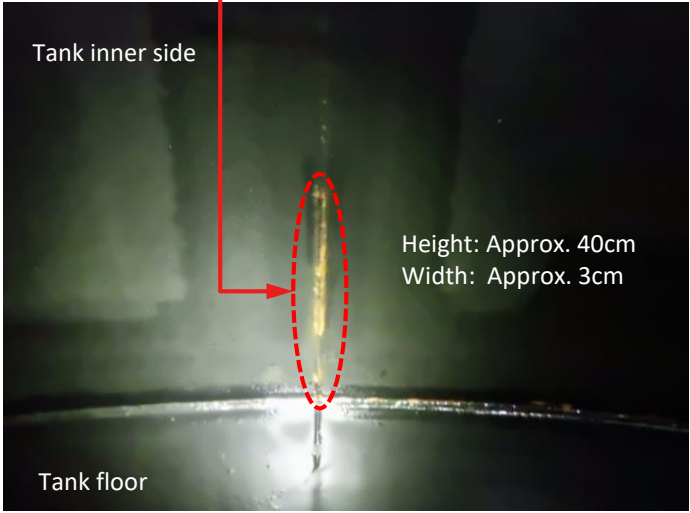
Location where rust was found

\*This area will be repainted because minor rust was found on the surface
