Fukushima Daiichi Nuclear Power Station Unit 2 PCV Internal Investigation/ Preparation Status of Fuel Debris Trial Retrieval

April 25, 2024

International Research Institute for Nuclear Decommissioning
Tokyo Electric Power Company Holdings, Inc.

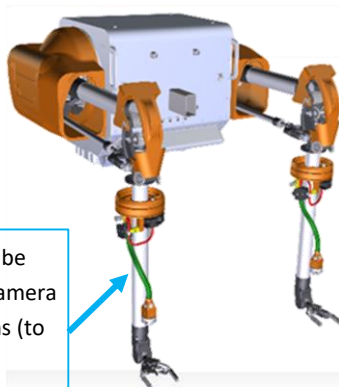
Double arm manipulator

- After the arm was withdrawn into the enclosure, a test to examine the user-friendliness of the mastering process using the double arm manipulator was conducted, and it was discovered that improvements are needed to both visibility and the jig itself.
 - Visibility improvement: The camera on the double manipulator arm will be changed to improve visibility
 - Jig improvement: The fitting hole will be fitted with a guide in order to make mastering jig attachment easier

The existing camera will be replaced with another camera of different specifications (to improve visibility during mastering)

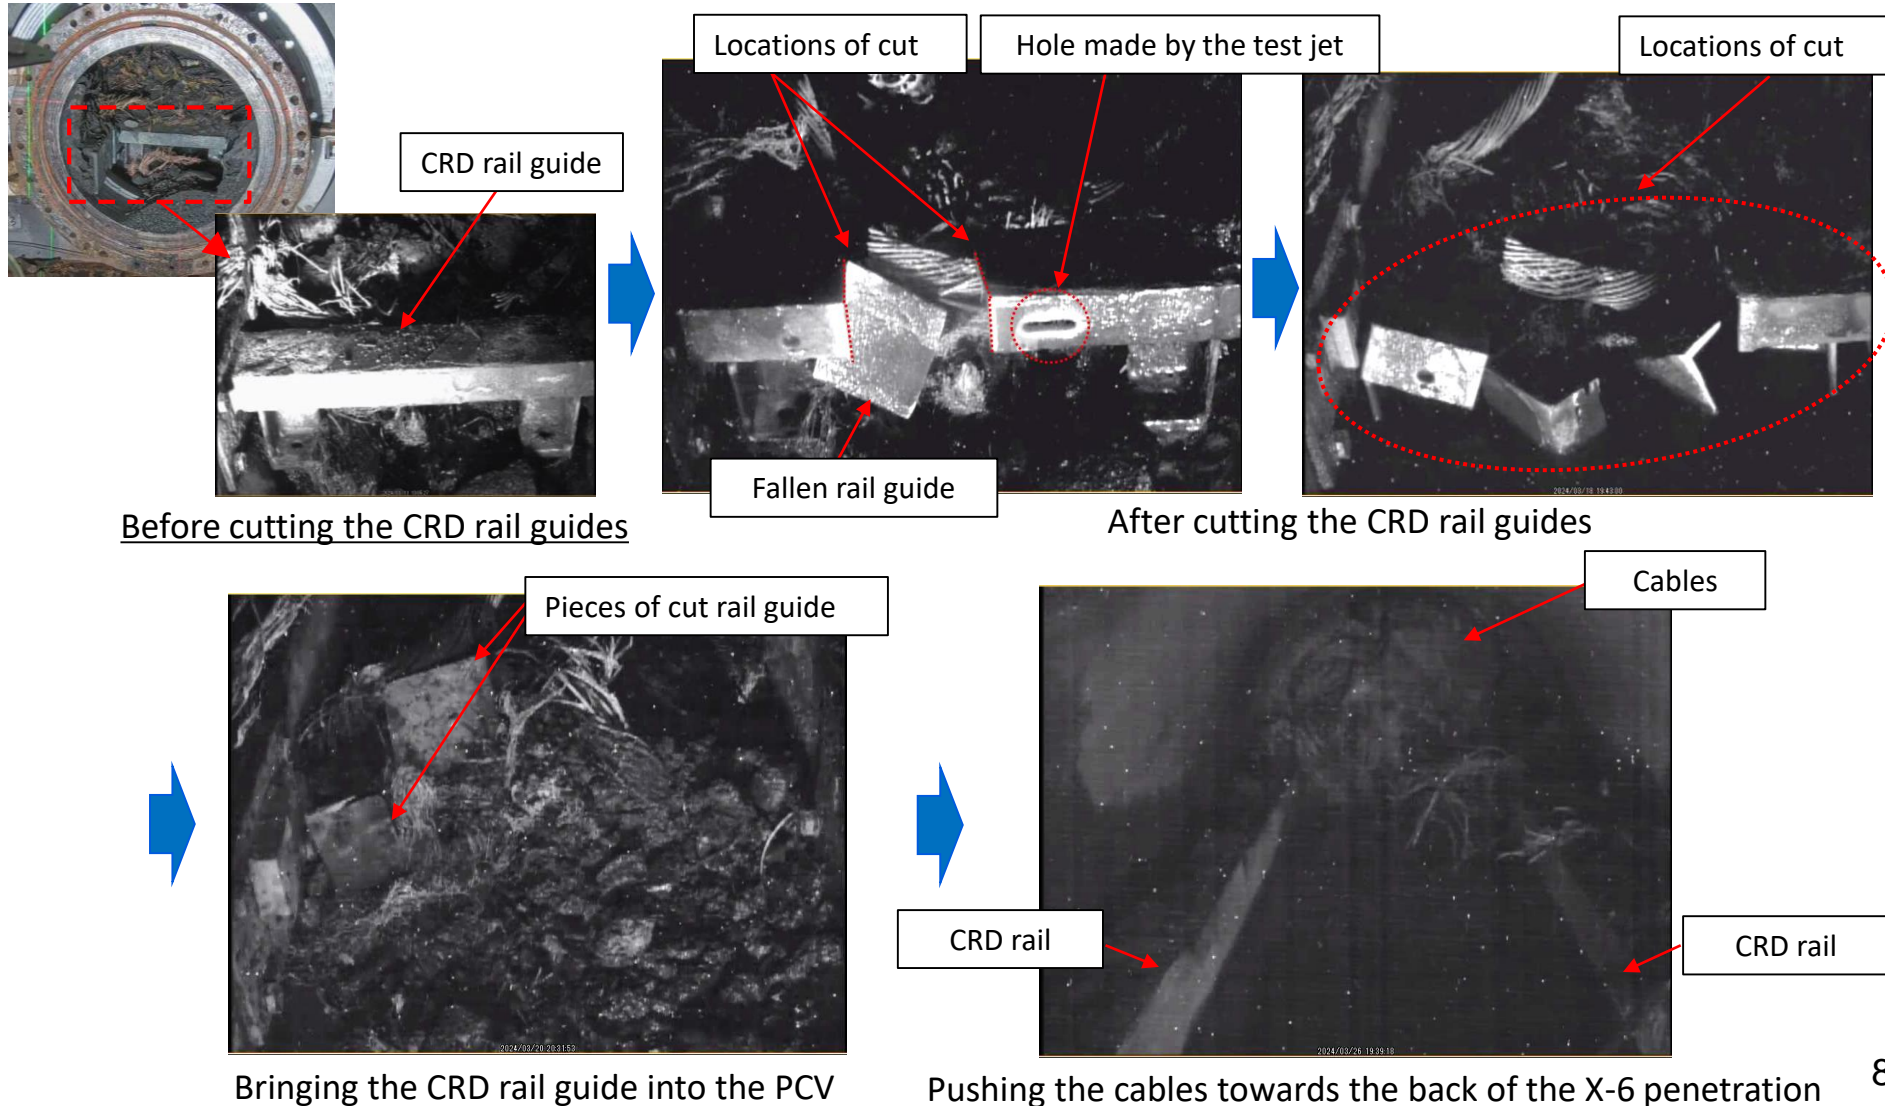
- We started to use the AWJ on March 18, and removed the CRD rail guides that are in front of the X-6 penetration. Since March 22, we have been pushing and cutting the cables using AWJ. Following that, we will remove the CRD rail guides at the back of the X-6 penetration.

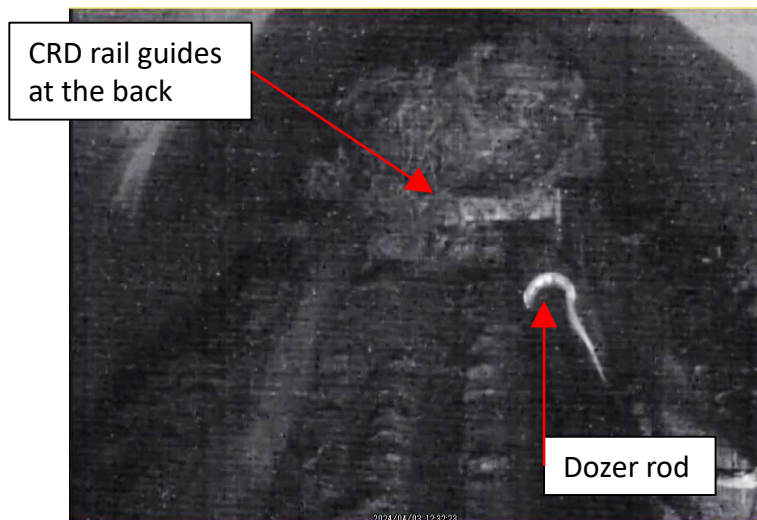
Prior to removal of the CRD rail guides at the back of the X-6 penetration

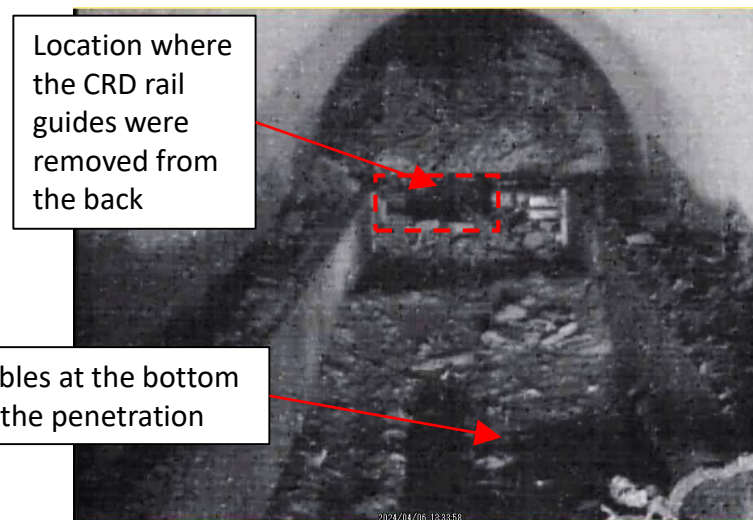
During removal of the CRD rail guides at the back of the X-6 penetration

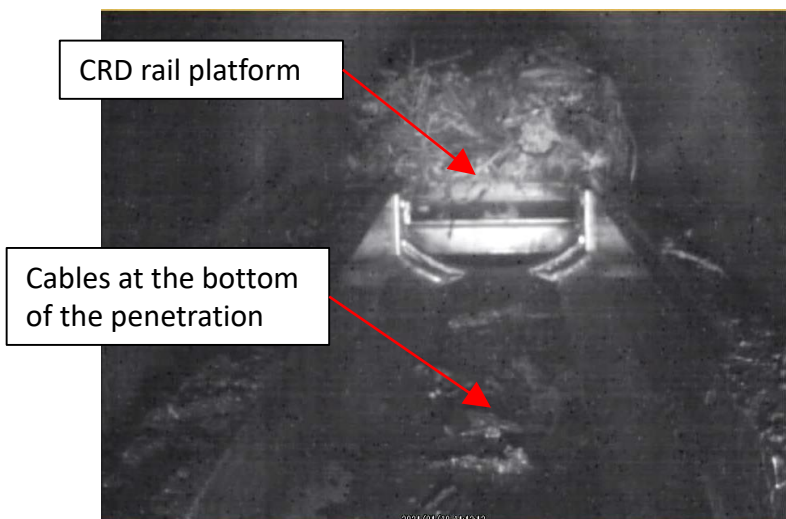
After removal of the CRD rail guides at the back of the X-6 penetration and the rail platform lock pin

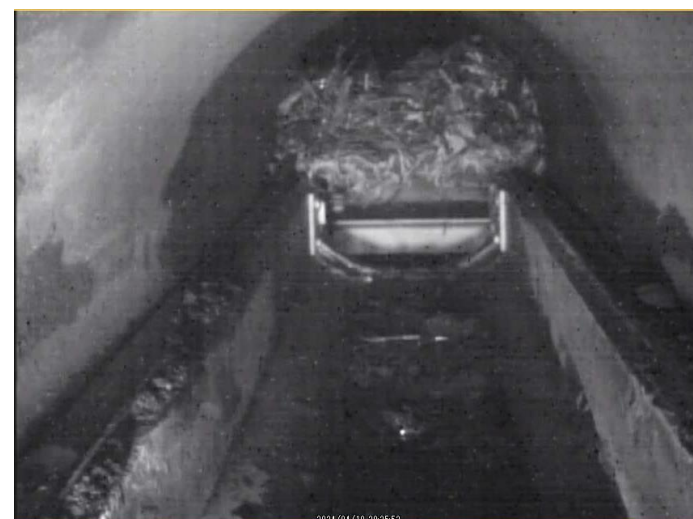
After removal of the cables at the bottom of the X-6 penetration

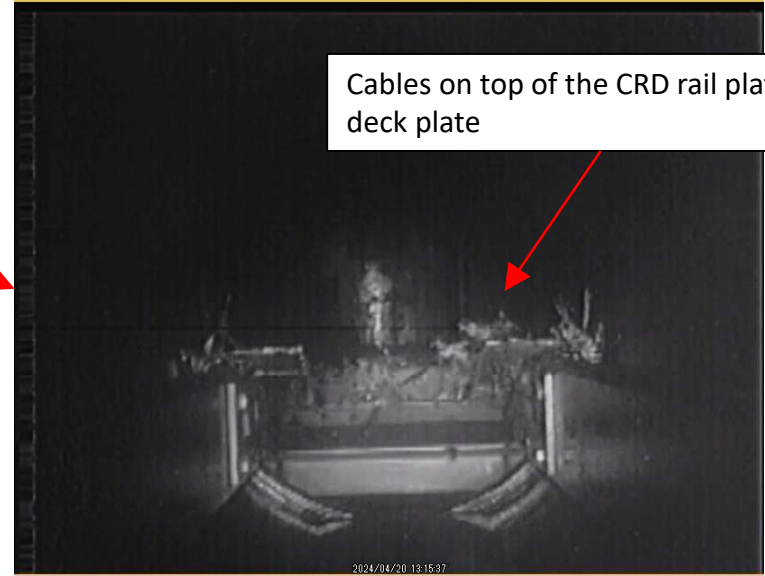
Cables on top of the CRD rail platform deck plate

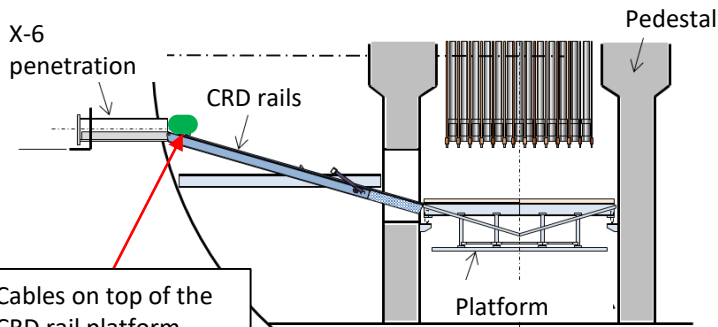
Removing the cables on top of the CRD rail platform deck plate on the outside of the X-6 penetration

Cables on top of the CRD rail platform deck plate

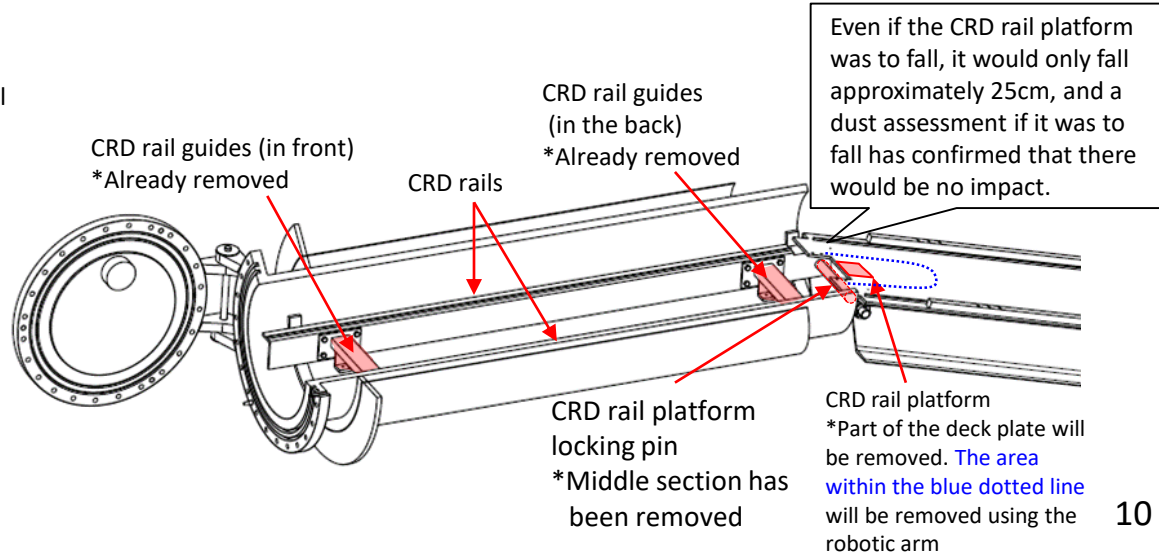
CRD rail guides (in front)
*Already removed

CRD rail guides (in the back)
*Already removed

Even if the CRD rail platform was to fall, it would only fall approximately 25cm, and a dust assessment if it was to fall has confirmed that there would be no impact.

CRD rail platform locking pin
*Middle section has been removed

CRD rail platform
*Part of the deck plate will be removed. The area within the blue dotted line will be removed using the robotic arm
