- At around 10:43AM today (April 24), the on-site electric power system A shut down.
- Functions that keep each plant stable (reactor cooling water injection, spent fuel pool cooling, primary containment vessel gas management system, etc.) remain in operation, and no significant fluctuations have been seen in parameters for monitoring posts or site boundary continuous dust monitors.

- At around the same time that the on-site electric power system A was lost, a contract worker engaged in excavation work (tearing up concrete paving (surface layer)) on the west side of the on-site large equipment inspection building was injured. A field inspection of the site of the accident found that the cable was damaged during the aforementioned excavation work resulting in the suspension of the on-site electric power system A.

# 1. Construction overview

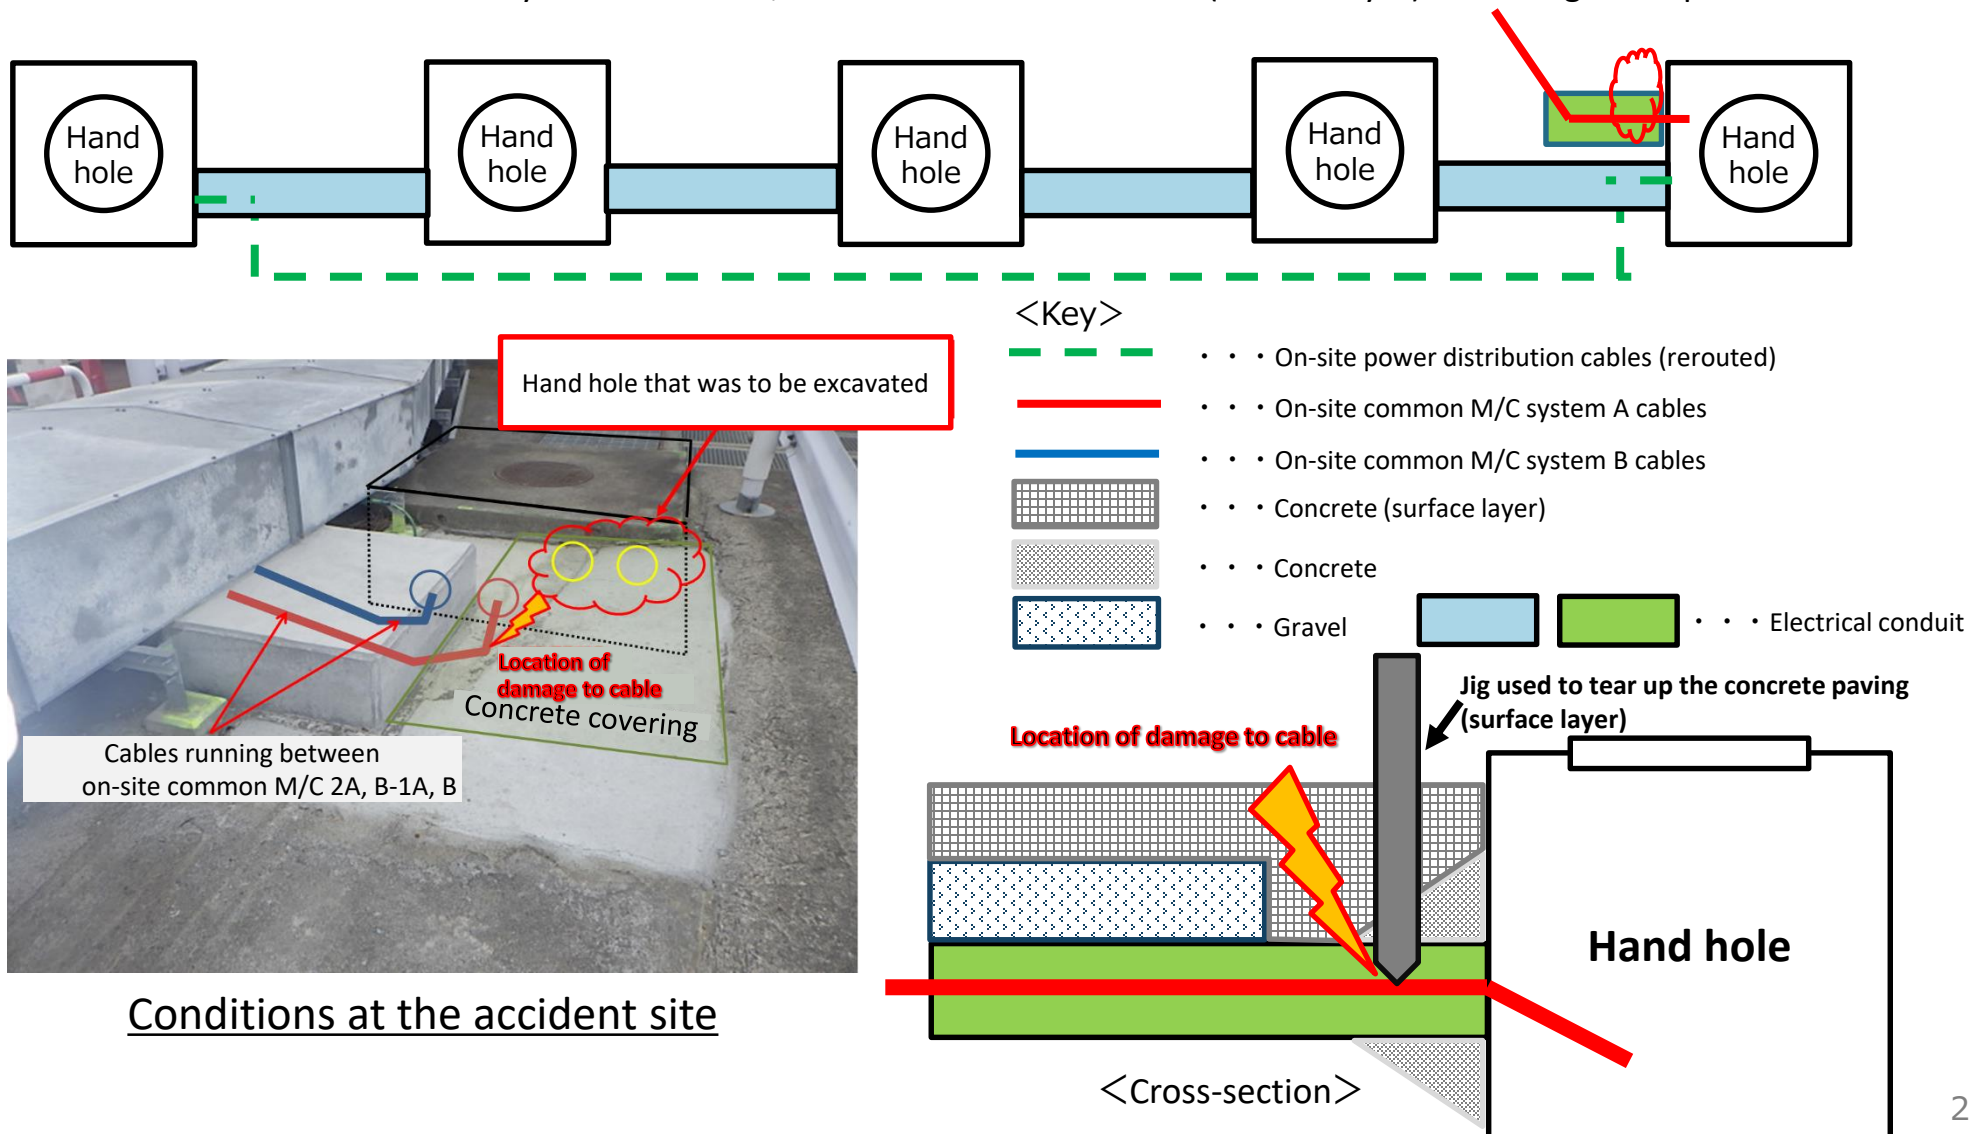
Outdoor paving was being torn up in conjunction with the maintenance (rerouting) of buried electrical conduits for the on-site power distribution cables. On the day of the accident, the surface of the concrete (surface layer) was being torn up.

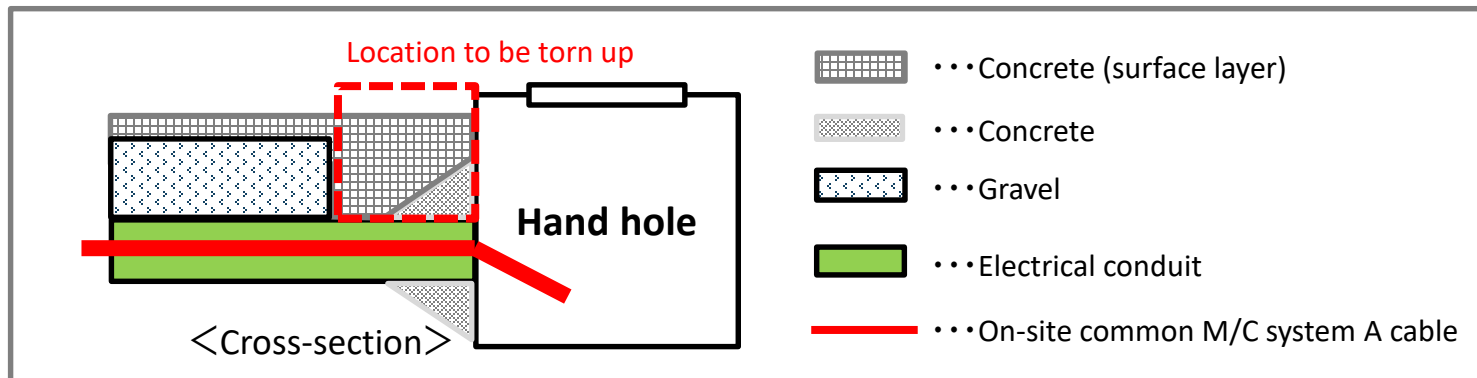
- On the day of the accident, concrete paving (surface layer) was to be torn up so a work team (work team leader: 1, workers: 3) was engaging in said work in accordance with the guidelines.
- In the area to be torn up (near the hand hole), the concrete paving is integrated with the concrete portion that secures the buried electrical conduit and the hand hole.
- Therefore, the aforementioned work team continued to tear into the concrete portion that secures the buried electrical conduit and the hand hole, thereby damaging the buried electrical conduit and the cable inside.

- TEPCO and the aforementioned contractor inspected the work site together prior to this construction and were both aware that there was a buried electrical conduit and a live cable underneath.
- TEPCO was aware of the risk of the cable being damaged during the course of this construction, but on this particular day, only the concrete paving (surface layer) was to be torn up so TEPCO estimated there is no risk of damaging the cable. Therefore, TEPCO did not instruct the contractor to give particular precautions to the work team.
- The aforementioned contractor made the same estimates as TEPCO, and therefore did not give particular precautions to the work team.

- During risk assessments performed prior to work close to charging area\*, TEPCO shall identify particular precautions for work team based on the pre-work field inspection, and make sure that the contractor thoroughly instructs all members of its work teams to take precautions.

- Regardless of the details of the construction, when work close to charging area is being performed, a risk assessment that assumes the risk of cable damage shall be performed and it shall be deliberated whether or not the power should be turned off during such construction and whether or not the work plan should be revised.

- When work close to charging area is being performed, for example, this work to tear up the concrete paving (surface layer), pre-work inspection shall be made beforehand, and TEPCO employees shall be on-site to observe.

- In light of the risk assessment and the instruction by TEPCO, the aforementioned contractor shall identify in detail the precautions that should be taken based on the pre-work field inspection for each daily task, and shall thoroughly convey this information to work teams through TBM-KY, and field KY.
