## Addressing the Decrease in Water Level in the Unit 2 Spent Fuel Pool Skimmer Surge Tank

# Unit 2 SFP: Water temperature gauge/water level meter installation (implemented on August 16)

# Unit 2 reactor building, third floor, inside FPC pump room: Field investigation results (conducted on August 16)

# Unit 2 reactor building, third floor, inside FPC heat exchanger room: Field investigation results (conducted on August 17)

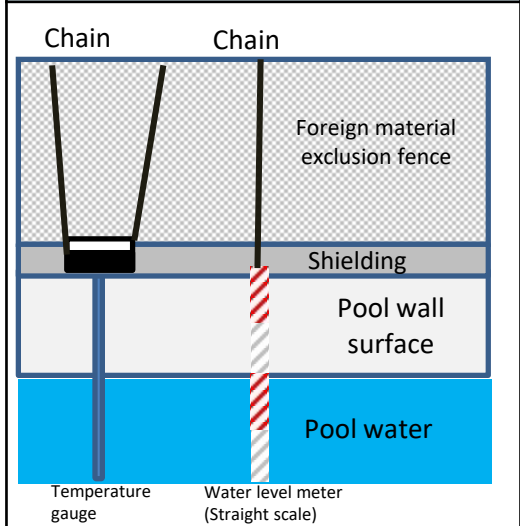
<p>Installed on the south side of the fuel pool</p>

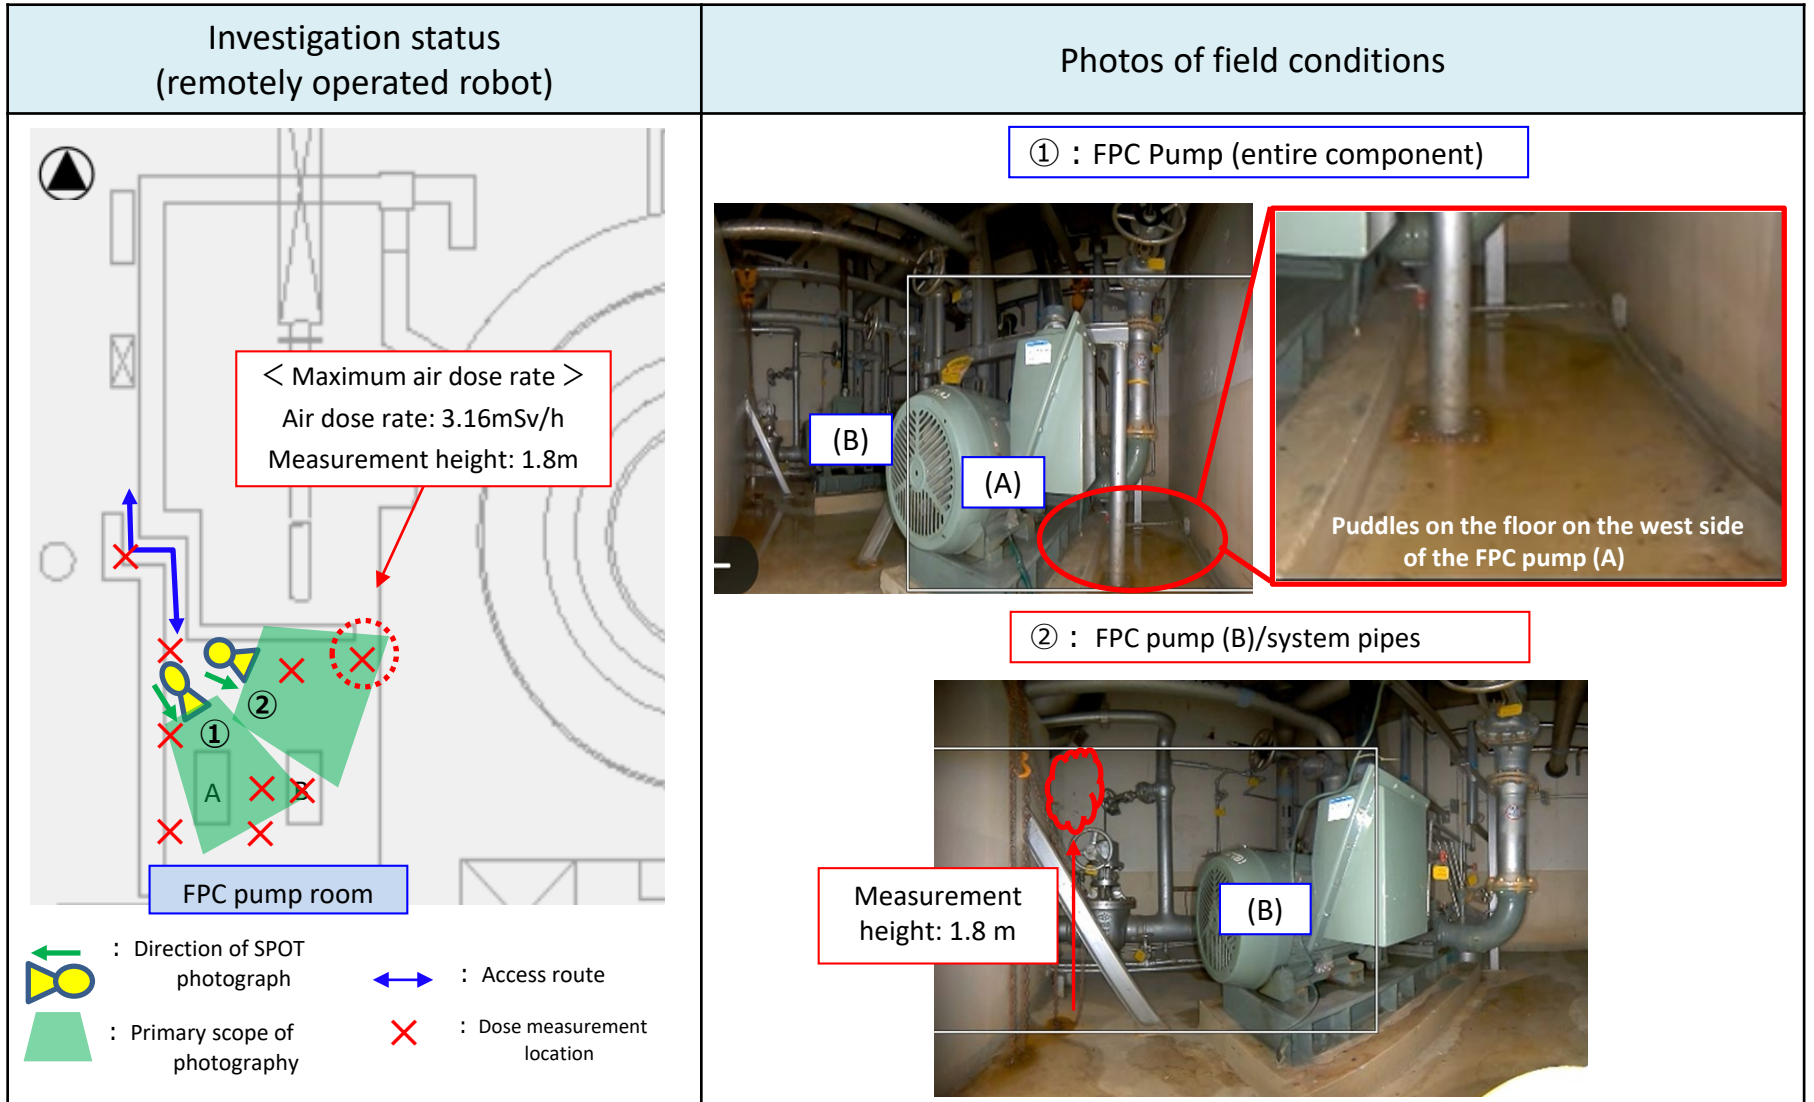
- Puddles were found on the floor on the west side of the FPC pump (A) but no leaks were seen from equipment, pipes, or valves, etc.
- Air dose rates taken at nine locations found the air dose rates ( $\gamma$ ) to be between 0.60~3.16mSv/h

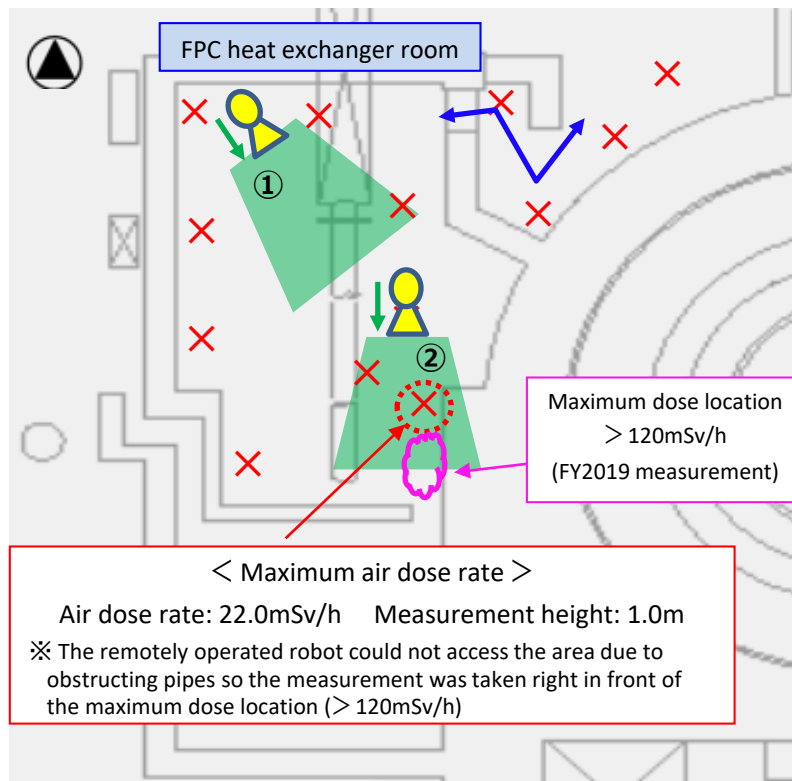
## Investigation status (remotely operated robot)

- Puddles were found on the north side of the FPC heat exchanger but no leaks were seen from equipment, pipes, or valves, etc.
- Air dose rates taken at 13 locations found the air dose rates ( $\gamma$ ) to be between 2.03~22.0mSv/hour.
