Causes and Countermeasures for Suspension of Unit 2 PCV Fuel Debris Trial Retrieval

September 5, 2024

Tokyo Electric Power Company Holdings, Inc.

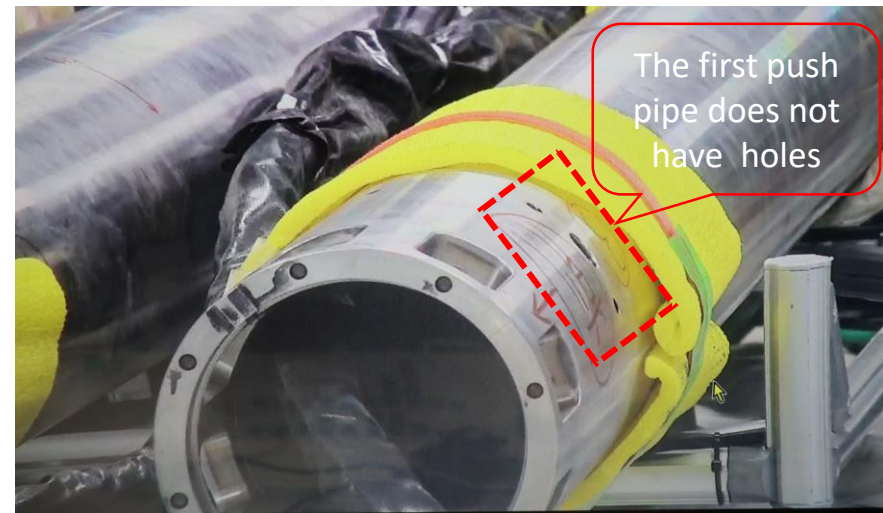
- At the site, it was confirmed the push pipe that should have been in the first position was in the fourth position. (The order was ②→③→④→①→⑤, whereas it should have been ①→②→③→④→⑤)

Installation status of push pipes

Reference : The end of the second push pipe (③)

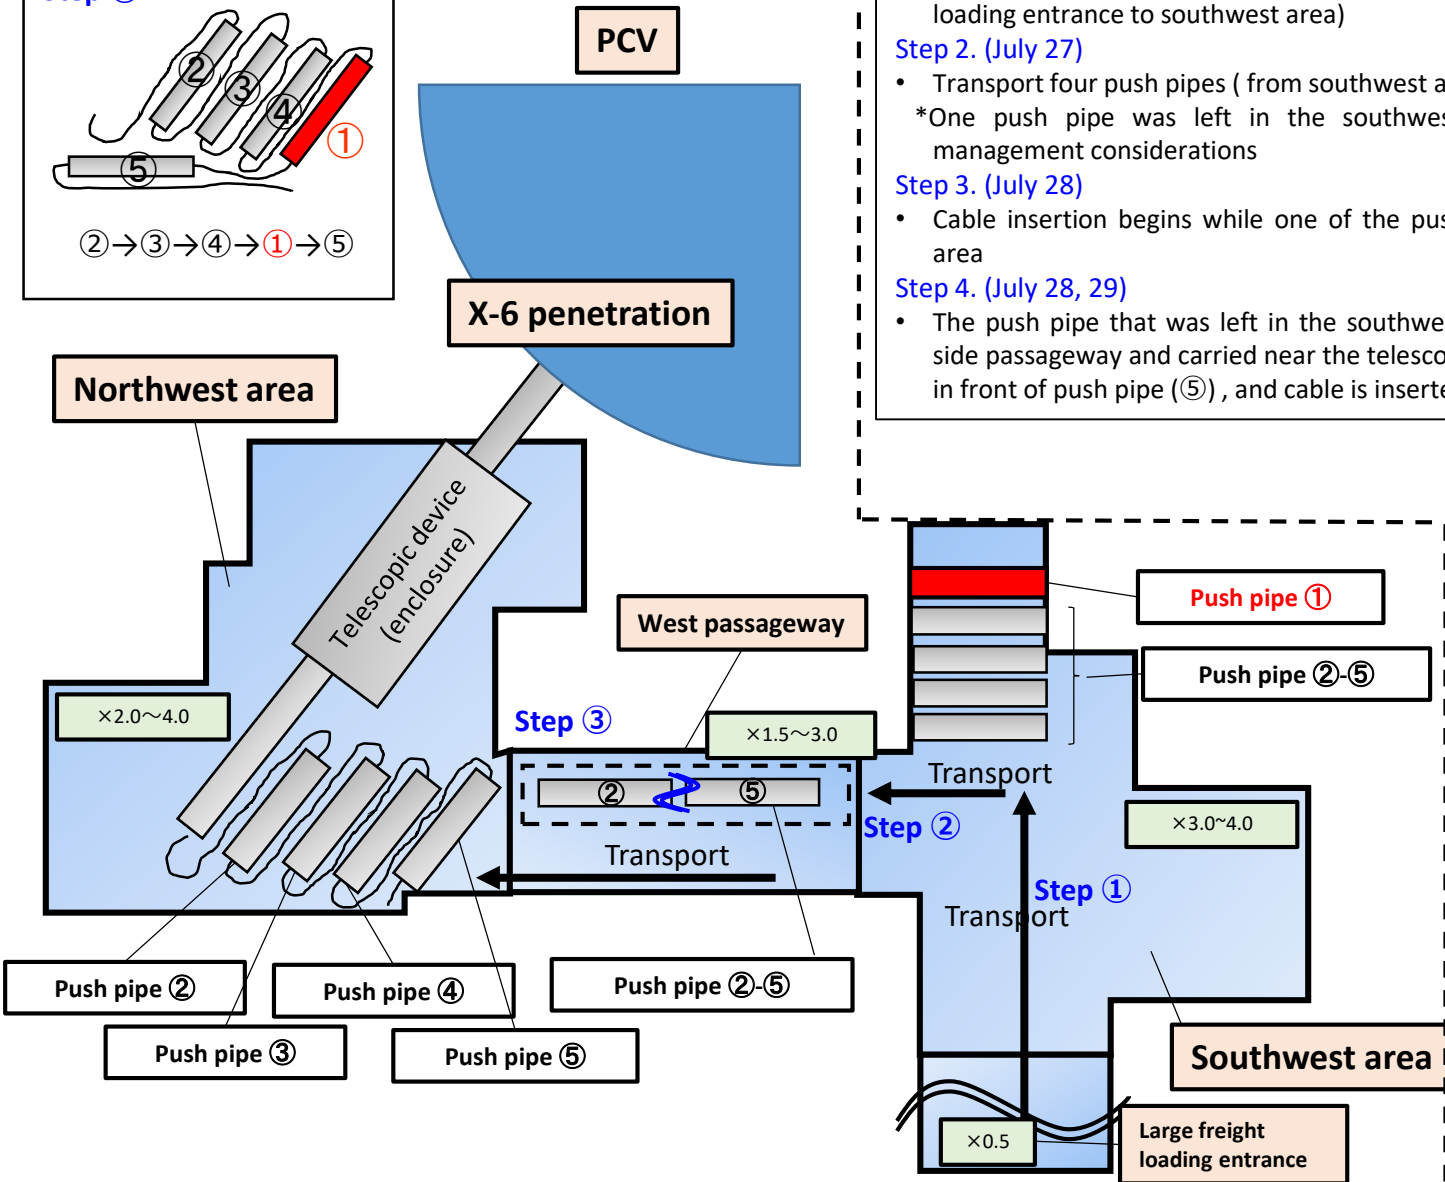
3. Chronological order of events for push pipe installation and field conditions (July 27-29) **TEPCO**

- Transport four push pipes (from southwest area to west side passageway)
- *One push pipe was left in the southwest area due to exposure dose management considerations

- Cable insertion begins while one of the push pipes is still in the southwest area

- The push pipe that was left in the southwest area (①) is unpacked at west side passageway and carried near the telescopic device. The pipe is positioned in front of push pipe (⑤) , and cable is inserted inside.

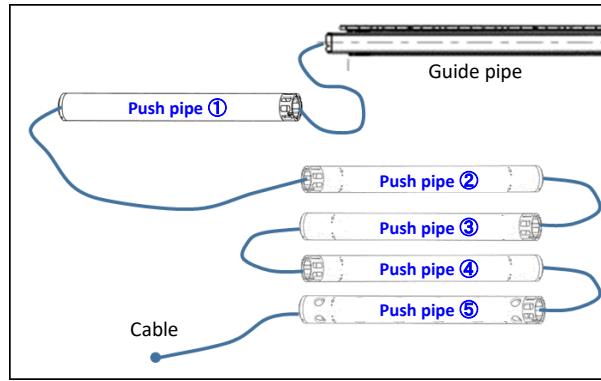
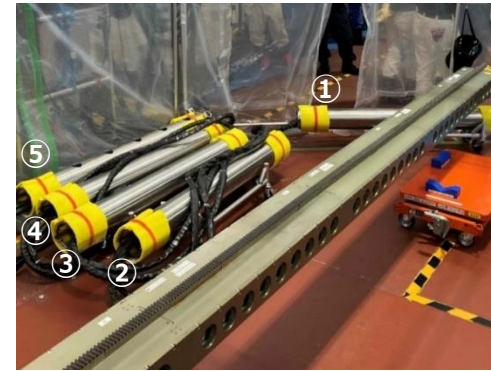
Position of the push pipes during the training in simulated environment
(Correct position)

Five push pipes were positioned while considering the cable wiring

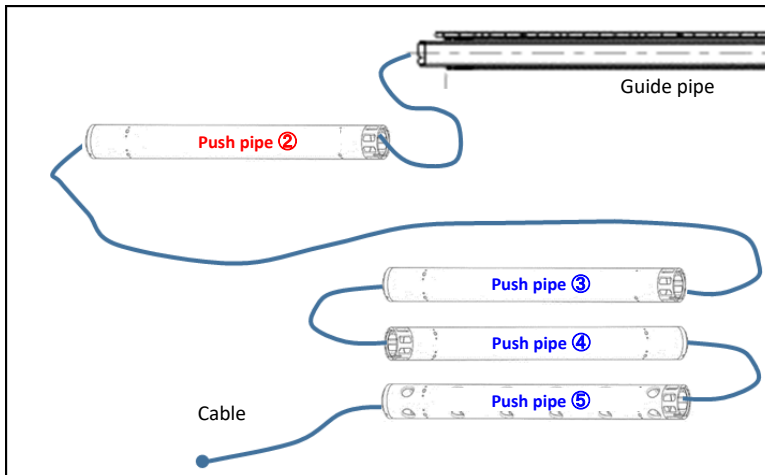
Position at the site (As of July 28)

- d. On July 28, Assuming that all five push pipes had been carried in the primary contractor work manager gave instructions to the contractor workers to start inserting the cable. The contractor workers followed the instructions from the primary contractor and started inserting the cable into the push pipes. Even though there were only four at the worksite (push pipes ②～⑤), they mistakenly recognized that push pipe (①) was already installed in the telescopic device and inserted the cable into the push pipes in the order of ②③④⑤.

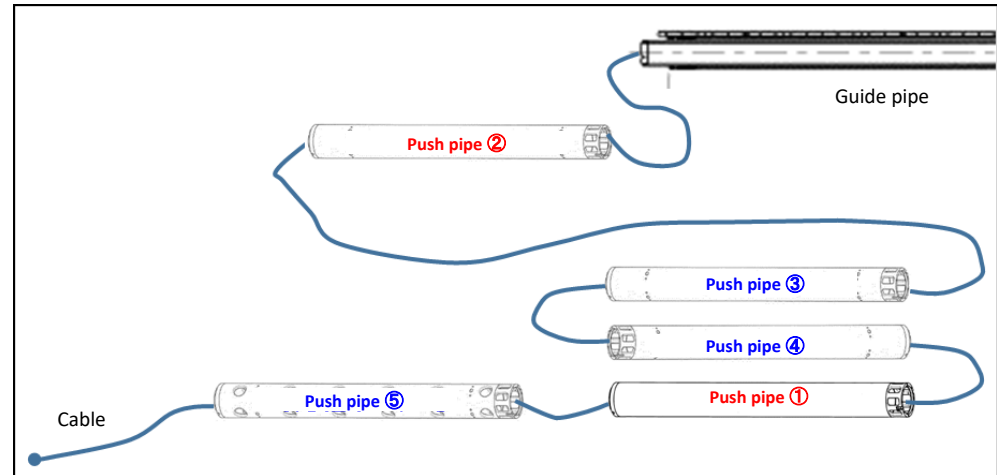
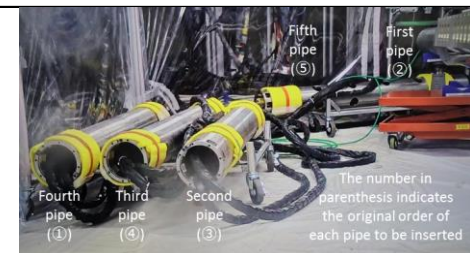
Position as of July 29 (when the push pipe ① was added)

- h. Since push pipes ②③④ are of the same design, the primary contractor work manager decided that inserting the aforementioned push pipes without ⑤ (actually ① which he thought was ②) would not cause any functional problems and would be logical from the perspective of reducing exposure, so he gave instructions to insert the aforementioned push pipes without ⑤ (actually ① which he thought was ②) , and the contractor workers complied with his instructions. The contractor workers positioned the push pipes as instructed by the primary contractor work manager and the task was completed.

The push pipe ① was positioned between the push pipes ④ and ⑤, changing the position as of July 28.
The photo of the position is as on the right.

- We will reconfirm and newly examine the entire fuel debris trial retrieval process, including preparatory tasks, from the perspective of field workers. (Personnel that have experienced performing difficult tasks in the field have been recruited to help with this re-checking and process examining)
- Upon doing this, work processes shall be revised if necessary with more consideration for actual conditions in the field.
For example,
 - ✓ Clearly noting the position of the push pipes and the order of inserting the cables in the work procedures
 - ✓ Attaching additional identification markings to the push pipes
 - ✓ Rearranging the push pipes into the correct positions and inserting cables
