Status of the Investigation into Camera Malfunctions during the Trial Retrieval of Fuel Debris at Unit 2

Results of camera signal intensity measurements taken with instruments

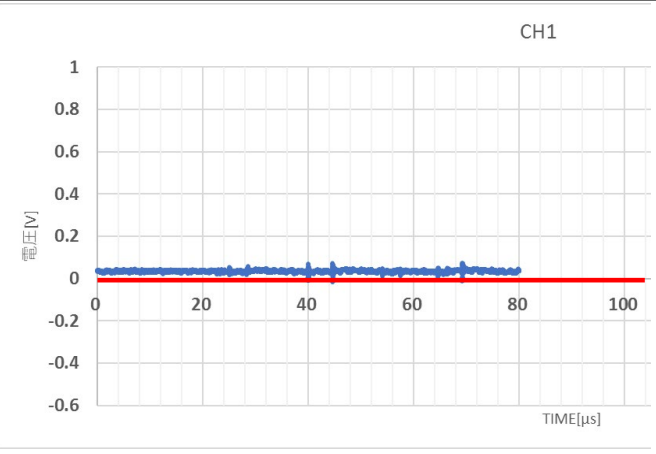
① End jig monitoring camera

■ When measuring the intensity of the camera signals on the end of the telescopic device (① End jig monitoring camera, ② Camera on the end of the arm) and other cameras, we confirmed a difference in signal behavior between of the cameras on the end of the device and other cameras.
