Fukushima Daiichi Nuclear Power Station Unit 2 PCV Internal Investigation/ Preparation Status of Fuel Debris Trial Retrieval

September 26, 2024

International Research Institute for Nuclear Decommissioning
Tokyo Electric Power Company Holdings, Inc.

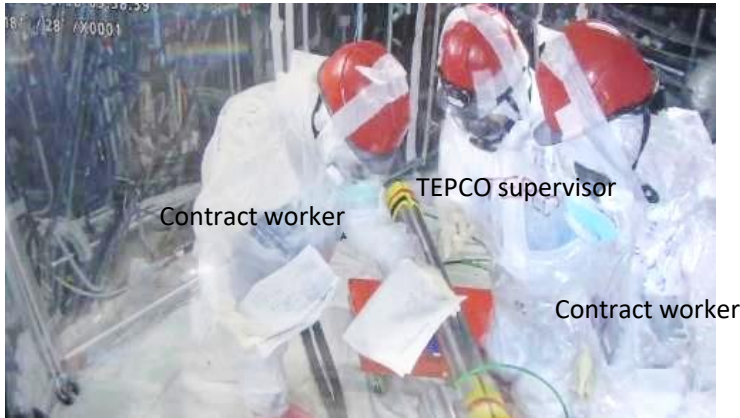
Rearranging push pipes in their correct order(field check)

- On September 6, “rechecking/examination of the entire work process”, “further revise procedures”, and the “checking/examination the task training and implementing additional countermeasures for insufficiencies” were completed. Therefore, on September 7-8, the order of the push pipes was corrected and a device function check was performed, and it was confirmed that there are no problems.

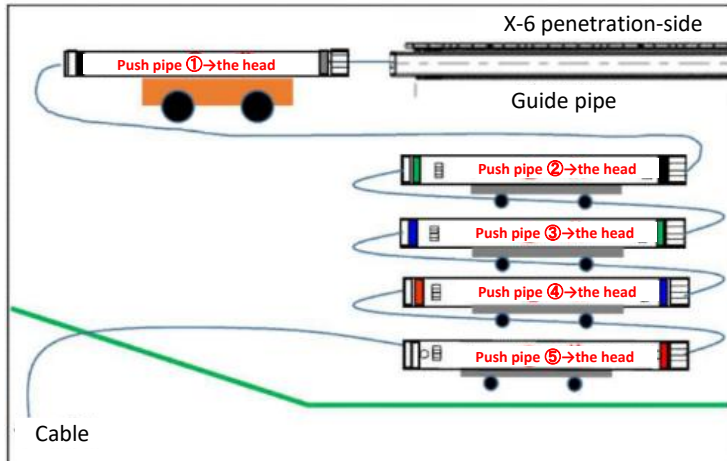
Image of completed push pipes restoration work

- The identification numbers were written in an easily visible position so that it can be identified by wearing full protective equipment and remote cameras as well as by visual inspection.
- Different color tapes were attached to the protective sheet at the end of the push pipes.

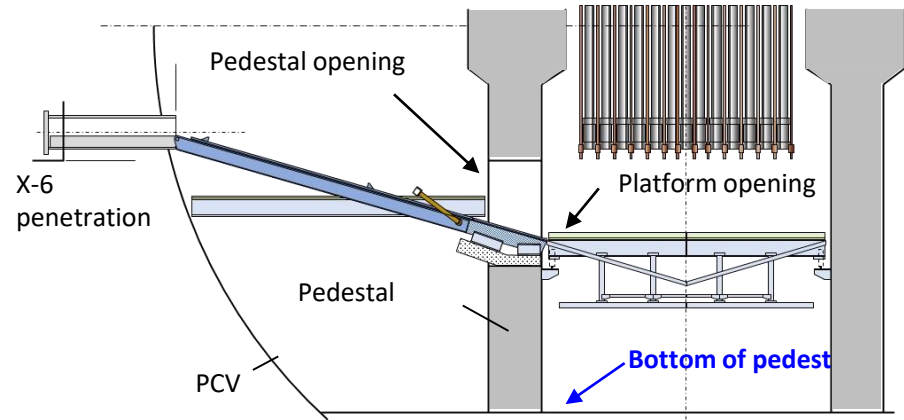
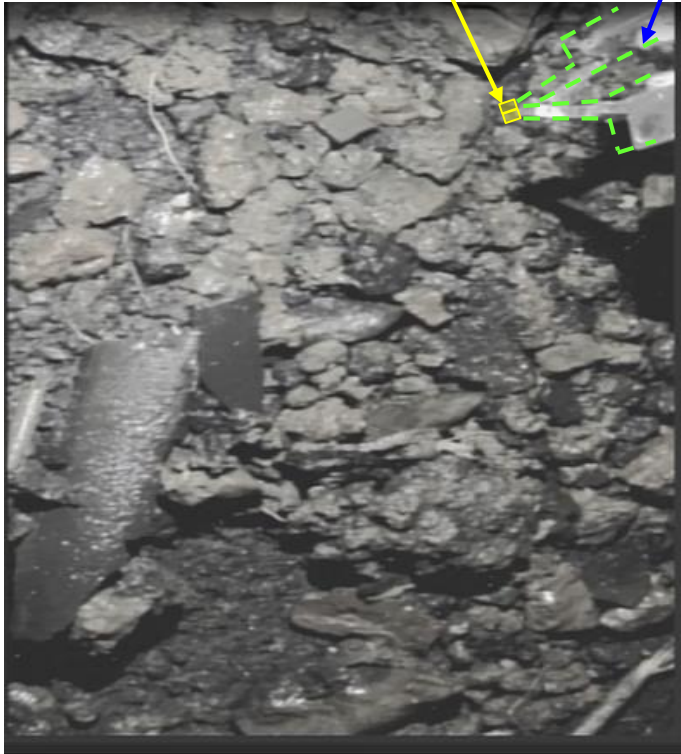
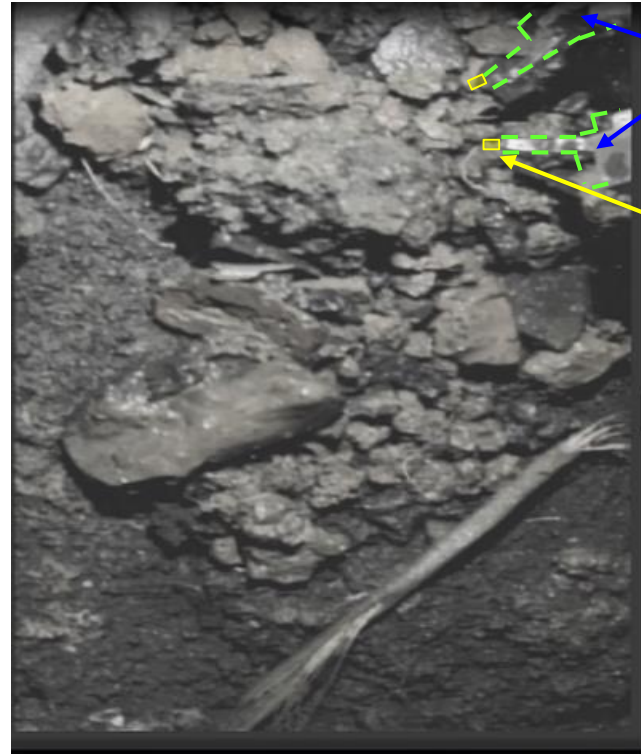
Footage from the telescopic arm camera (conditions at the bottom of the pedestal)

- On September 14, the telescopic device end jig was lowered to confirm conditions at the bottom of the pedestal. Fuel debris at the bottom of the pedestal could be seen via the end jig camera and the fuel debris was touched with the gripper tool.

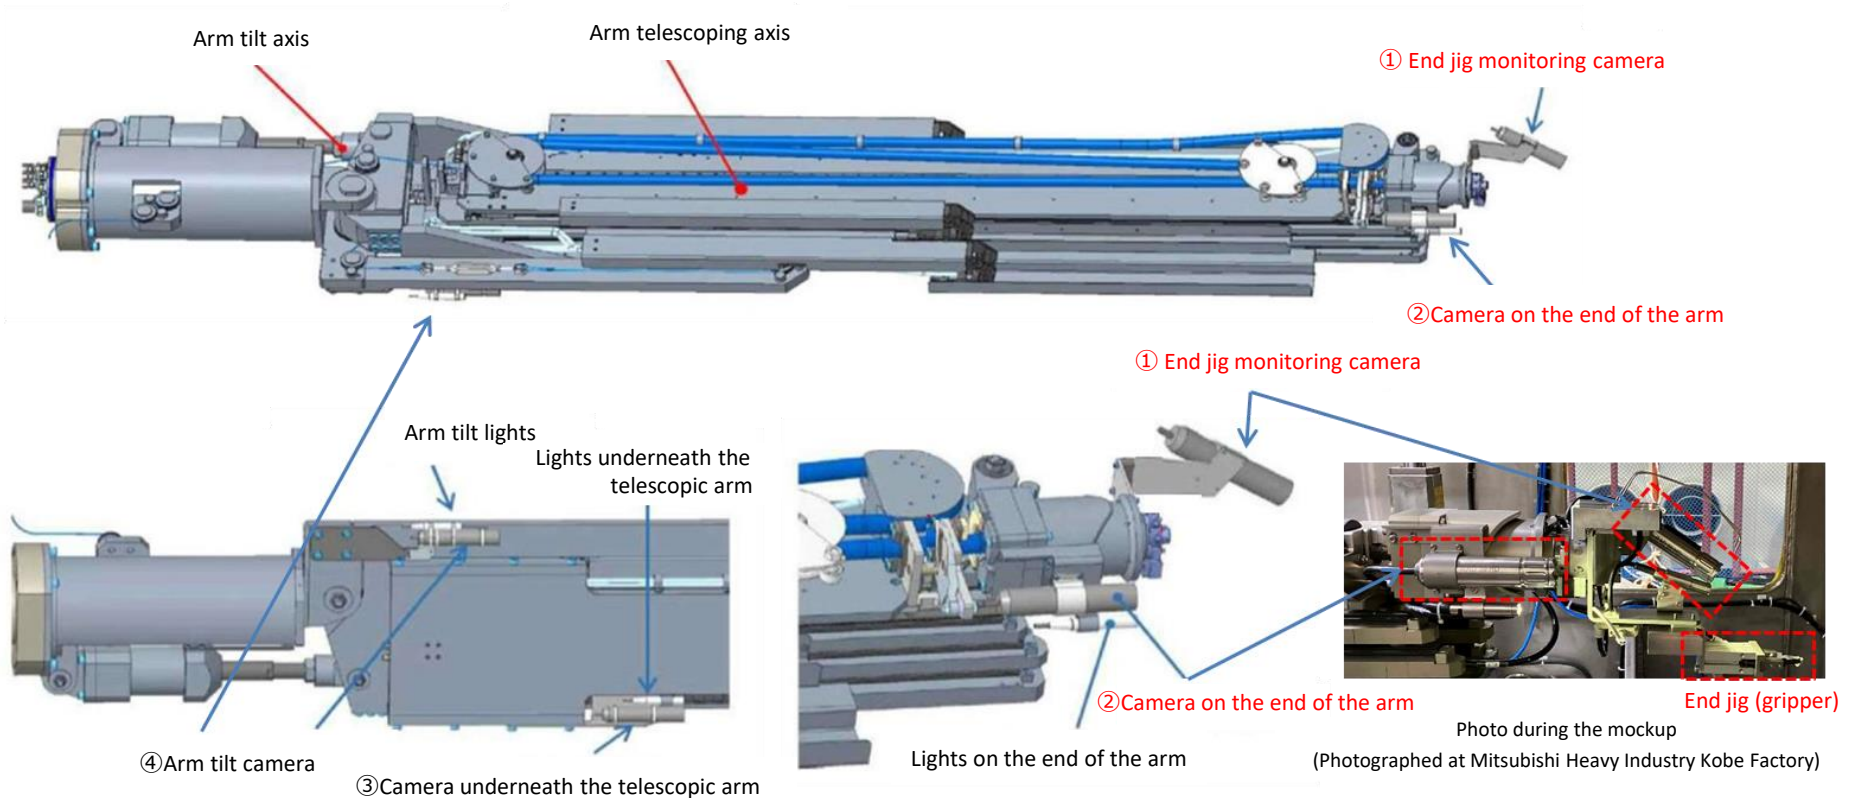
Cameras installed on the telescopic device

- On September 17, as a preparation to grasp fuel debris, conditions inside the primary containment vessel was being checked and a functions check of the telescopic device was being performed. As a result, it was detected that footage from the cameras on the end of the telescopic device (① End jig monitoring camera, ② Camera on the end of the arm) was not being sent properly to the monitors in the remote operations room for some reason.

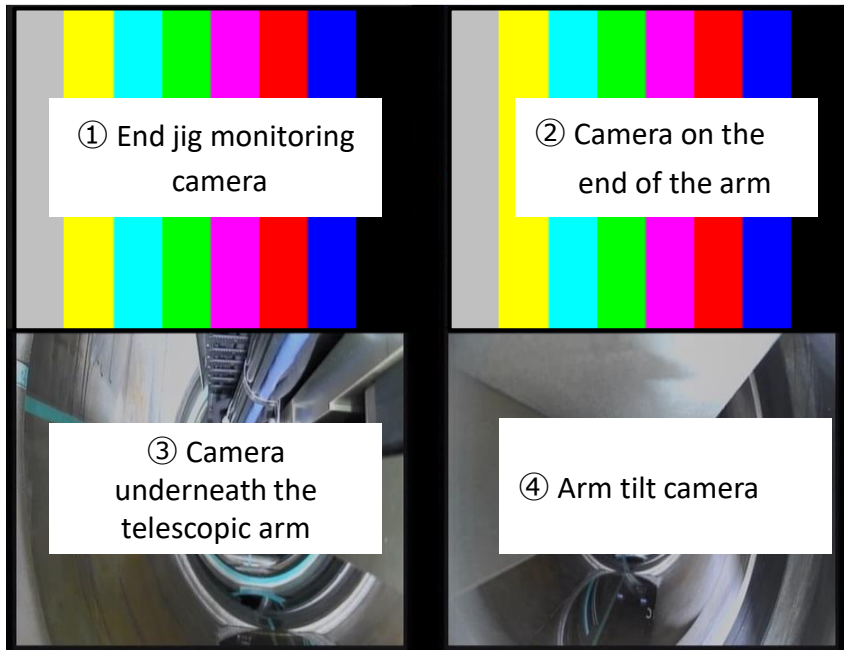
Prior to swapping video converter connections (reference photos)

- On September 17, cameras ① and ② out of the four cameras attached to the telescopic device were not sending video to the monitors in the remote operations room, and only the color bar test pattern was displayed.

- When the connections to the four video converters for each of the cameras were switched (changed connections of ① and ③), the monitors to which the problematic cameras were connected to displayed the color bar test pattern (refer to the images below) thereby confirming that there are no problems with signal wiring from the control panel in the reactor building to the remote operations room.

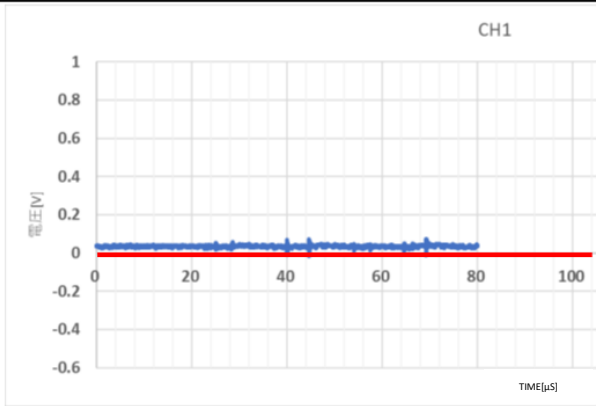
①End jig monitoring camera

- When measuring the intensity of the camera signals on the end of the telescopic device (① End jig monitoring camera, ② Camera on the end of the arm) and other cameras', we confirmed a difference in signal behavior between of the cameras on the end of the device and other cameras.

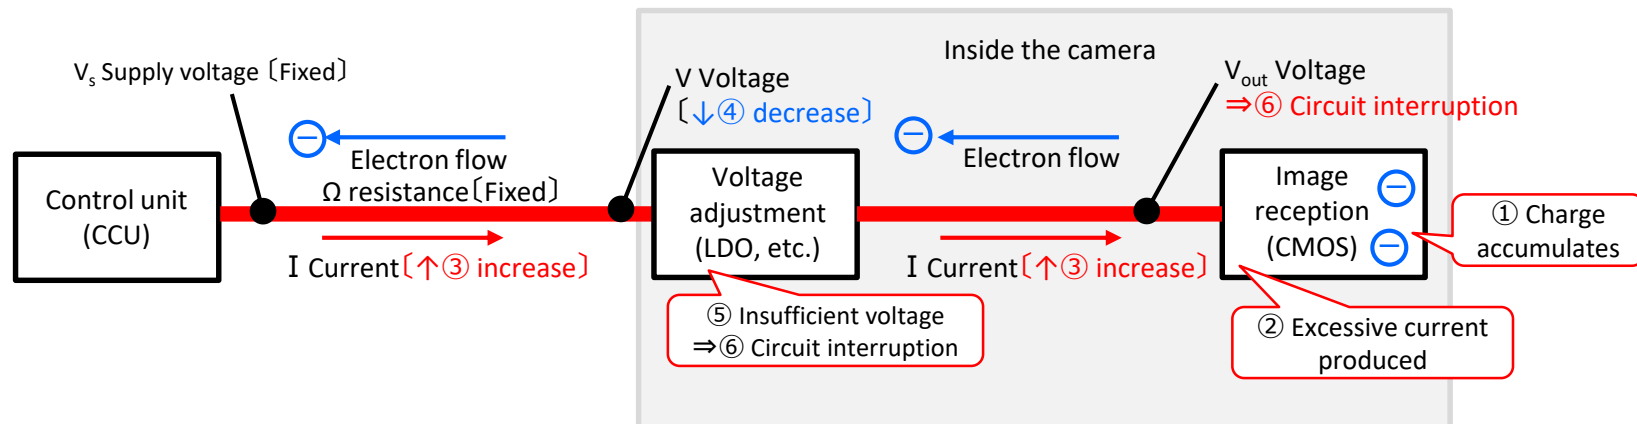
< Electrical charge mechanism >

- It is hypothesized that as radiation passed through the camera's semiconductor elements a large amount of electrical charge was created due to the ionization effect.

- An electrical charge is created when radiation passes through the semiconductor elements, but if the control device is off, this charge will accumulate in the camera circuits.

- When the control device is then turned on, excessive current will flow as a result of the accumulated charge the current and causing a drop in voltage to the camera thereby interrupting the camera circuits.

① A charge will accumulate as radiation passes through the semiconductor elements, but the charge will naturally want to dissipate

② When the control device is then turned on, excess current will flow as a result of the accumulated charge and increasing the current then causing a drop in voltage to the camera thereby interrupting the camera circuits

- Considering this mechanism, if the power to the cameras is left on, the accumulated charge can be reduced since it is drained through the power circuit.

- As far as these malfunctions are concerned, the telescopic device has been brought back into the enclosure temporarily in order to inspect the appearance and the status of camera footage. Furthermore, the telescopic device will be left for several days inside the enclosure, which is a lower dose environment, and kept on standby while camera footage status is checked and the effect of the radiation can be examined. This is because the accumulated charge will be drained and the cameras may return to normal if the cameras put in a relatively lower dose environment and left on.

- If the camera footage does not return to normal, the cameras will be replaced.
