Cameras installed on the telescopic device

Examinations regarding replacement of the cameras

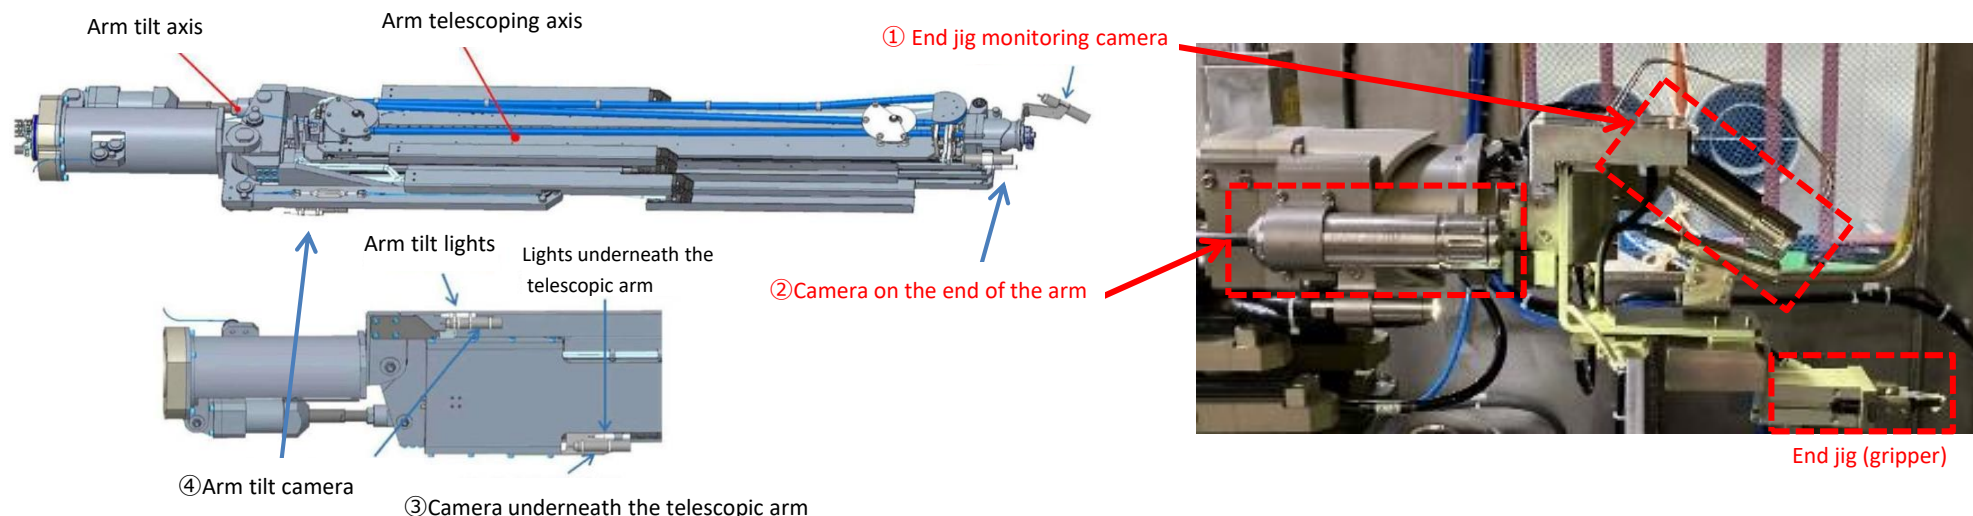
- On September 17, as a preparation to grasp fuel debris, conditions inside the primary containment vessel was being checked and a functions check of the telescopic device was being performed. As a result, it was detected that footage from the cameras on the end of the telescopic device (① End jig monitoring camera, ② Camera on the end of the arm) was not being sent properly to the monitors in the remote operations room for some reason.

- In order to investigate the cause of this incident, we inspected the camera cables, connection terminals, the outside of the video converters and their signals, and measured insulation resistance. One of the probable causes is that the high radiation may have caused the camera to temporarily shut down due to lack of voltage required to operate the camera. Therefore, we attempted to recover the cameras by maintaining their switch “on” and “off” in the enclosure, where the radiation is relatively low compared to the primary containment vessel. (However, the camera signals are still not being sent properly.)

- On October 4, we sent voltage higher than the usual to the cameras to check and examine the footage to see if there was any change in the cameras. (Again, no changes were observed in the status of the camera footage.)

- Going forward, we are reviewing tasks and the schedule, and making preparations to replace the cameras, then we will replace the cameras after confirming their feasibility.

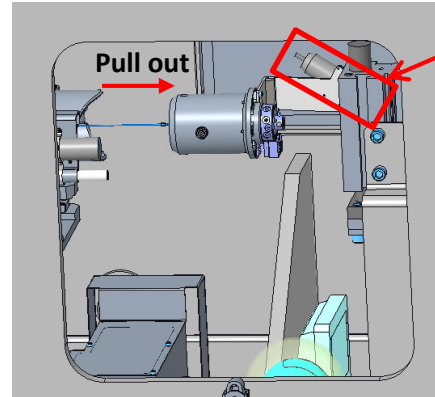
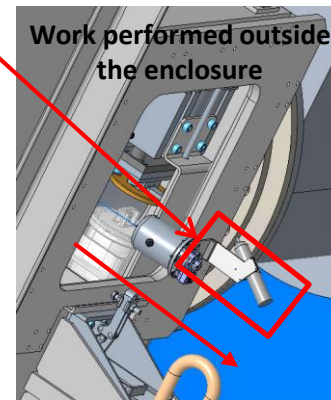
① End jig monitoring camera

- Since the “① end jig monitoring camera” can be removed from inside the enclosure, this it will be conducted outside the enclosure. “② camera on the end of the arm” is fixed to the arm, therefore it will take place inside the enclosure.
