Fukushima Daiichi Nuclear Power Station Unit 1

Pre-checks for an investigation of vicinity of the X-25 penetration

< Reference document >
November 18, 2024
Tokyo Electric Power Company Holdings, Inc.
Fukushima Daiichi Decontamination &
Decommissioning Engineering Company

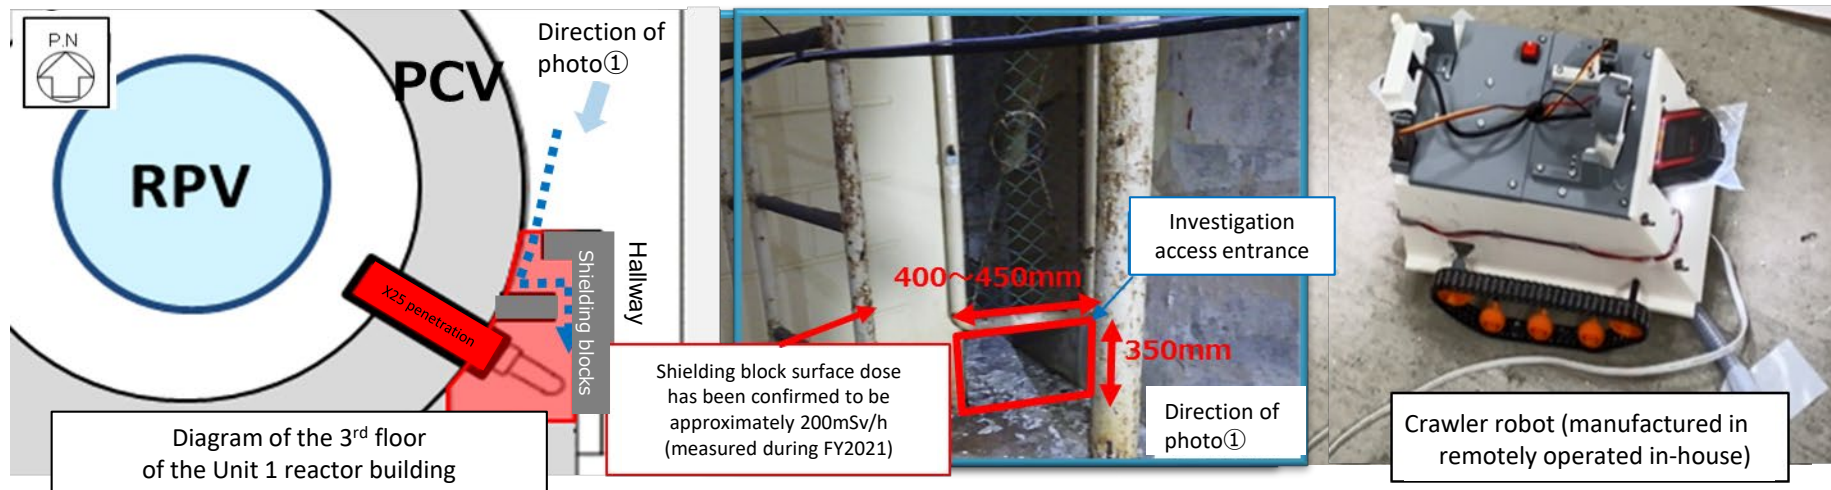
- During an investigation conducted in FY2021, we measured high dose rates of approximately 200mSv/hour in the vicinity of the X-25 penetration (outside the shielding blocks)* on the east side of the 3rd Floor of the Unit 1 reactor building. Based on these investigation results, we believe it is highly possible that there are high-dose areas that exist on the inside of the shielding blocks.

- * There are D/W vent pipes and valves on the inside of the shielding blocks that branch off from vent lines used during the accident, but the surface dose rates of the shielding blocks are higher than the branching pipe inlets, therefore we assume that the cause of the high dose rates is something other than the vents (refer to slide 3).

- In order to conduct a detailed investigation of high-dose areas, we have been identified, preliminary confirmation of accessibility to the inside of the shielding block will be conducted starting on November 19, 2024. Since the area inside the shielding blocks is narrow and a high-dose area, this check is being performed using a crawler robot. Video footage of the area is being taken along with air dose measurements.
- Based on the results of this pre-check, we plan to conduct the investigation using a combination of remote operated devices such as crawler robots and drones.
- The information obtained through the investigation will be used to hypothesize the route by which radioactive substances leaked during the accident and also examine methods for reducing dose rates in high-dose areas.

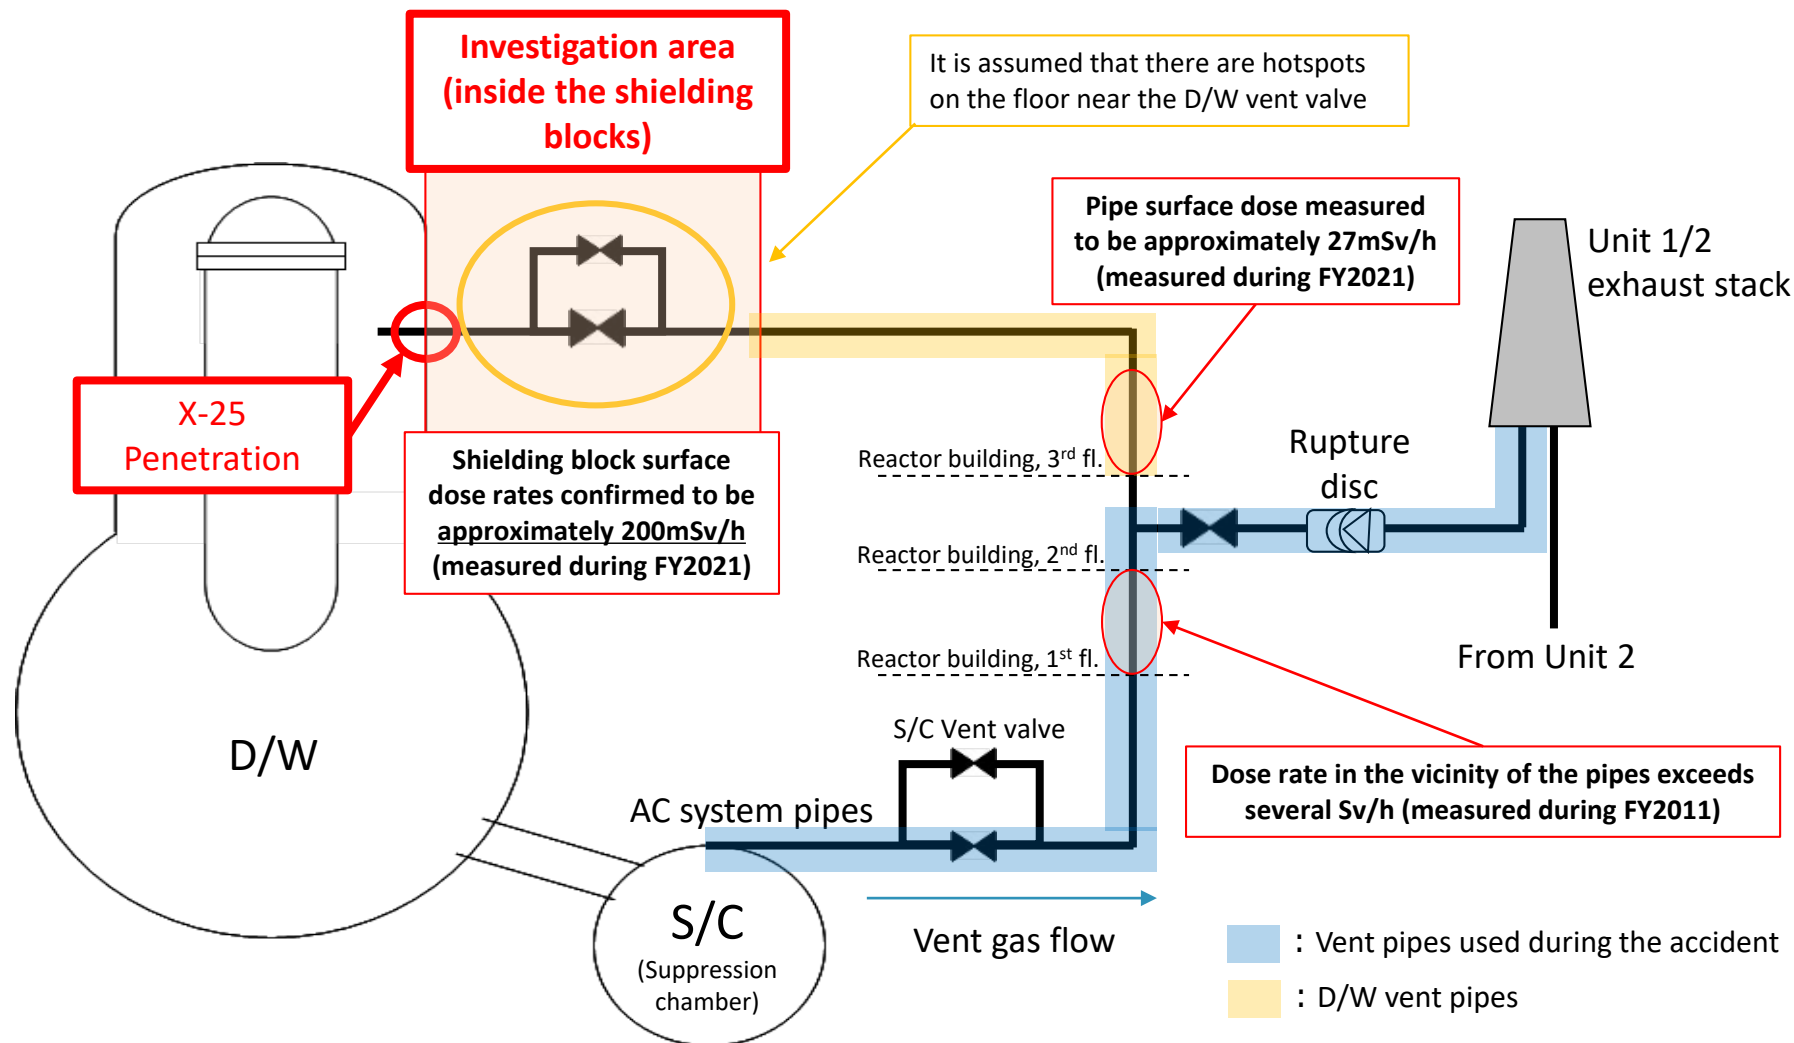
(Reference) Unit 1 AC system piping (vent piping) diagram

- The D/W vent piping branches off from the vent lines used during the accident but the dose rates in the vicinity of the investigation area (approximately 200mSv/h) are higher than the dose rates at the inlets to the branching pipes (approximately 27mSv/h), therefore we assume that the source of the high dose rates is something other than the vent.
