- We have been engaged in a scheduled shutdown of the Unit 2 spent fuel pool (SFP) primary cooling system ever since a drop in the water level of the skimmer surge tank (tank used to confirm that the spent fuel pool is filled with water) was noticed on August 9.

Investigation ② (Examining dissimilar metal joint welds)

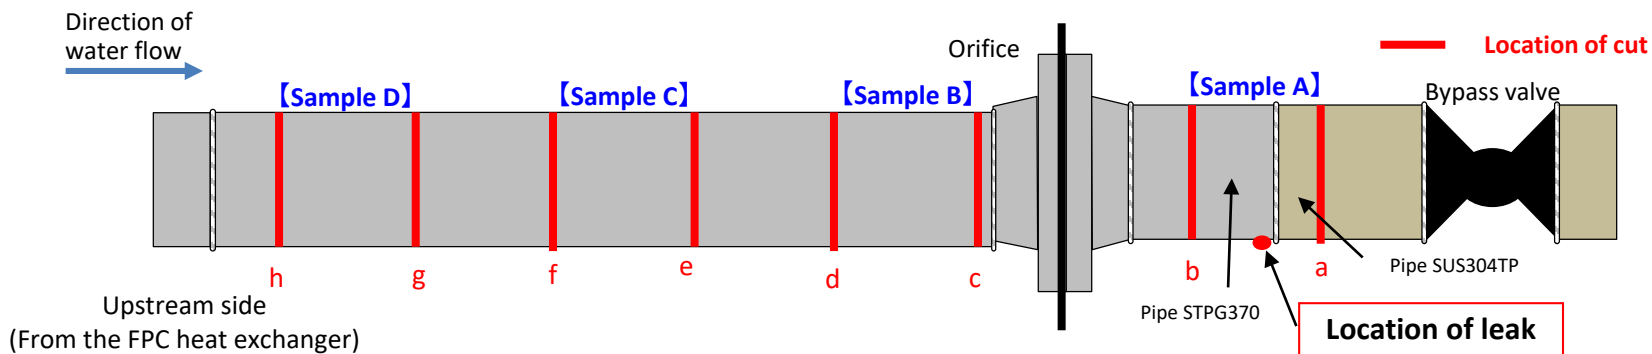
As shown below, samples A~D were cut out of the pipes in the vicinity of the leak to examine the status and composition of deposits inside them, measure the thickness of the pipes, and check for corrosion inside.

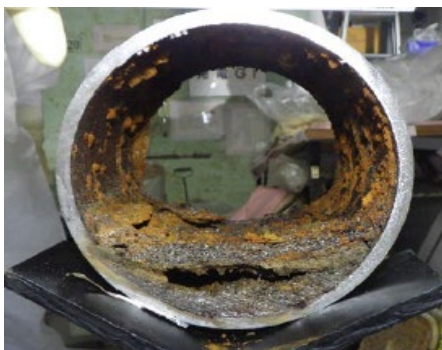
- Adhesions cover the inside of Samples A~D
- Most are iron oxide

Deposits inside the pipe (Sample B)

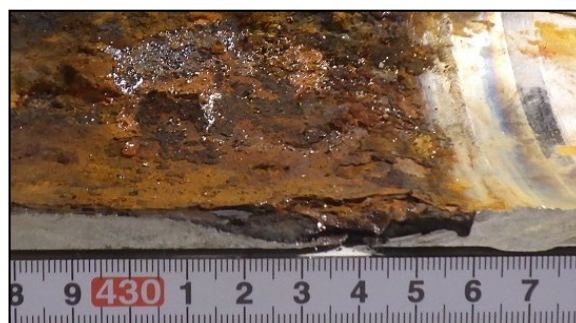
- Remarkable thinning of the carbon steel pipe was found near the leak location
- There was less thinning the further you move away from the weld of dissimilar metals

Remarkable thinning around the area of the leak (Sample A)

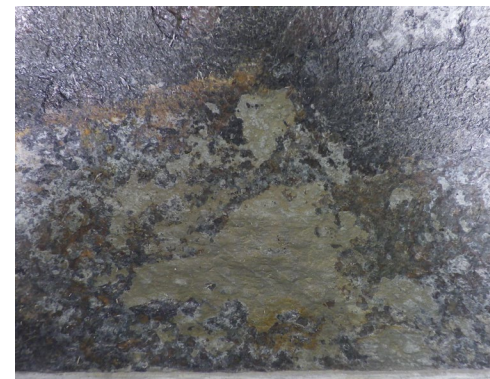
- The entire inside surface of Samples A~D were corroded

Corrosion inside the pipe (Sample D)

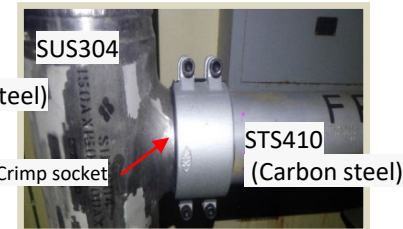
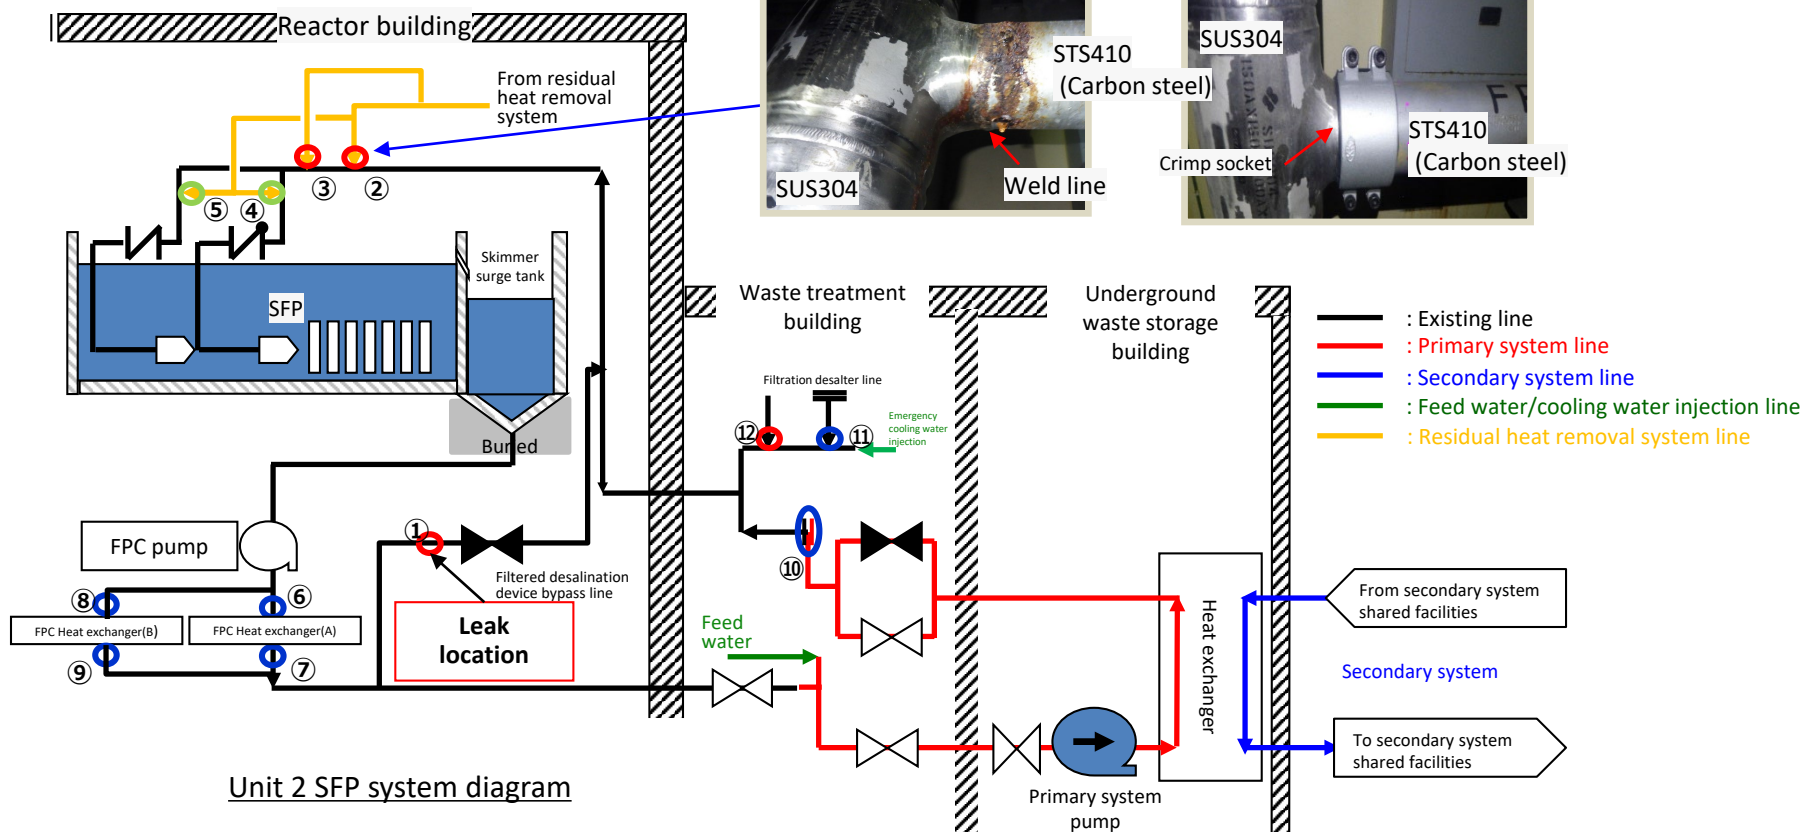
< Example of outer surface corrosion/repairs at location ② >

- Including the leak location (①), there were 12 dissimilar metal pipe welds.
- ② ③ ⑫ have corrosion that was found on the outer surface of the pipes at three locations (shown by the red circles).
- ① ② ⑫ have been repaired. ③ will be repaired by the time the primary cooling system is put back into operation.
- ④ ⑤ are embedded in frame concrete so the outer surface of the pipes cannot be examined (shown by the green circles).
- ✳ Water passage tests and trial operation have confirmed that there are no abnormalities such as leaks, etc.
- ⑥~⑪ were subjected to visual pipe inspections and pipe thickness measurements, and we've confirmed that there are no abnormalities (shown by the blue circles).

- Leak repairs
- Repairs to three pipe locations at which outer surface corrosion was discovered (Two locations have been repaired. The remaining one is scheduled to be repaired before the resumption of operation of the circulation cooling system)
- Configuration of a bypass line to be prepared for nonconformities involving the FPC pump or FPC heat exchanger

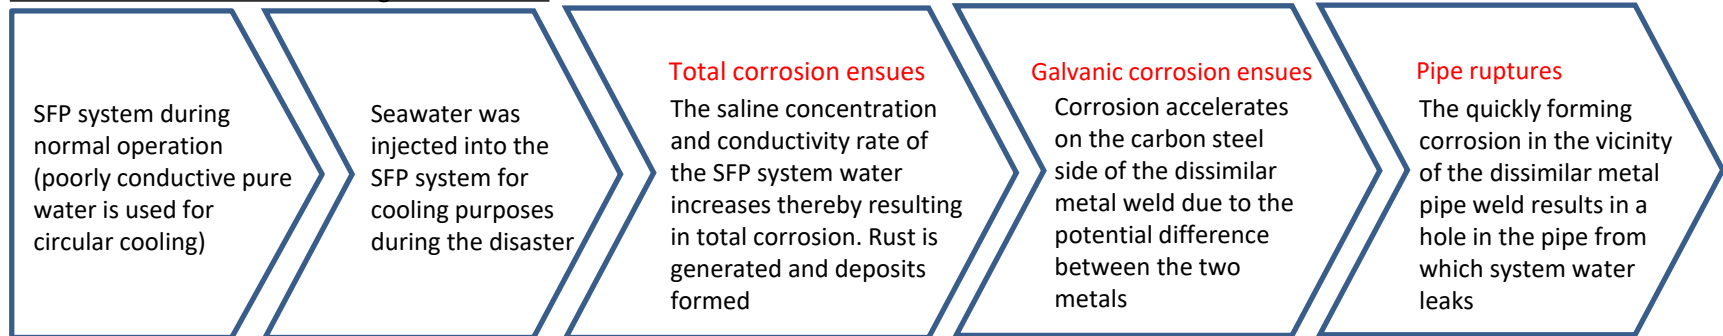
< Assumed mechanism resulting in the leak >

- Since seawater, etc. injected during/after the disaster, the system water in the Unit 2 SFP contained impurities and had increased conductivity.
- The leak locations is located near the area of a weld connecting two different materials, carbon steel and stainless steel.
- A recirculating cooling water was retained because the pipes in the leak locations has not been used after the disaster.

- While substantial thinning of the metal in the vicinity of the leak (on the carbon steel side of the dissimilar metal weld) was confirmed, the thinning dissipated the further away from the weld you got leaving sufficient pipe thickness.
- Deposits comprised of mostly iron oxide (metal rust) were found all over the inside of the pipes around the location of the leak
- Corrosion on the outer surface of the pipes was found at three other dissimilar metal pipe welds that are like the location of the leak.

- In addition to corrosion of the entirety of the inside of the pipes caused by an increase in the saline concentration of the system water, corrosion caused by the welding of dissimilar metals (galvanic corrosion) was found near the dissimilar metal weld, and it is this corrosion that resulted in the pipe rupture and the leak of SFP system water.

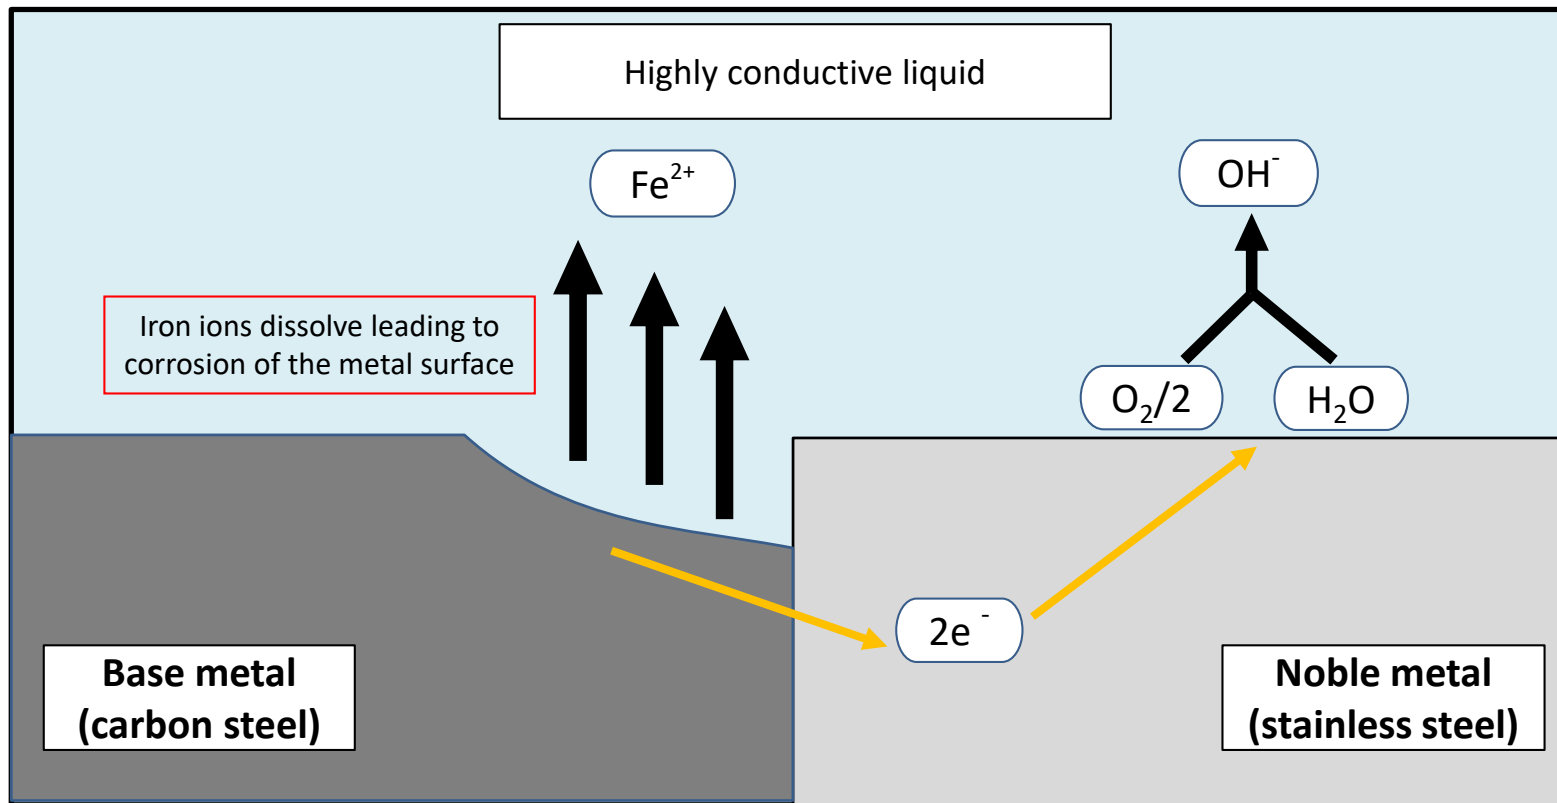
Phenomenon that occurs when dissimilar metals are in contact in a highly conductive environment, such as in saltwater. In conjunction with the migration of electrons, metal ions dissolve into the base metal side (side that loses electrons) causing corrosion.
